STAFF REPORT: 02-12-2020 MEETING

APPLICATION NUMBER: 20-6623

ADDRESS: 4060 STURTEVANT

SCOPE: REMOVAL OF STEEL CASEMENT/TRANSOM/SIDELIGHT WINDOWS; INSTALLATION OF FIBREX CASEMENT WINDOWS

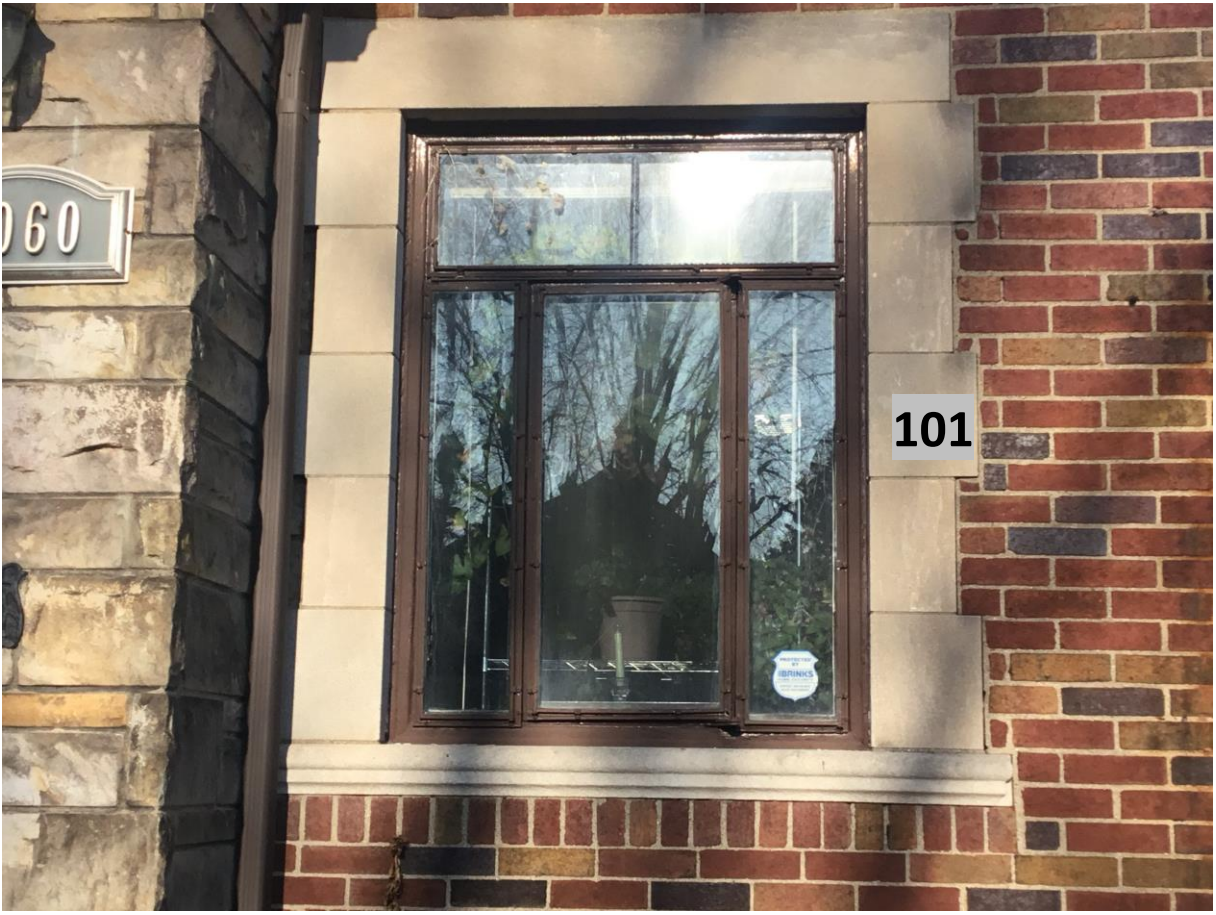
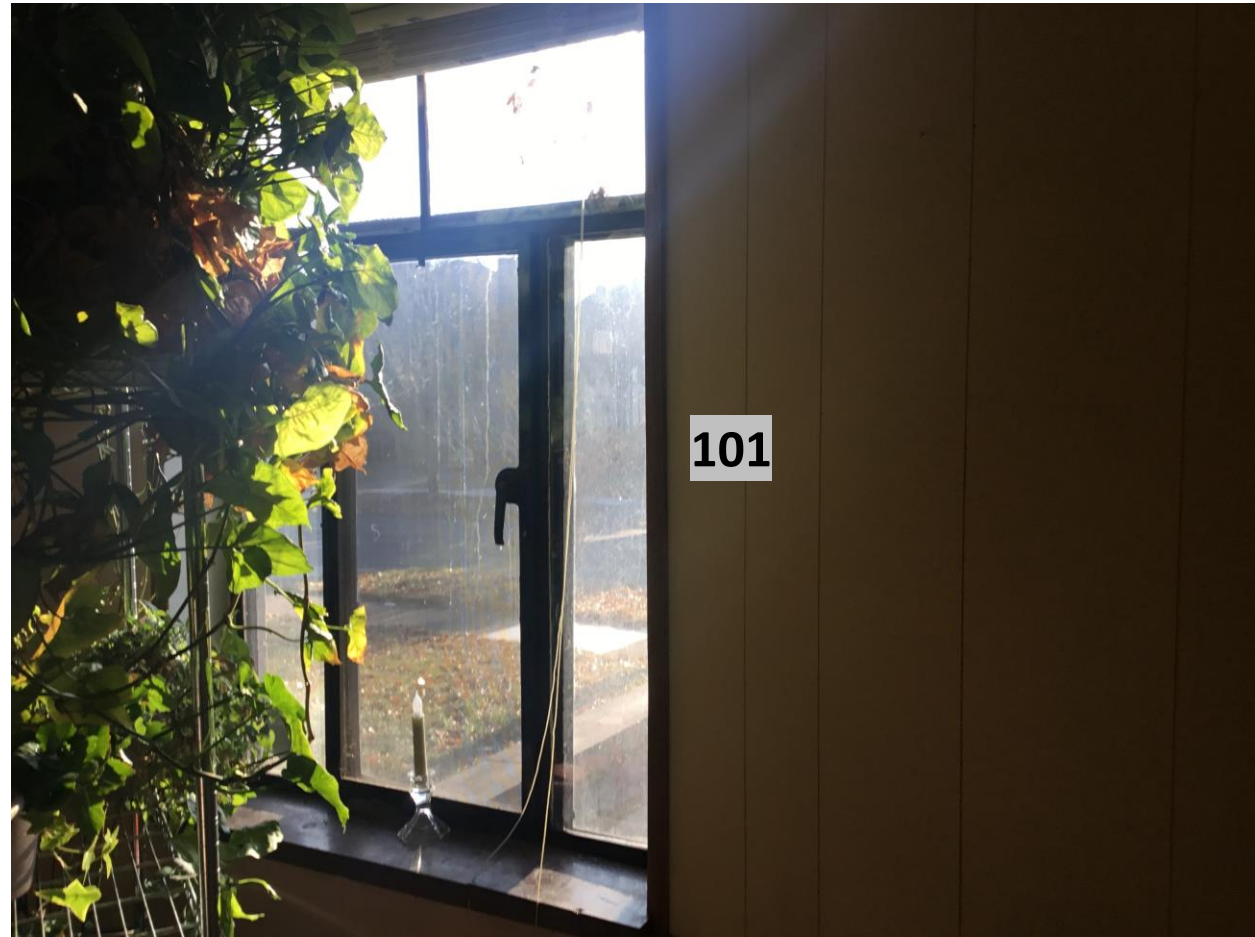
Unit 101

Existing:

- Unit does not have stained glass
- Center window opens

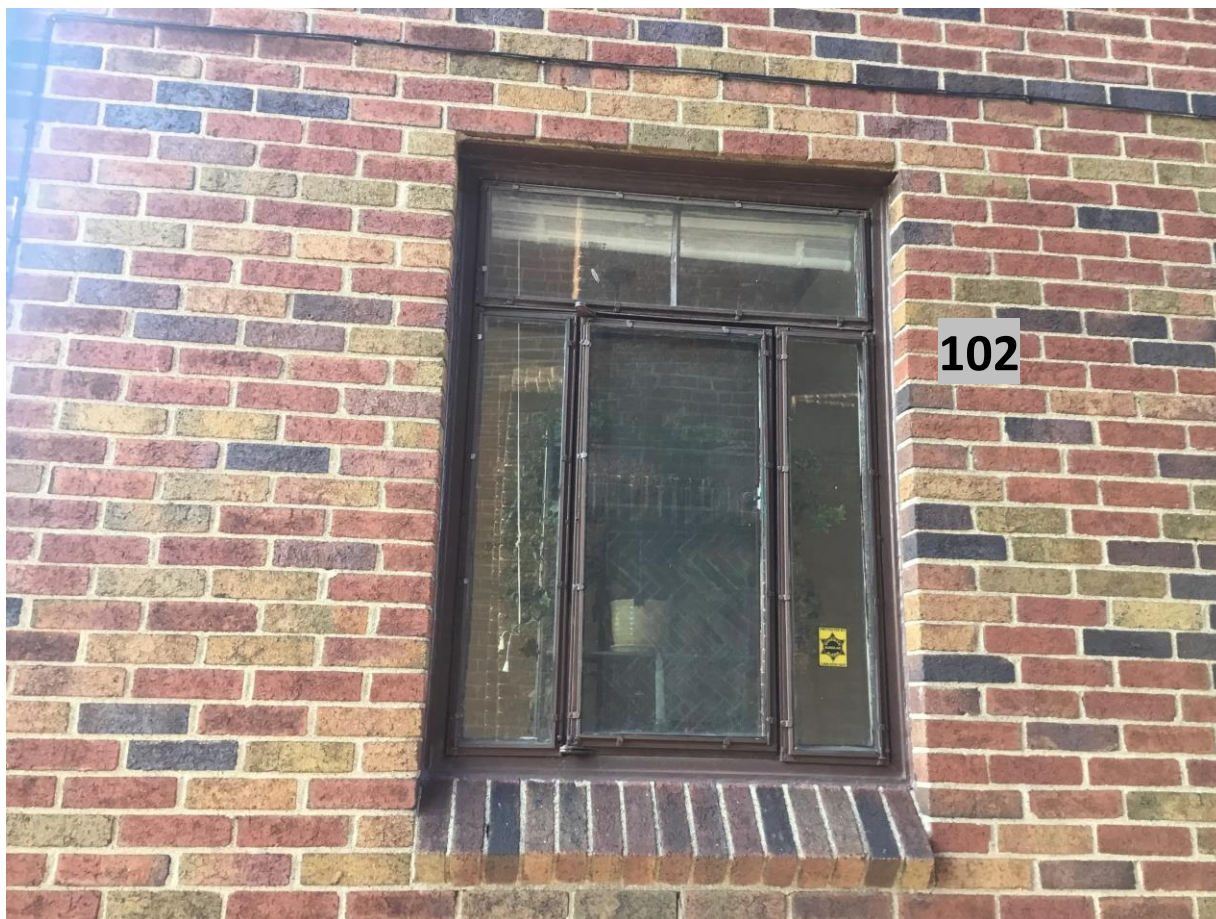
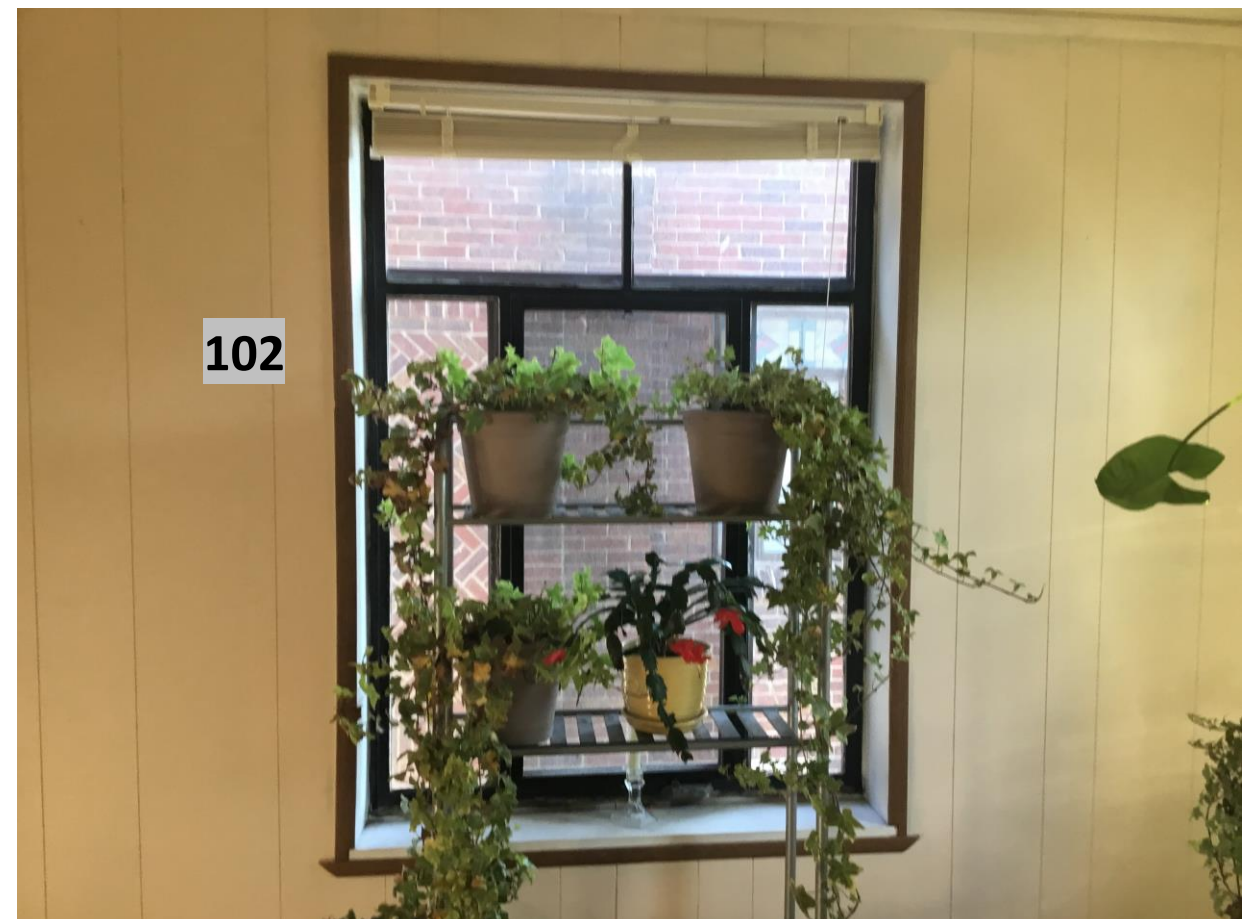
Unit 102

Existing:

- Unit does not have stained glass
- Center window opens

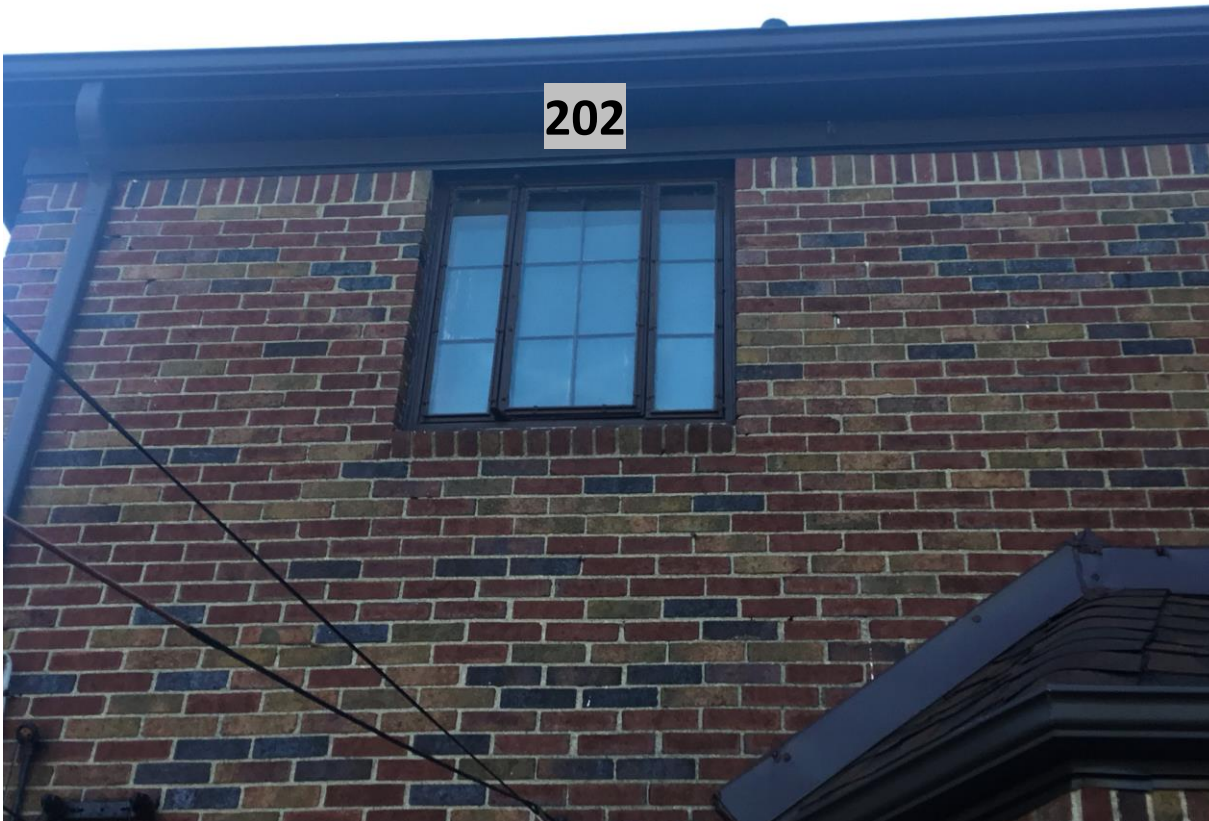
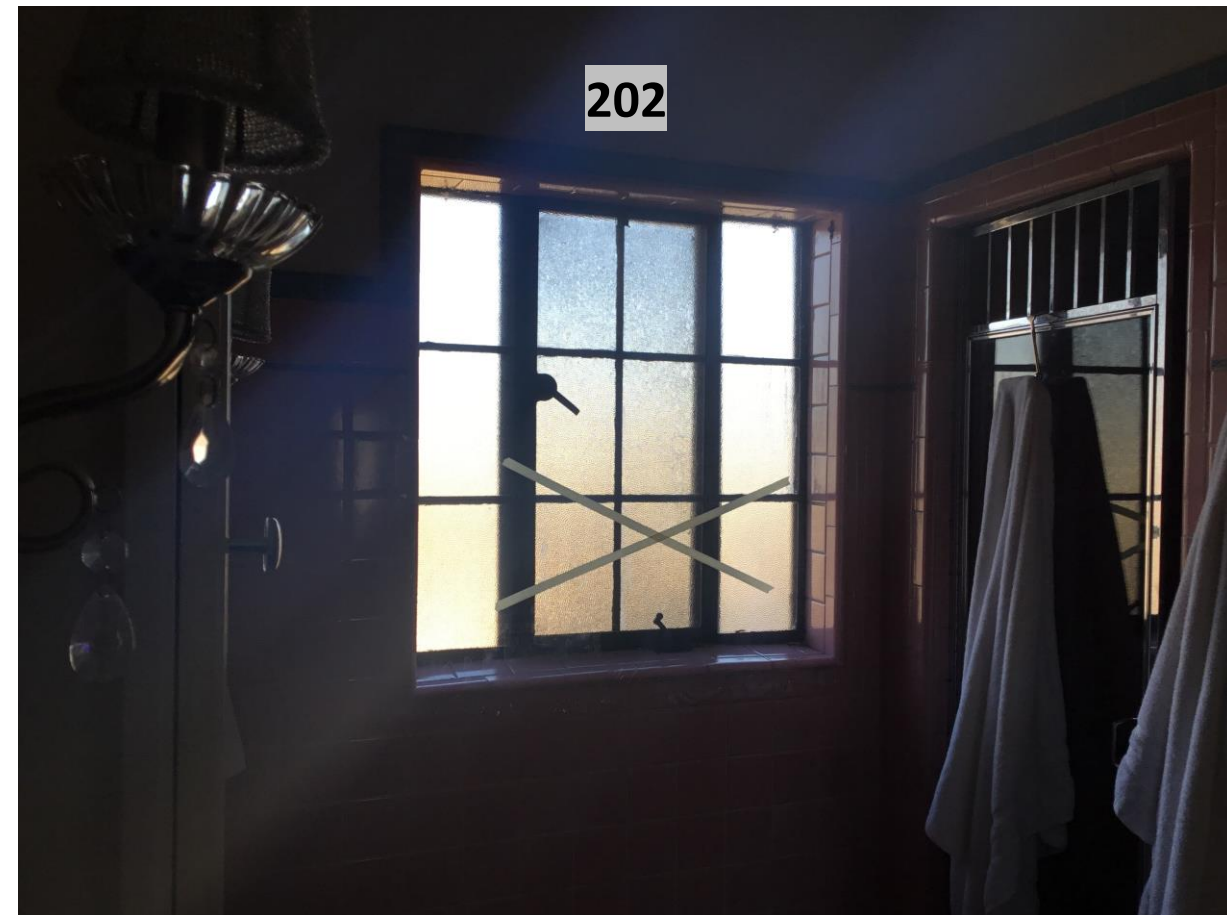
Unit 202

Existing:

- Unit does not have stained glass
- Center window opens
- Window is broken on interior

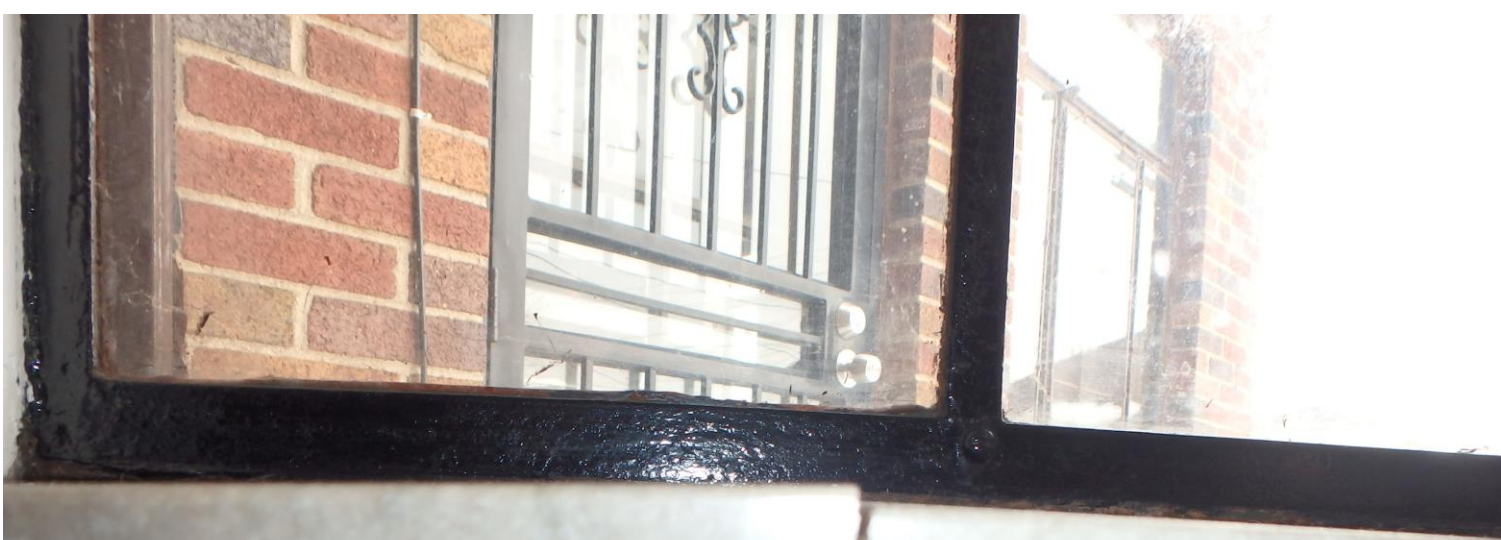
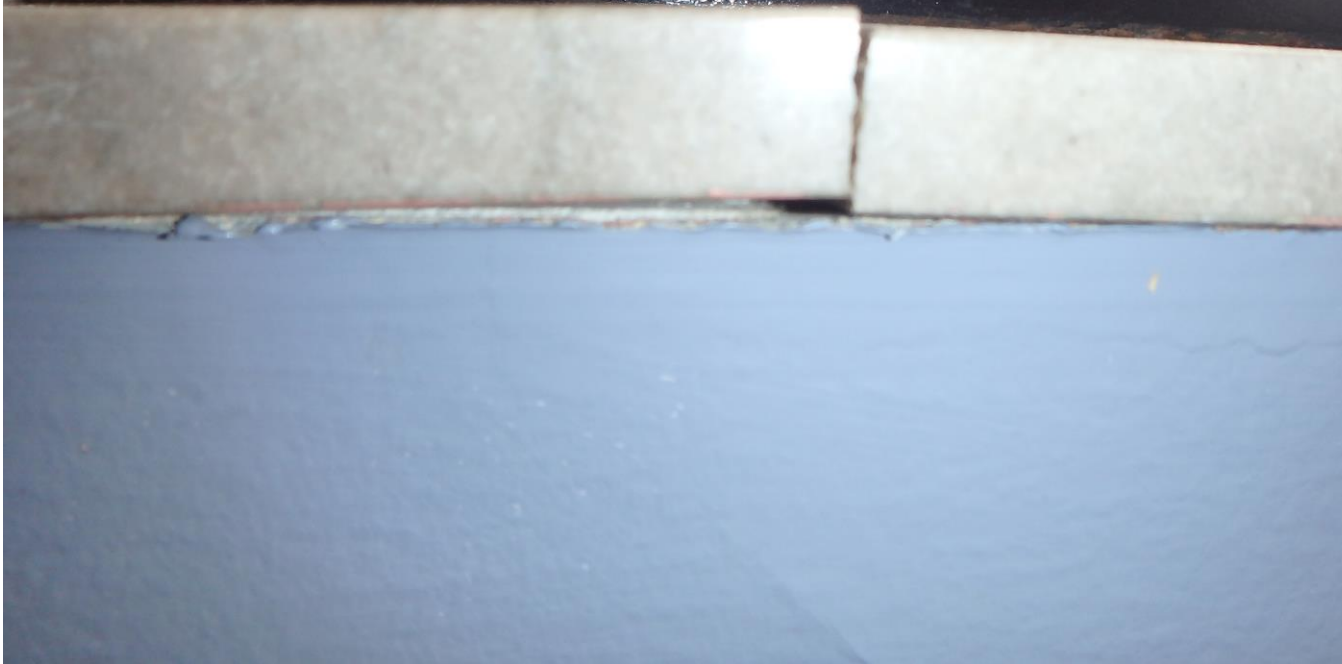
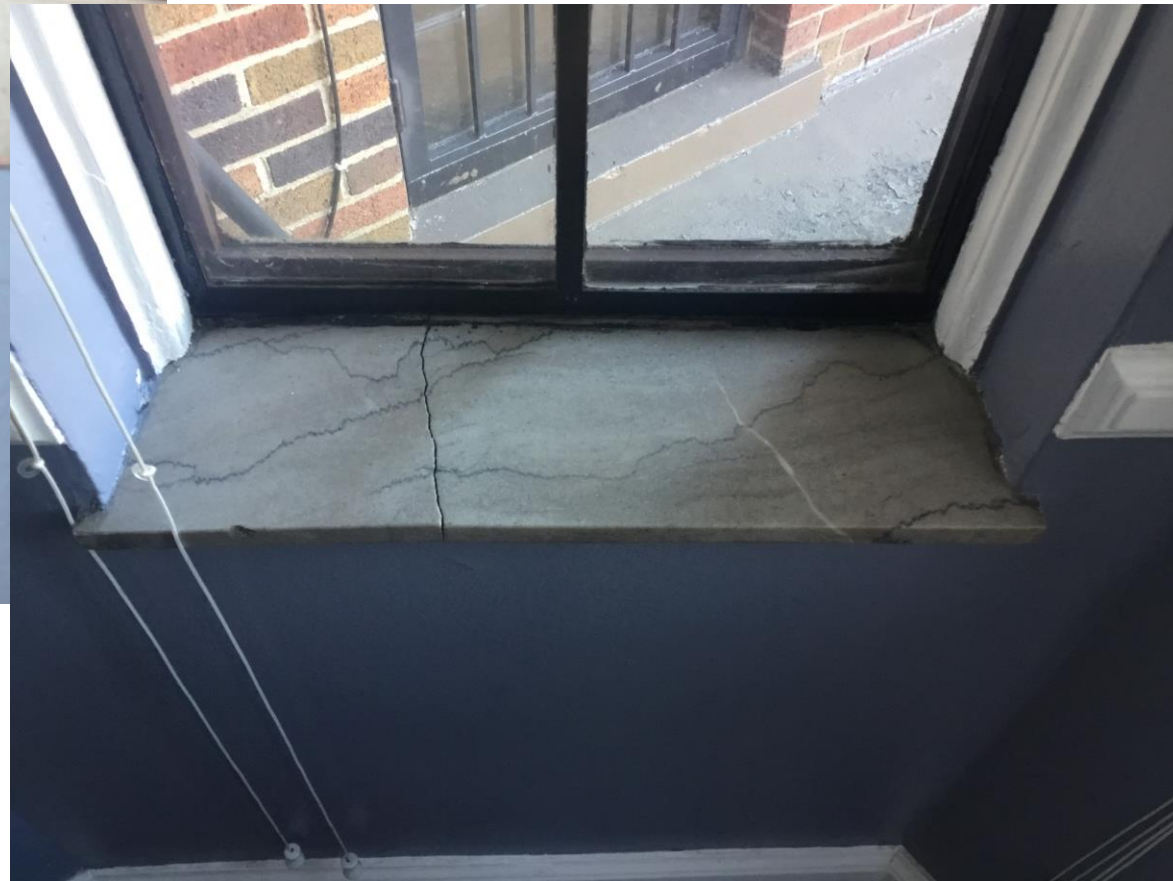
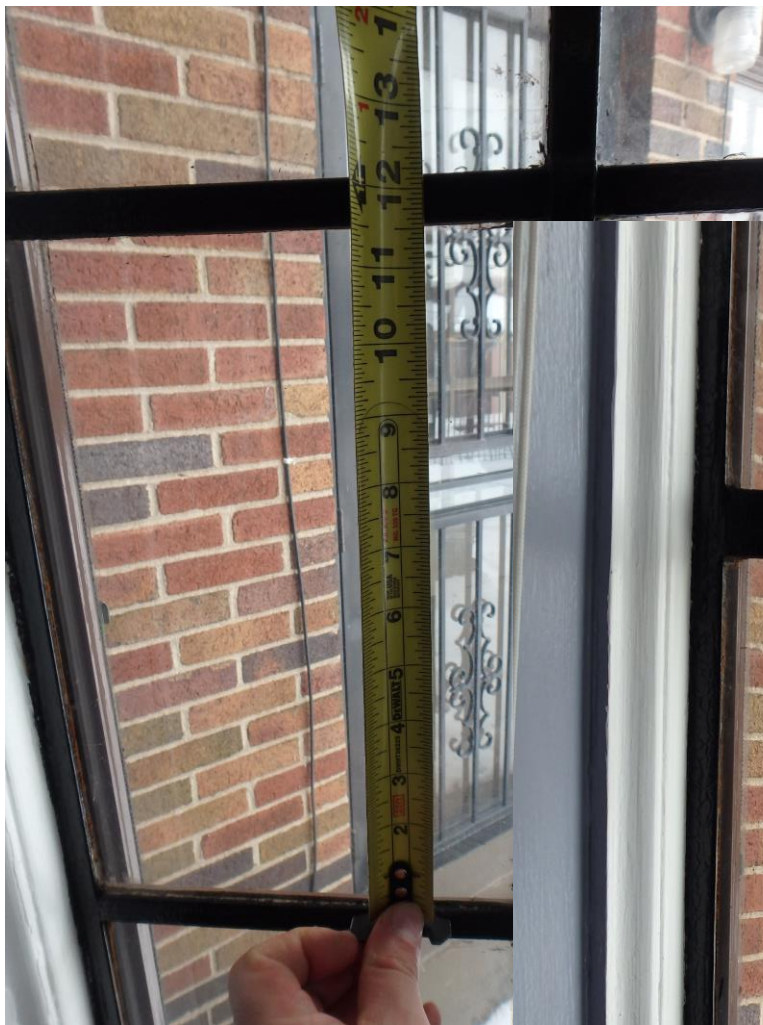
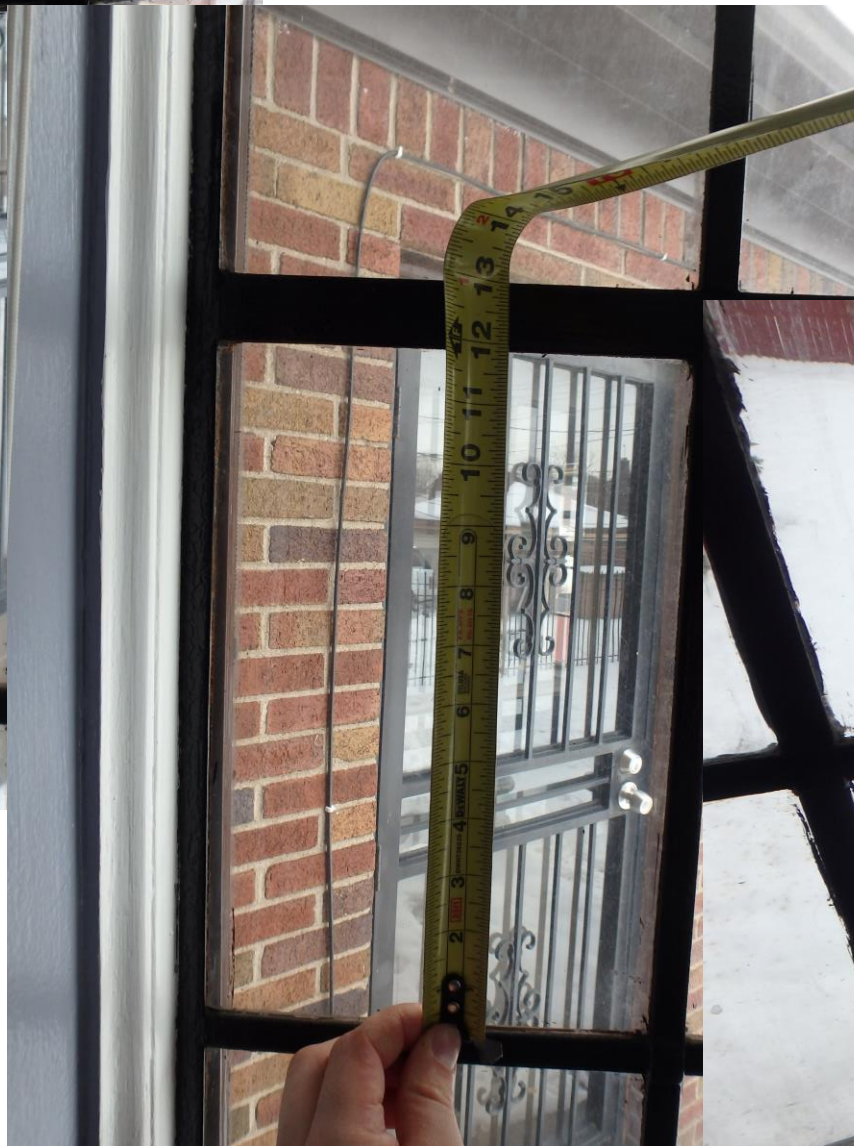
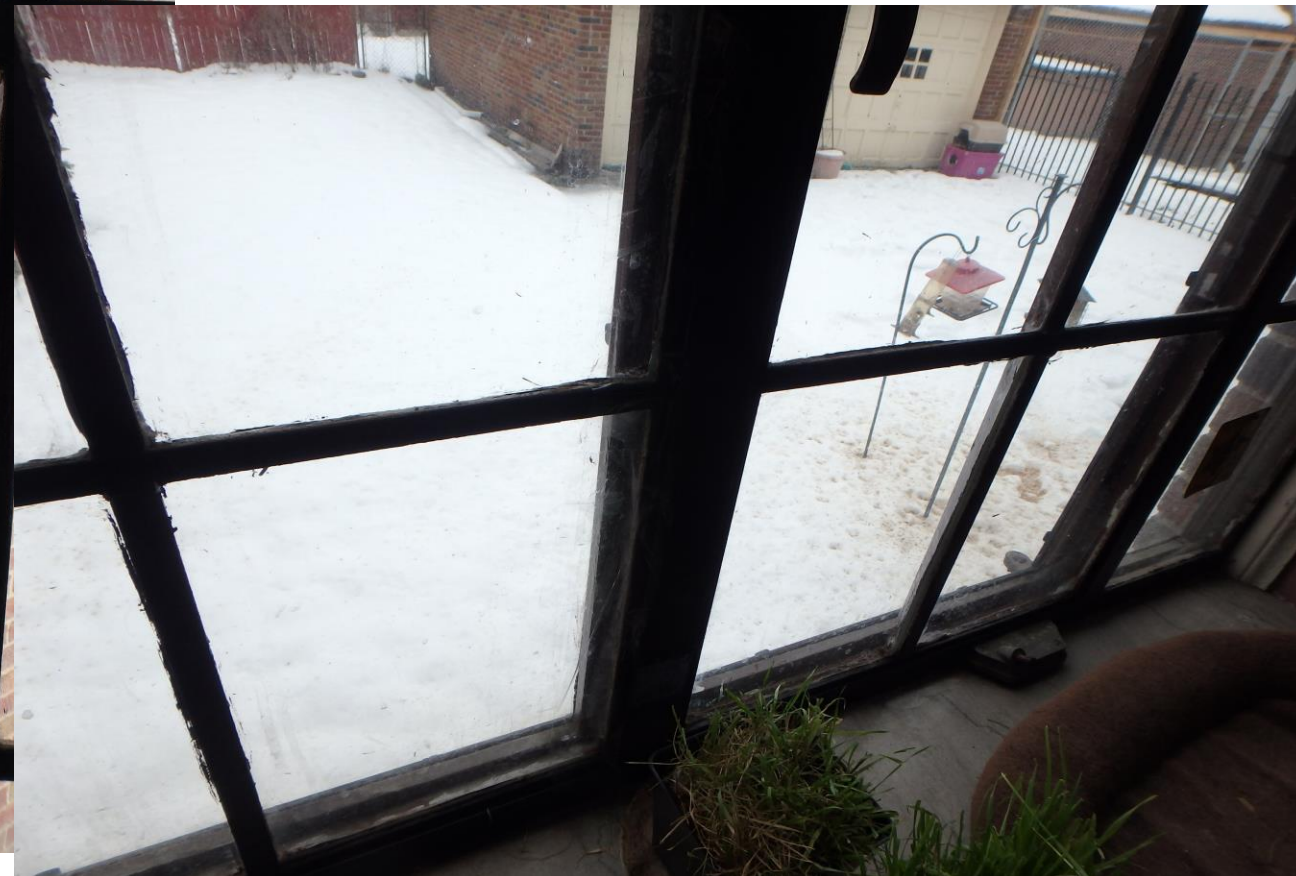
Interior Condition

- Sills are broken over many units
- Will reset/level sills that have been broken and repair any rotted wood below the windows

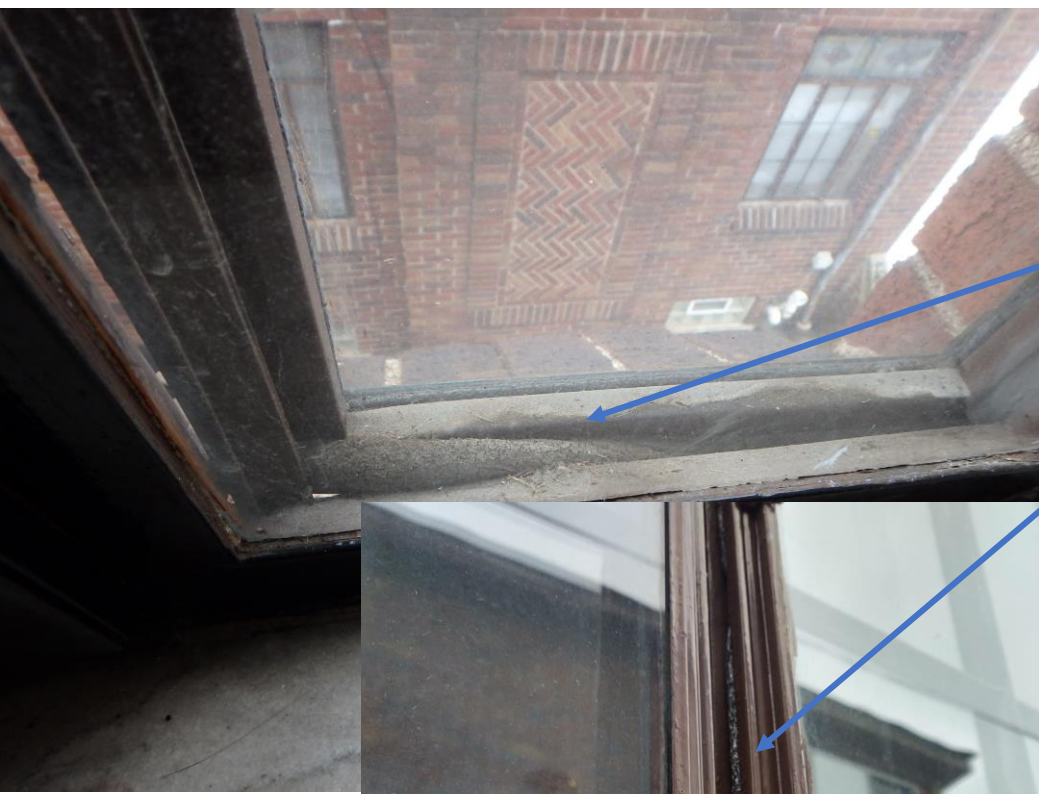
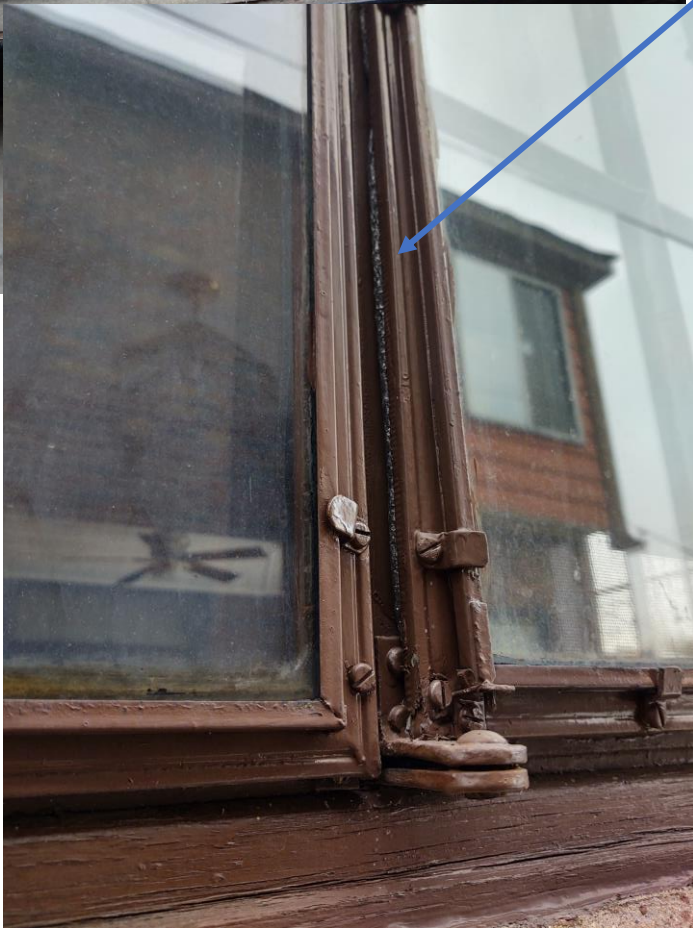
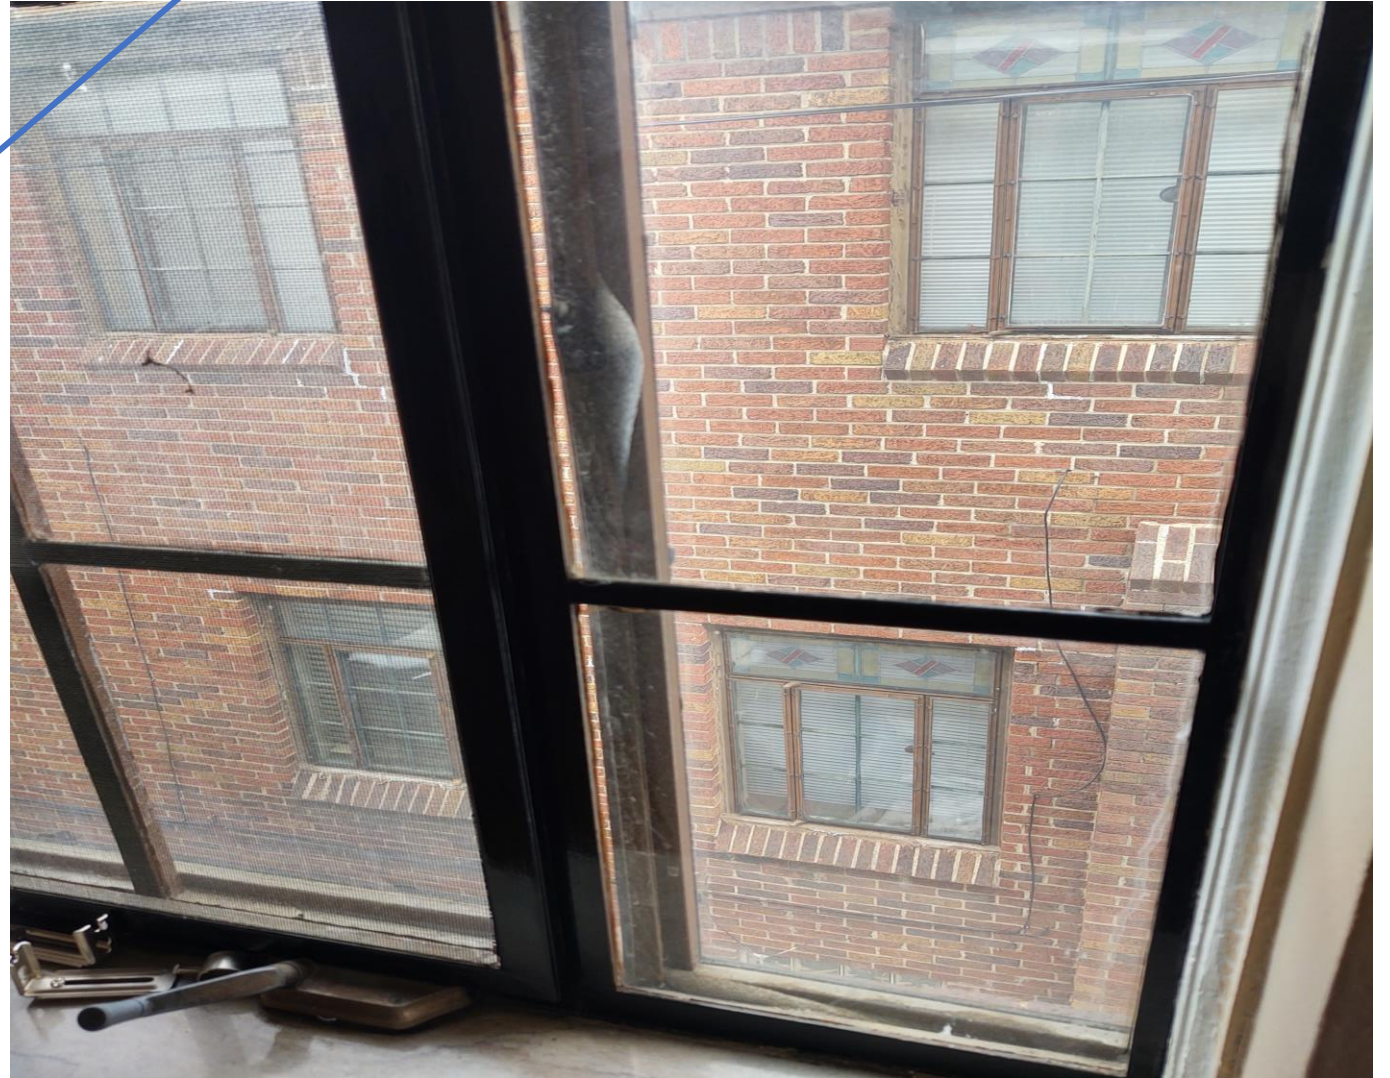
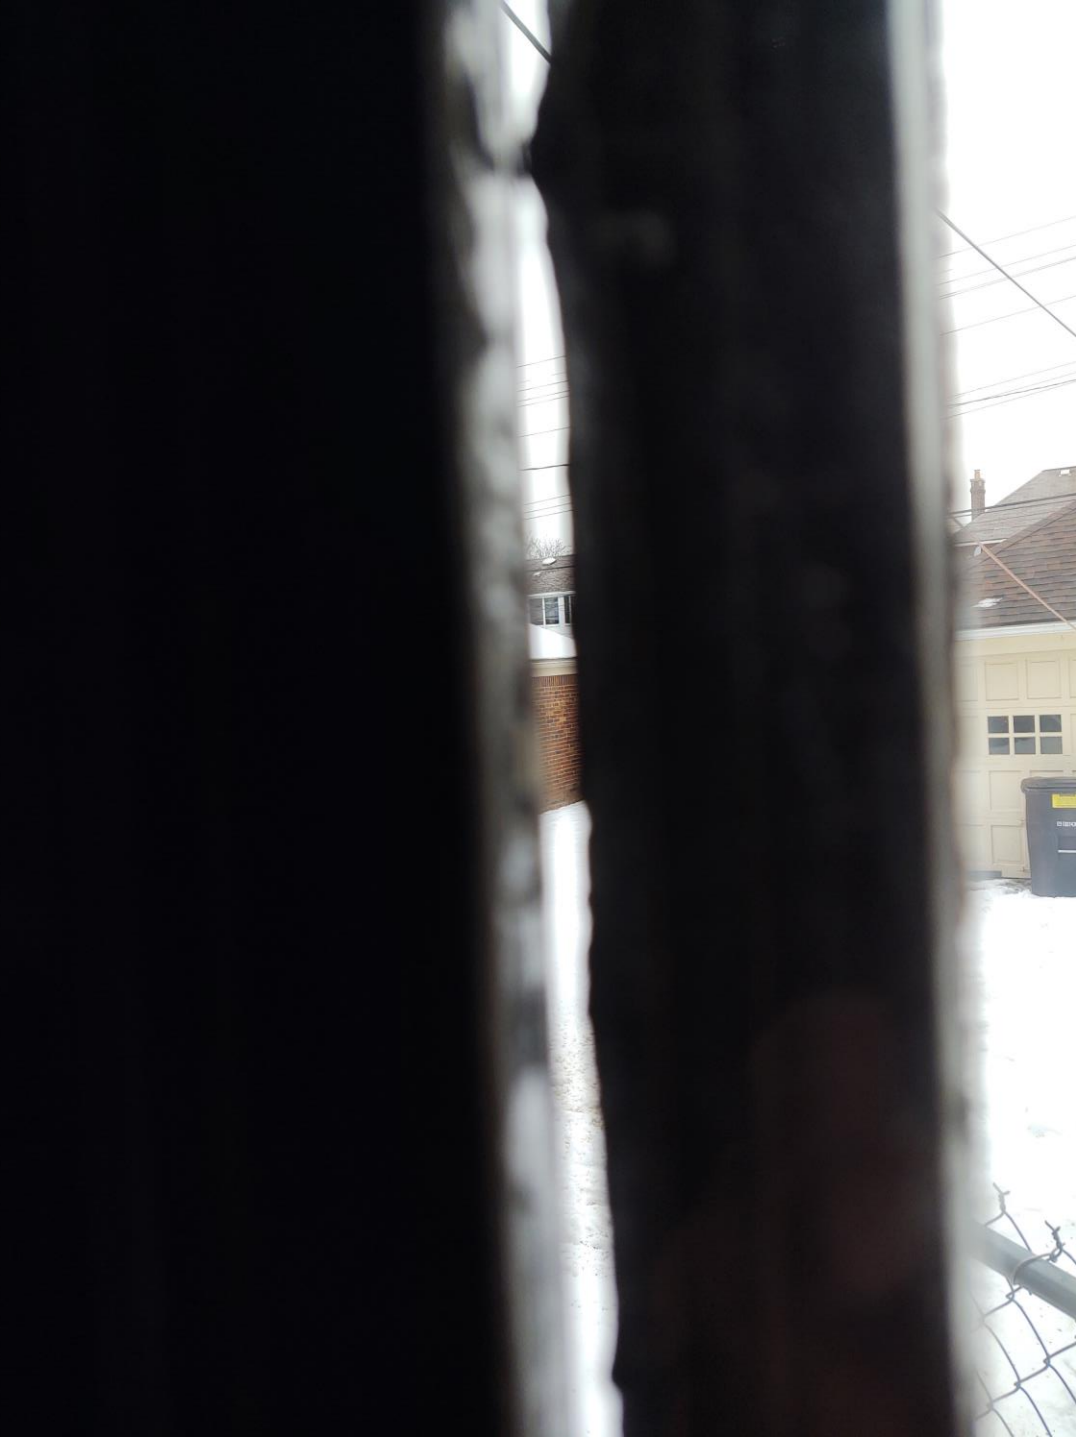
Interior Condition

- Grilles are not uniform and don't line up.
- Each window pane has a $\frac{1}{2}$ " – 1" difference in height (Widths are all equal around 8")
- Some grilles are falling apart

- Windows have foam packed into cracks
- There are still visible openings/gaps between the window and storm window

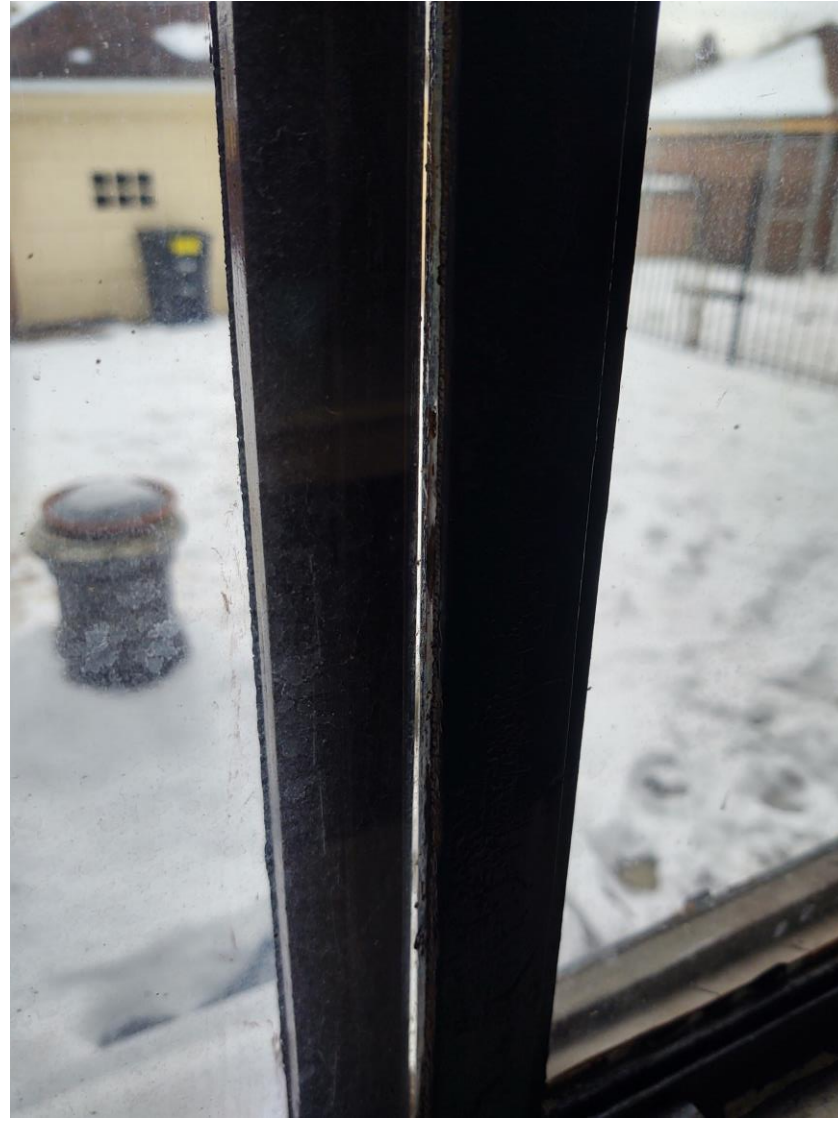
Interior Condition

- Windows have foam packed into cracks
- There are still visible openings/gaps between the window and storm window

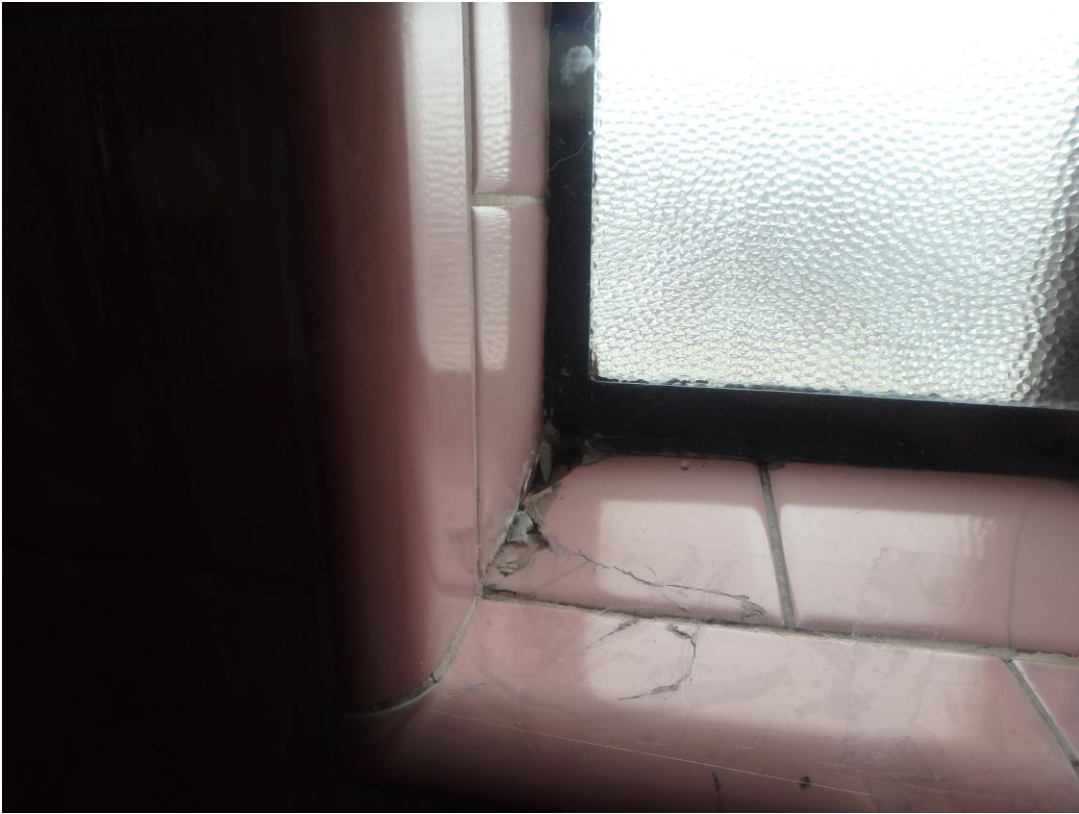
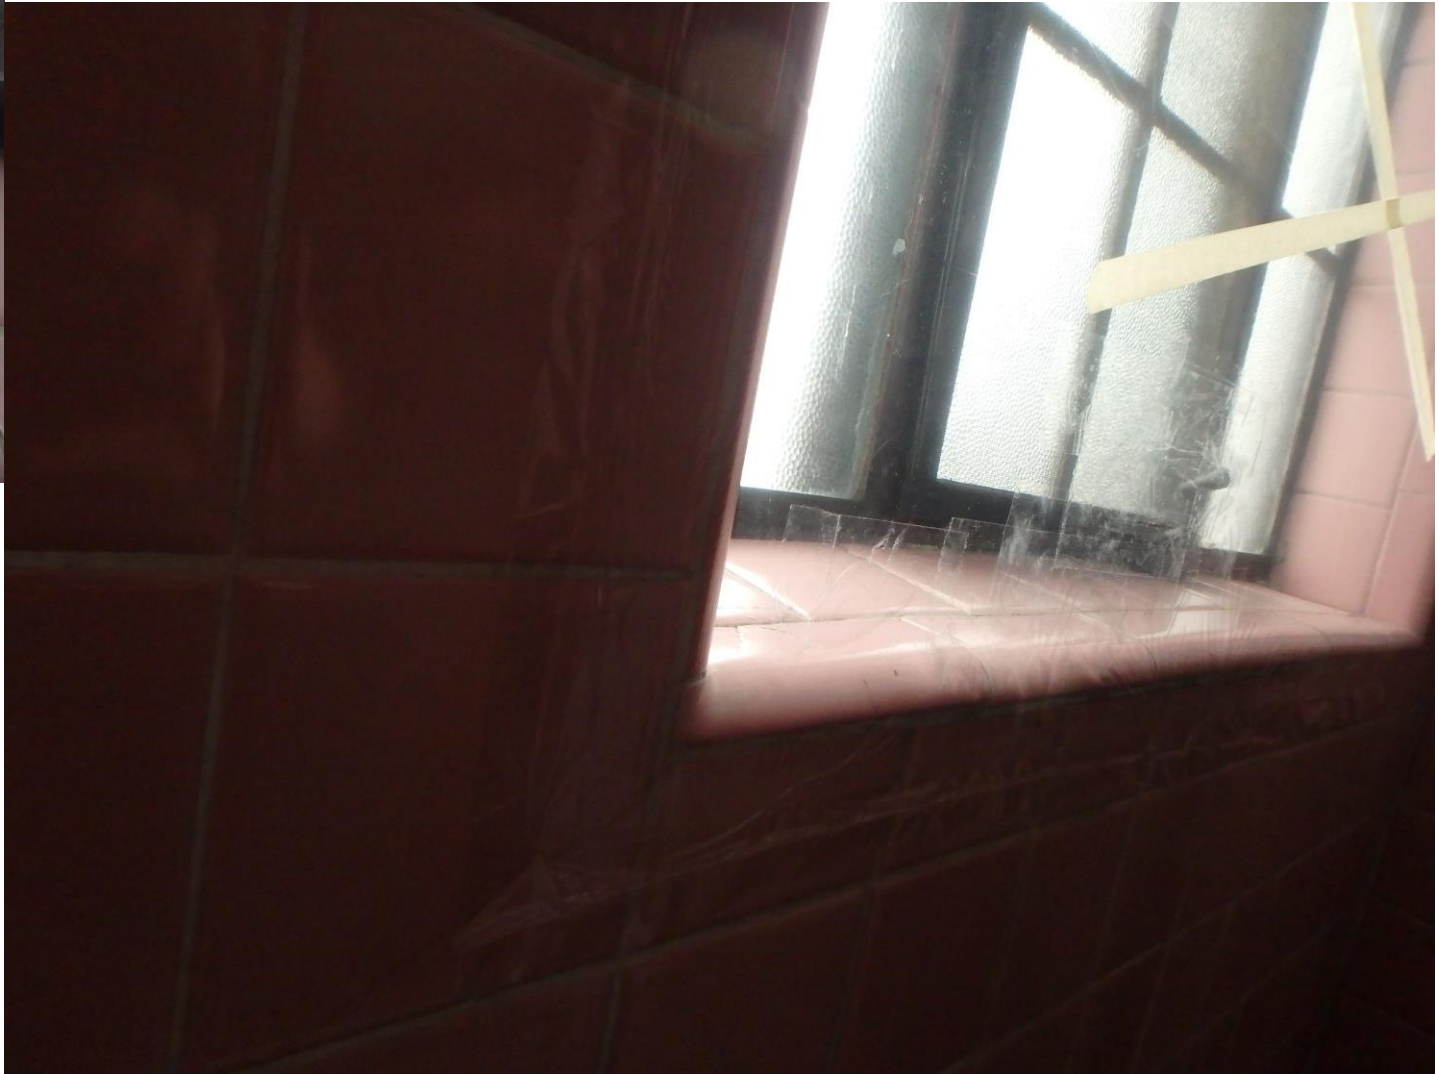
Interior Condition

- Bathroom window sill is bowed
- Will replace any damaged wood in sill if rotted (tile in corners breaking)
- Plastic over window openings

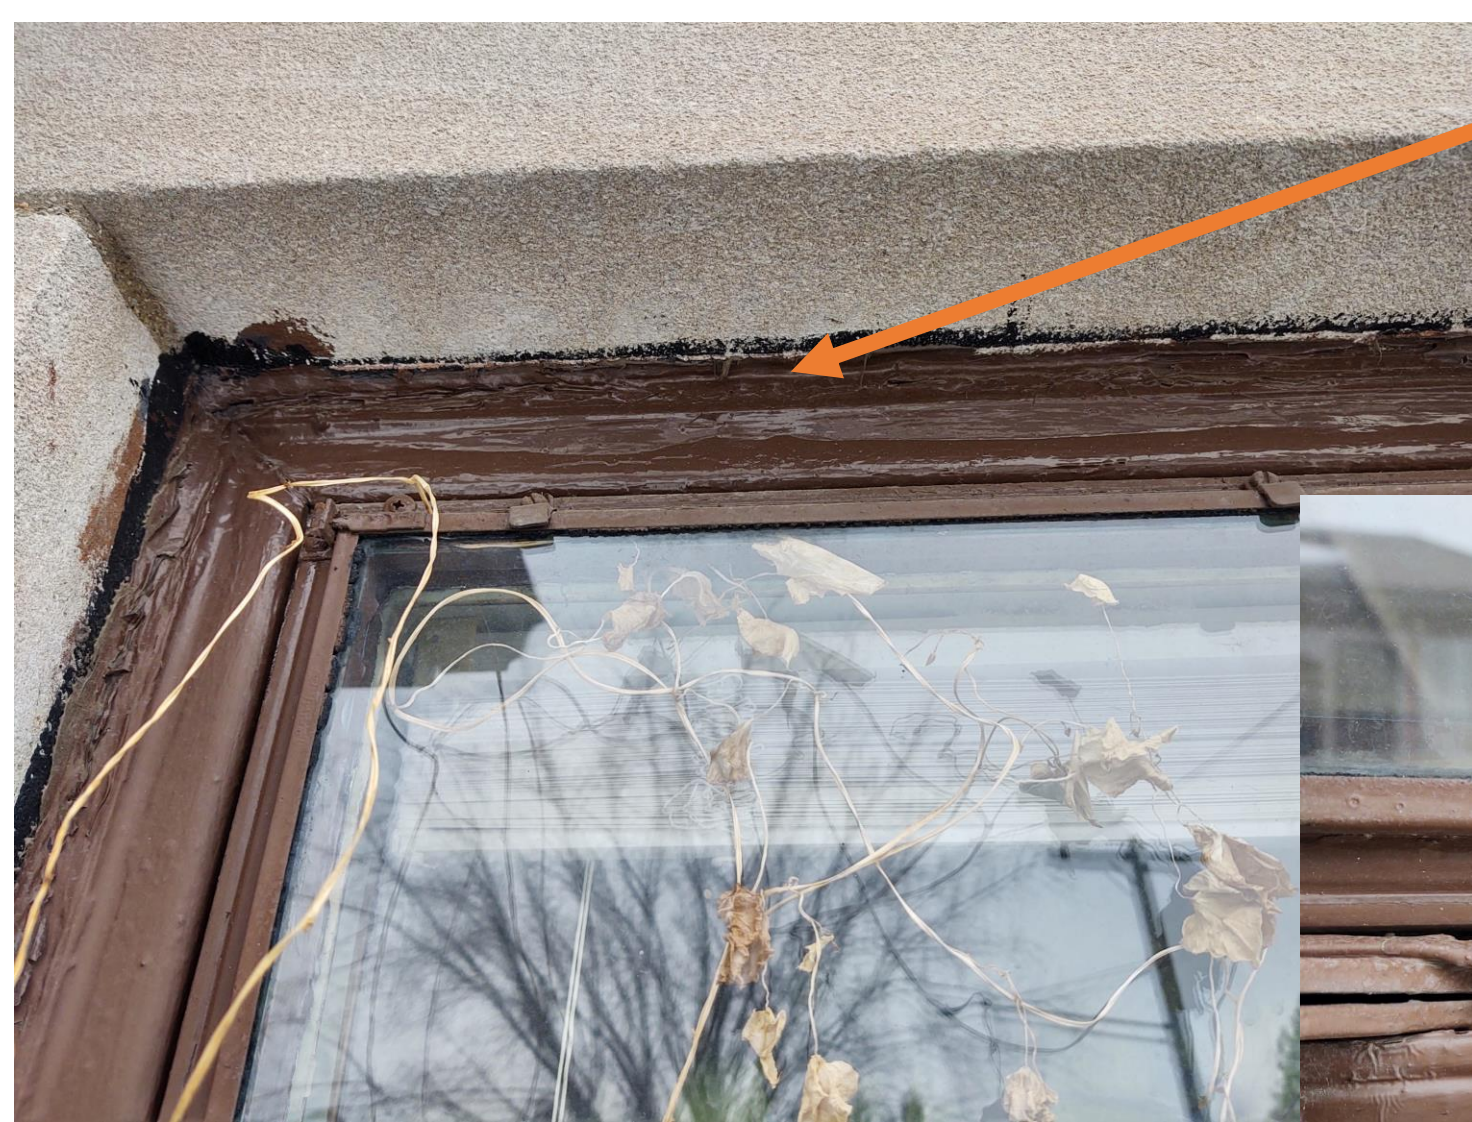
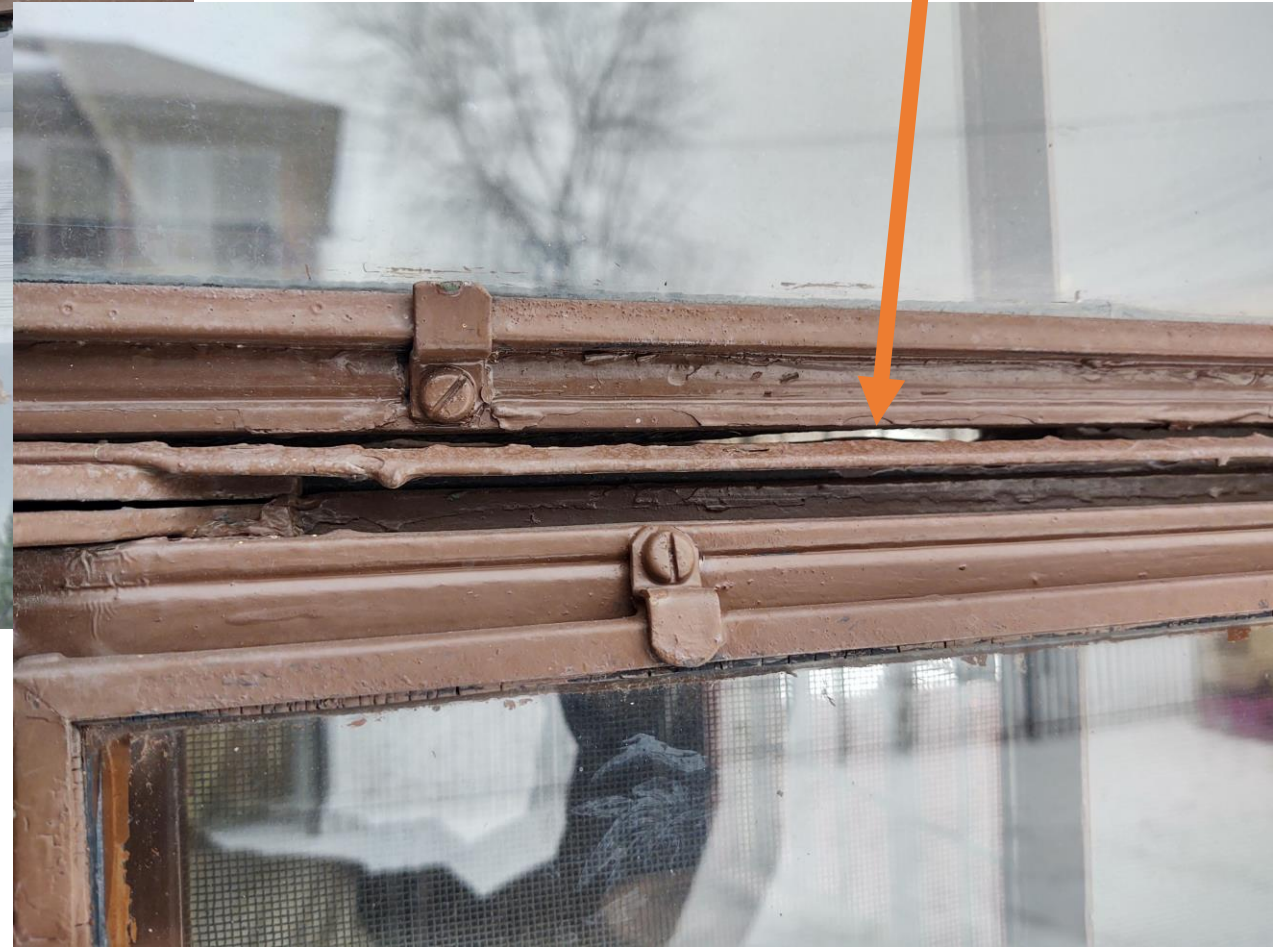
Exterior Condition

- Top rail (paint is peeling/bubbled)
- Can see through gaps around the operable (casement) sash
