STAFF REPORT: 02-12-2020 MEETING

APPLICATION NUMBER: 20-6623

ADDRESS: 4060 STURTEVANT

SCOPE: REMOVAL OF STEEL CASEMENT/TRANSOM/SIDELIGHT WINDOWS; INSTALLATION OF FIBREX CASEMENT WINDOWS

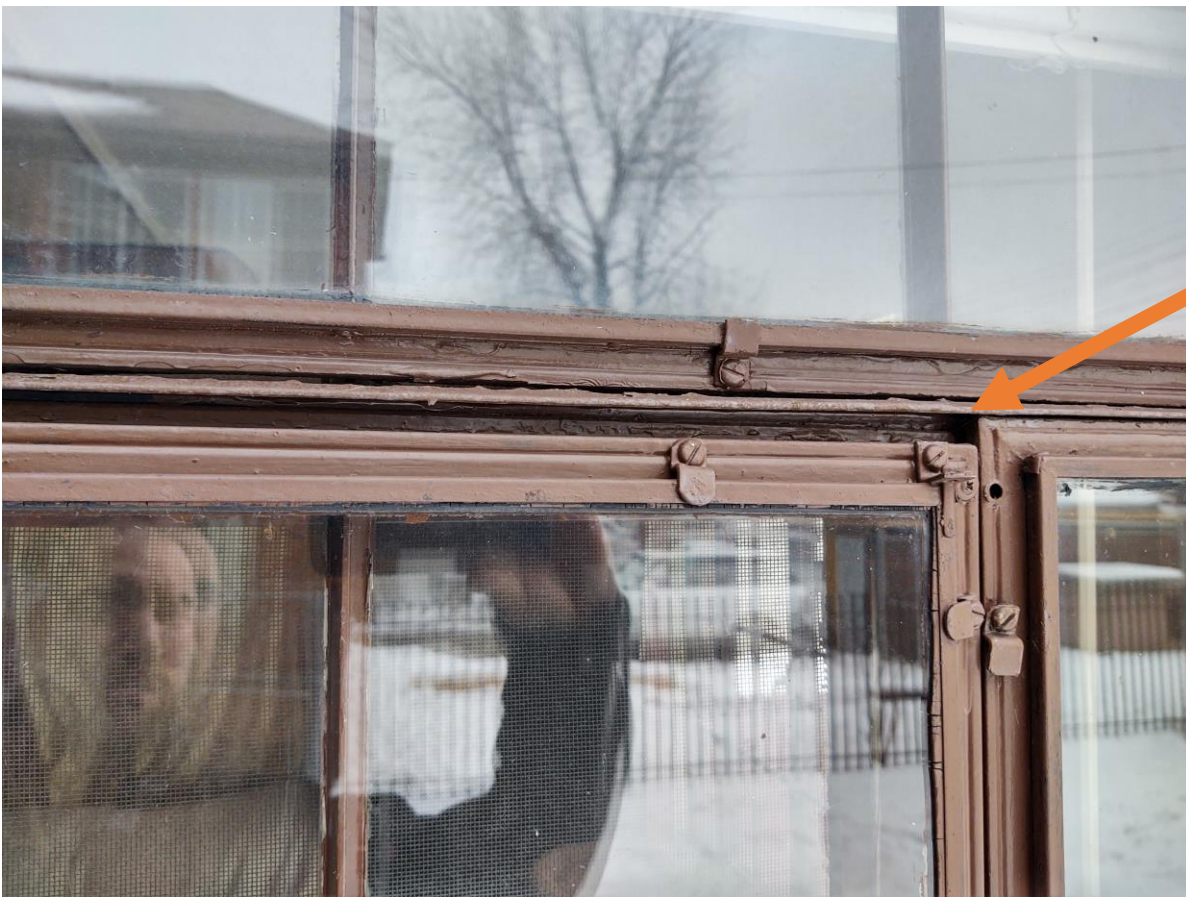
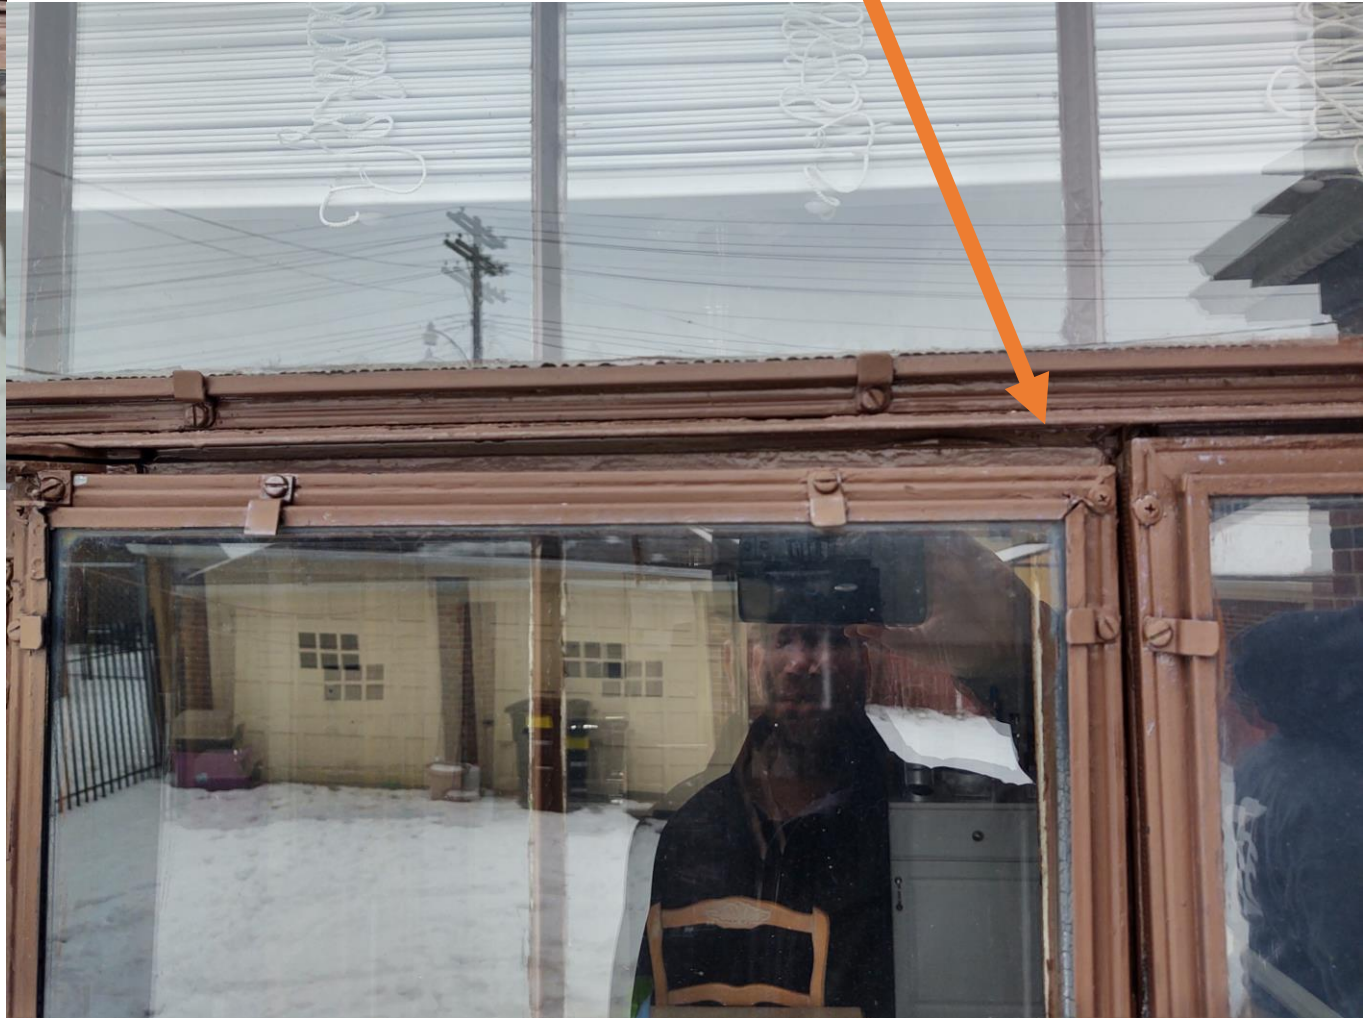
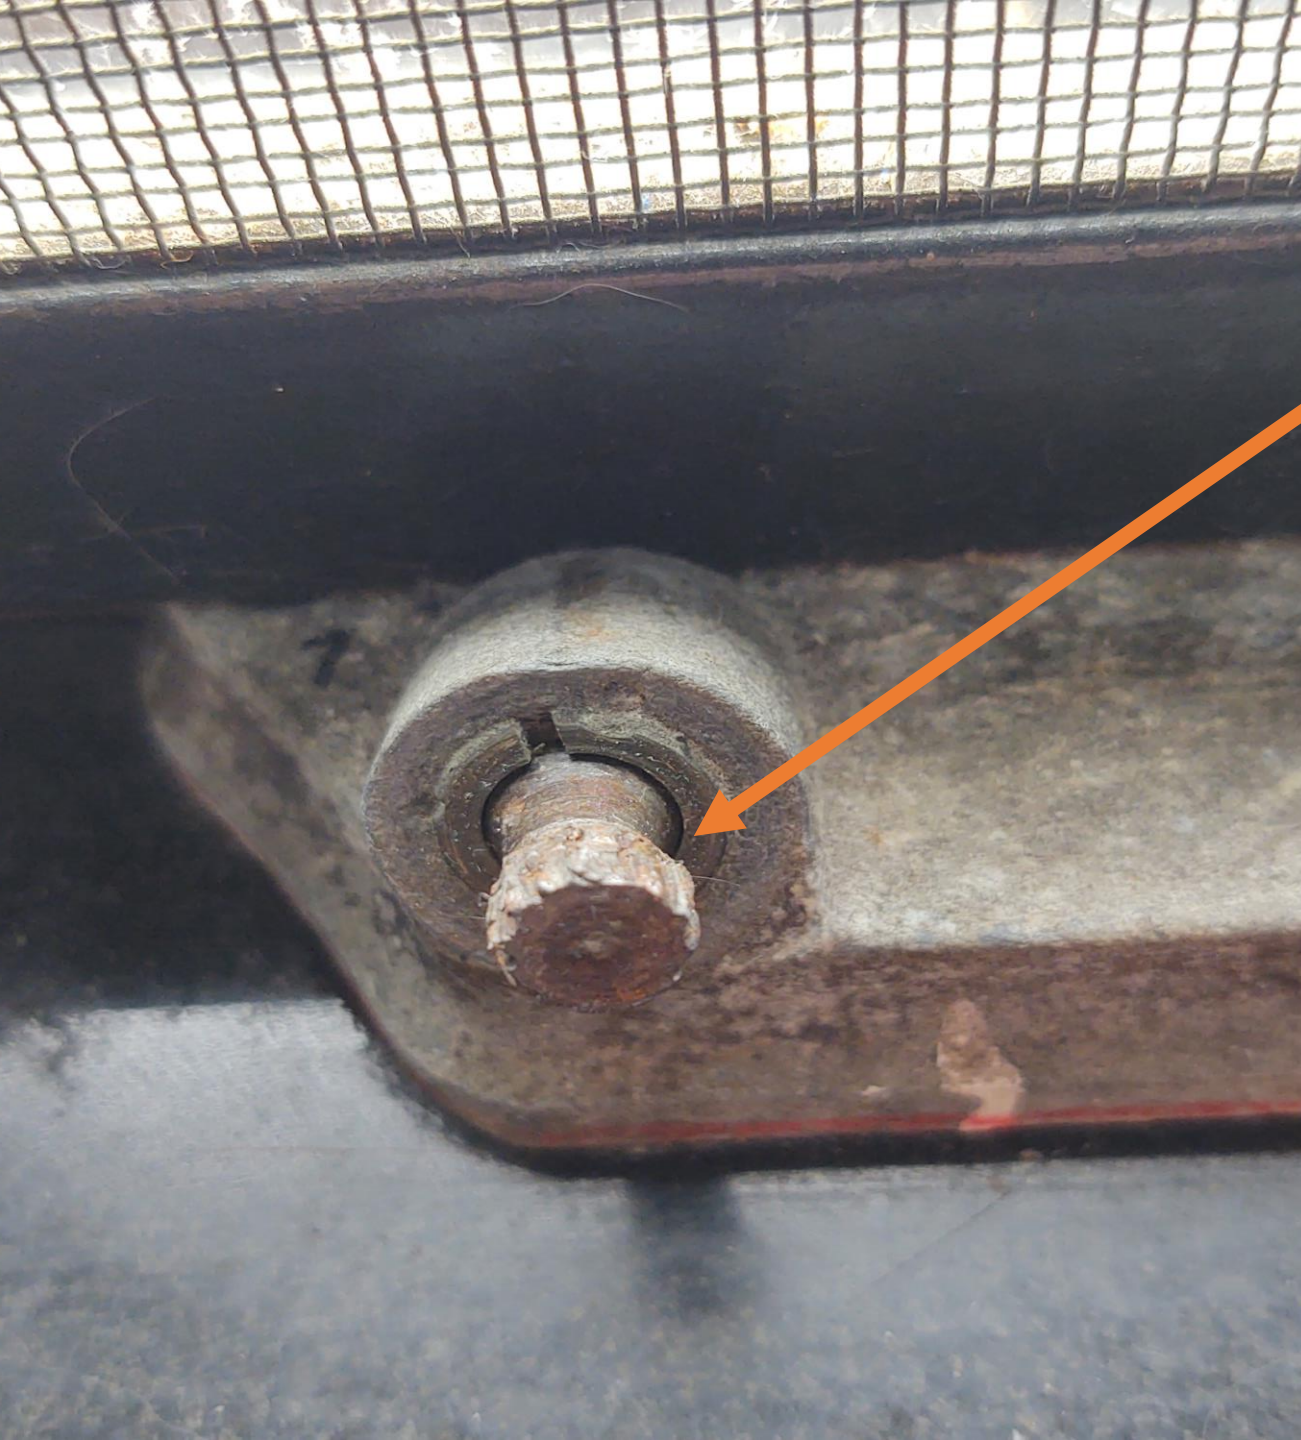
Exterior Condition

- Casement window (operable) sashes will not open and are not level with fixed panes next to them
- Possibly the hinges are bent (didn't try and open (Winter))

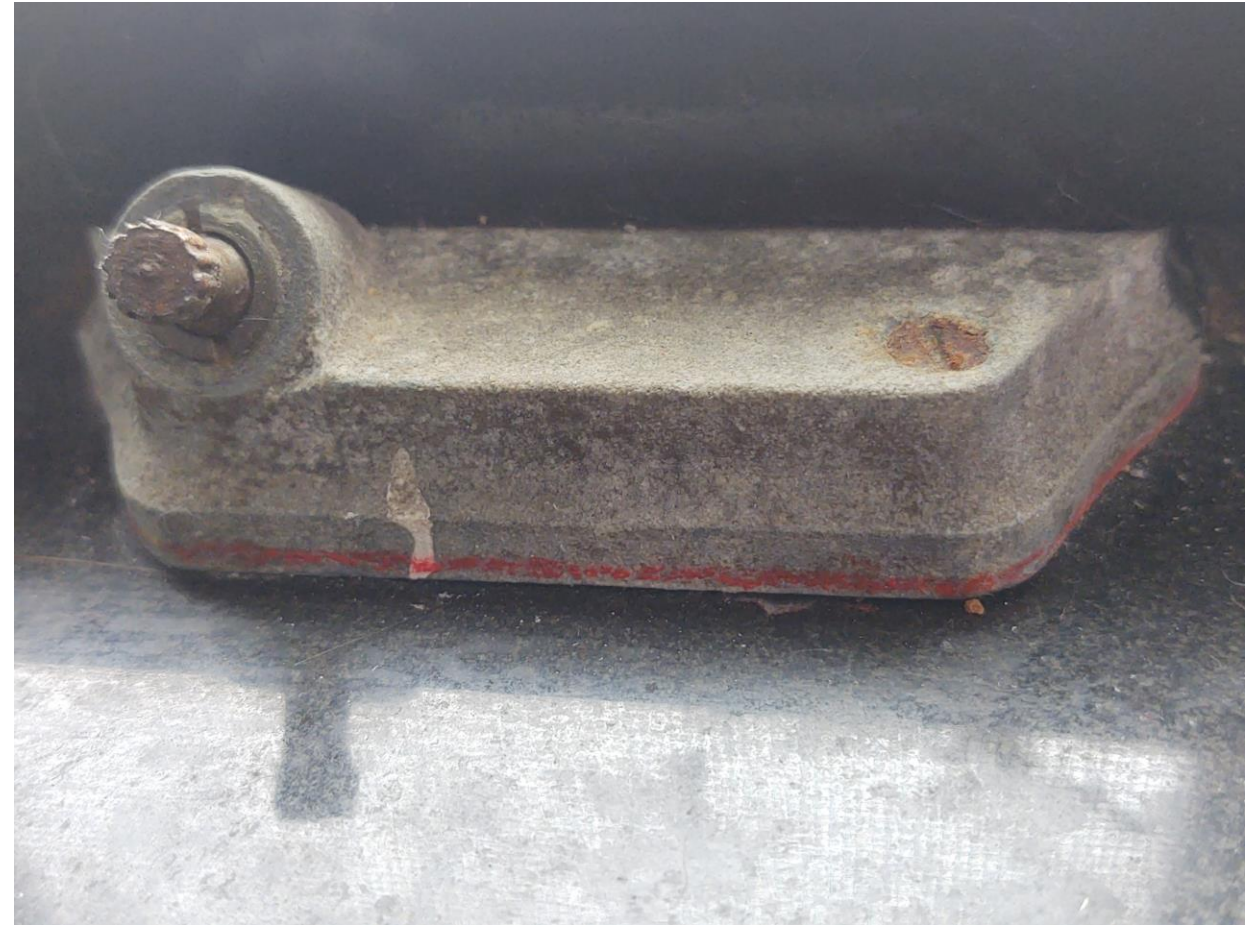
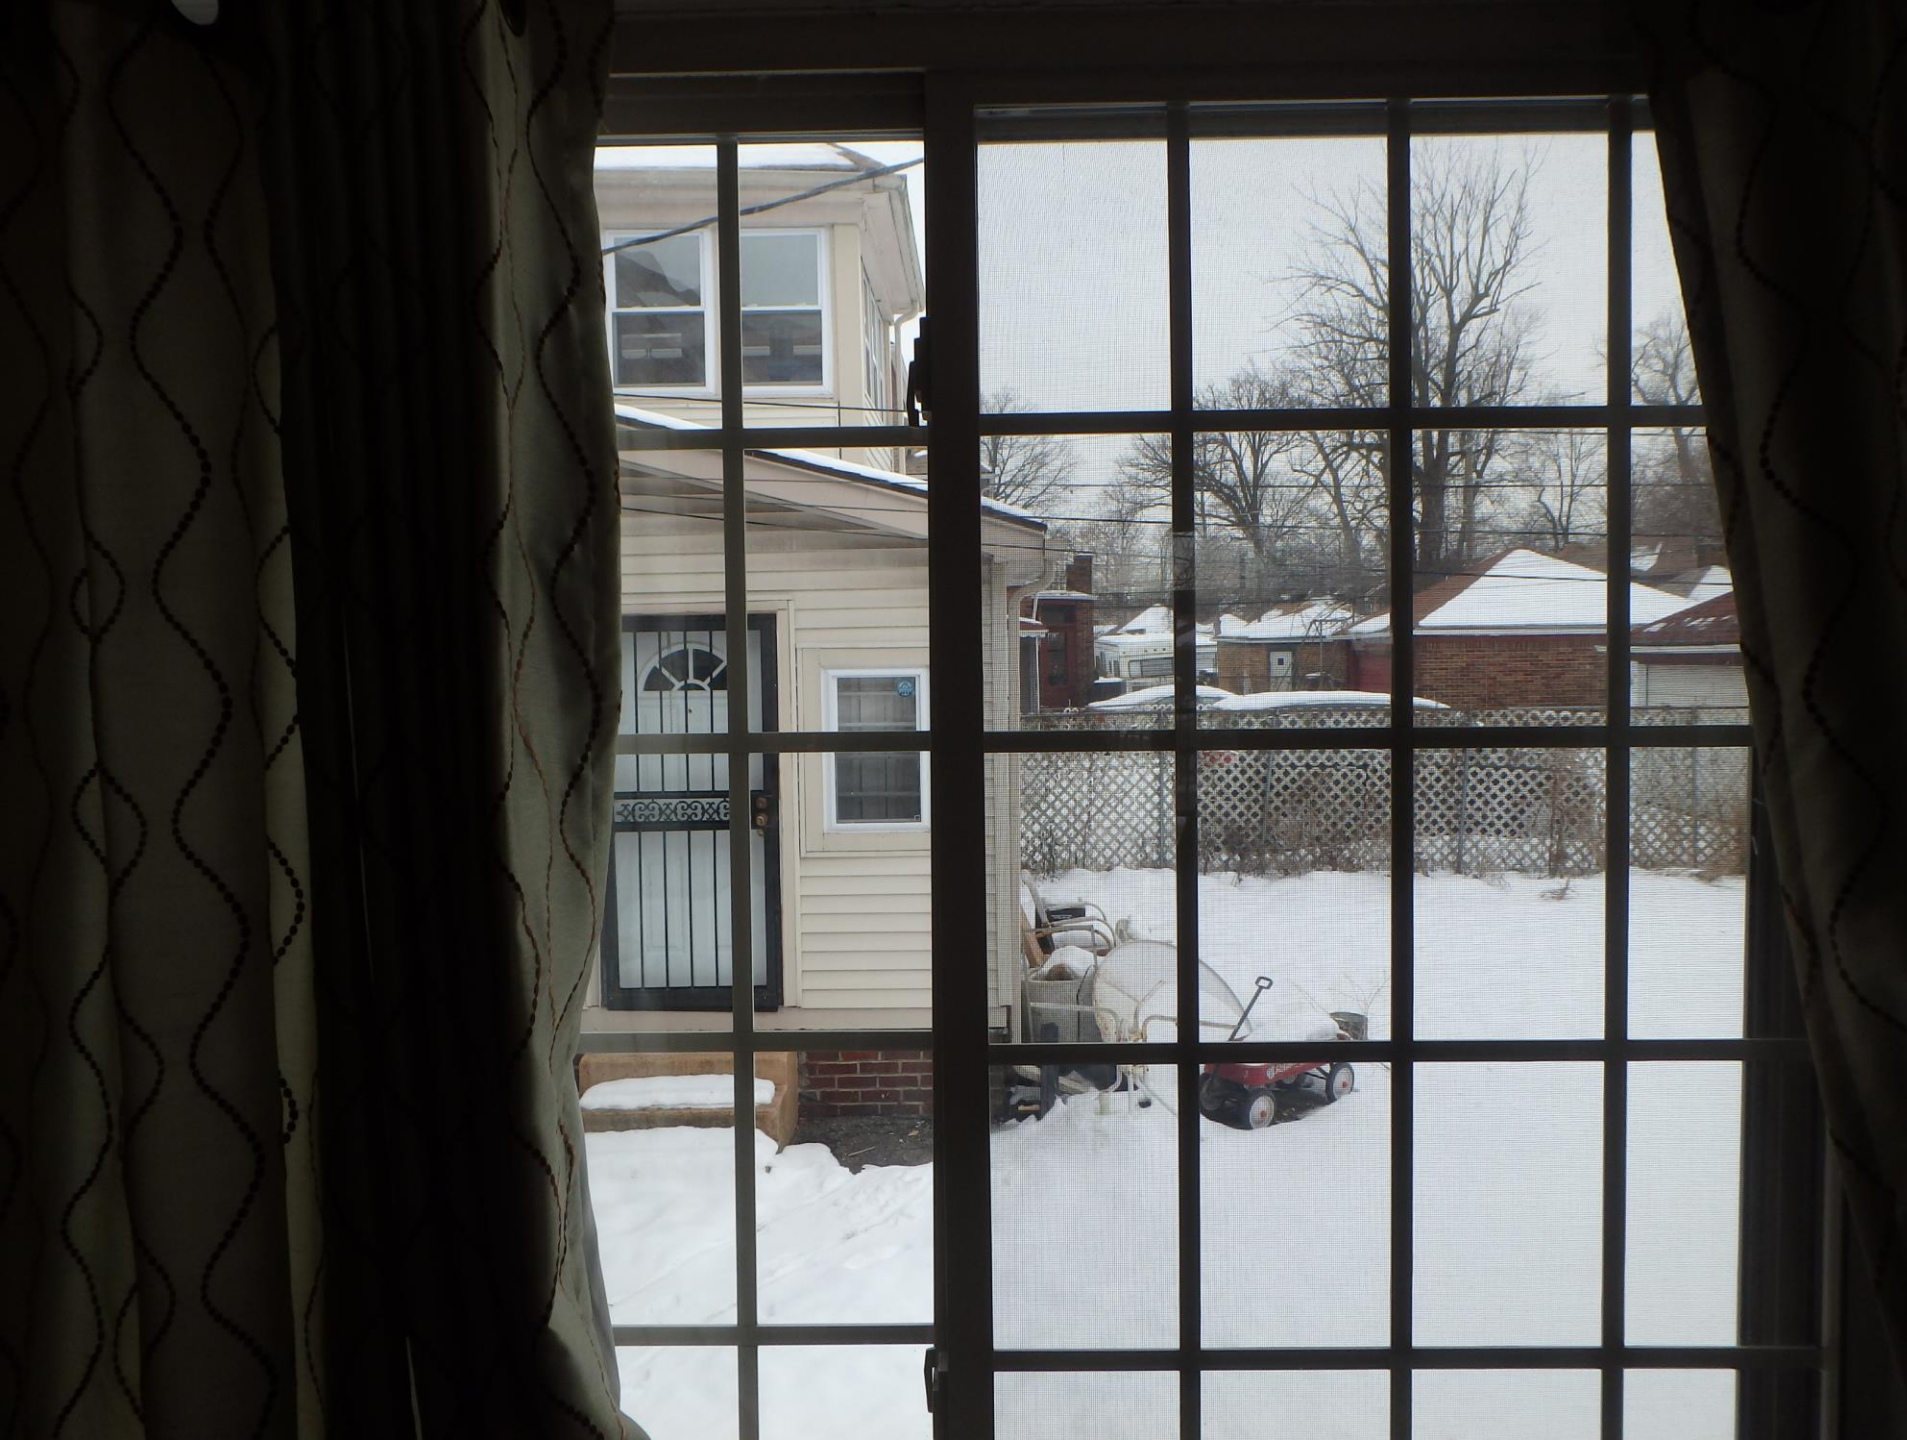
Exterior Condition

- Most of the windows are missing crank handles
- Some of the knobs are rusted/stripped
