STAFF REPORT 03-11-2020 REGULAR MEETING

**APPLICATION NUMBER: 20-6649**

ADDRESS: 31 ARDEN PARK BOULEVARD (HENRY STEINBRECHER HOUSE)

**SCOPE:** ERECTION OF FENCE (WORK COMPLETED IN VIOLATION)

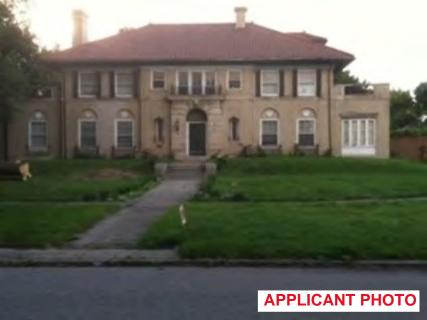
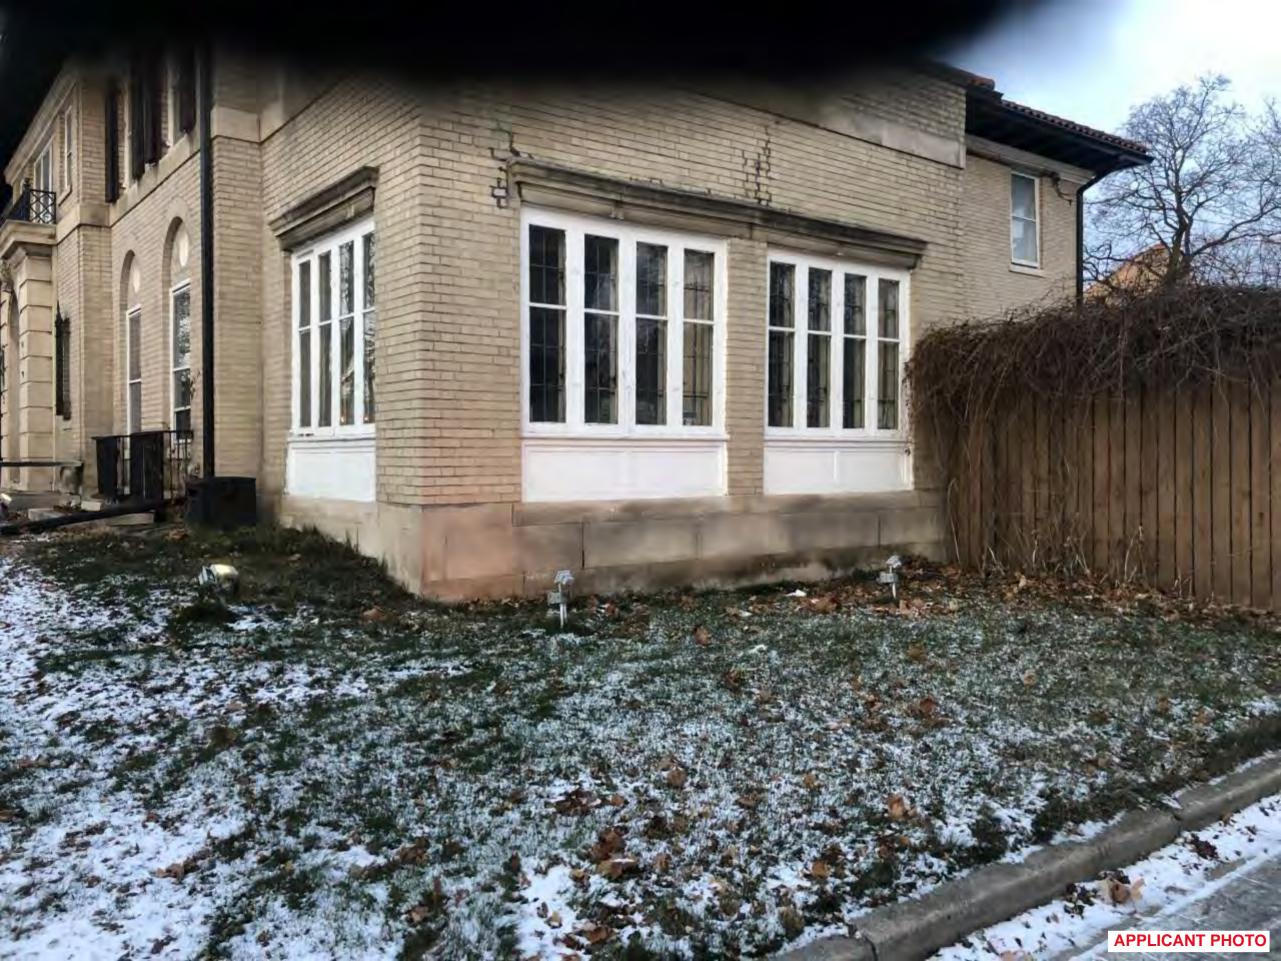
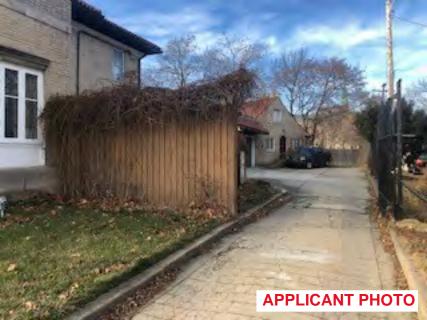
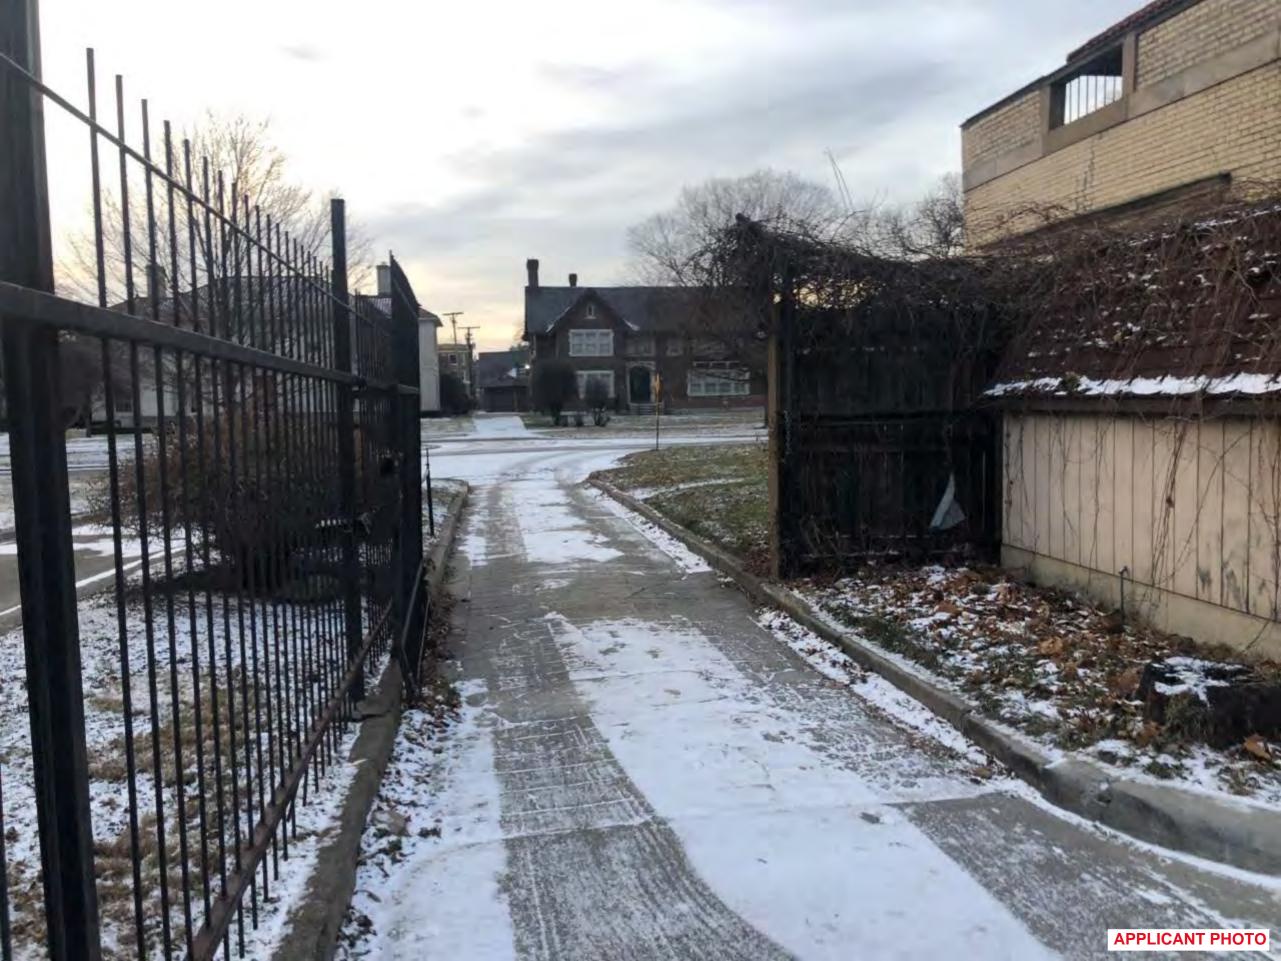
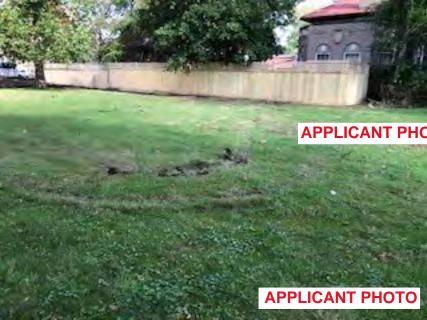
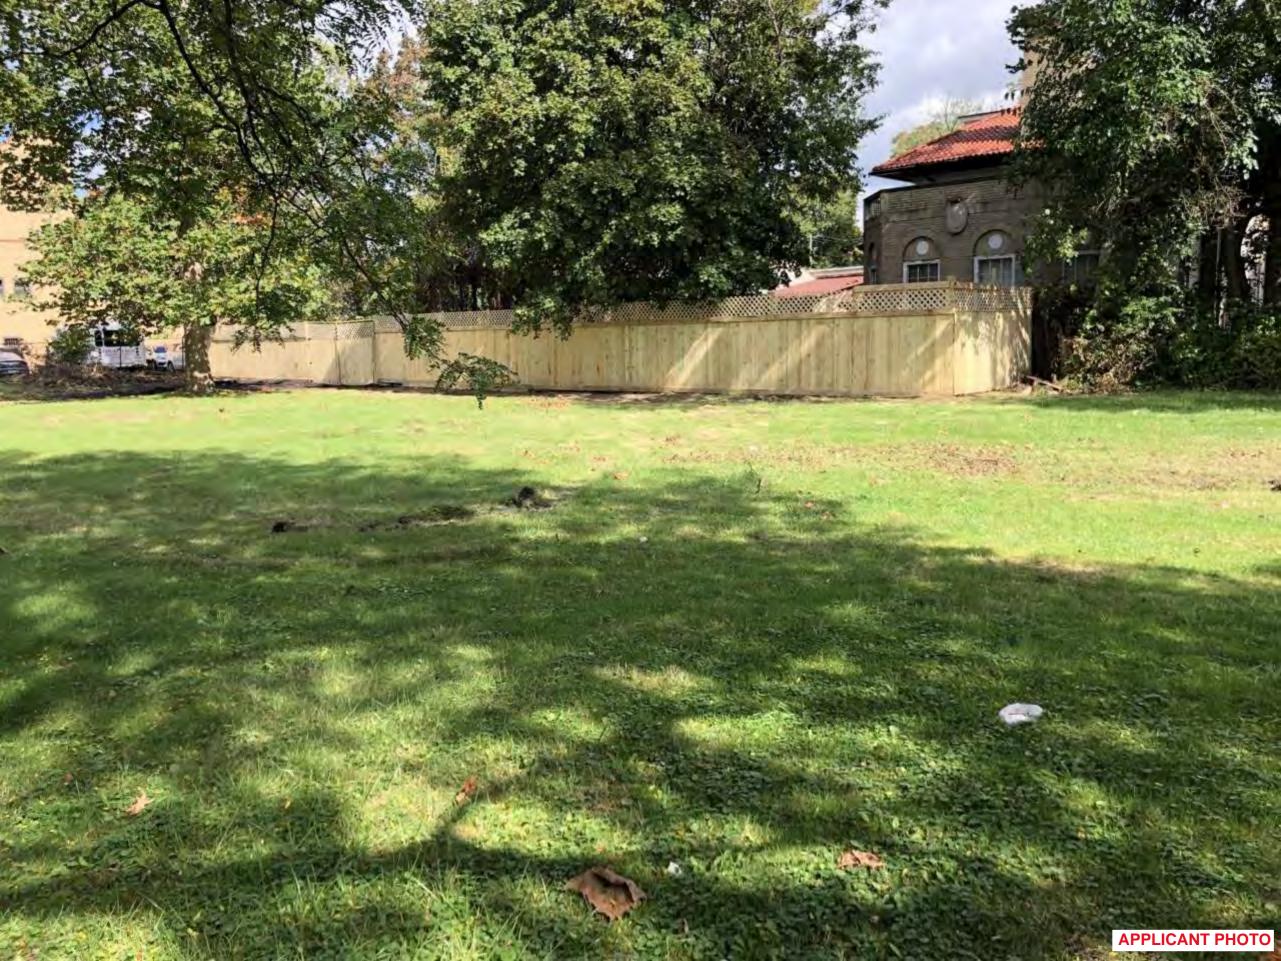
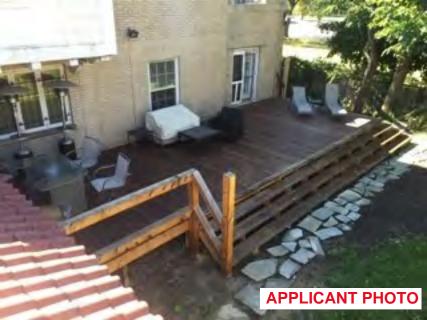
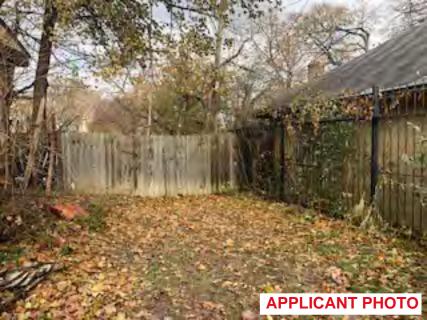
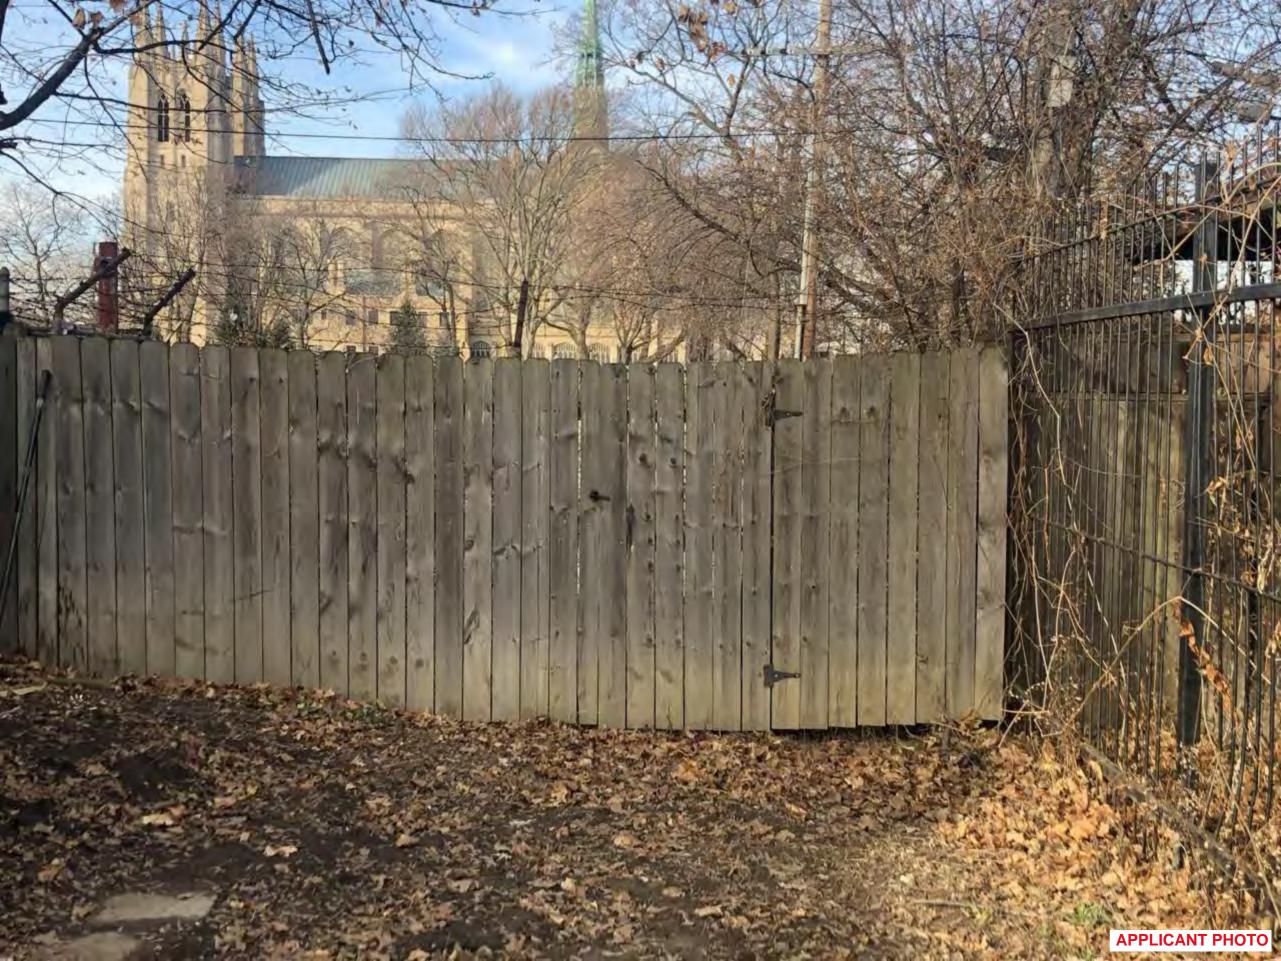
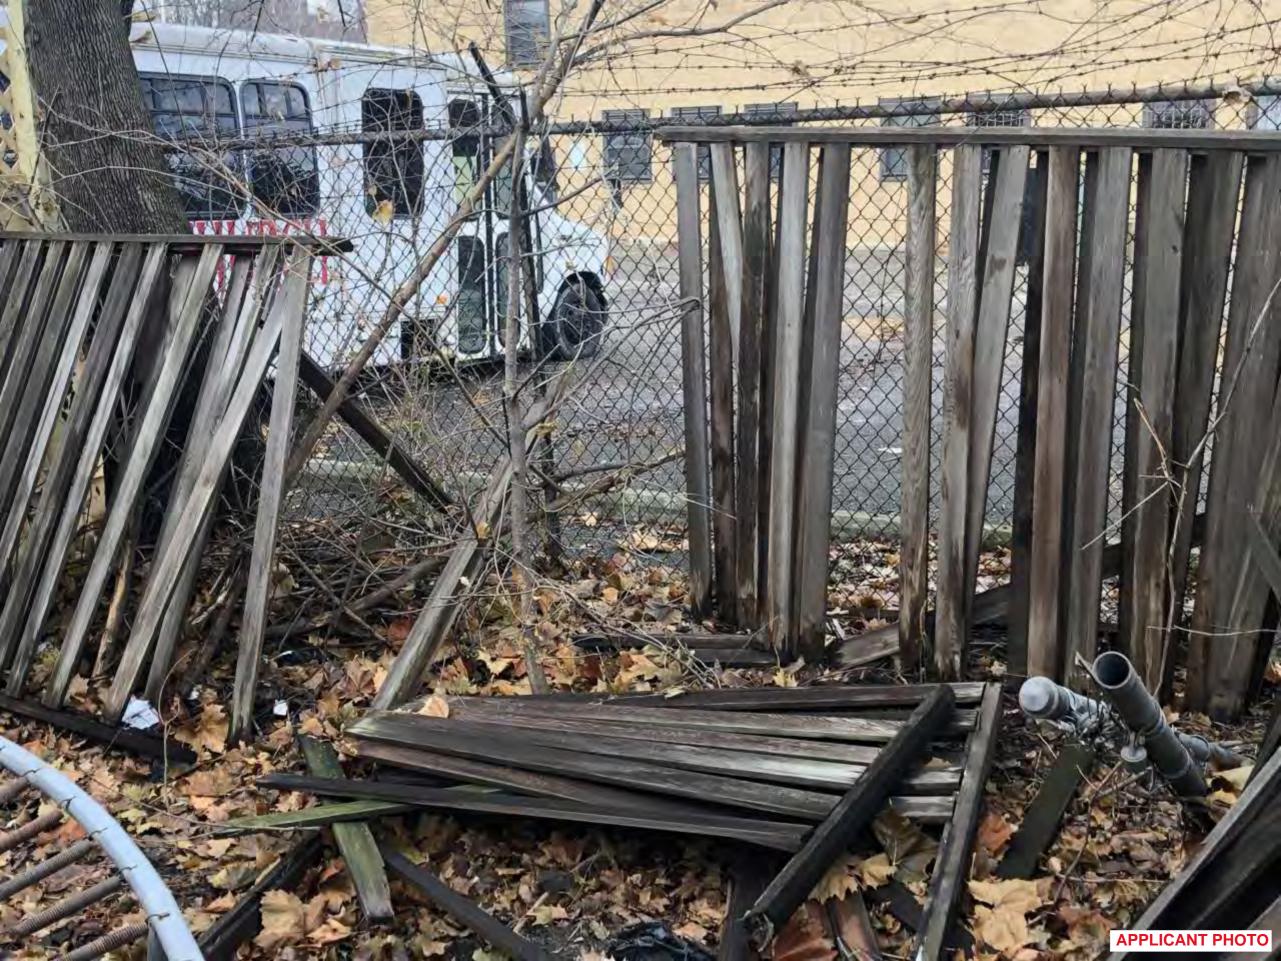
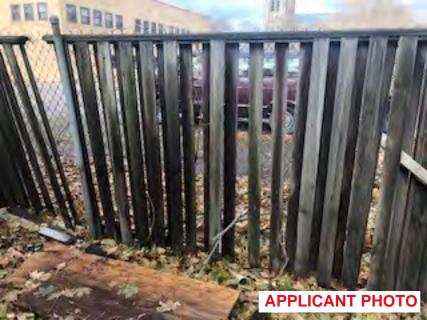
- The 8' height of the new fence does not meet the Commission's Fence & Hedge Guidelines as an allowable height at side lot lines. Additionally, not all of the fencing found on the property was replaced, only a portion of it. The remaining fence along the east lot line is black wrought iron, a short portion of chain link fence extends perpendicular to the new fence at the south elevation -- past the front face of the house, and a small section of 8' tall wood fence exists adjacent to the driveway west of the house. See submitted diagram for locations and fence types. Note that the portion of the chain link fence that exists perpendicular to the new wood fence at the front yard (past the front face of the house) is not represented in the diagram. There are currently 3 types of fencing material on the lot which does not meet the Commission's Fence & Hedge Guidelines which state, "A single lot shall contain no more than two types of fencing material."

- It is staff's opinion that the lattice portion of the new fence detracts from the historic character of the property and is therefore not considered appropriate.

- The lattice portion located at the top of the fence be removed.
- The fence be stained or painted to complement the house.

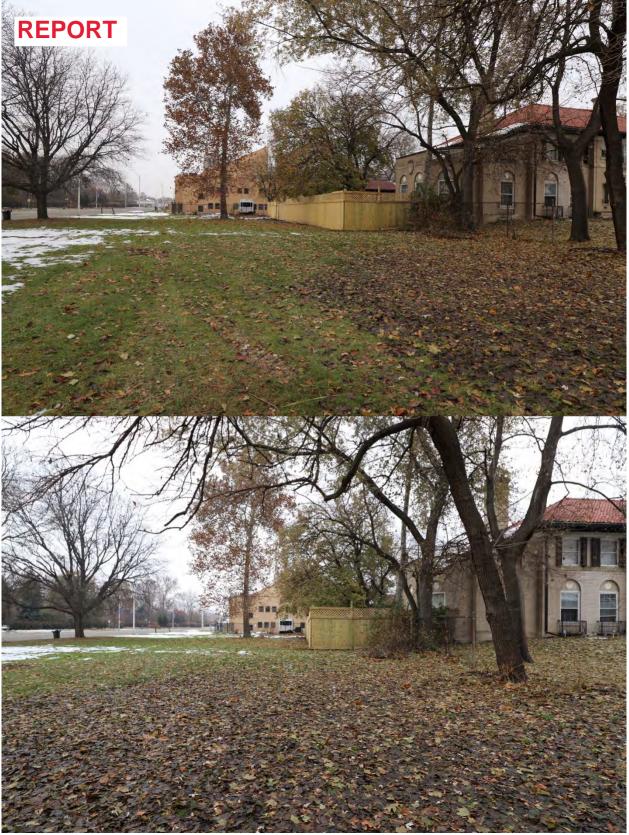
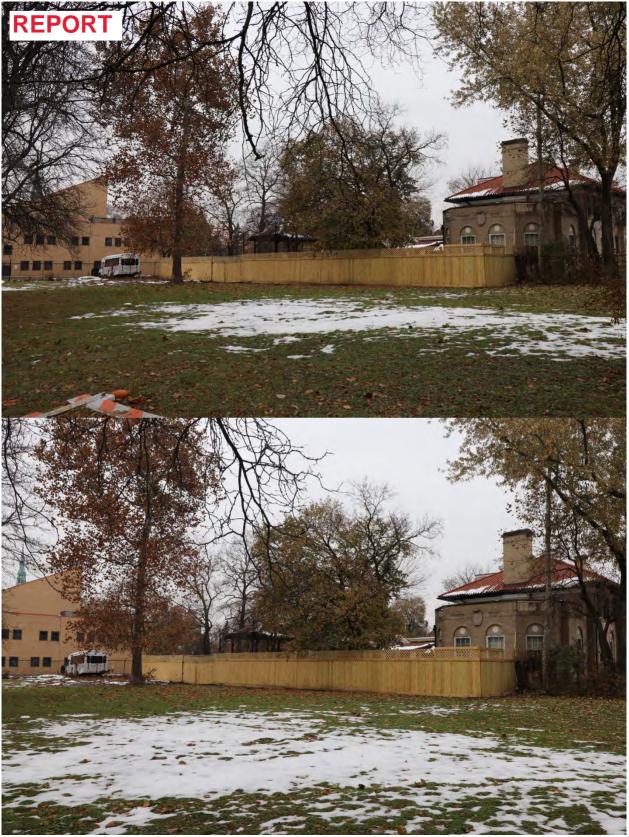
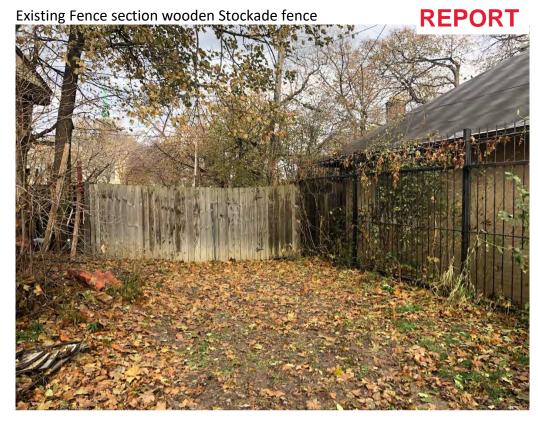
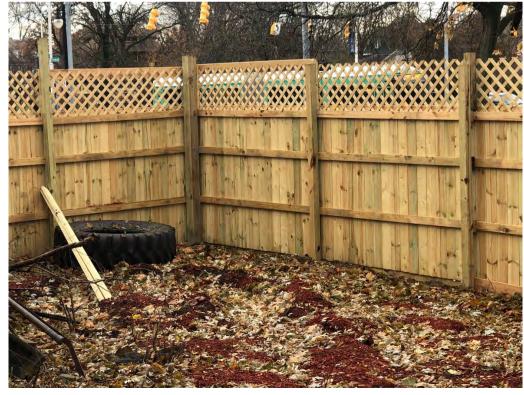
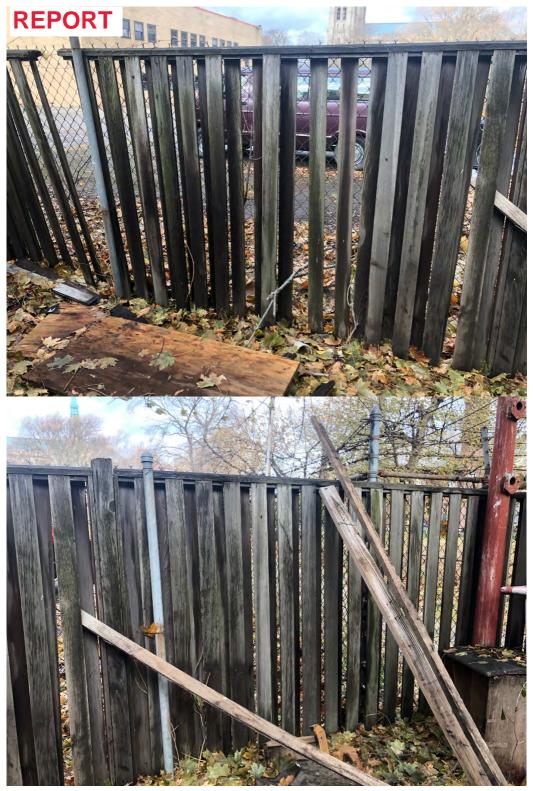
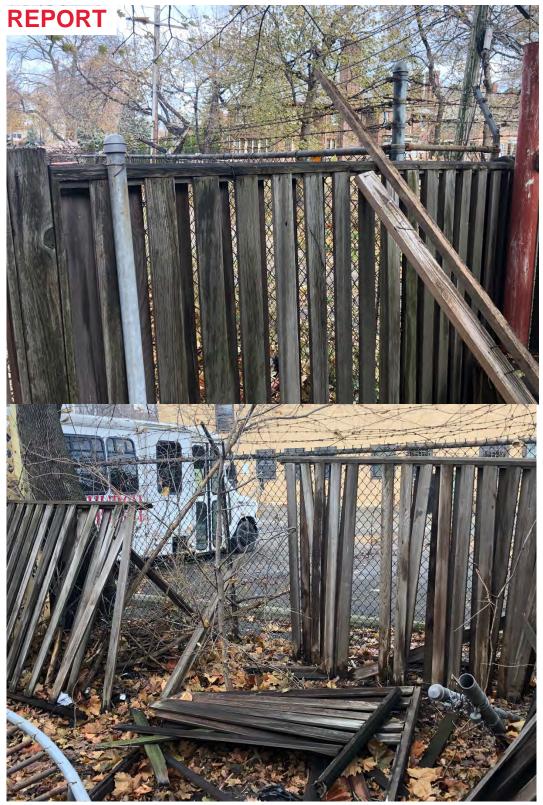
My wooden stockade fence was damaged by trees. The fence was not repairable due to sustained damage. The fence was a 7ft chain link fence with a Wooden privacy fence covering the chain link fence. At the top of the fence was 18in of barbed wire taking the total height of the fence to 8'6". The previous fencing material was not of a historic nature and featured a significant amount of rotten wood and different types of wooden sections exist. The eastern section of fencing is black rod iron 8ft fencing.

Due to storms multiple sections of the fence were damaged. The fence was no longer repairable. To replace the fence it was necessary to clear weed trees brush and other vegetation that previously screened the fencing. A new wooden 6ft stockade fence was erected with 2ft of lattice above to maintain the original height of the fence. The wooden lattice is boxed with 6in 5/4 board.
