STAFF REPORT 03-11-2020 REGULAR MEETING PREPARED BY: A. PHILLIPS

APPLICATION NUMBER: 20-6654 **ADDRESS:** 3453 BURNS AVENUE

HISTORIC DISTRICT: INDIAN VILLAGE

SCOPE: REPLACE 35 HISTORIC WOOD WINDOWS WITH NEW WOOD, ALUMINUM-CLAD

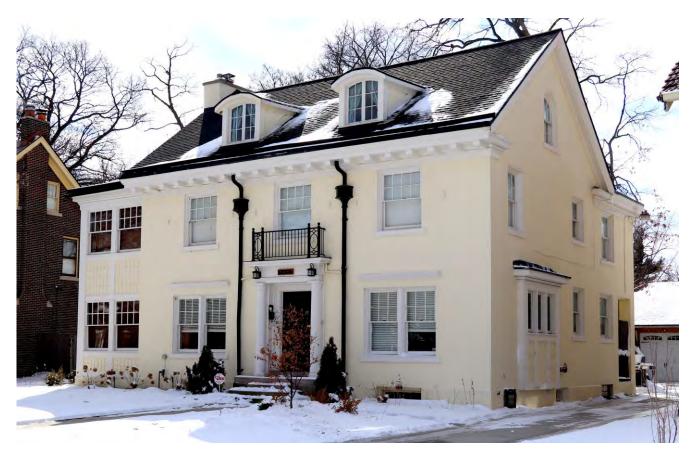
The building located at 3453 Burns Avenue is a 2 ½-story single-family residence constructed in 1915. A two-story sun room exists off the south elevation of the primary building form and a two story addition exists at the rear façade. The house is clad in stucco which is painted off-white in color. Painted wood and metal detailing articulate the simple form of the property. All of the original wood double-hung, casement, and leaded panel windows are intact. The side-gabled roof is covered in dark gray dimensional asphalt shingles and includes a chimney at the south edge, two small arched-top dormers at the front roof elevation and one larger hipped roof dormer at the rear roof elevation. A small portico flanked by two wood columns and topped with metal ornamentation makes up the front entrance of the building which is centered within the symmetrical front façade of the primary massing. A garage is located at the far northwest corner of the lot.

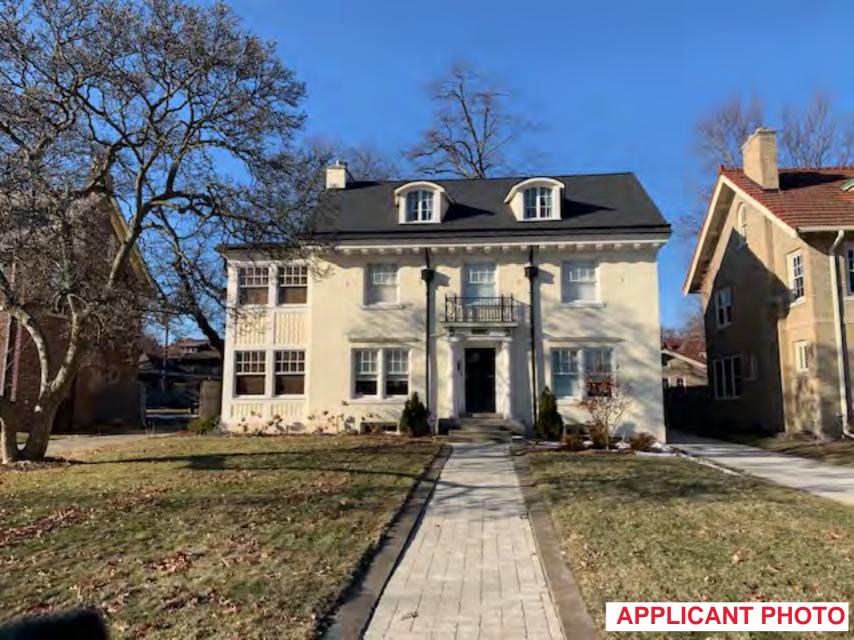
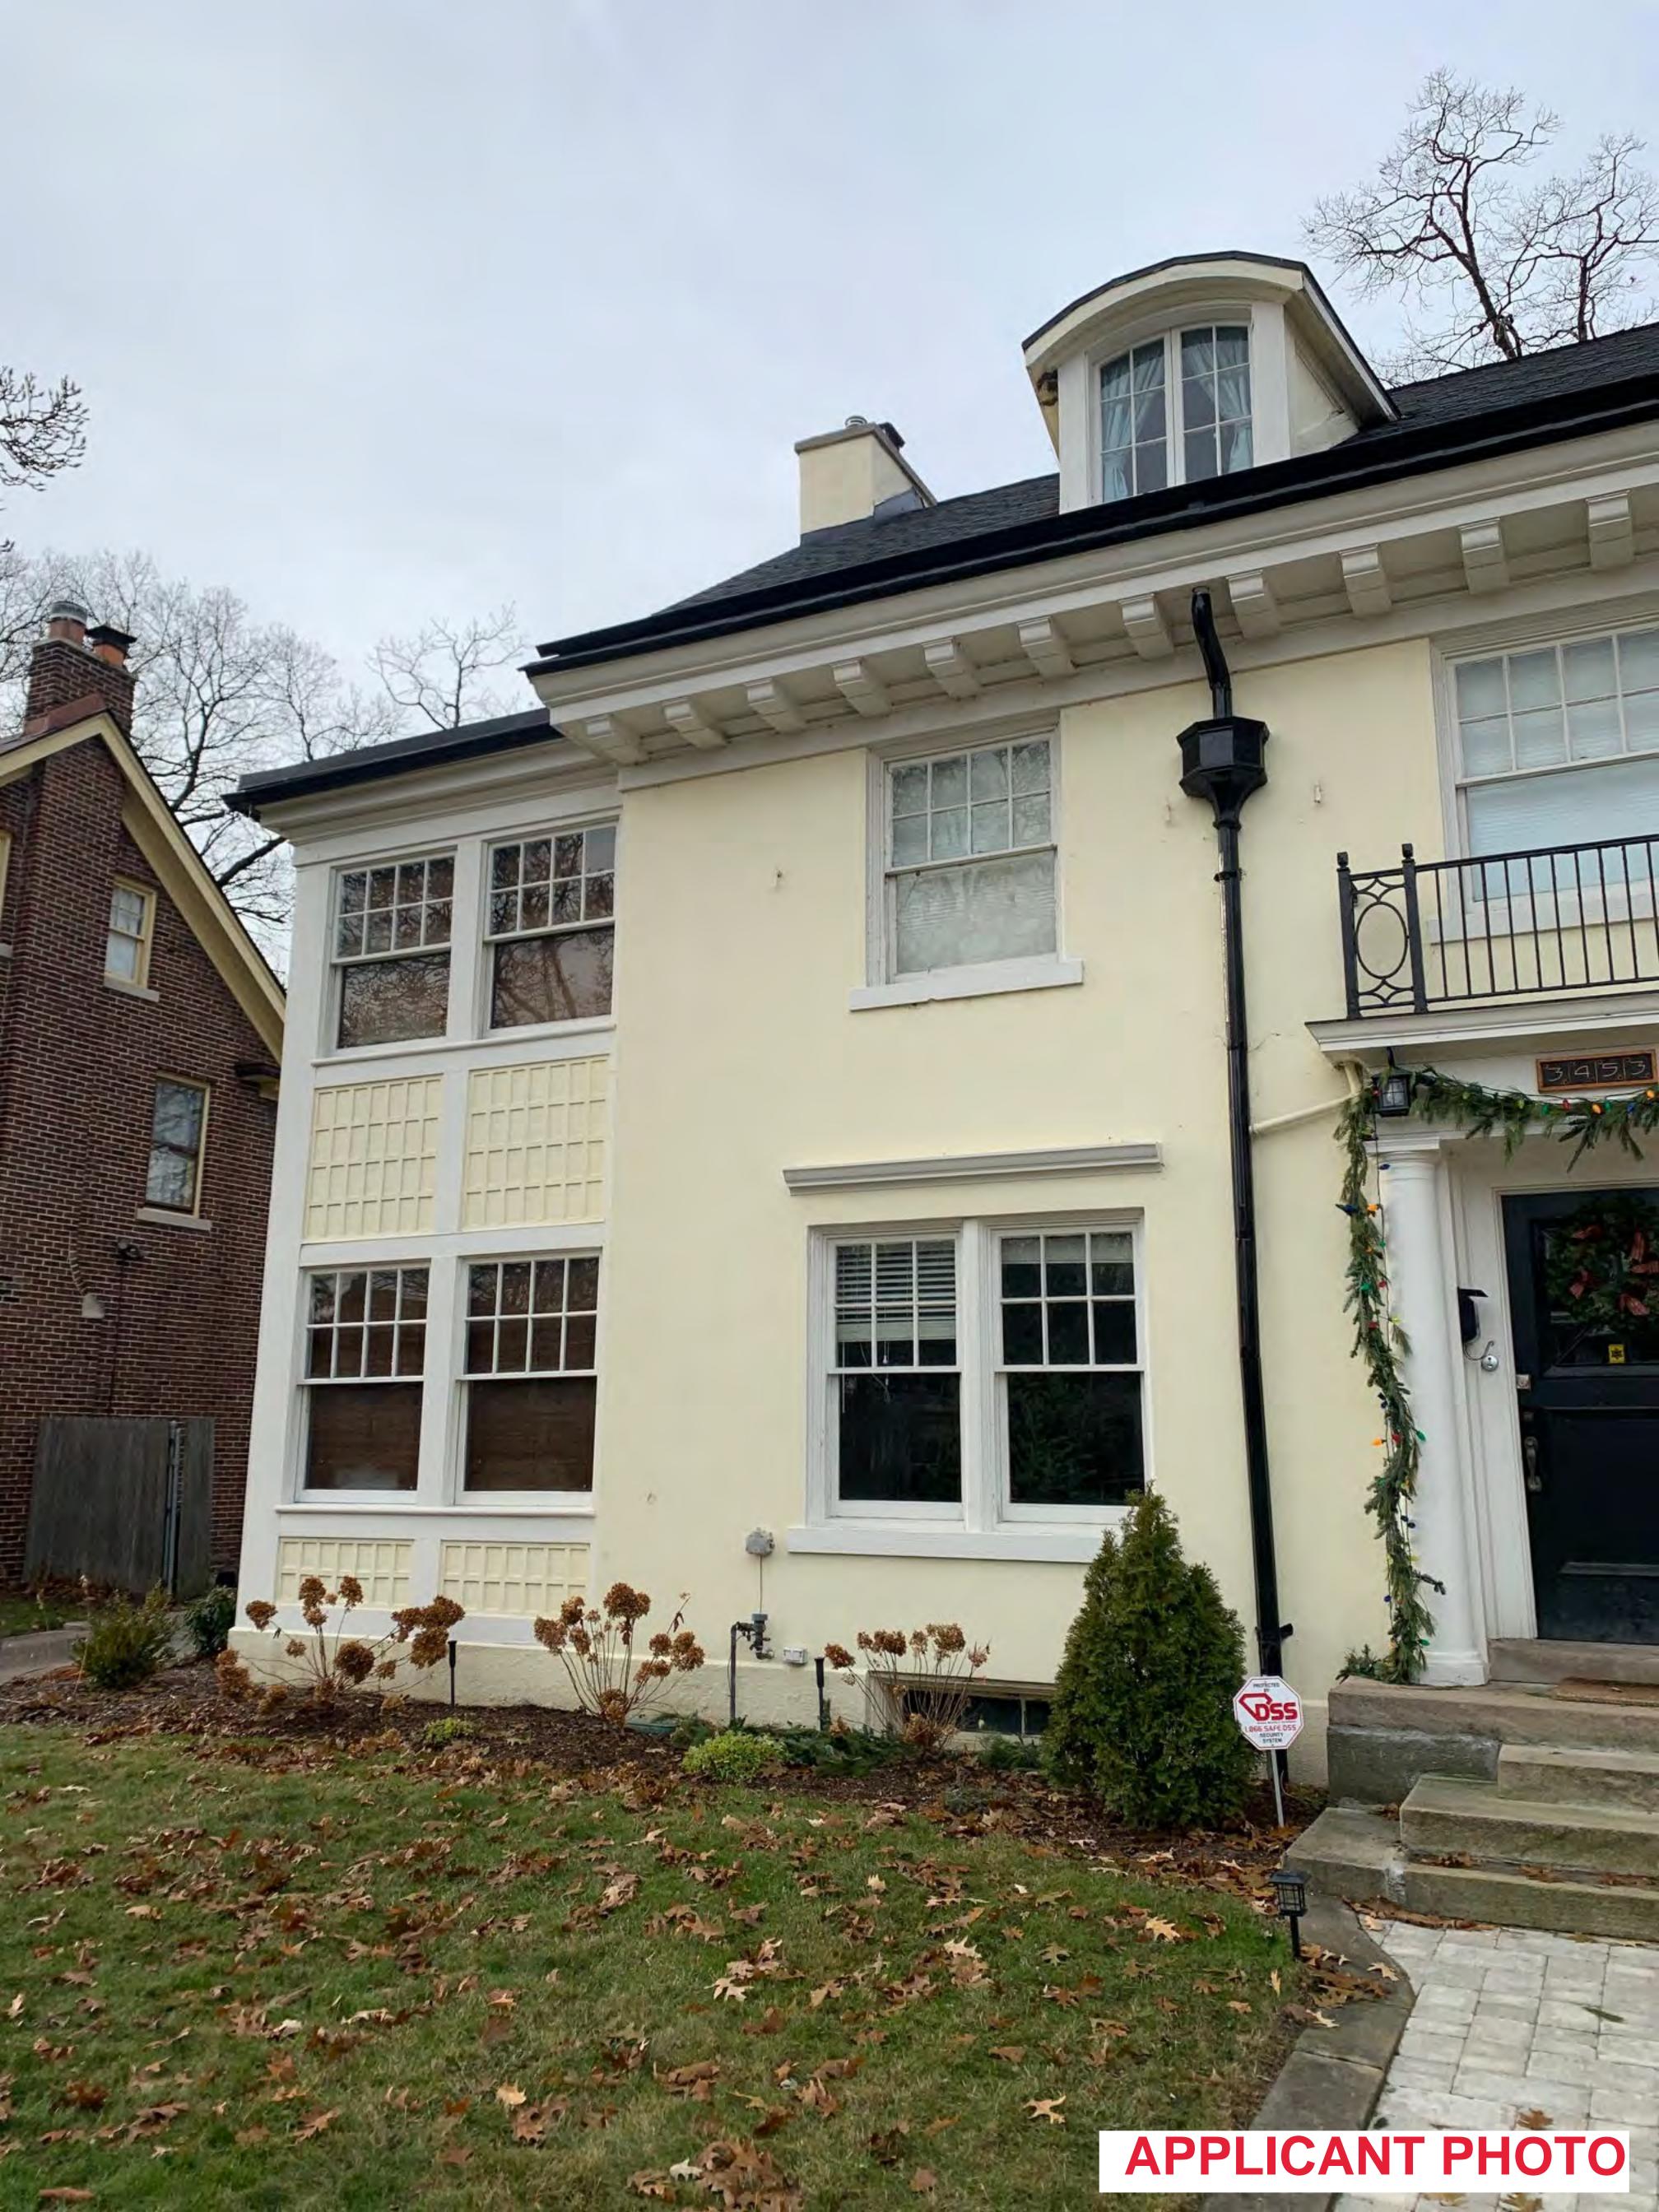
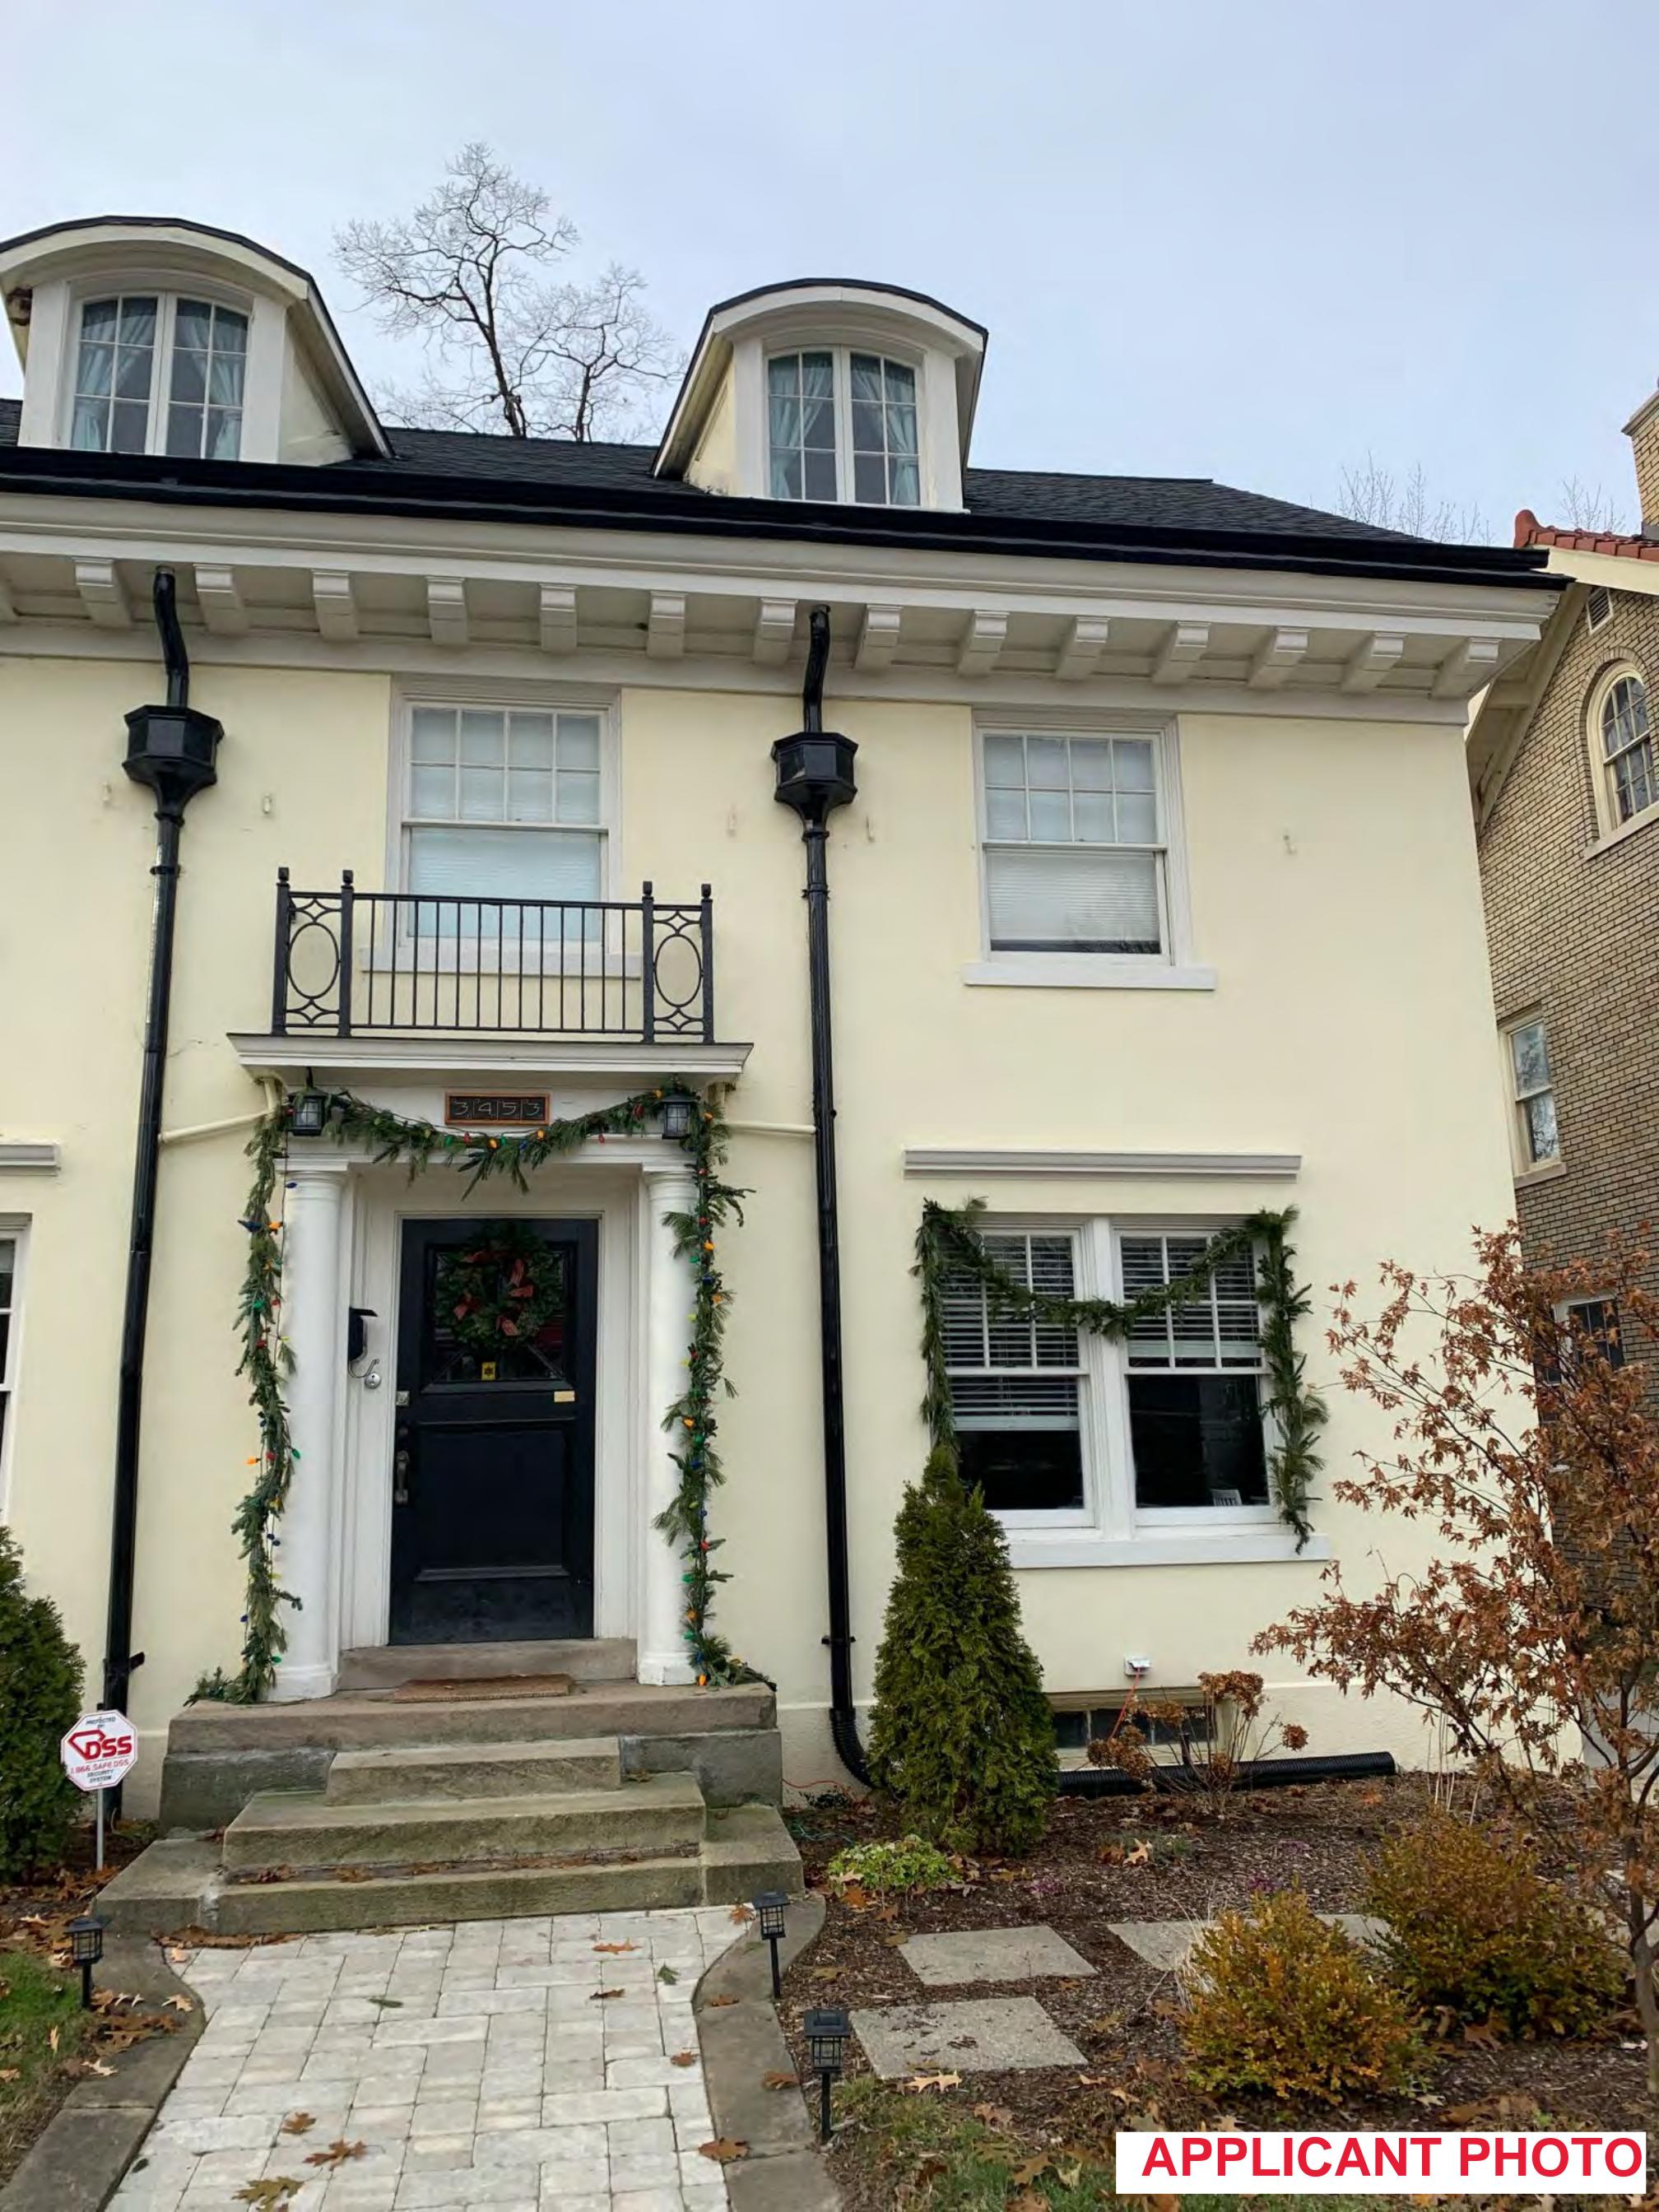
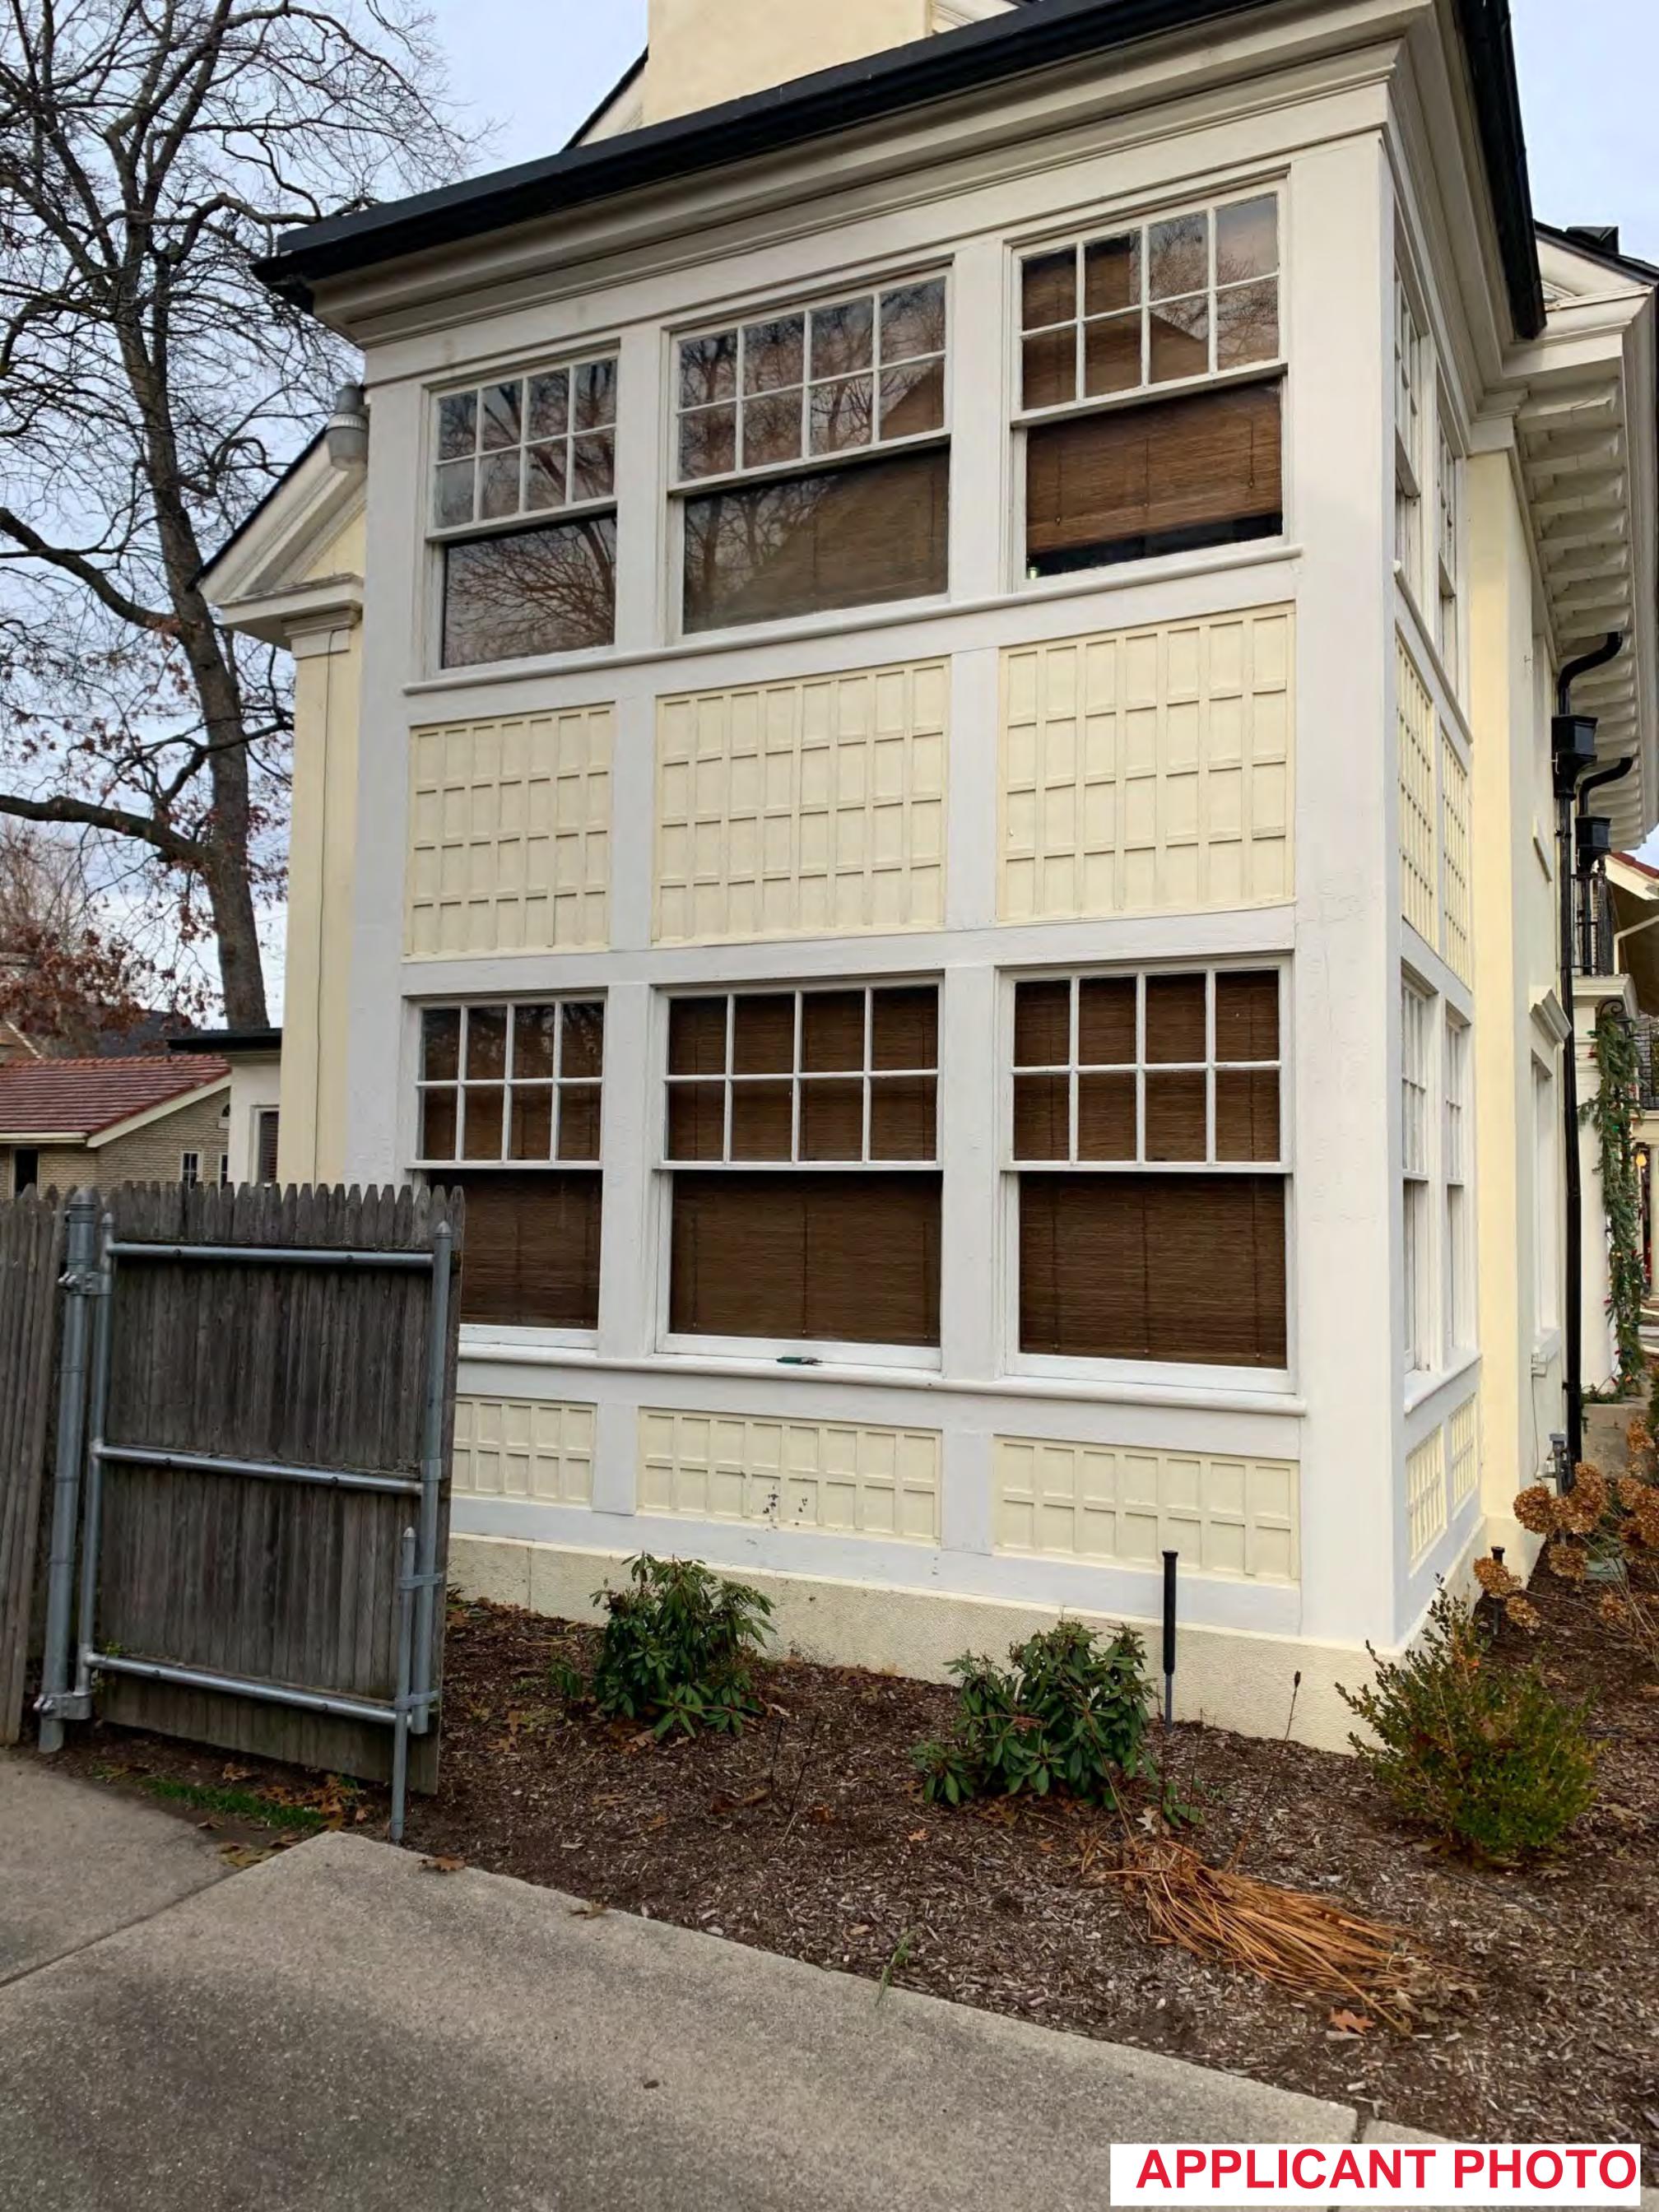
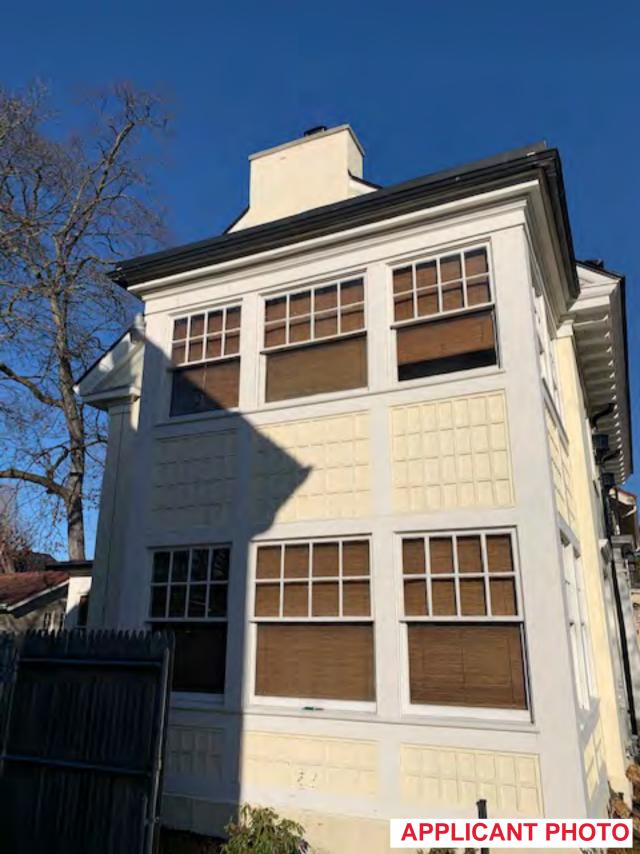
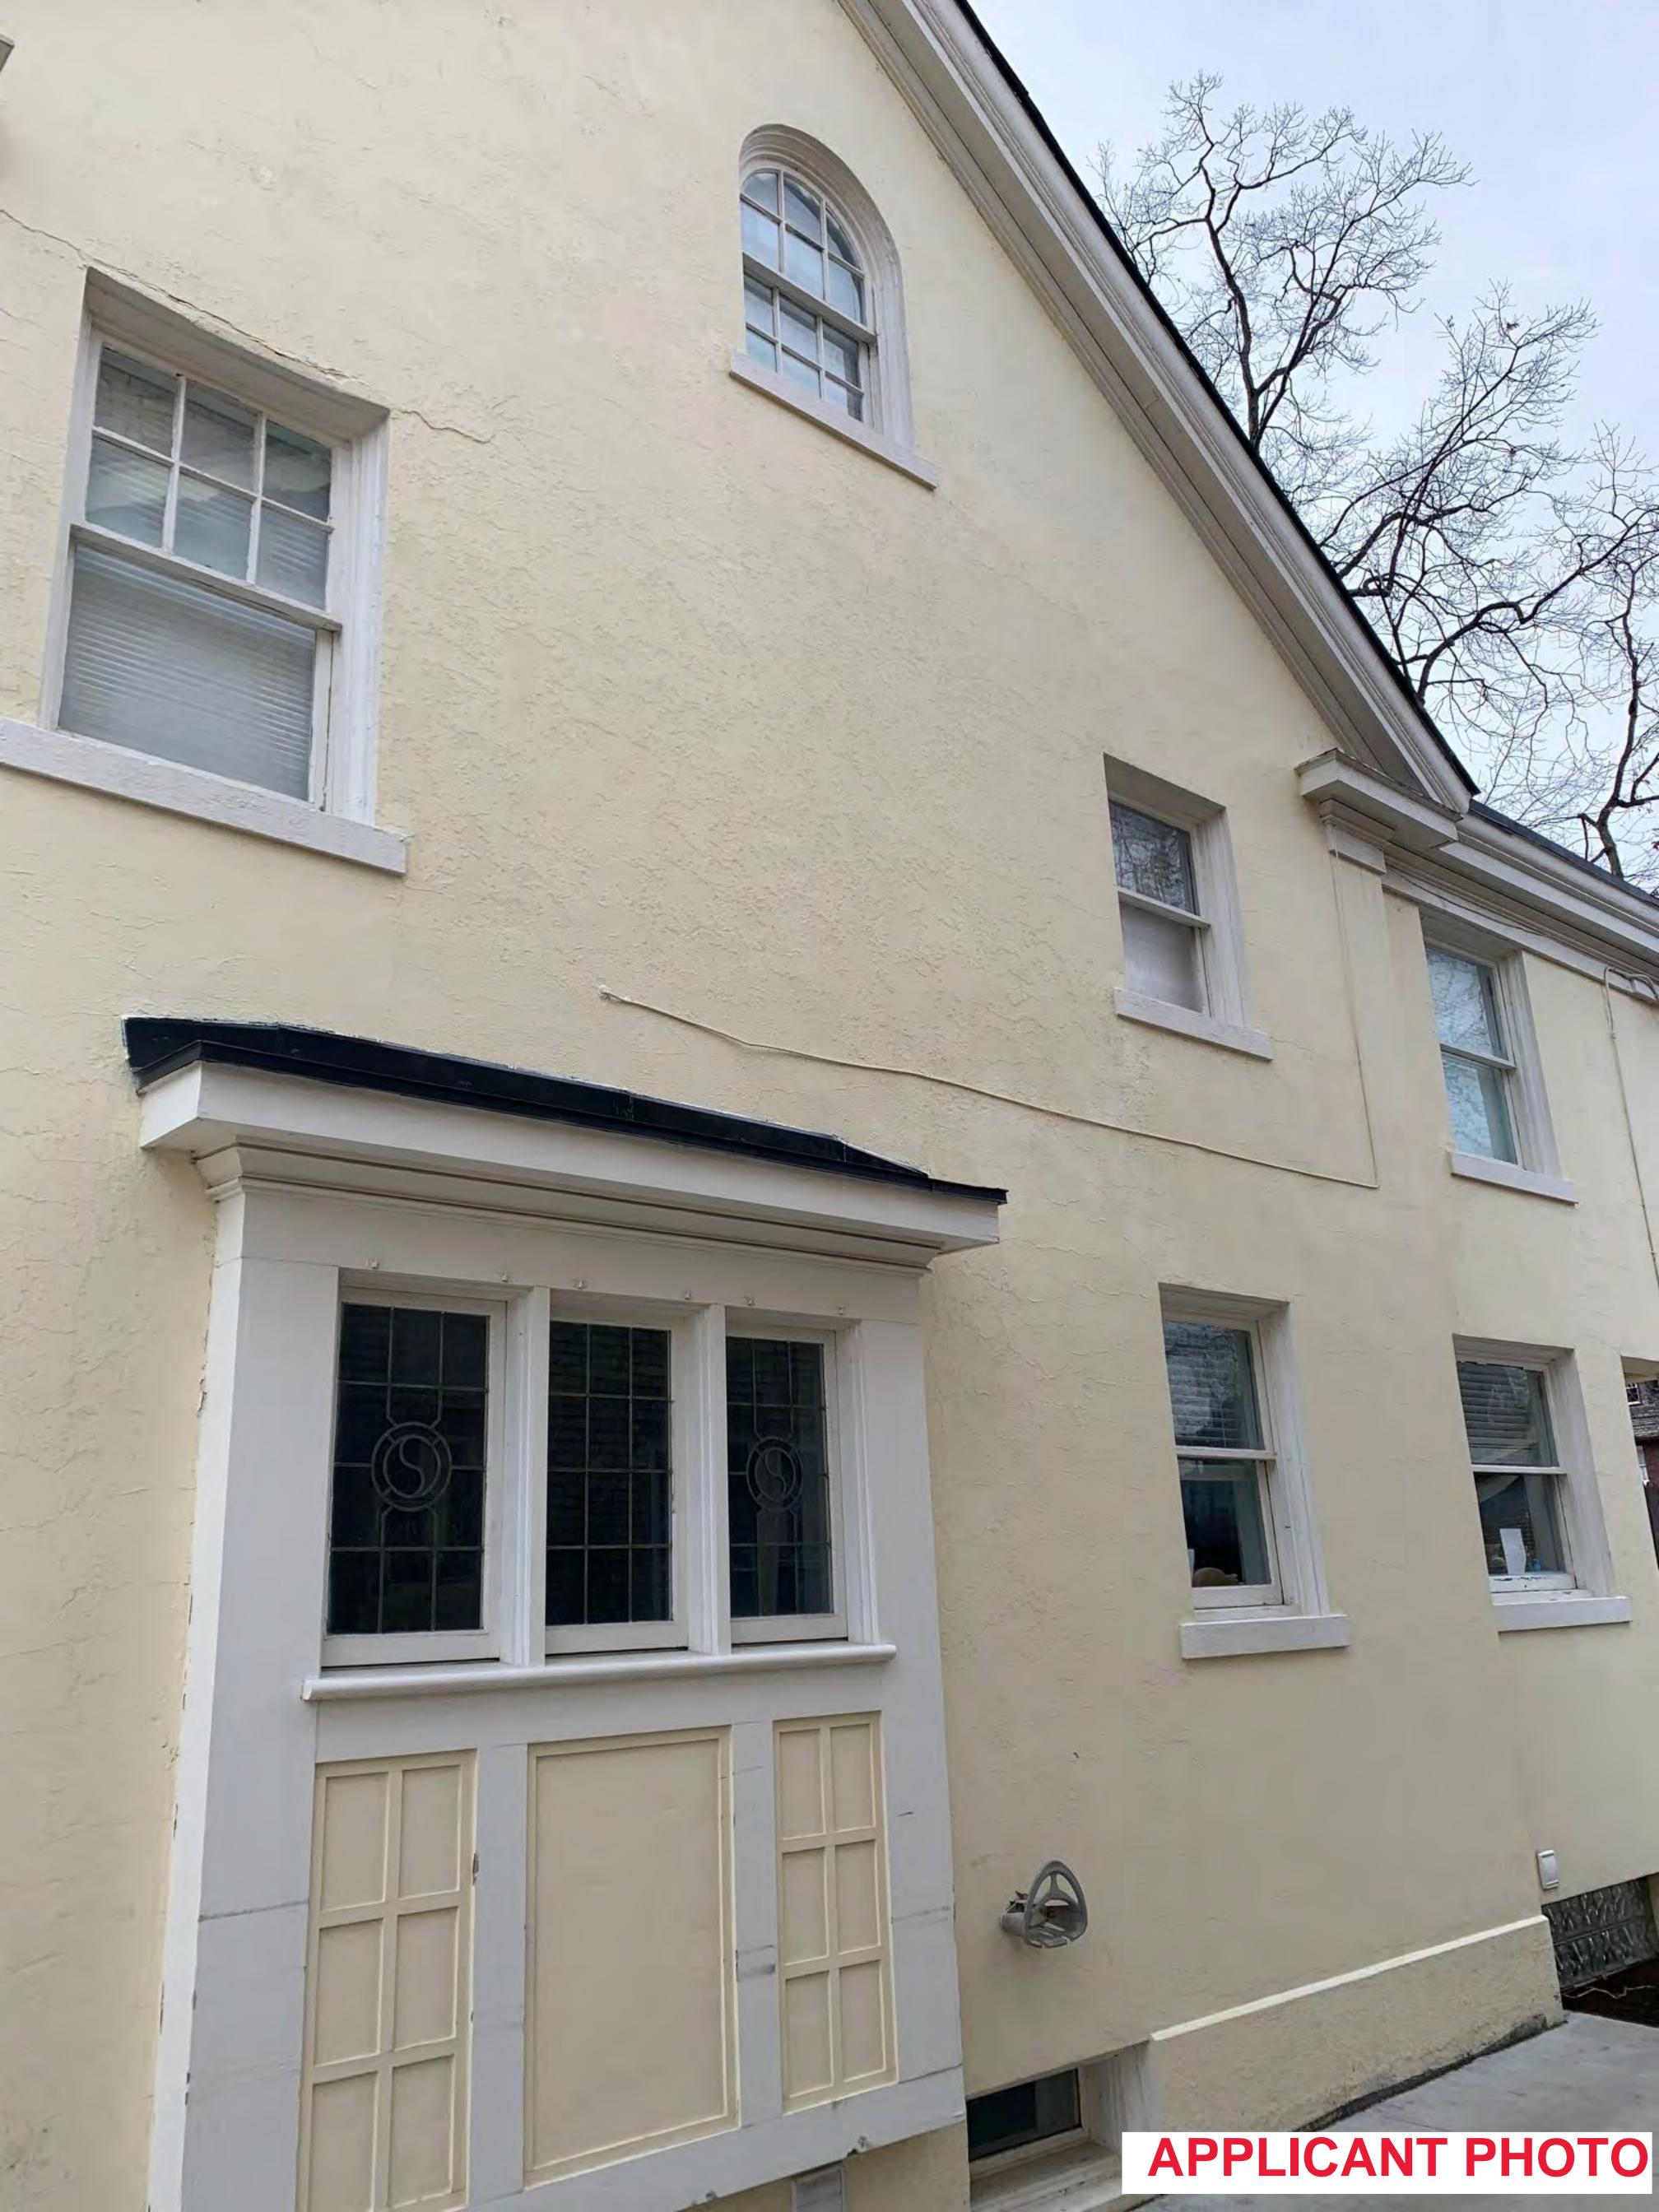
EXISTING CONDITIONS: Existing condition of the double hung can be described as rough (see photos). The subject windows had gone thru a restoration which has now failed, wood filler and glaze is popping and revealing the rotted sashes that were covered. On the interior, water damage from non insulated glass; condensation has continued to damage the interior and cause mold issues.

All windows show obvious signs of zero maintenance. Double hung units showing signs of lower sash rot, exterior sill rot and weather stripping failures. Severe ice/moisture build up on interiors contributing to mold growth and wood rot. Customer states that previous owner was an investor "flipped" house and an effort to restore windows was made 5 years ago, efforts are visible of wood putty failure, caulking installed in place of missing putty and peeling paint. See attached photos. Original decorative will be restored properly and wood rot will be removed and replaced with new wood. Contractor advises replacement of double hung units, existing conditions are rough and restoration will not last long enough vs expense to restor being equivalent to historically accurate replacements.

DESCRIPTION OF PROJECT: We will contract Quaker windows to custom make us replacement wood windows using insulated glass panels from their "Historic Fit" product line to replace 34 double hung units. Quaker will replicate SDL grid patterns to match the original size and quantity. Grids will be present on both the interior and exterior of windows. Contractor will carefully remove existing windows to not disturb exterior original moldings, new windows will be installed, insulated and caulk sealed from exterior and interior. NOTE: Decorative, casement, awning and leaded glass windows will remain and be restored not replaced. Exterior color of windows will match existing, best described as an "off white".
