STAFF REPORT: 3-11-2020 MEETING **ADDRESS: 2405 EWALD CIRCLE** HISTORIC DISTRICT: ADJACENT TO OAKMAN BOULEVARD **INTERESTED PARTY: TYLER TINSEY (DETROIT BUILDING AUTHORITY)** DATE OF SUBMISSION: 2/17/2020 DATE OF STAFF SITE VISIT: 3/6/2020

SCOPE: DEMOLISH BUILDING (ADVISORY OPINION PER 21-2-5)

2405 Ewald Circle Residence

Historic Structural Assessment Report

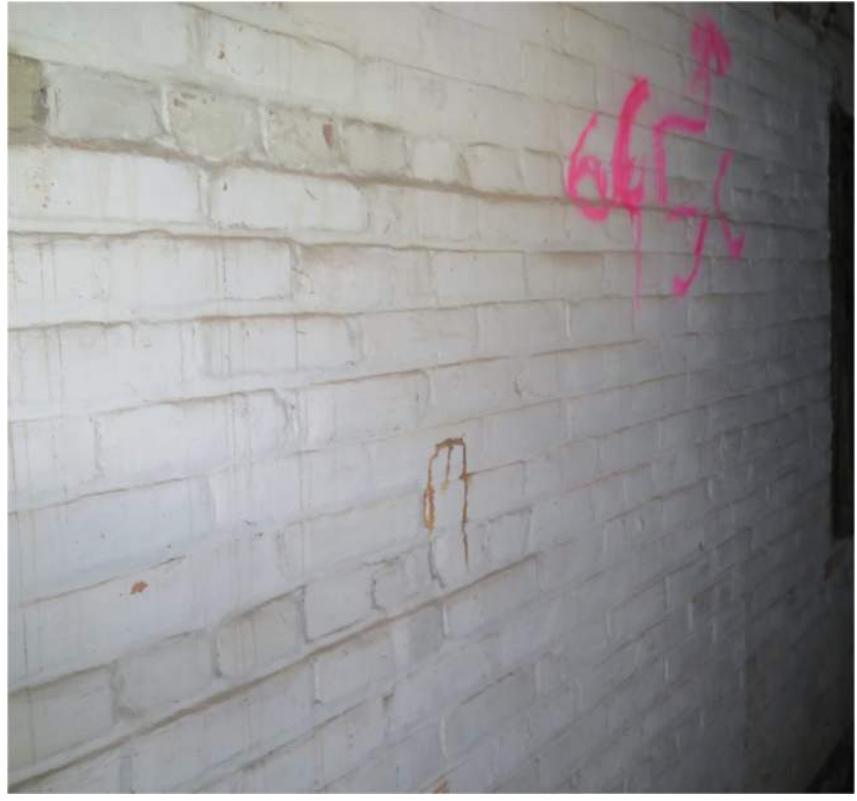
Figure 4 Typical Condition of Basement Brick Masonry Foundation Walls

Where visible, the brick masonry foundation walls were observed to be in good condition in both the central building and south-east wing (Figure 4). There were a number of discrete locations where cracking was observed; typically at the end bearing locations of the floor joist (Figure 5). The slab on grade could not be appropriately assessed due to the large amount of debris present.

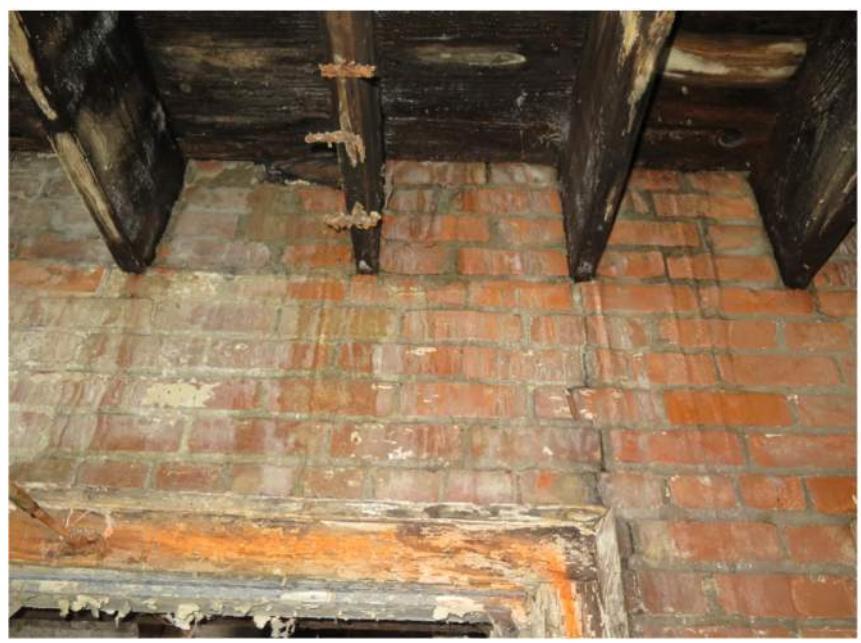
Figure 5 Typical End Bearing Condition of First Floor Joist at Foundation Walls

The first-floor wood joist framing, within the southern portion of the central building and south-east wing, typically appeared to be in poor condition or collapsed. Extensive water deterioration was observed throughout most of the visible joists (Figure 5). Large areas of the floor framing were collapsed in the south portion of the building (Figure 7 & Figure 8). Large portions of the joist framing within the building's western half was observed to have collapsed (Figure 9 & Figure 10). Access to the northern portion of the building was restricted due to the large amount of debris obstructing the walkway caused from the collapse of the first floor above (Figure 11 & Figure 13). Where visible, the steel wide flange girders were observed to be in fair condition, exhibiting moderate amounts of surface rusting (Figure 6).

- Most of the floor framing observed at the first floor was either collapsed or severely deteriorated. We recommend that the first-floor framing be replaced. In the interim access should be restricted to this area of the first floor.

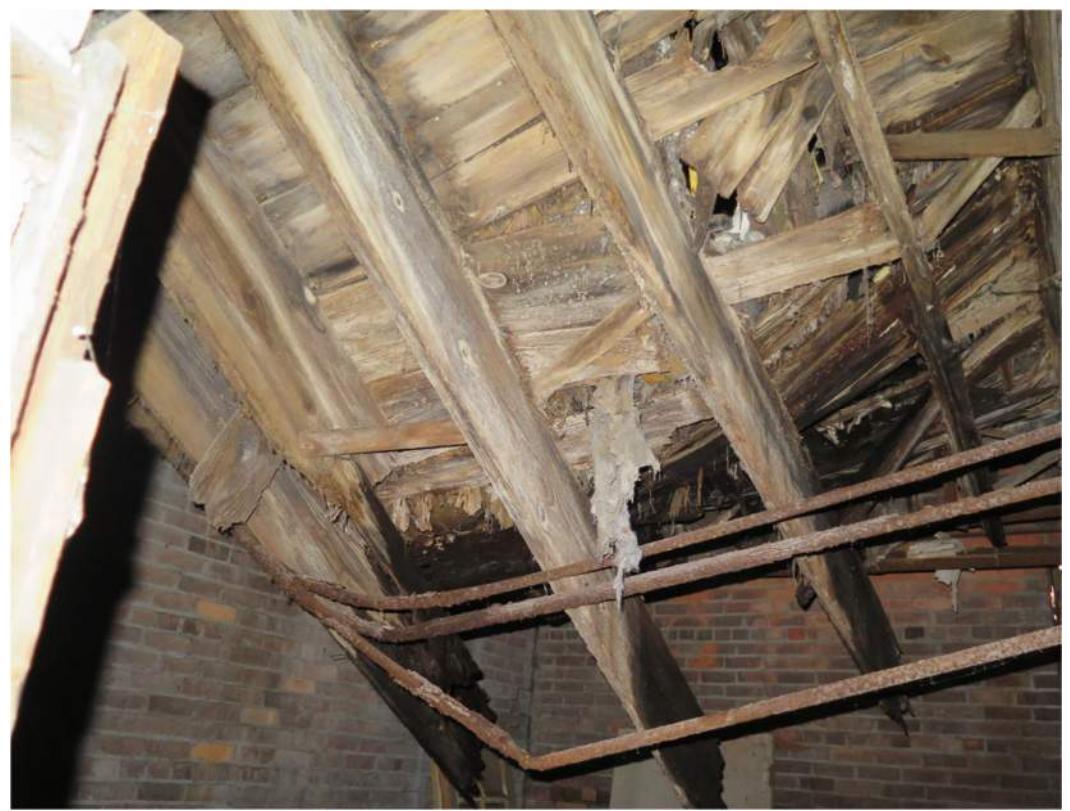
Figure 7 Local Collapse of First Floor Framing in South West Corner of Central Building

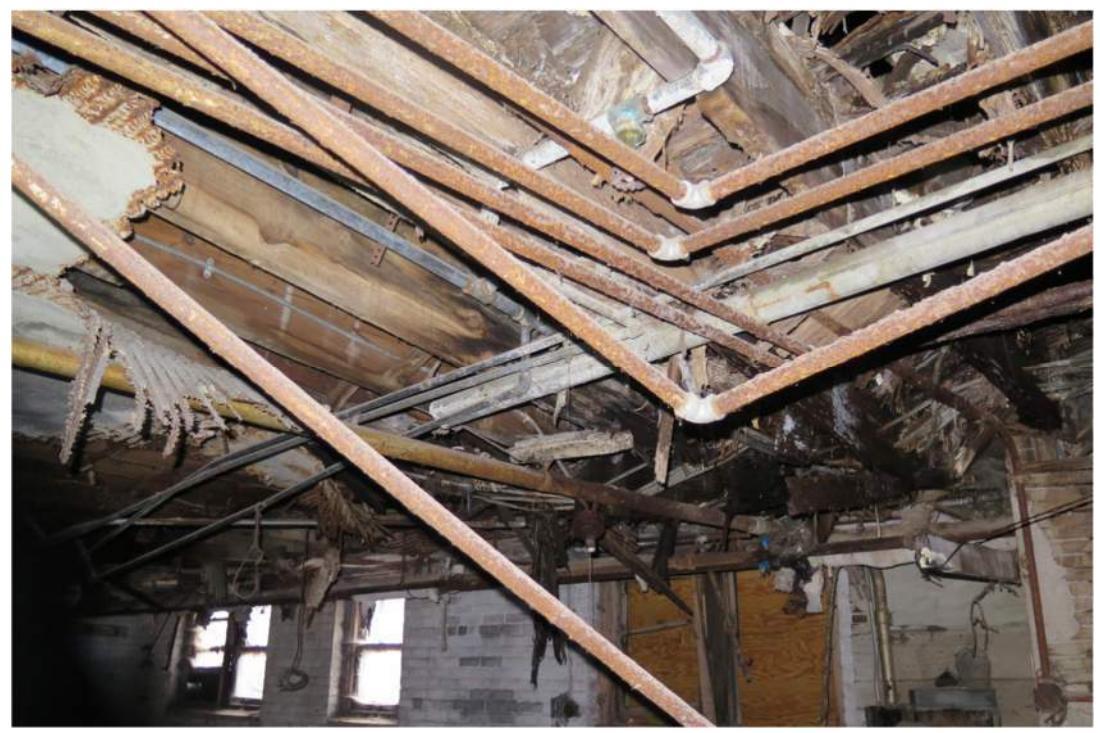
Figure 8 Local Collapse of First Floor Framing in South East Building Wing

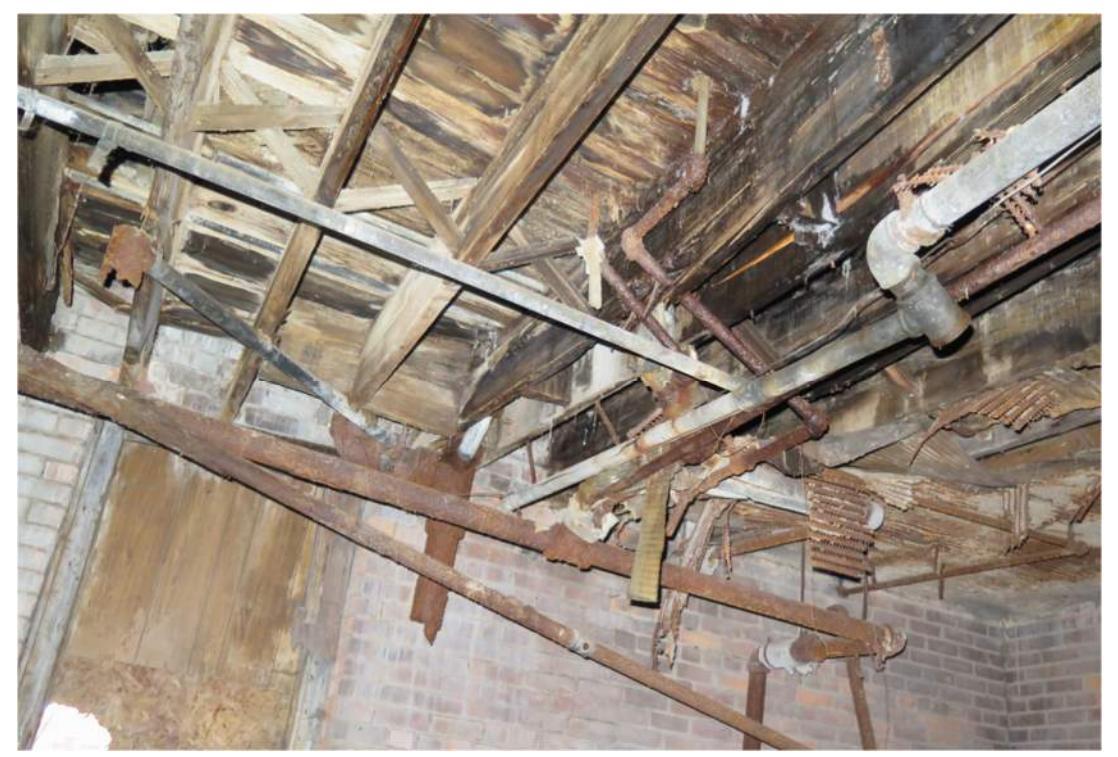
Figure 9 Extensive Water Damage and Local Failure of Floor Joist within the Central Building's Western Half

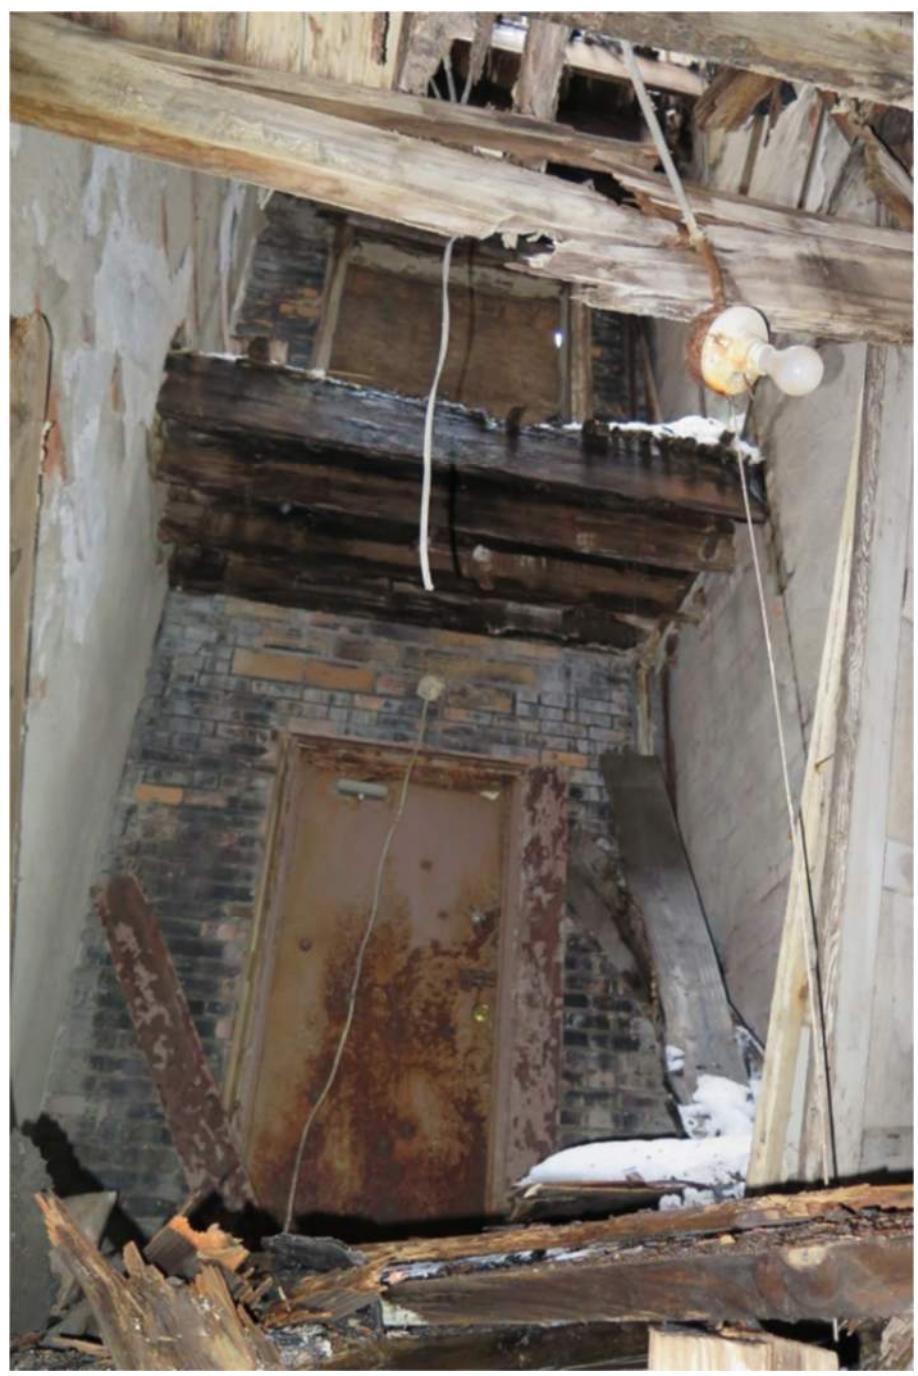
Figure 10 Multiple Level Floor Collapse Adjacent to the West Side Entrance of the Central Building

- Observation of the upper floors was extremely restricted due to the unsafe nature of the first-floor framing and stair. Due to the amount of water infiltration observed in the building and views of upper floors from the exterior we suspect that large portions of the upper floors are also severely deteriorated. Access to the upper floors should be provided so that the upper floors can be surveyed to confirm the extent of damage.

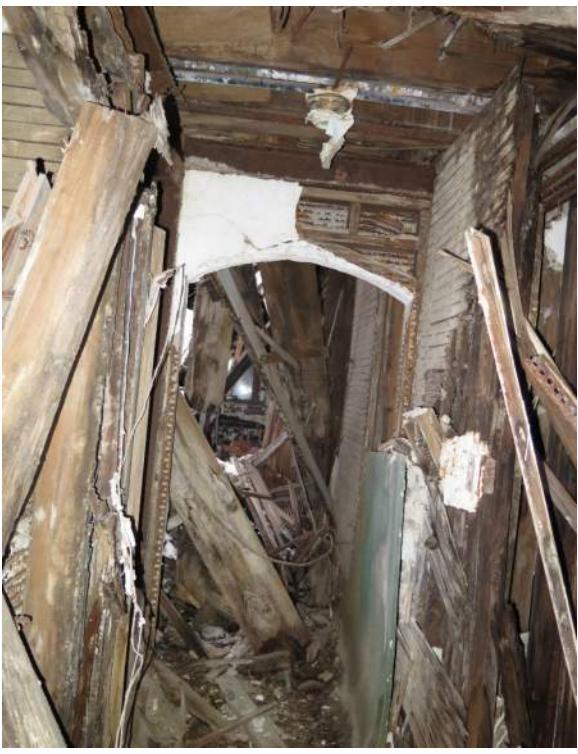
Due to the poor and unsafe condition of the stair well, Silman could not access the third floor to assess the underside of the roof framing. The stair's wood stringers and tread assembly had exhibited extensive amounts of water damage typically at each floor (Figure 11).

Figure 11 Collapse of First Floor Framing within the Central Building's Northern Half

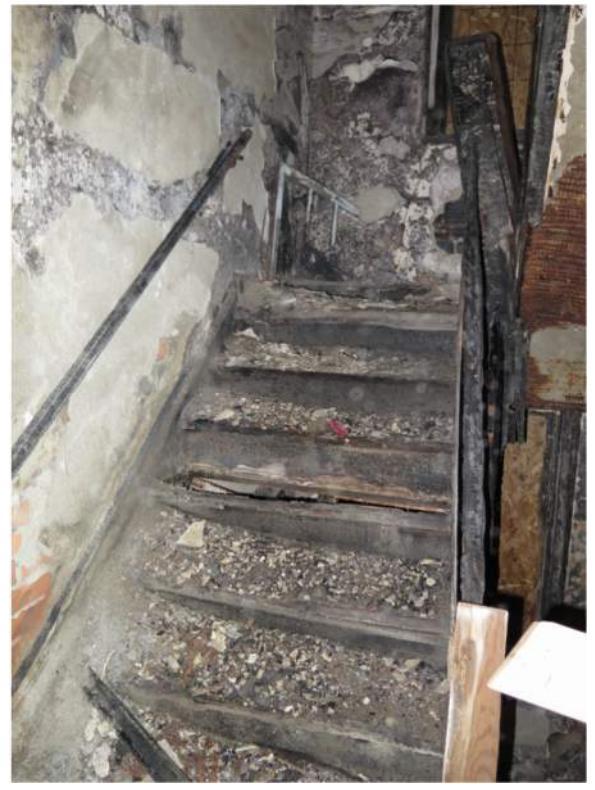
Figure 12 Typical Condition of Wood Frame Egress Stair within the Central Building

- The stair framing is in danger of collapsing. The stair should be removed and replaced. In the interim access should be restricted to this area of the first floor.

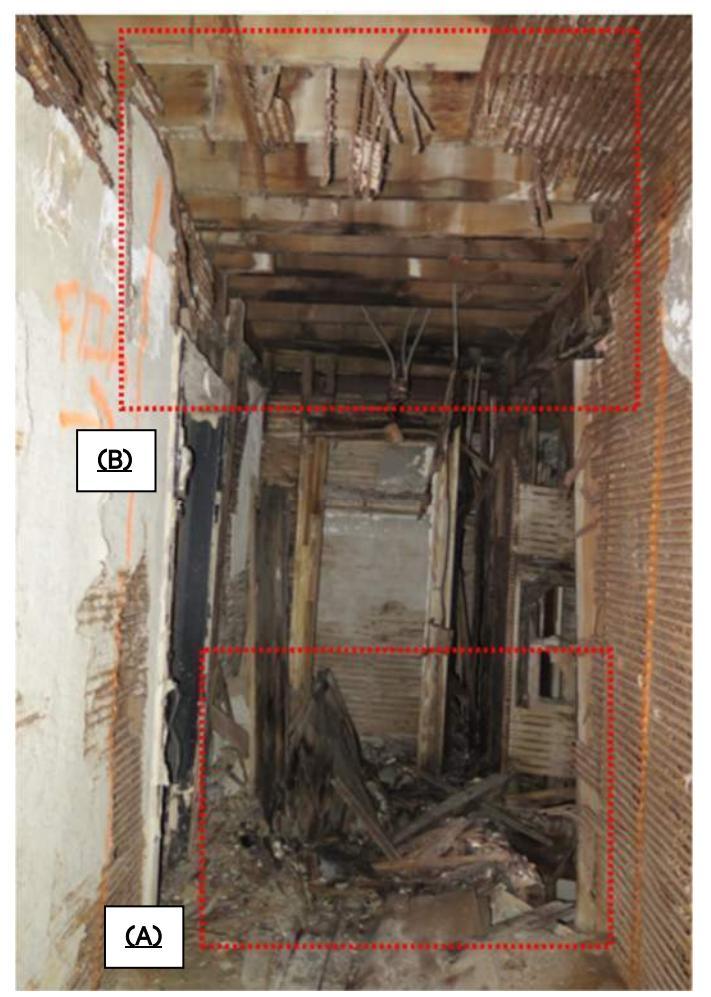
Figure 13 (A) Local Floor Collapse at First Floor North Hallway & (B) Second Floor Joist Framing of Central Building

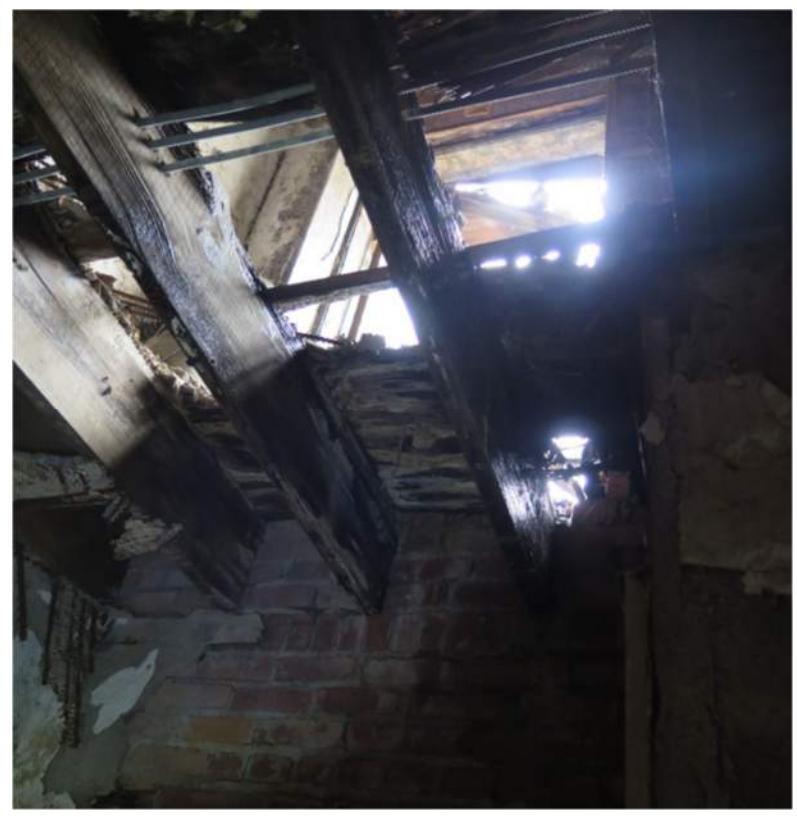
The north façade of the main building was generally in fair condition. There were bricks throughout the façade that were observed to have severe spalling, were missing or were broken (Figure 15 and Figure 16). Rusting of the steel lintels was observed at the first-floor openings and cracking was observed at the brick surrounding the opening (Figure 20).

Figure 15 Third Floor Collapse at Western Bay of Framing within the Central Building

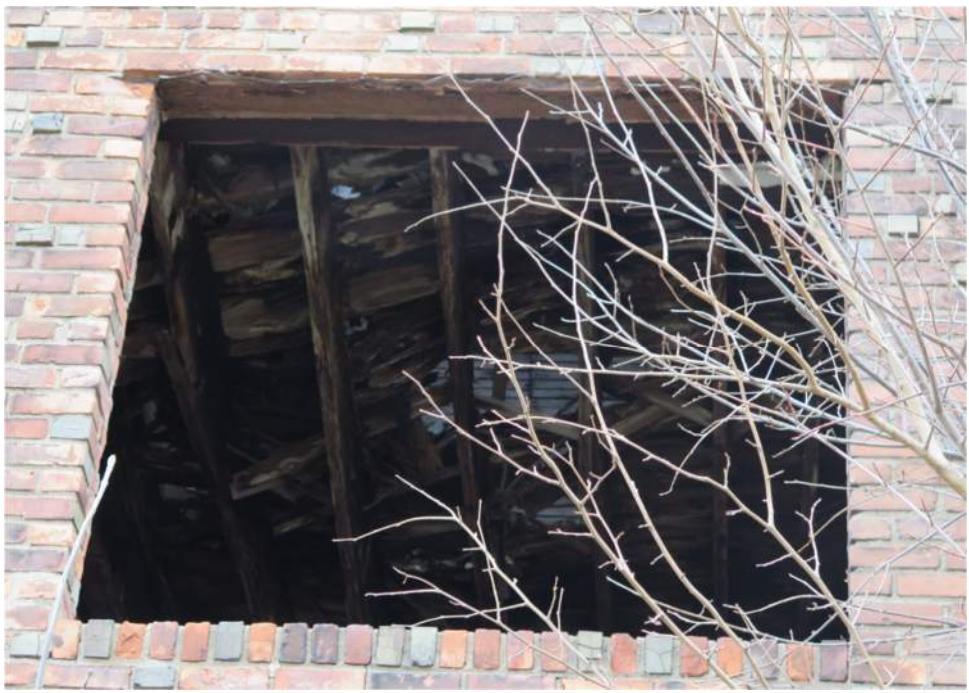
Due to the extensive water damage at the joists and large portions of the first floor that have collapsed, Silman's observation of the second-floor joist from the first floor below was restricted to the local vicinity of the stairwell. The observable joists within the hallway appeared to be in fair condition exhibiting moderate amounts of water staining (Figure 13). When observing the underside of the third floor framing from the floor below, Silman had observed similar deficiencies within the joist spanning over the hallway (Figure 14). In addition, Silman had observed a collapse of the local framing directly west of the stairwell (Figure 15). Note that observations of these joist were also made primarily from the stairwell. From the exterior, Silman observed a portion of the third floor framing to be collapsed (Figure 23).

The west façade was in similar condition. Rusting of the steel lintels at openings was visible with brick deterioration observed at the lintel bearings and above the opening (Figure 23 to Figure 25). Water staining was visible below a roof gutter (Figure 26).

Figure 2317 Observed Collapse of Third Floor Joist Framing from Exterior of Central Building

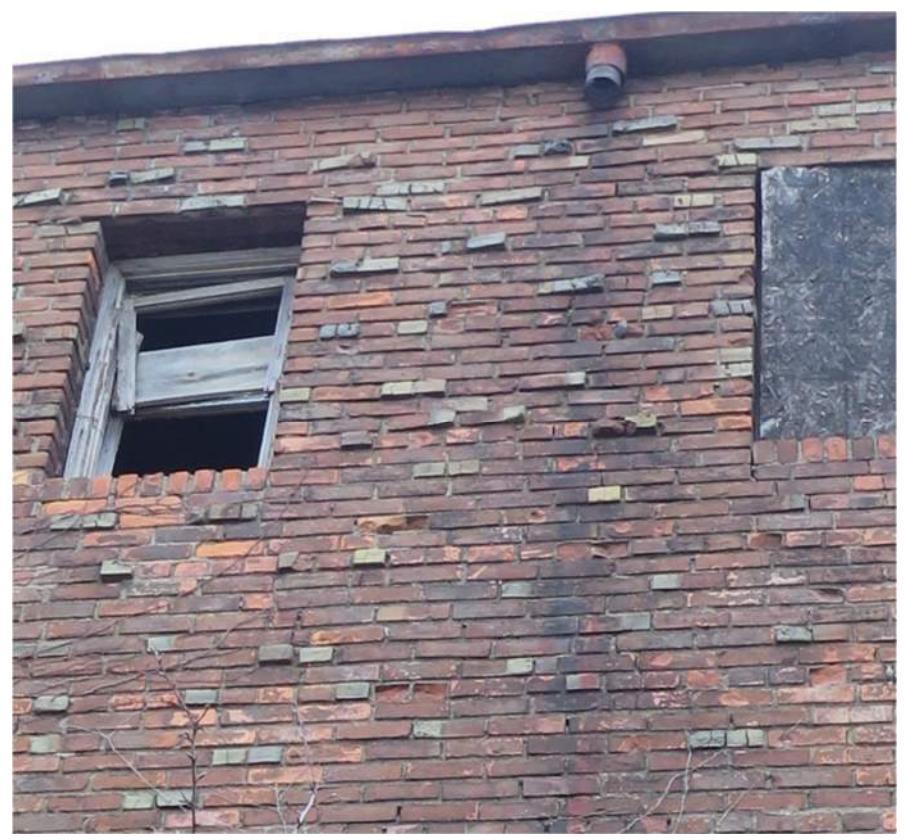
Figure 26 Water Staining of Brick Facade Below Gutter Drain at North Façade of Central Building

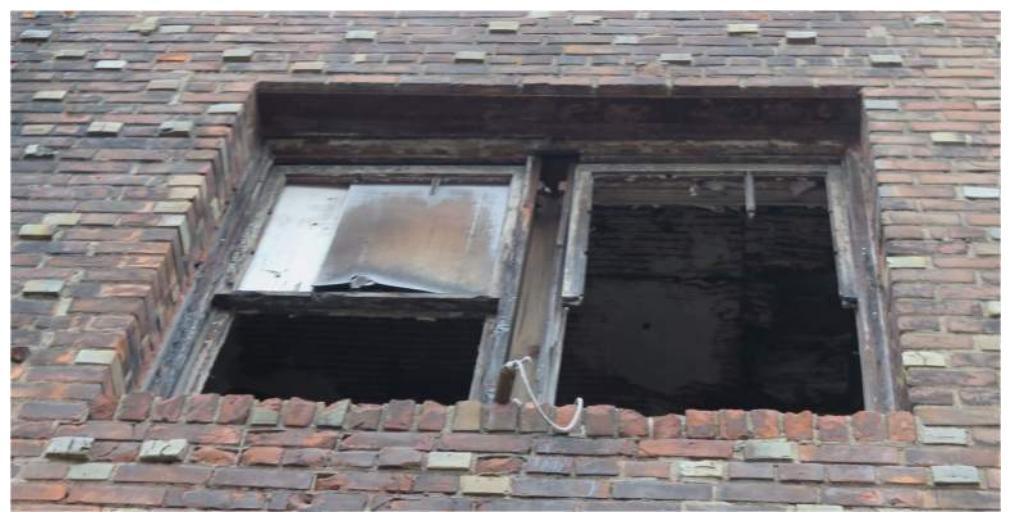
Figure 29 Typical Exposed Window Opening at South Façade of Central Building

The brick masonry at the east façade was in similar condition to the north and west. The steel lintels appeared to be in better condition at this façade with no visible rust or rust-jacking observed (Figure 29). The dormer at the south façade appeared to be leaning back, it was unclear if this was intentional or a deformation of the framing.

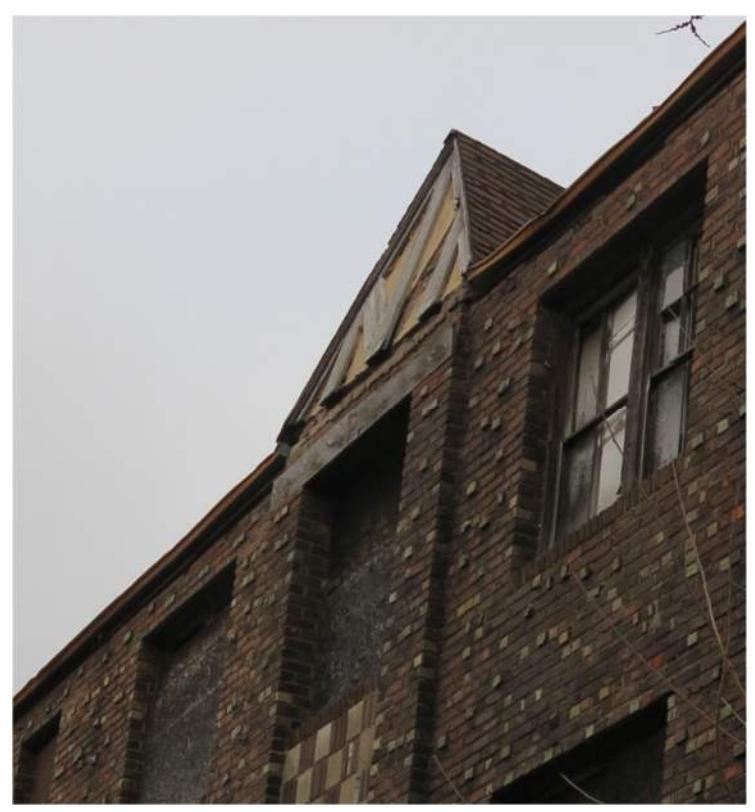
Figure 30 Apparent Leaning of Dormer at South Façade of Central Building

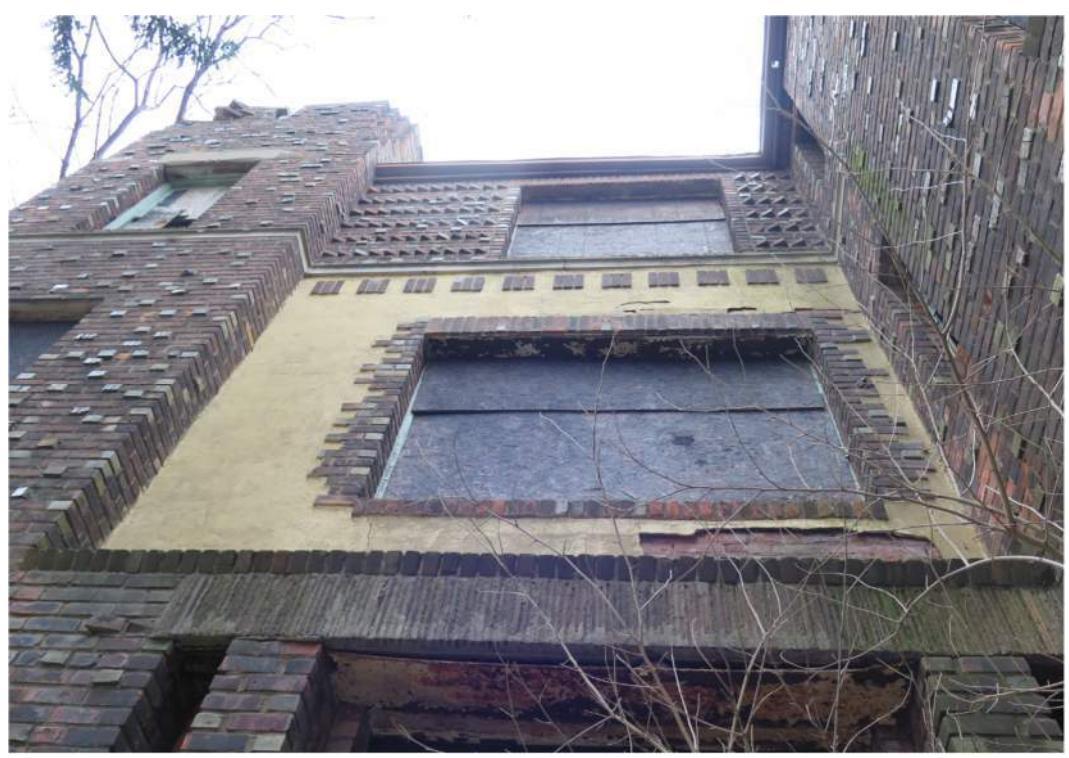
Figure 32 North Facade of South-East Building Wing

The north façade of the south-east wing was observed to be in similar condition (Figure 32). The parapet at the northeast corner was severely deteriorated with missing and loose bricks observed (Figure 33).

- Areas at the façade with mortar deterioration should be repointed and cracked, loose, spalled or missing bricks should be replaced. Cracks in the masonry should be repaired.
- At window openings where rusting of the lintels or displacement at the surrounding brick was observed, the lintels should be exposed to determine the extent of rusting. At this time an engineer should review the lintels to determine if they can be repaired in place or must be replaced.

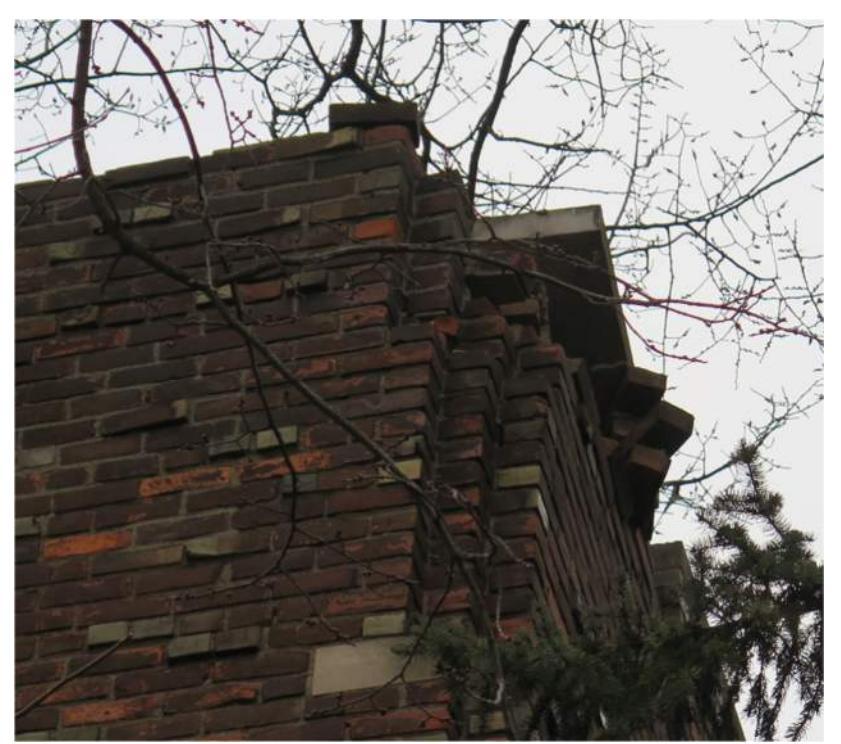
Figure 33 Apparent Local Collapse of Brick Masonry Parapet at North Facade of South-East Building Wing

- At the parapet in the south-east wing there are bricks in danger of falling from the façade. The bricks and coping stone in this area should be secured. The parapet should be taken down to sound brick and rebuilt.

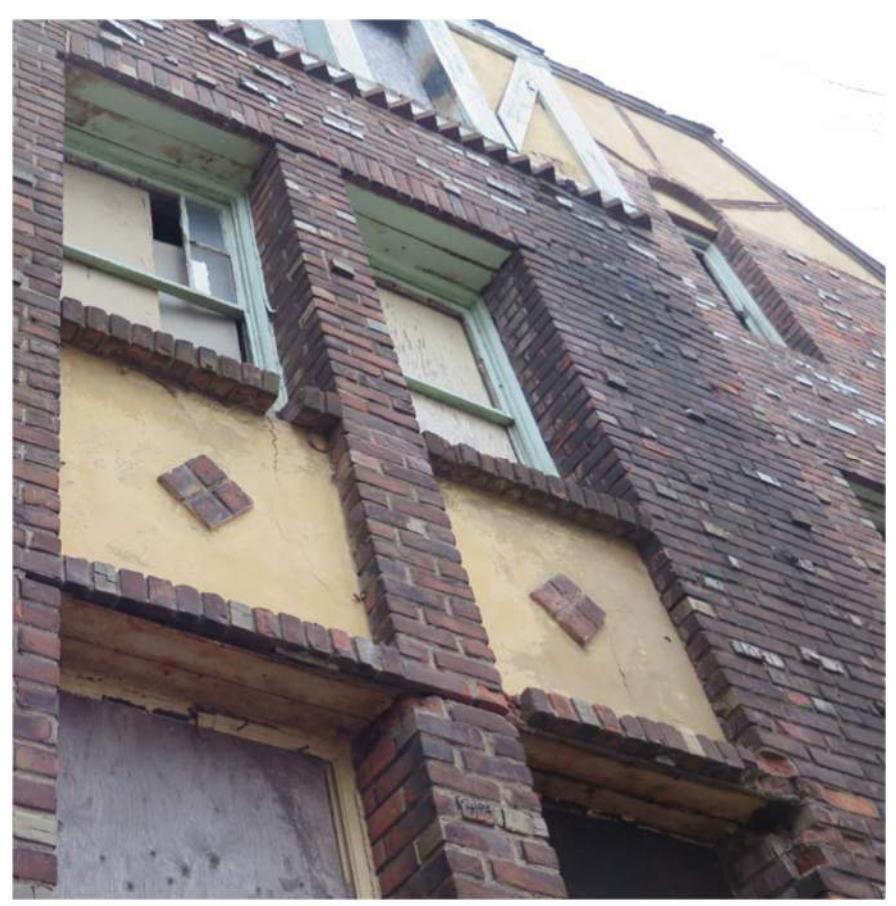
The east façade was in similar condition with brick spalling observed throughout. Local deterioration of the brick was observed around window openings (Figure 36 and Figure 37). At the entrance at the east façade, deterioration and voids in the roofing was observed (Figure 38).

Figure 36 Deteriorated Brick Façade Near Window Sill and Lintels of Central Building

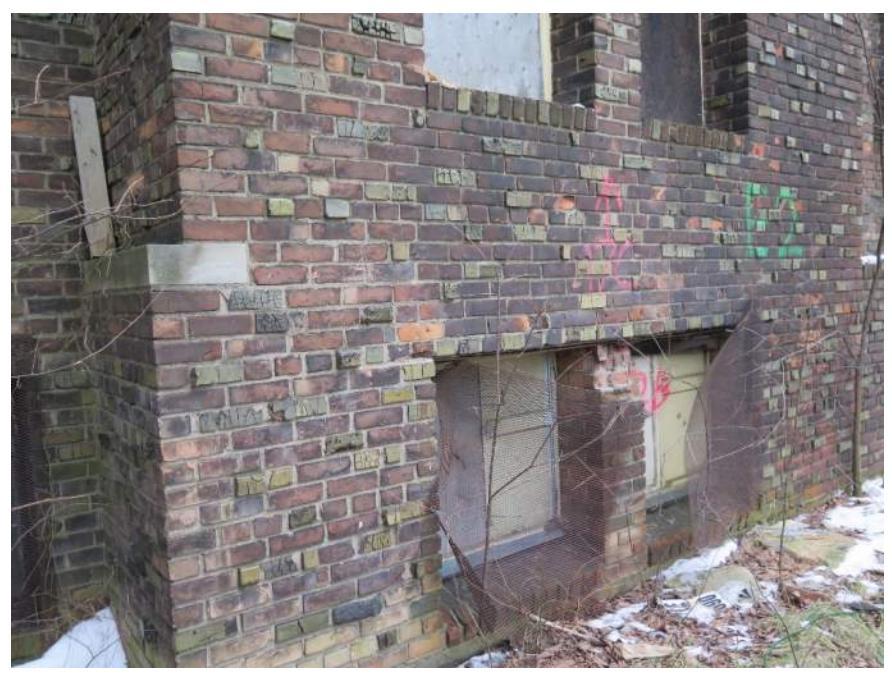
Figure 37 Deteriorated Brick Façade Near at Cellar Window

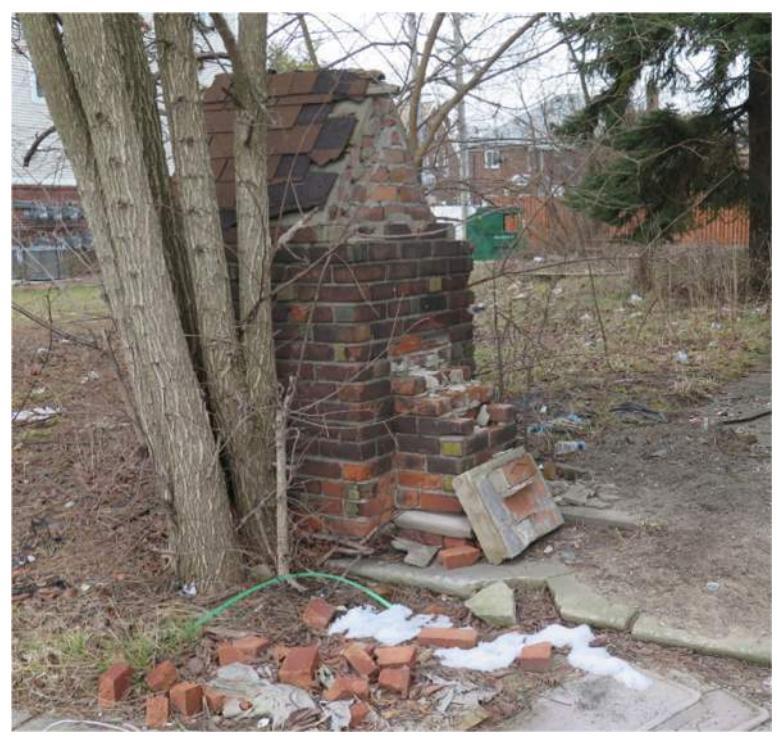
At the building entrance there was a brick pillar that was severely deteriorating and partially collapsed (Figure 39).

Figure 39 Deteriorated Brick Stack at North East Corner of Property
