**STAFF REPORT 04-15-2020 REGULAR MEETING**

**APPLICATION NUMBER: 20-6687**

**ADDRESS: 961 BURNS AVENUE**

**SCOPE: REPLACE EXISTING ALUMINUM WINDOWS WITH NEW WOOD WINDOWS**

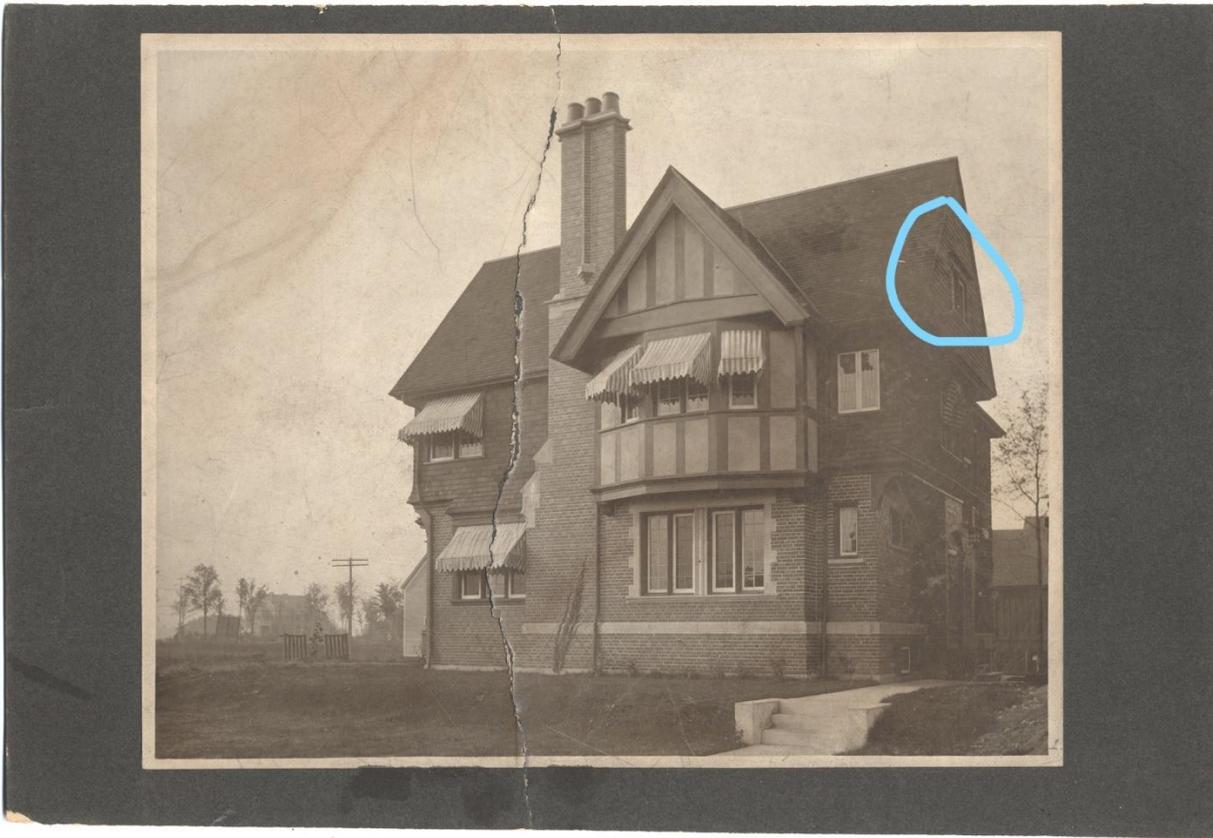
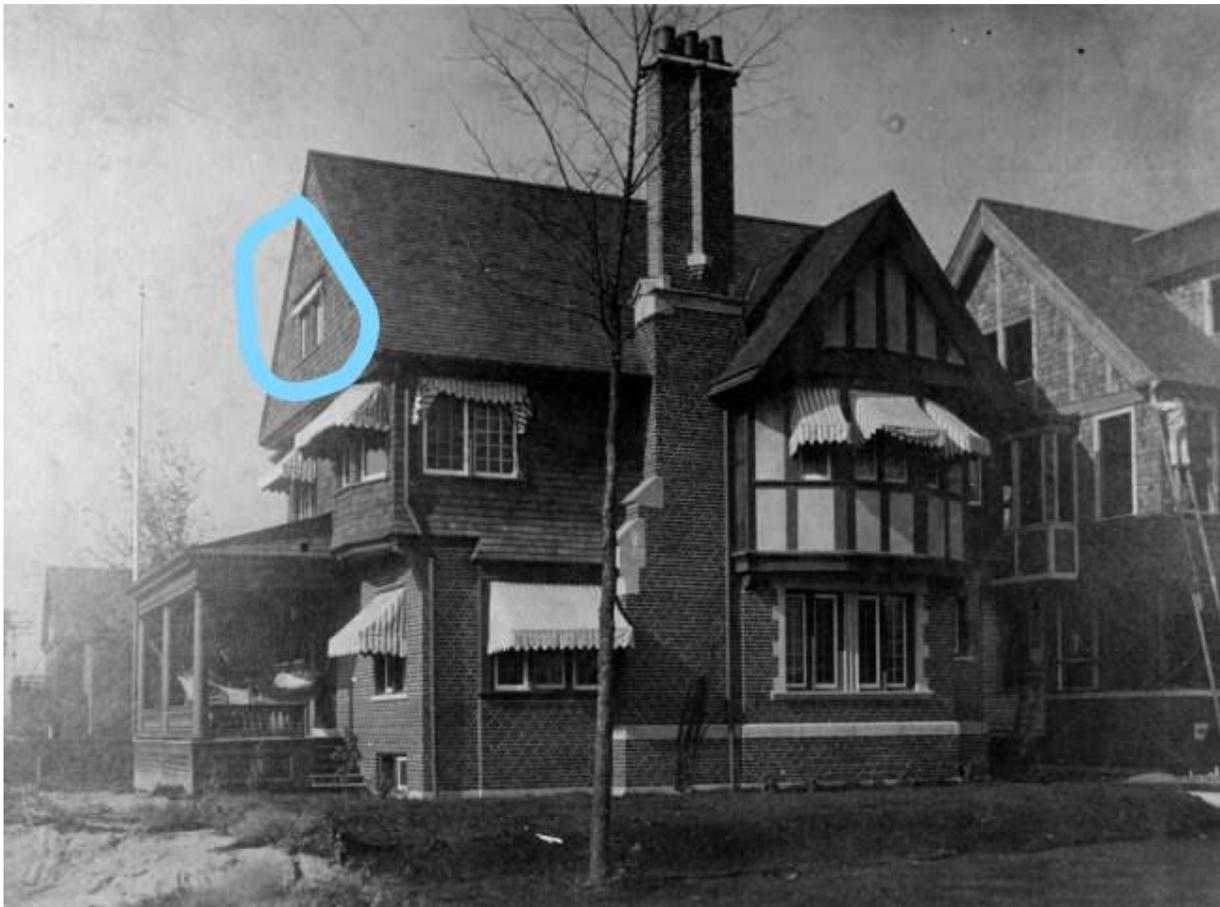
Original windows depicting 2 sashes:

- The **photograph** which the applicant is using to show the original inswing windows is of a set of windows on the second floor, not the third floor. Additionally, upon looking at the historic photos provided by the applicant, the third floor opening in the gable end at the front of the house is not present which means it was added at a later date and is not original.
- At the time of designation, the house included the (3) mullied windows in each gable end.
- It is not apparent that the configuration of the existing openings was at any point two sashes rather than three.

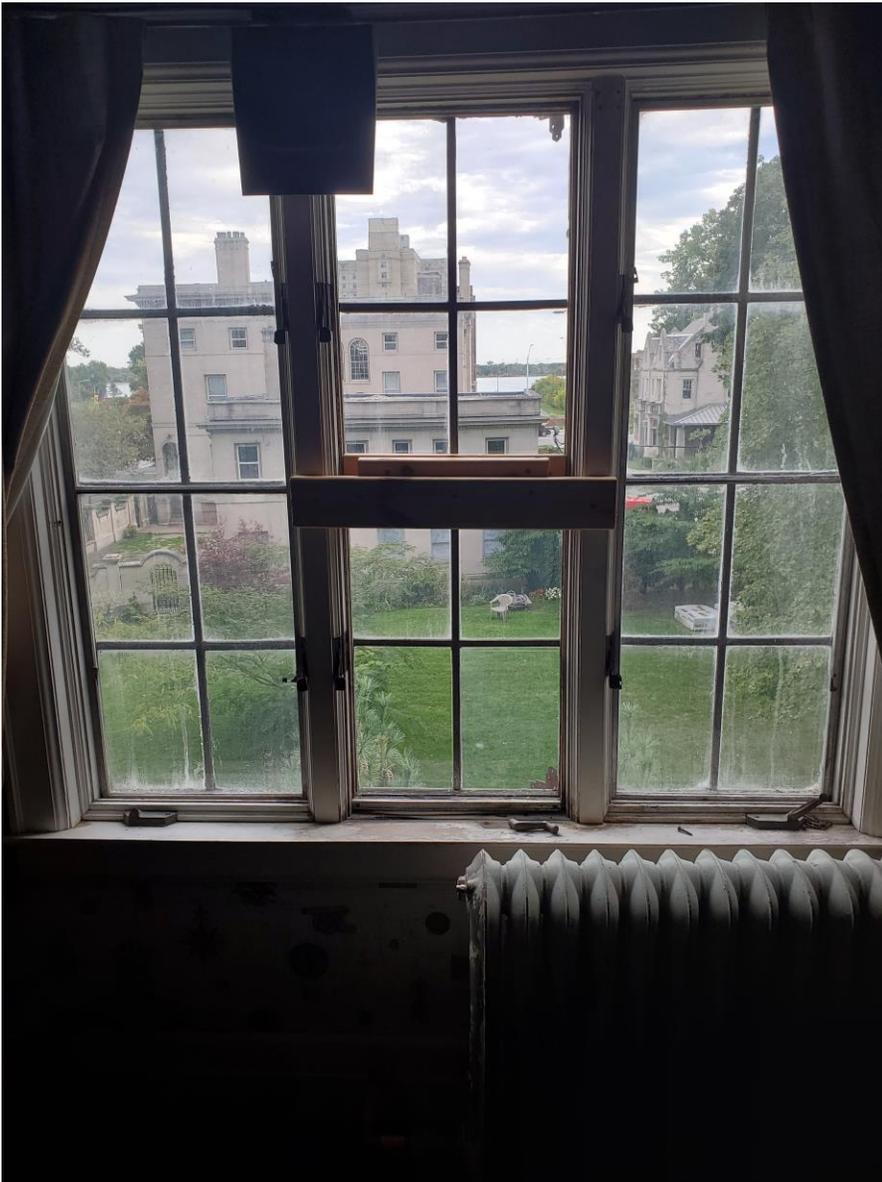
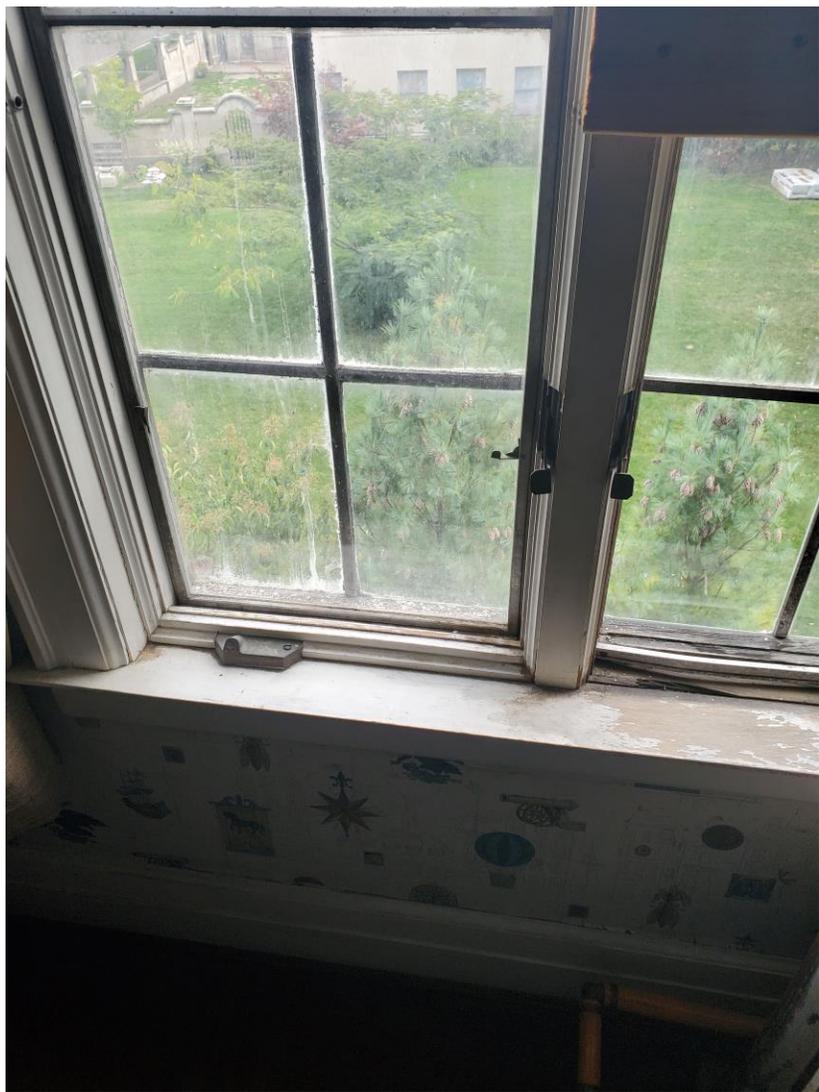
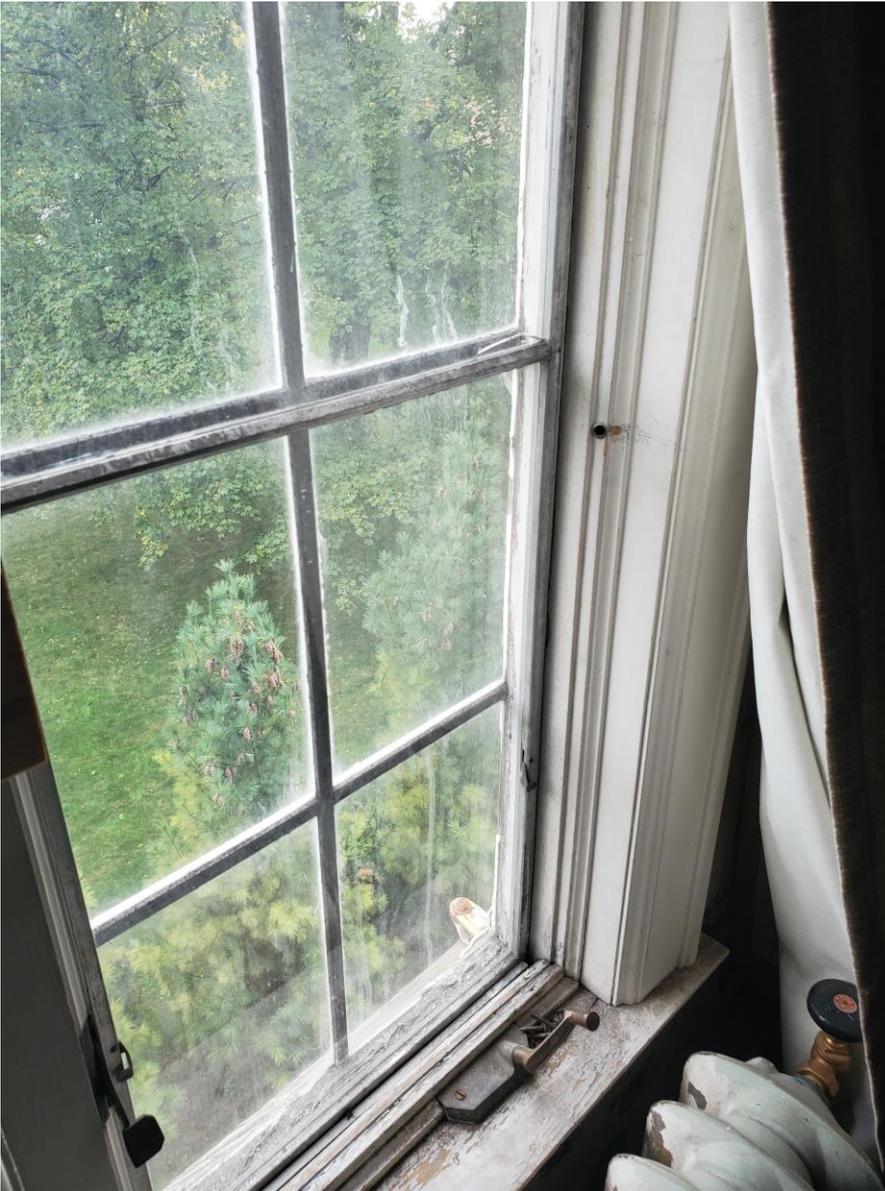
### 1940's windows on the third floor:

There are 2 sets of windows on the third floor of the house that were installed in the 1940's. The 1940's windows have aluminum mullions and sashes. These windows have not been maintained and have subsequently deteriorated beyond the point of saving. They may match the home's original windows in mullion pattern, but the hardware and storm windows do not match. The current windows are outswing casements with aluminum storm windows. The home has original inswing casement windows with tilt out wood storm windows everywhere else. Originally, the windows on the third floor had 2 inswing casements instead of the 3 current sashes. This exists on the north and south side of the 3<sup>rd</sup> floor of the house.

The goal is to match what was on the house when it was first built as closely as possible. Almost every window in the house now are the original windows, except for the 2 locations on the third floor. The solution is to replace the current 1940's windows with new wood windows and storms to match the original windows that exist throughout the rest of the house. The new windows would be double inswing casements per the photos from 1900.
