**STAFF REPORT: MAY 13, 2020 MEETING**

**VIOLATION NUMBER: 19-332**

**ADDRESS: 2415 SEMINOLE**

**SCOPE OF WORK: DEMOLISH GARAGE AND REMOVE TREES -WORK COMPLETED / EXISTING VIOLATION; INSTALL A NEW WINDOW; NEW HARDSCAPING**

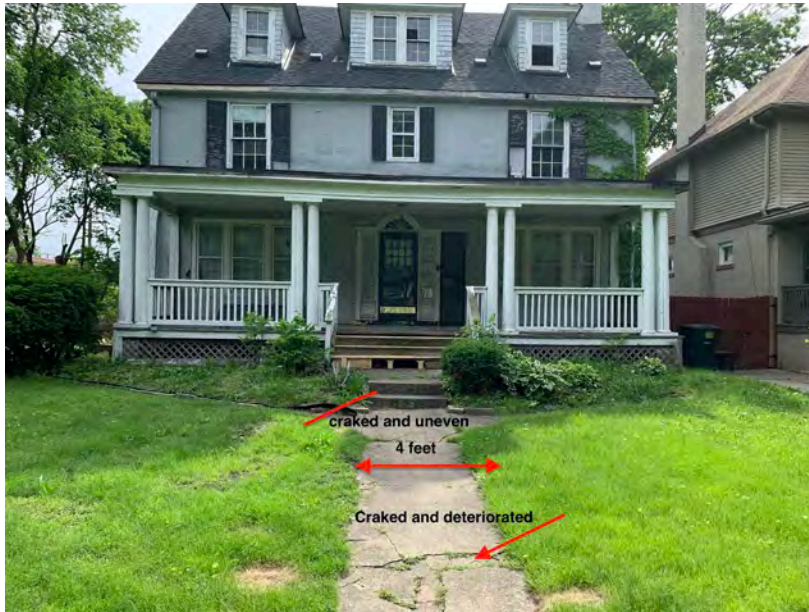
Current Walkway.

The front walkway is crack and unsafe, existing landscape bricks are deteriorated and no longer effective.

The current walkway is cracked broken and safety hazard see the pics. A new walkway will be installed the same size as the existing walkway. 4 feet wide stretching the distance from the porch steps to the side walk and then from the other side of sidewalk to the city curb.

- **Front Walkway:** It is staff's opinion that the walkway as proposed with the Unilock pavers is an appropriate replacement for the deteriorated concrete walkway and front steps, and recommends that the Commission issue a Certificate of Appropriateness based on Secretary of the Interior's Standards for Rehabilitation, especially standard number 9) *New additions, exterior alterations, or related new construction shall not destroy historic materials that*

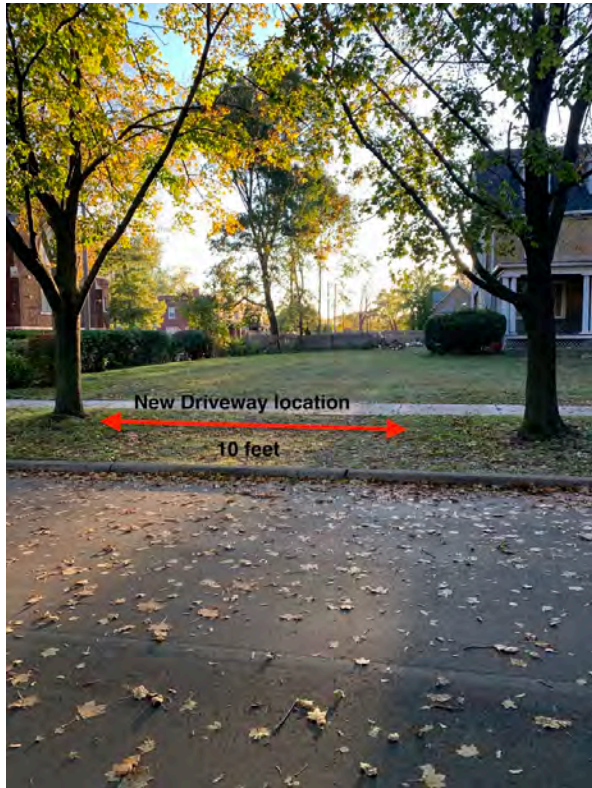
No driveway existing, view from curb.

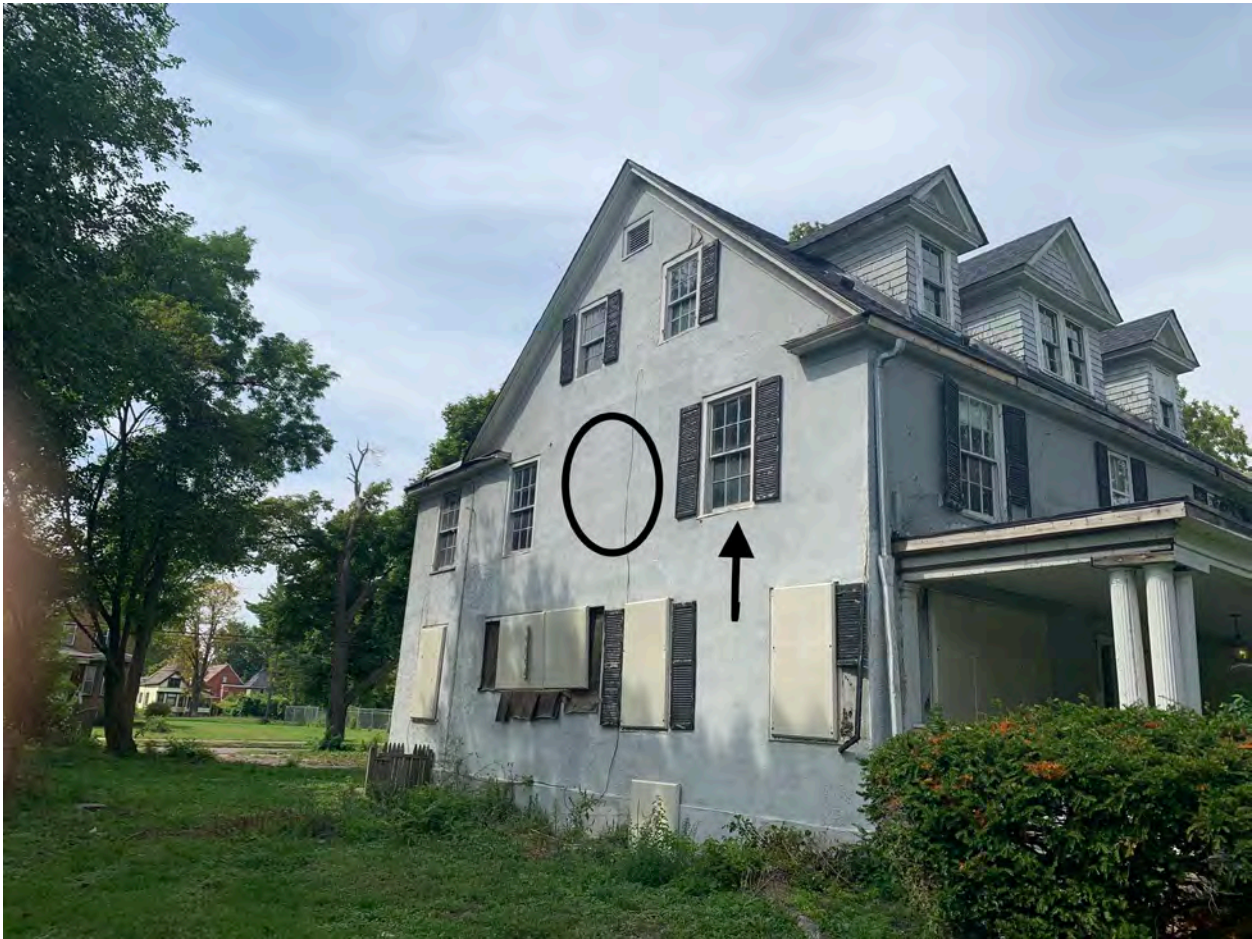
The existing windows appear original to the home one appears to have been moved. When I purchased the home the walls were open and upon some investigation found that a window had been moved.

Location where window was closed previously

- **Window Installation:** The documentation provided illustrates that a window was likely located at this location and staff recommends a Certificate of Appropriateness based on Secretary of the Interior's Standards for Rehabilitation, specifically numbers 2) *The historic character of a property shall be retained and preserved. The removal of historic materials or alteration of features and spaces that characterize a property shall be avoided* and 9) *New additions, exterior alterations, or related new construction shall not destroy historic materials that characterize the property. The new work shall be differentiated from the old and shall be compatible with the massing, size, scale, and architectural features to protect the historic integrity of the property and its environment.*
