NOTICE OF DENIAL

RE: Application Number 20-6894; 1991 Chicago; Boston Edison Historic District

CERTIFICATE OF APPROPRIATENESS

STAFF SITE VISIT PHOTOS: 1991 Chicago, Detroit, MI OCTOBER 1, 2020

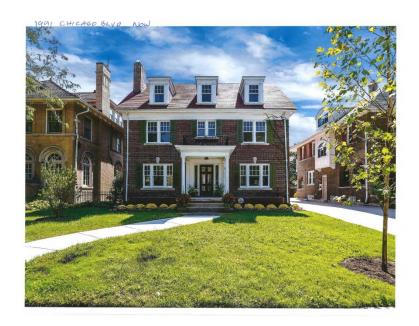
North/Front Elevation (AFTER) 2020

- 1) Wings of porch removed. The wings were collapsing due to failing footings (See attached photo). The wings could not have been repaired. They would have had to be completely re-built. In order for us to do so we would have had to dig out the old footings and pour new ones and re-build from that point. Rebuilding the wings would have added \$20,000 to the cost of the porch rebuild. This would not have made financial sense considering the value of the home. The main porch's footings were in good shape so we were able to just rebuild the brick work etc. for the center porch. In respect to the old footings, we dug them out and removed to accommodate installation of the new landscaping and grading from the exterior walls of the house. We also used as much of the original porch materials as possible in the re-build which is evident in the photos.

- 2) Railings on wings of porch removed. The railing was corroded and damaged, but intact, on the left wing but none attached to the right. The vintage of the railing was undetermined.

- 3) Columns reduced from 4 to 2. The two interior columns were rotted out and could not be salvaged. The exterior columns were able to be salvaged and re-built/repaired.

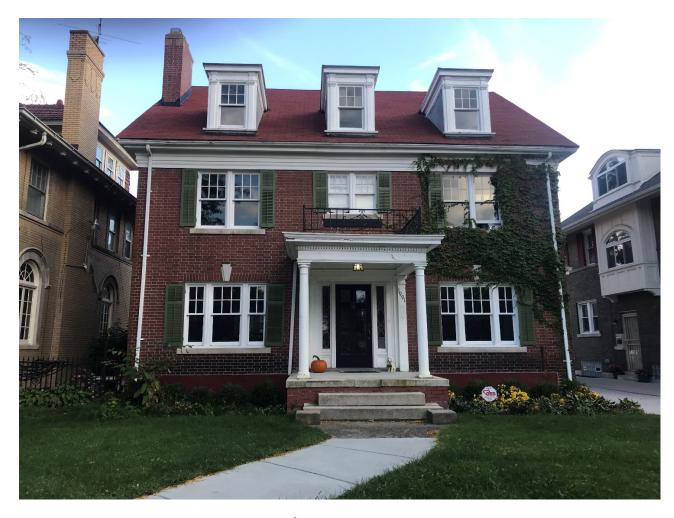
North/ Front Elevation

• The removal of porch wings, columns and railings and front elevation wall treatment without permit and/or approval of the Historic District Commission.

- 1. Rebuild porch to its original dimensions using matching materials, including wings with iron railings to match original, and including wood columns to match originals.
- 2. Correction work must receive a COA in order to receive a Building Permit, prior to beginning work.
- 3. Correction should be completed by June 2021
