DHDC 22-8093

CERTIFICATE OF APPROPRIATENESS

**RE: Application Number 22-8093; 226 Arden Park; Arden Park – East Boston Historic District
Project Scope: Erect 2nd story garage addition, rehabilitate front and rear porches, replace driveway**

Historic District Commission Narrative: 226 Arden Park

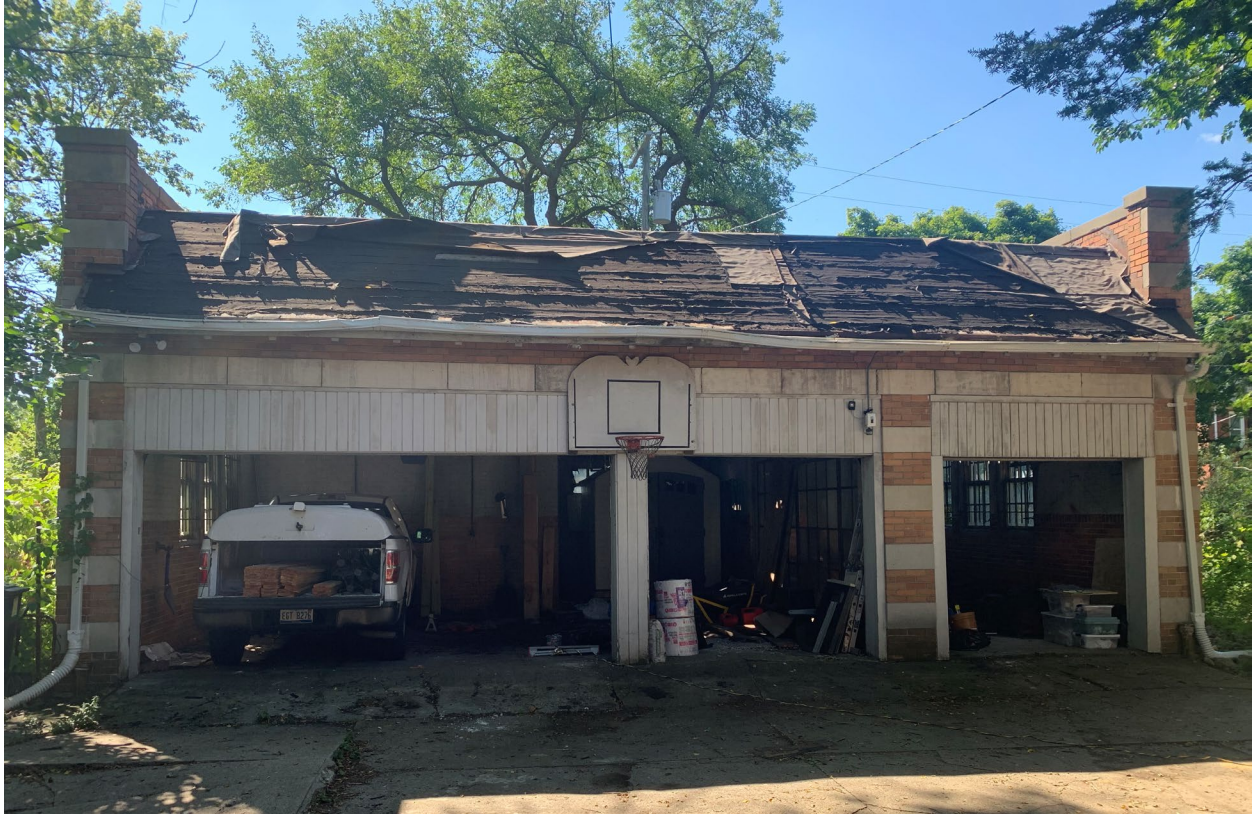
Garage, North Elevation.

- T-111 wood header infill to be removed.
- Gutters and downspouts to be replaced.

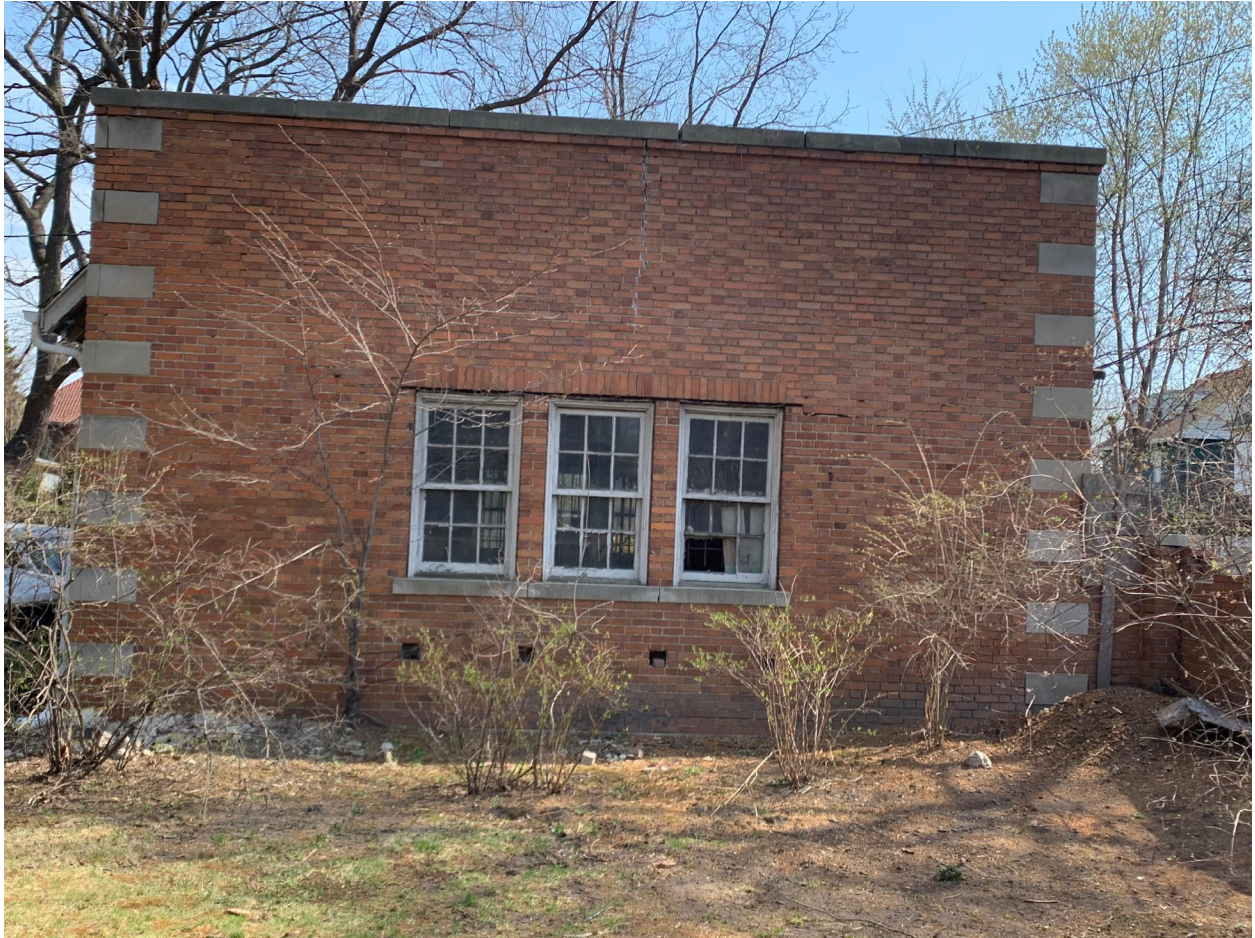
Garage, West Elevation, April 2021. East Elevation Similar.

- Existing brick and limestone to be cleaned, repaired, and pointed.
- Windows to be repaired.

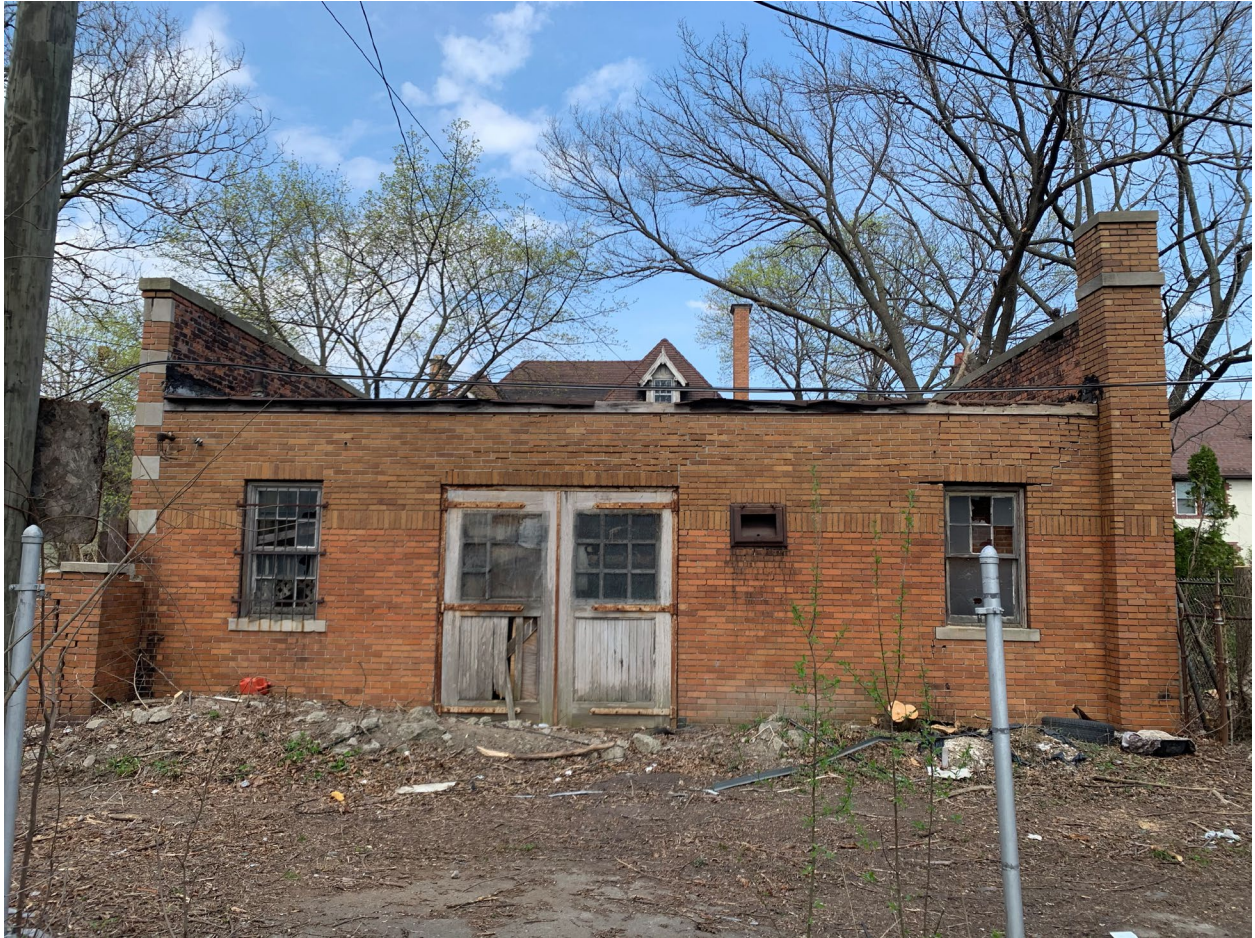
Garage, South Elevation, April 2021.

- Existing brick and limestone to be cleaned, repaired, and pointed.
- Doors to be replicated.
- Windows to be repaired.
- Alley garden wall to be reconstructed.

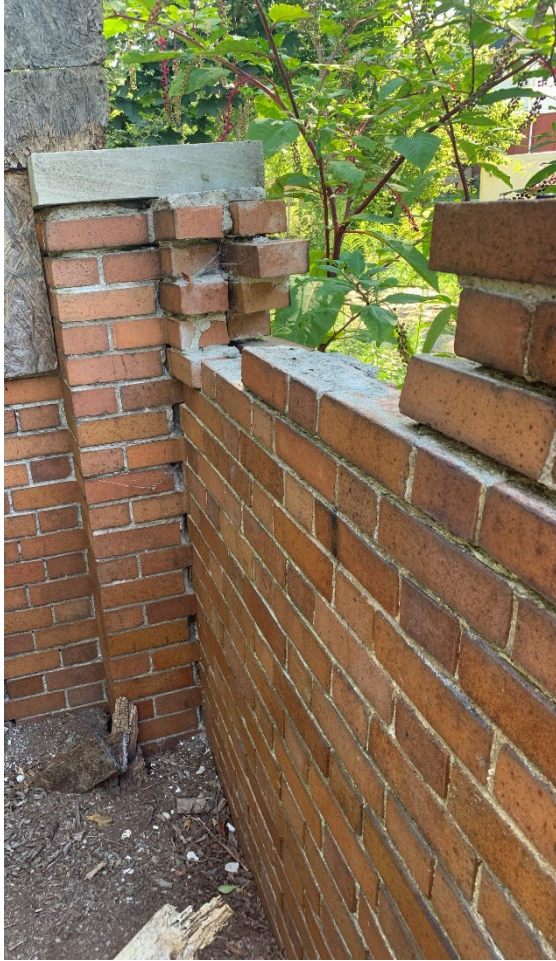
Alley / Garden Wall.

- Repair Alley / Garden wall with existing brick and limestone.
- Mortar to match existing in color and texture.

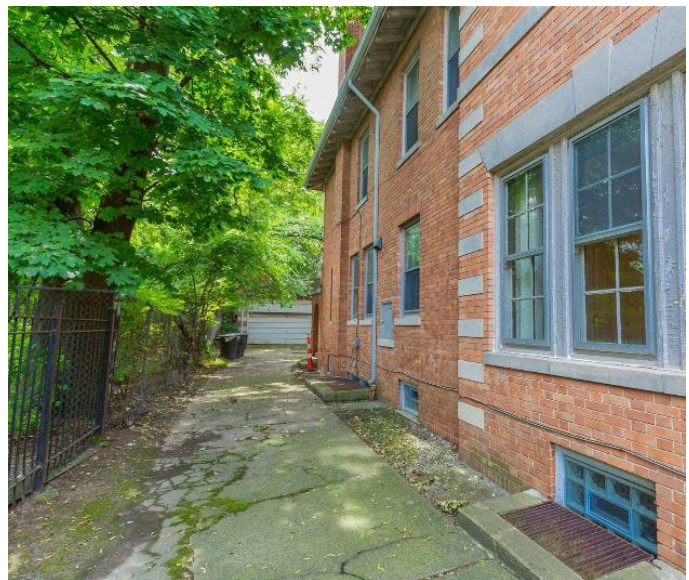
Driveway.

- Remove and replace concrete driveway.

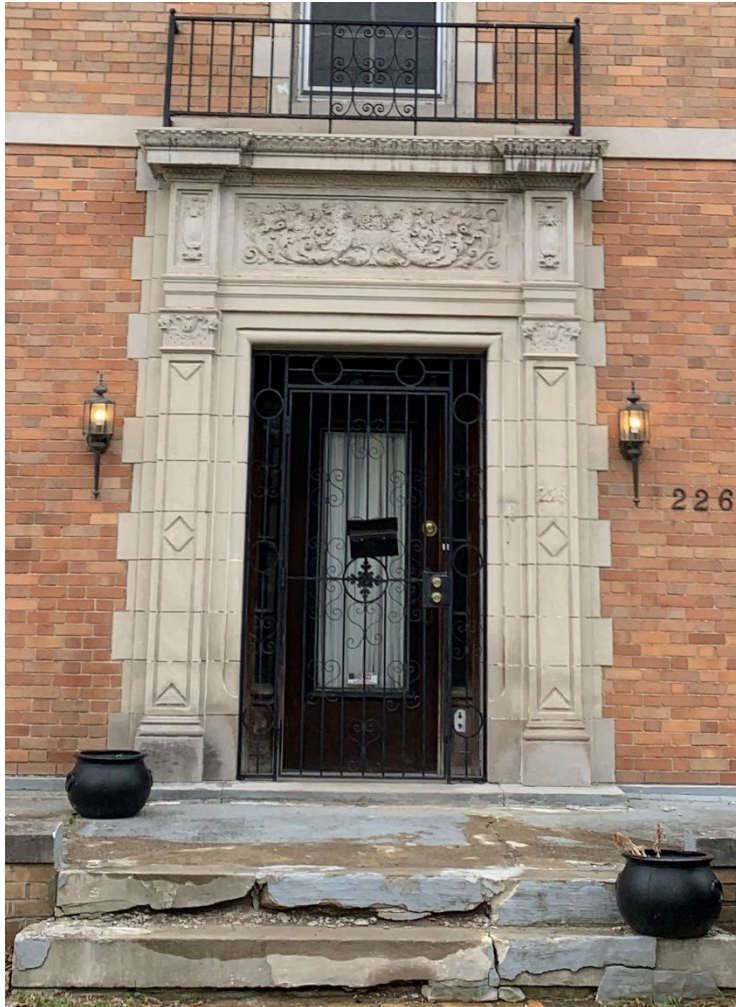
Front Porch.

- Repair front and rear porch concrete, brick, limestone caps, and steps.
- Material shall match existing in kind, color, and texture.

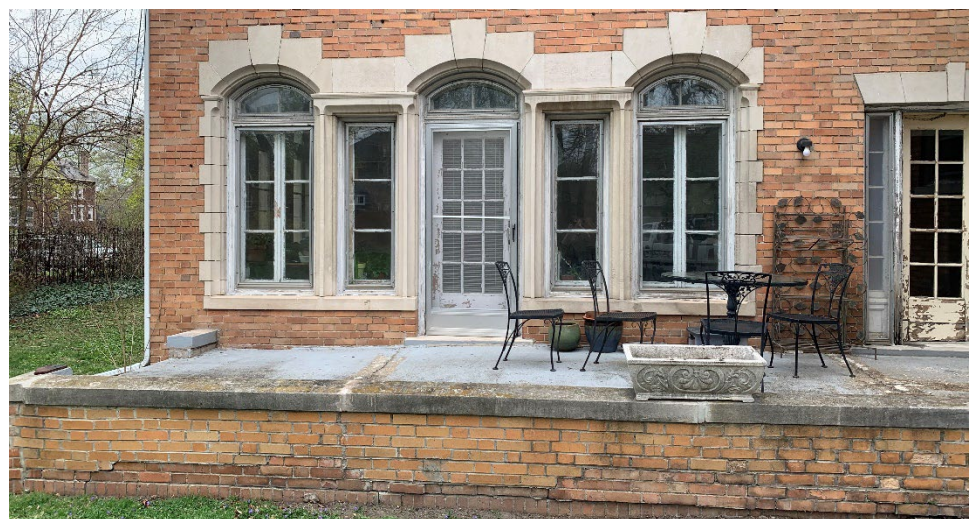
Rear Porch.

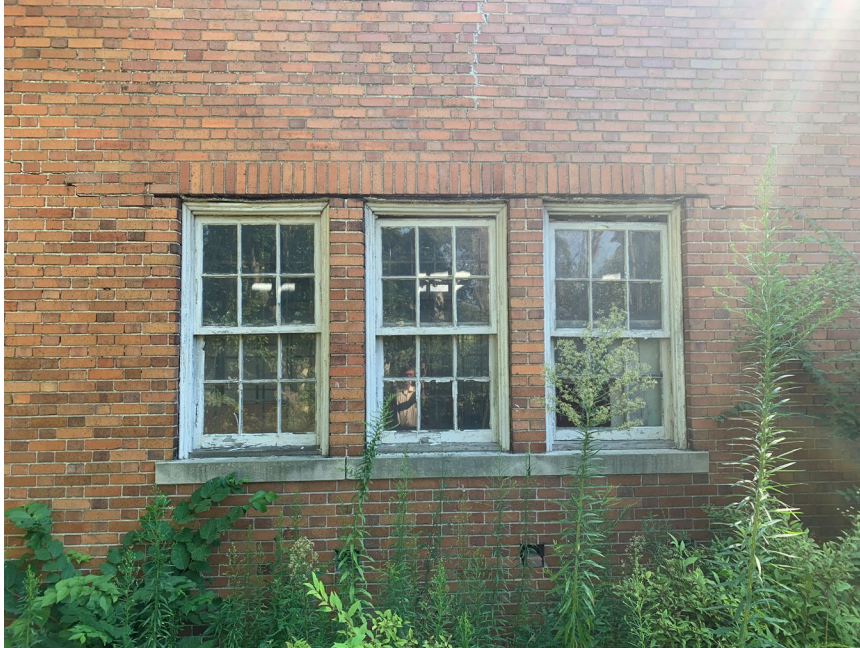
Garage: Existing Exterior Windows.

- Windows to be repaired.
- Brick and limestone to be cleaned, repaired, and pointed.

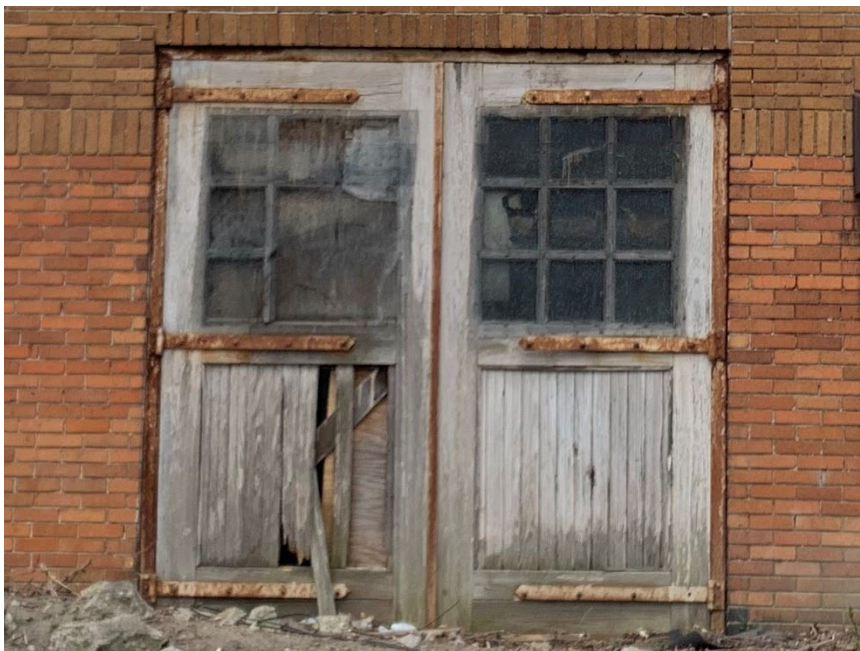
Garage: Existing South (Alley) Wood Door.

- Doors to be replicated.

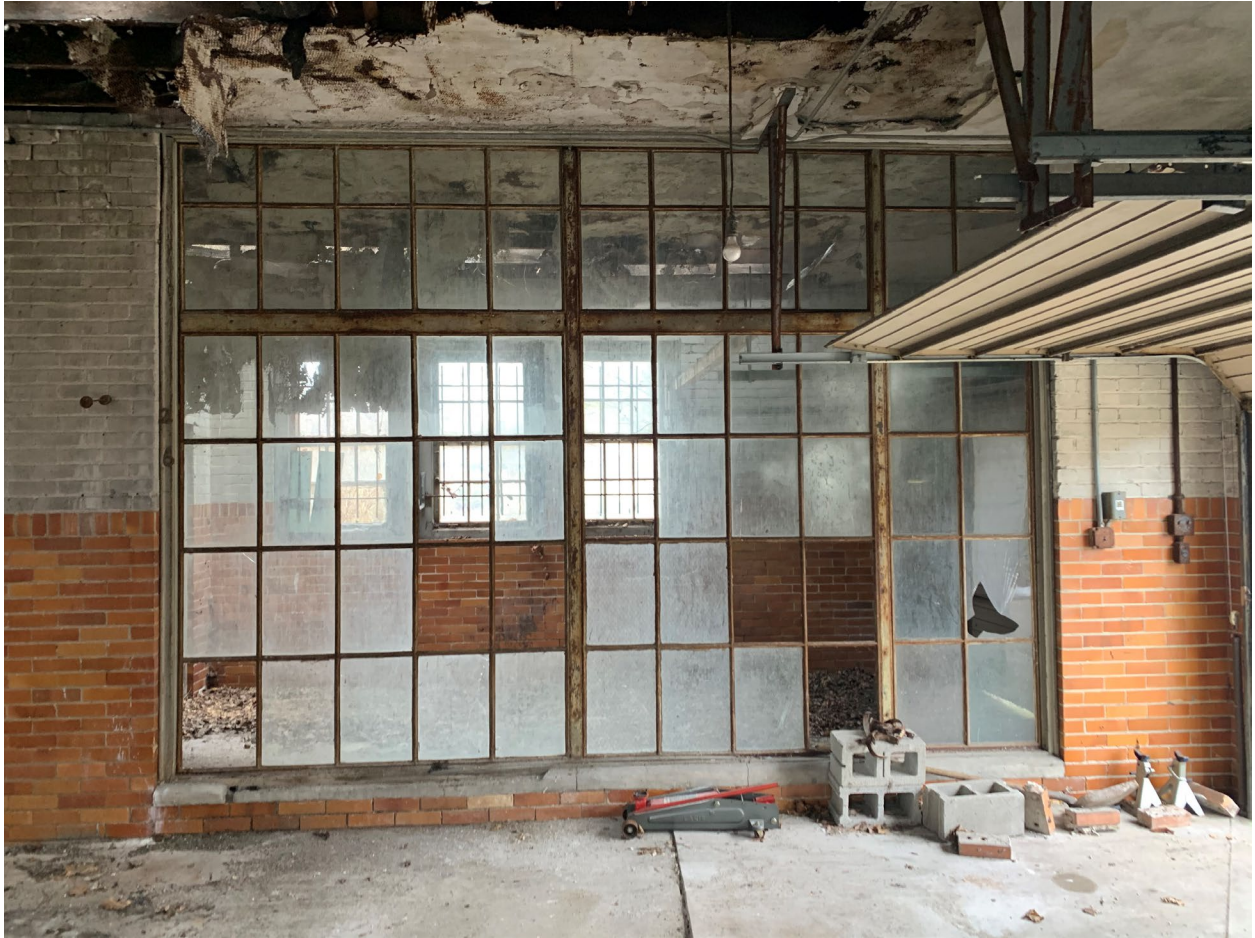
Garage: Existing Interior.

- Remove and replace concrete slab.
- Remove and replace overhead doors.
- Restore glass curtain wall.
- New ½" gypsum board ceiling.
