HISTORIC DISTRICT COMMISSION NOTICE OF DENIAL

Application Number: HDC2025-00009

NAME: Caren Paskel		COMPANY NAME:	
ADDRESS: 3470 Cambridge	CITY: Detroit	STATE: MI	ZIP: 48221
PROJECT ADDRESS: 3470 Cambridge			
HISTORIC DISTRICT: Sherwood Forest

Replacement of steel and wood windows with vinyl-clad wood windows, and covering of wood rake boards, soffits and fascia with aluminum coil.

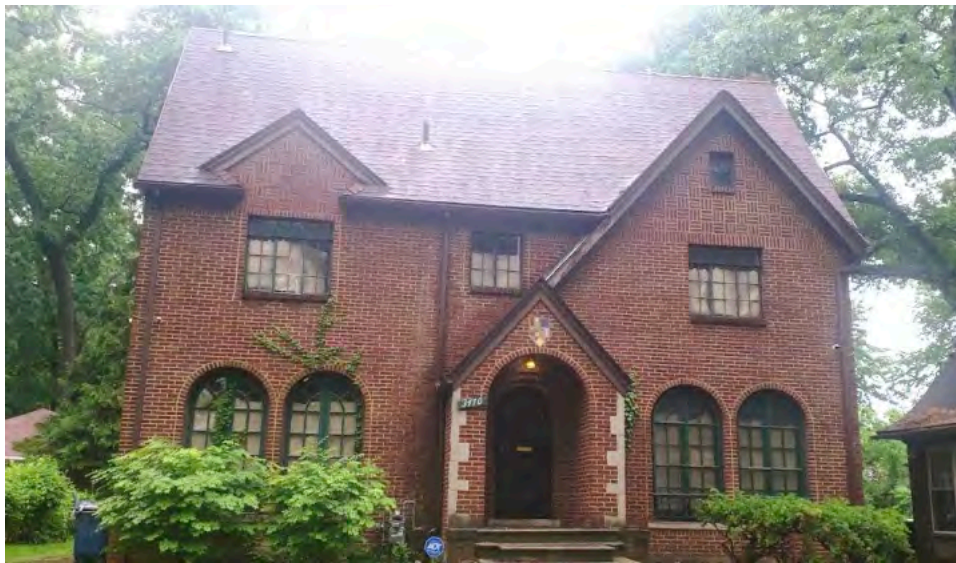
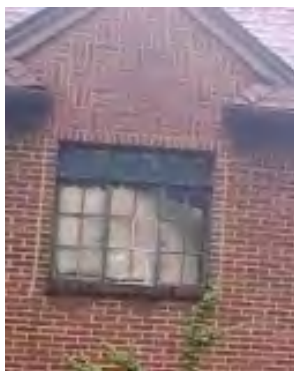
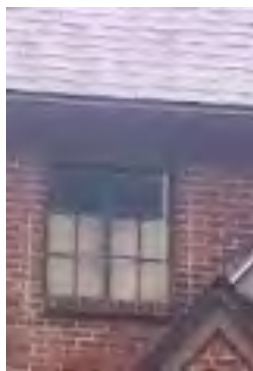
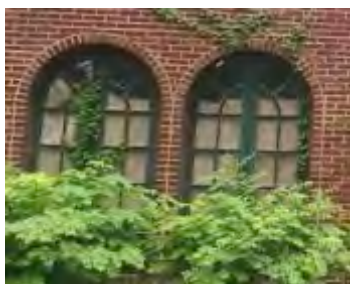
Old condition front elevation

- First floor - arched windows were retained and restored.
- Second floor - steel windows (transom, sidelights with single casement) were replaced with vinyl sliding windows (three-over-four pattern added to each window); double steel casement replaced with sliding window (each has two-over-three pattern).
- Third floor – original may have been single casement with two-over-two pattern and was replaced with a vinyl double hung (four-over-four pattern)
- The windows installed match the original casement-style windows.

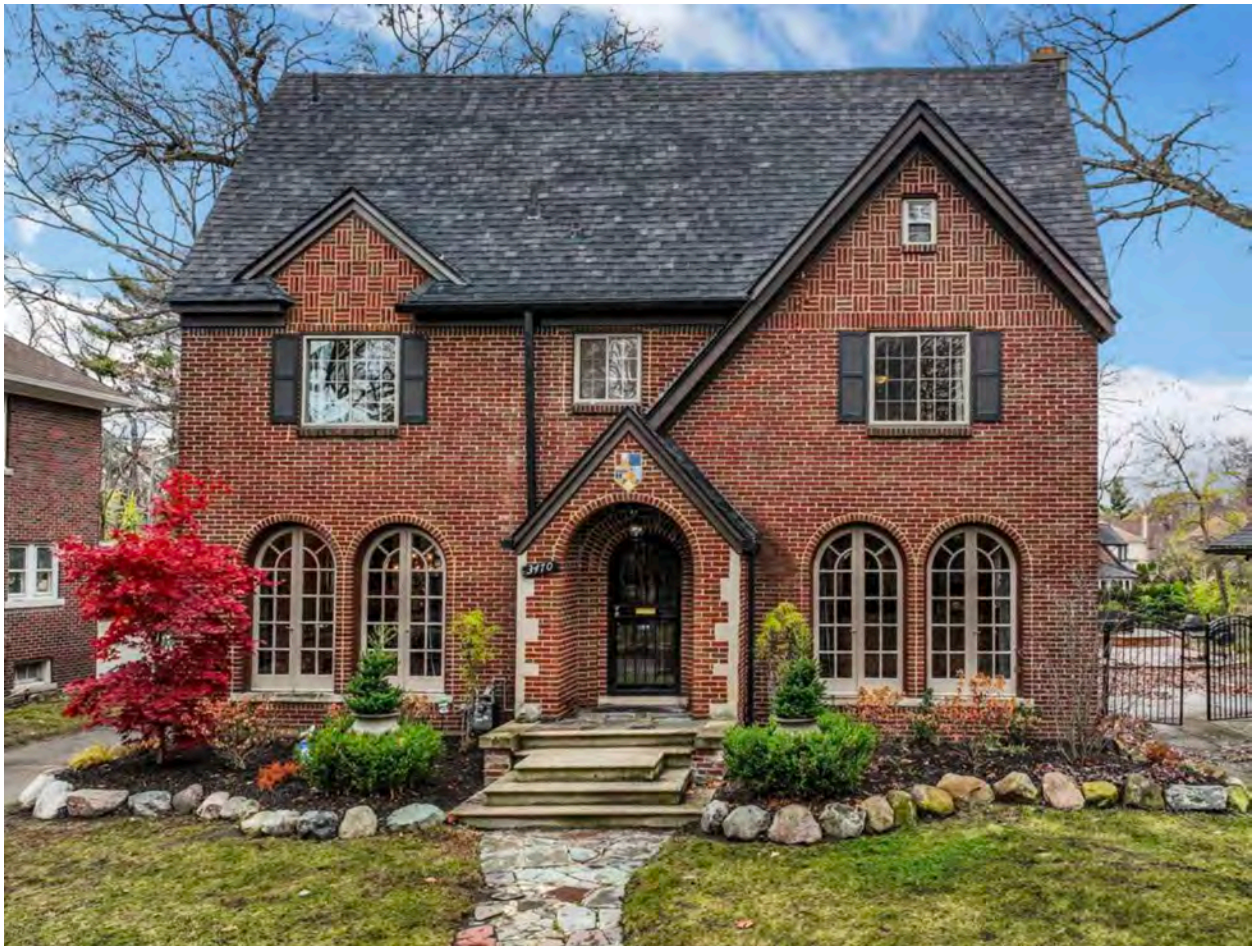
Current picture front elevation

- o The operation of the windows were changed, obliterating the consistent verticality and rhythm of the window and door openings on the house. The majority of openings now have double-hung one-over-one windows; however, the larger openings on the front, west side, and rear have sliding units. The front sliders have between-the-glass grilles. Sliding windows and between-the-glass grilles are not consistent with the general characteristics of a historic window and do not match the dimensional quality of the removed historic steel window sash.

- o The placement of the new windows doesn’t match the more deeply recessed location of the historic windows within the window openings. The depth of plane change between window and wall surfaces is an important feature on the elevations of the house and the current windows don’t convey the same visual appearance.

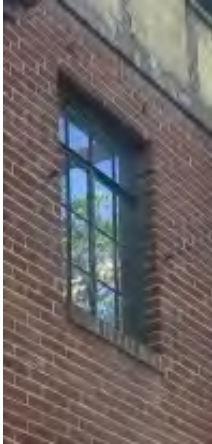
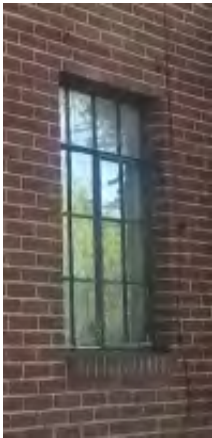
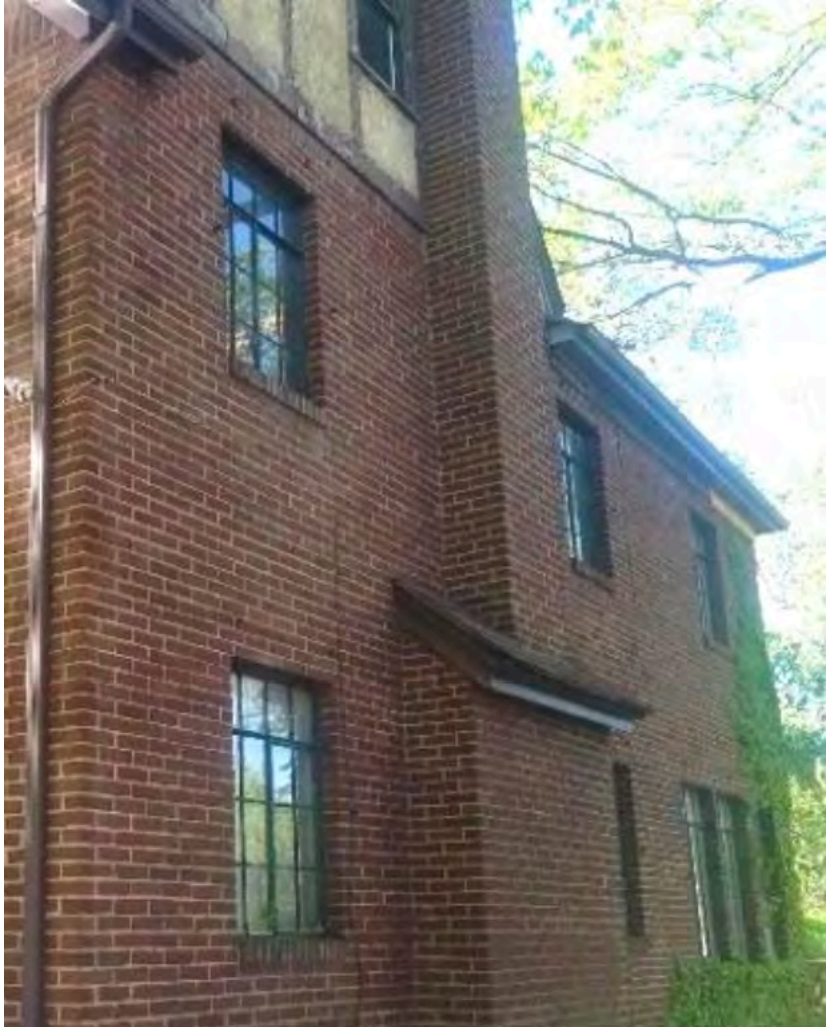
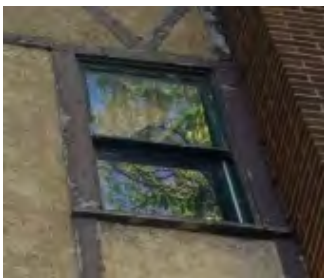
Old Condition east elevation

- First and second floor - steel casements (possibly double-casements with transoms) were replaced with vinyl double-hung windows (one-over-one).
- Third floor – wood double-hung replaced with vinyl double-hung (both one-over-one).

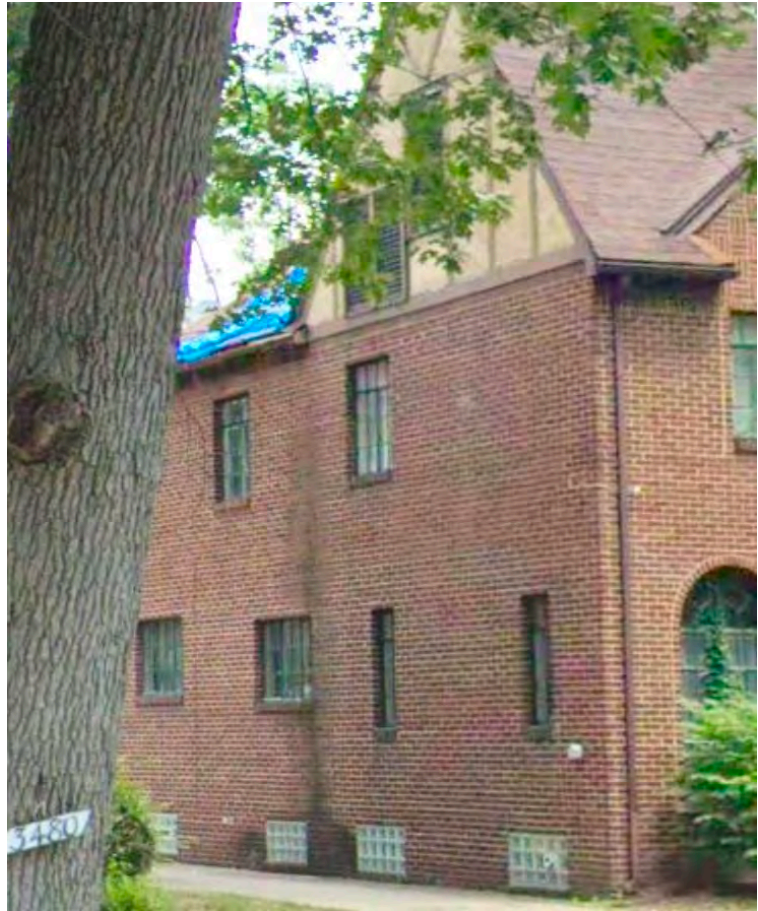
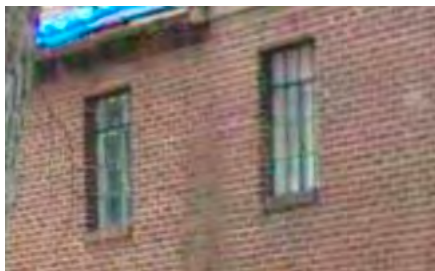
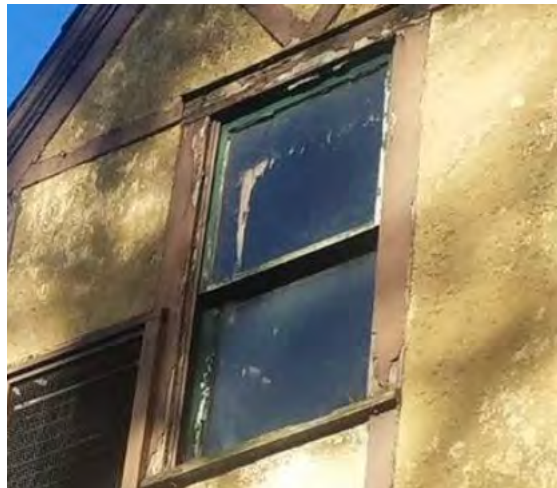
Old condition rear elevation

- First floor – Narrow steel casement windows (possibly two-over-four pattern) replaced with double-hung vinyl windows (one-over-one); wide steel windows replaced with vinyl sliding windows (clear glass)
- Second floor - steel casement/transom windows were replaced with vinyl double-hung windows (one-over-one pattern).
- Third floor – wood double-hung replaced with vinyl double-hung (both one-over-one).

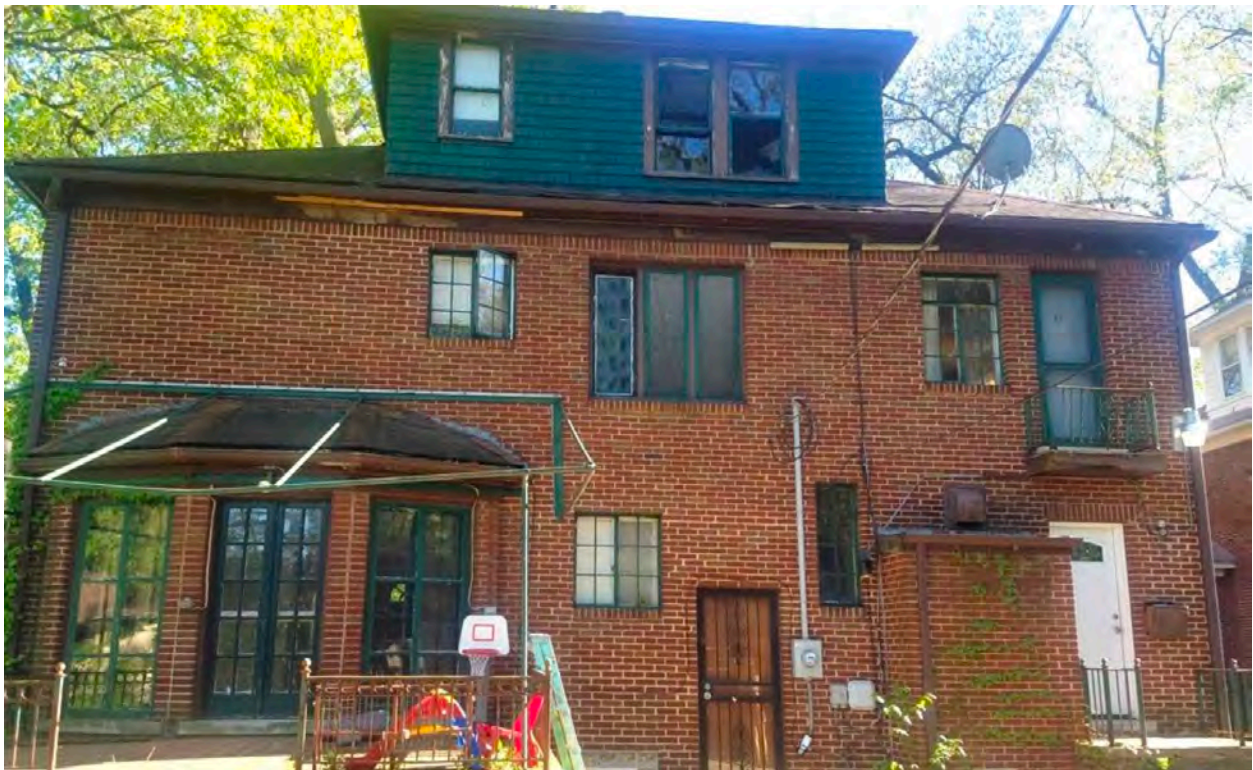
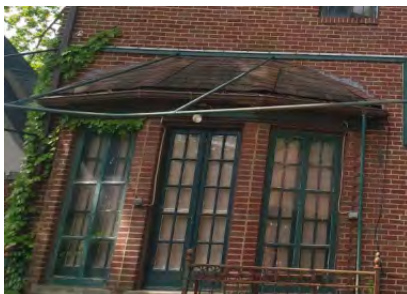
- First floor – Rear raised porch wood french doors remain and restored. Two steel double casement (two-over-three pattern) replaced with steel casement/transom (two-over-four pattern) replaced with vinyl double hung (one-over-one).
- Second floor – Leaded glass casements remain and restored. Two double steel casements (one with transom) replaced with vinyl double-hung windows (one over one).
- Third floor – one wood double-hung replaced with vinyl double-hung (one-over-one), two mullied wood double hung (one-over-one) replaced with one large sliding window.
