Application Number: HDC2025-00024	Effective Date: 02/19/25
Project Address: 14528 Ashton Rd.	Issued to: Joshua R. Maddox
Historic District: Rosedale Park Description of Work: At the front porch: Replace the existing non-historic wood floor and steps in kind/with new wood flooring and steps Replace the existing non-historic wood guardrails with new aluminum guardrails Replace the existing non-historic wood handrailing with new aluminum handrails Replace the existing 8'-0"-wide concrete two-track/ribbon driveway with a new 8'-0 wide, single slab concrete driveway Replace the existing concrete front yard walkway and step with a new concrete walkway of the same width With the Conditions that: N/A	
Pursuant to Section 5(10) of the Michigan Local Historic District Act, as amended, being MCL 399.205 (10) and Sections 21-2 Commission ("DHDC") delegation of administrative authority via Resolutions 97-01, 97-02, 98-01, 20-03, 21-04, and/or 21-07 application and hereby issues a Certificate of Appropriateness ("COA") for the description of work, effective date above, as it Elements of Design	, as applicable, the staff of the DHDC has reviewed the above referenced

RE: 14528 Ashton Rd. Porch Re

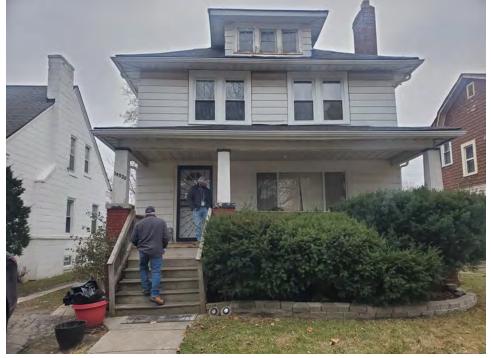
#### W ELEVATION OF HOME

- CONC. WALK IS CRACKED AND HEAVING
  WOOD STAIRS ARE NOT EQUAL RISER
- HEIGHTS
- SETTLING HAS CAUSED TREADS TO NOT BE LEVEL
- HANDRAILS ARE NOT SECURE

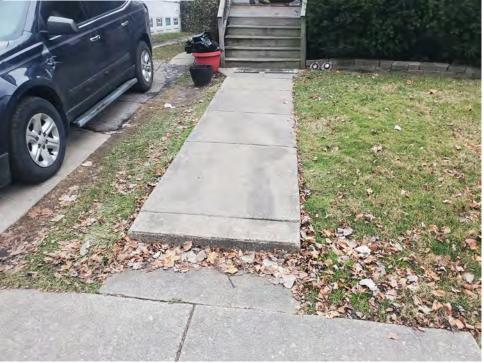
#### **EXISTING CONC. WALK**

AWKWARD 5" STEP AT SIDEWALK IS TRIPPING HAZARD

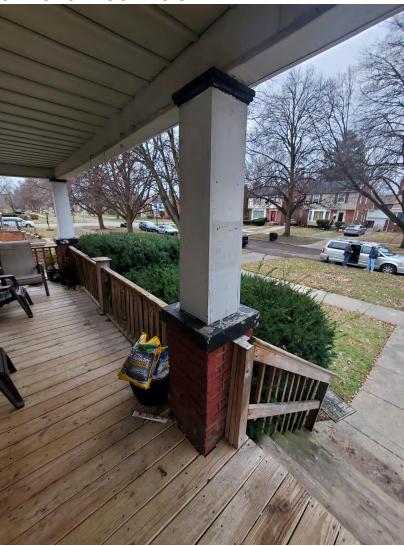
ON PORCH LOOKING SW

RAILINGS ARE IMPROVISED 2x CONSTRUCTION. 30" TALL, NOT TO CODE ALL WOOD IS UNFINISHED/UNPROTECTED AND IS VERY WEATHERED

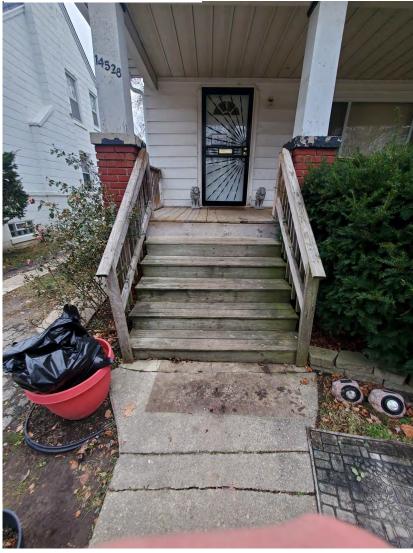
W ELEVATION OF STAIR

- CONC. WALK IS CRACKED AND HEAVING WOOD STAIRS ARE NOT EQUAL RISER
- HEIGHTS
  SETTLING HAS CAUSED TREADS TO NOT BE
- LEVEL
   HANDRAILS ARE NOT SECURE

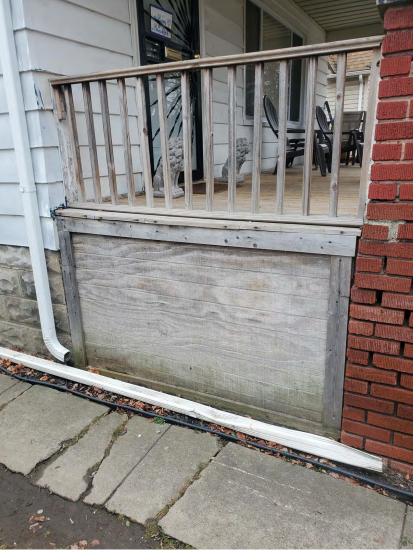
N ELEVATION OF PORCH AND RAILING

AT 30" TALL, RAILING IS NOT TO CODE UNFINISHED "T1-11" SIDING IS NOT VENTED AND NOT WEATHER RESISTANT
