## HISTORIC DISTRICT COMMISSION

## CERTIFICATE OF APPROPRIATENESS

**Application Number:** HDC2025-00591

Project Address: 2233 Park Avenue

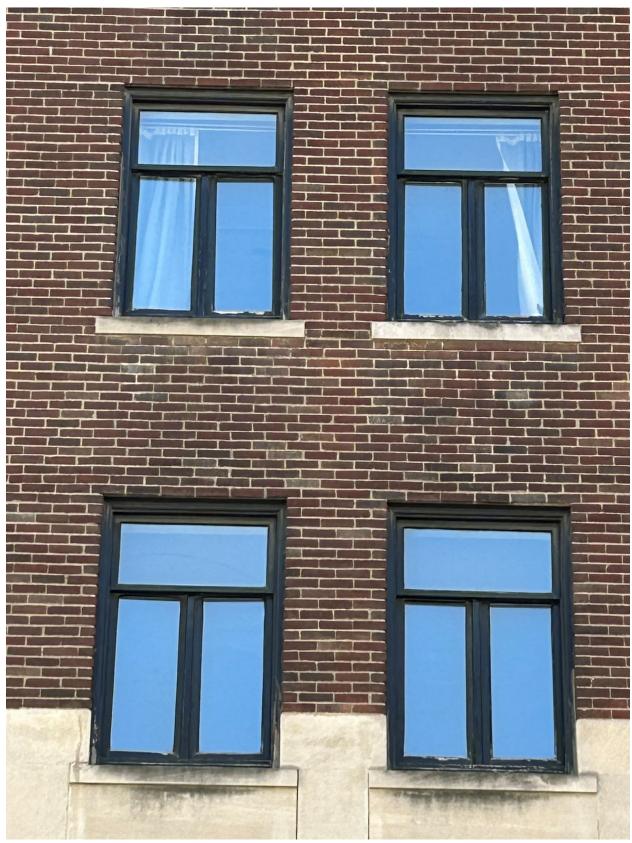
The existing wood windows are deteriorating, proper lacking weatherization and unsafe. The window sashes that were replaced in 2006 were installed with poor workmanship and using a soft wood windows that were painted, have not fared well with the extreme weather conditions that a high-rise building faces. The many of the sashes are warped and do not open or open properly. The weather stripping on the jambs, sill and head are greatly deteriorated or missing.

Exterior close up view of existing windows

Remove and replacement of the 112 windows located on the second thru eighth floor, on the north, east and south elevation. The new windows shall be Pella Reserve aluminum clad wood cottage style single hung window with a fixed transom above. The lower sash shall have a 2 inch wide exterior and interior applied vertical mutin dividing the lower sash into two lights, complementing the original window style of two separate sashes. The cottage style window has a taller bottom sash than the upper sash further complementing the original window style. The wood brick crown moulding will be replaced with similar size and profile aluminum brick moulding. See section 5 Brochures / Cut Sheets.
