SR-2 – ADVISORY STAFF REPORT (04/03/2026)

ADDRESS: 1606 CHICAGO

APPLICATION NUMBER: HDC2025-00679

SCOPE: REPLACE WOOD WINDOWS WITH VINYL WINDOWS (WORK COMPLETED WITHOUT APPROVAL)

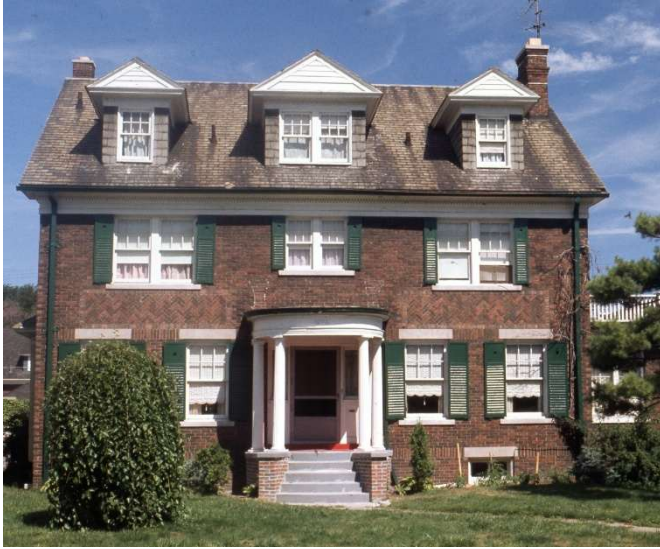
HDAB designation photo, 1974, showing historic windows

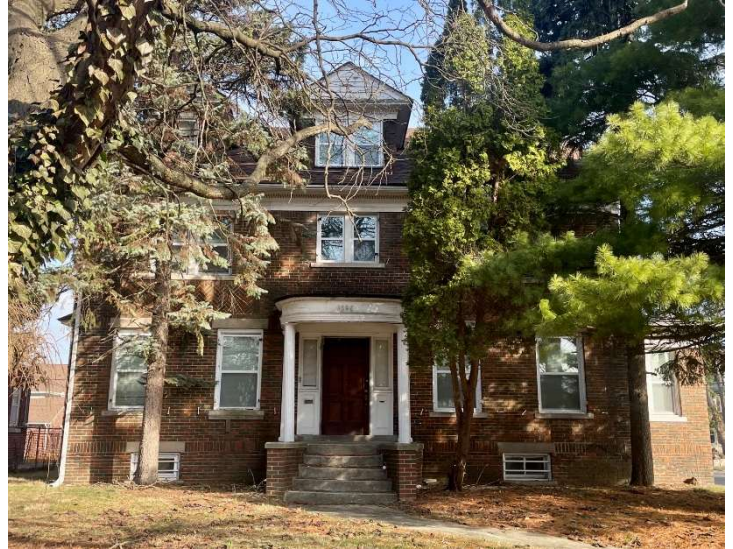
Staff photo, 03/24/2026, showing vinyl windows installed without approval

3. Due to their plasticity, flatness, detracting color/sheen, component profiles, and poor material quality, consumer-grade vinyl windows are incompatible with the building's overall historic character and do not exhibit an appearance consistent with the general characteristics of a historic window of the same type and period, as required by National Park Service Guidance.

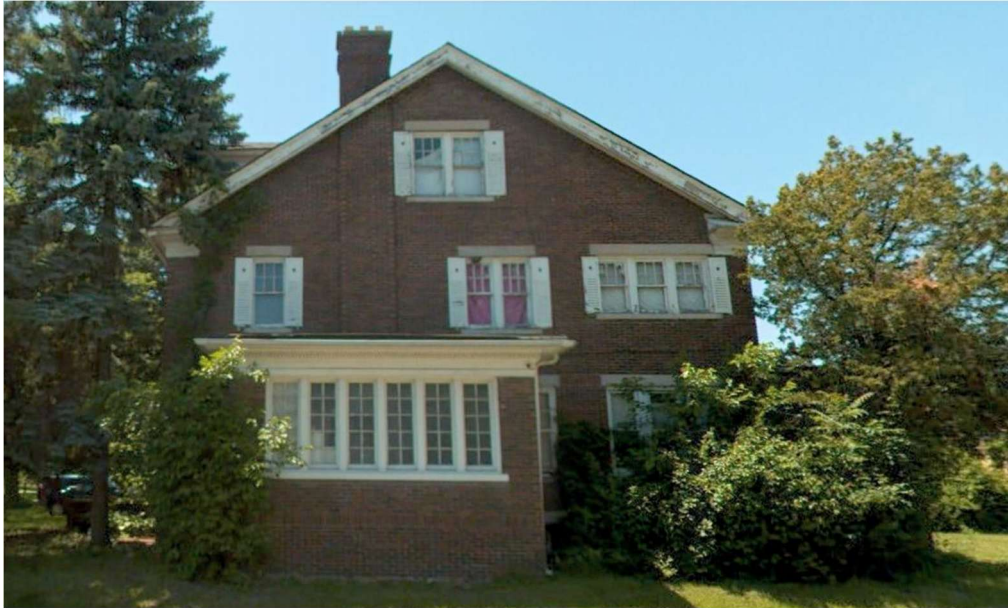
West side of house, Mapillary, 05/31/2024, prior to window replacement

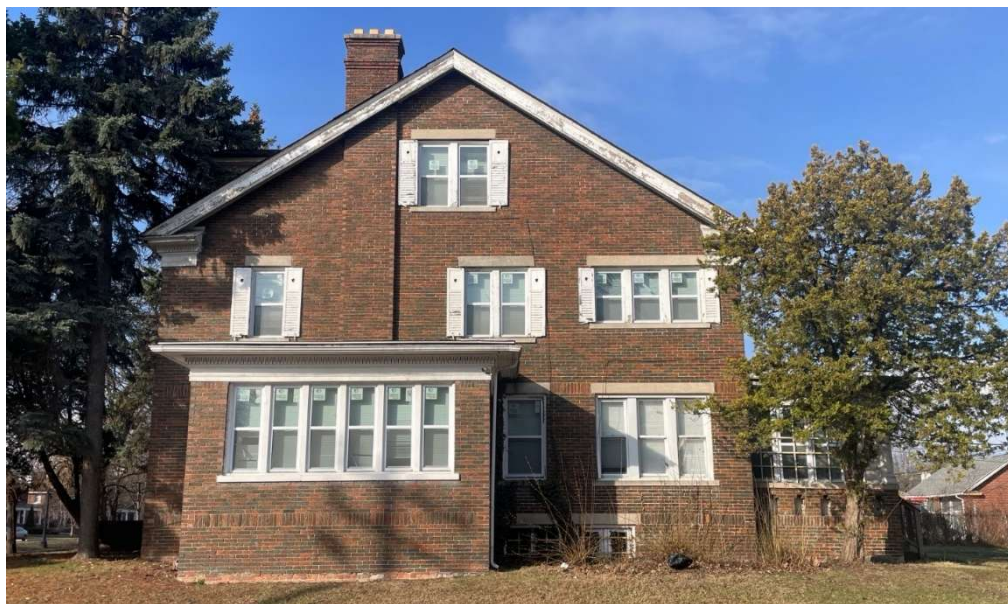
West side of house, staff photo, 03/24/2025, after window replacement

- The installation of the vinyl windows does not follow the [Historic District Commission's 'Historic Wood Window Guidelines'](#) or the [NPS 'Replacement Windows that Meet the Standards.'](#) As stated in the NPS' guidelines for replacement windows, "When historic windows exist, they should be repaired when possible. When they are too deteriorated to repair, selection of the replacement windows must be guided by Standard 6. Design, visual qualities, and materials are specific criteria provided by the Standard that are pertinent to evaluating the match of a replacement window. Evaluating the adequacy of the match of the replacement window involves the consideration of multiple issues." Specifically, referencing the factors to consider in evaluating the match of a window:
