SR-2 – STAFF ADVISORY REPORT (04-03-2026) Revised 04/06/2026

ADDRESS: 4221 CORTLAND

APPLICATION NUMBER: HDC2026-00097

SCOPE: REBUILD REAR AND SIDE WALLS OF REAR WING; INSTALL FRONT PORCH RAILING

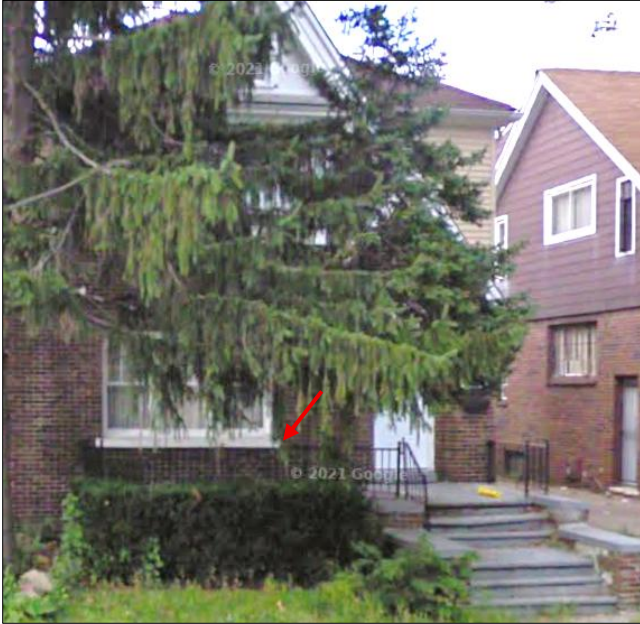
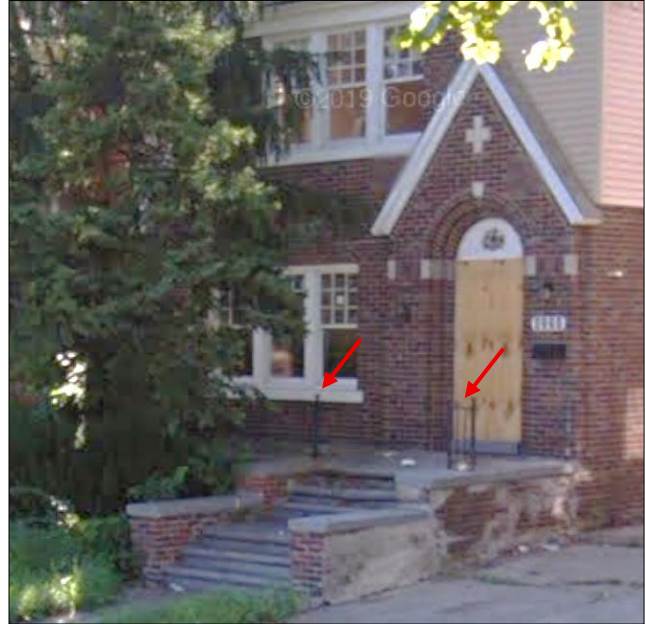
Google Street View, Left: July 2009 -- Right: August 2011. Although the front of the house is only partially visible due to a pine tree, the 2009 view offers a full view of a low height railing intact at the perimeter of the porch. The 2011 photo shows one small railing remnant and one post remained two years later.

- While the historic, character-defining railing is no longer present (outside of one end post), staff notes that it was removed without HDC approval between 2009 and 2011, ten to twelve years after the district’s historic designation (1999).

- The original railing height was below, or in line with, the bottom of the sill of the grouped windows. It created a visual and physical boundary to the porch while not compromising a full view of the historic, distinctive character-defining window opening.

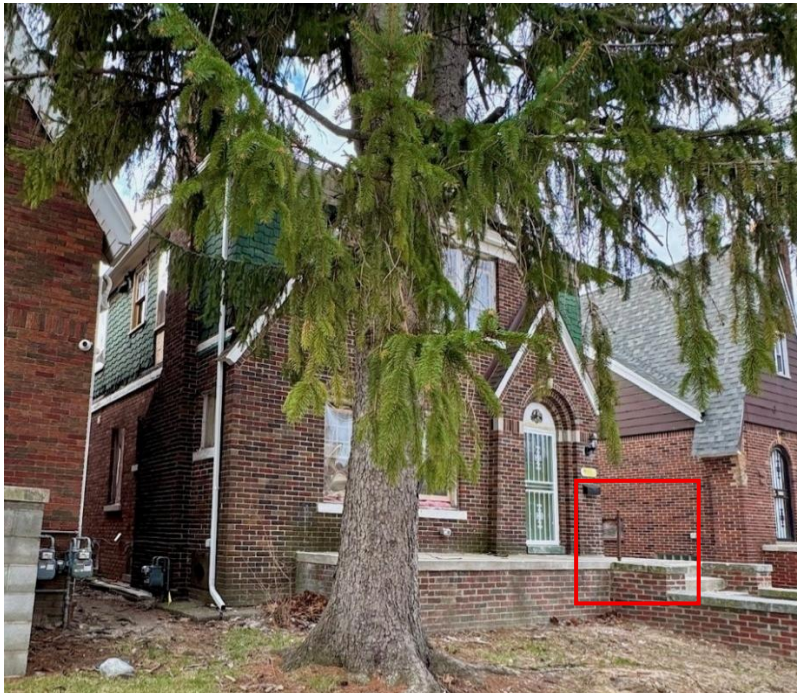
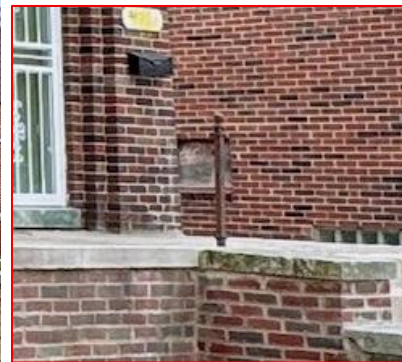
Currently, only one post at the top left of the stairs remains intact. Staff photo, March 19, 2026.

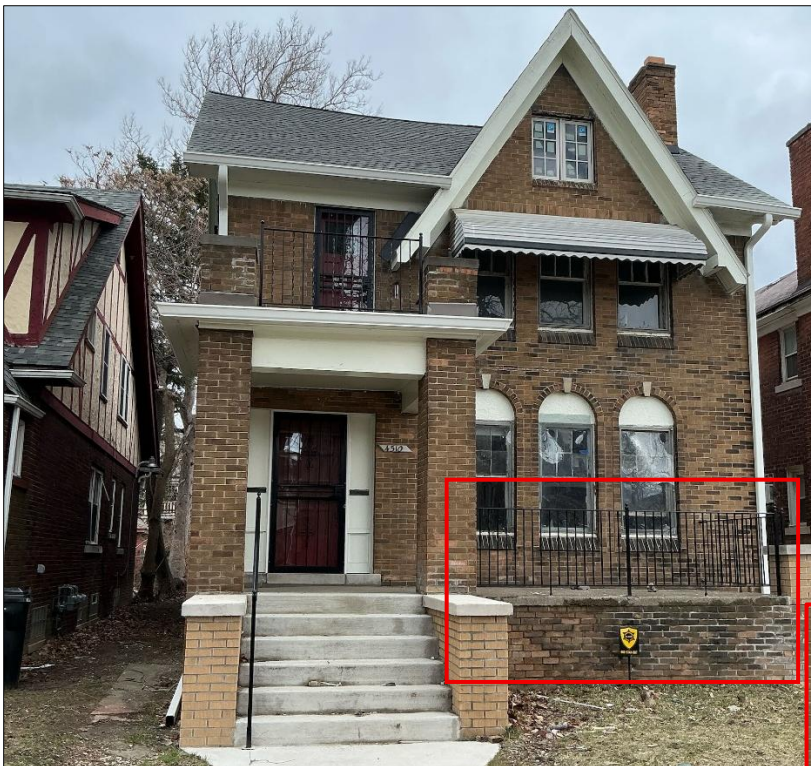
- The installation of a 36” high railing at the front porch does not match the low height of the historic railing that was removed without HDC approval. The taller metal railing would project (or extend) above the height of the windowsill at the first floor and would not provide an appearance that is appropriate to the early 20th century historic and architectural character of the dwelling, thus altering the features and spaces that characterize the property.

Applicant photo of 4510 Cortland. This is the railing proposed for installation at 4221 Cortland.

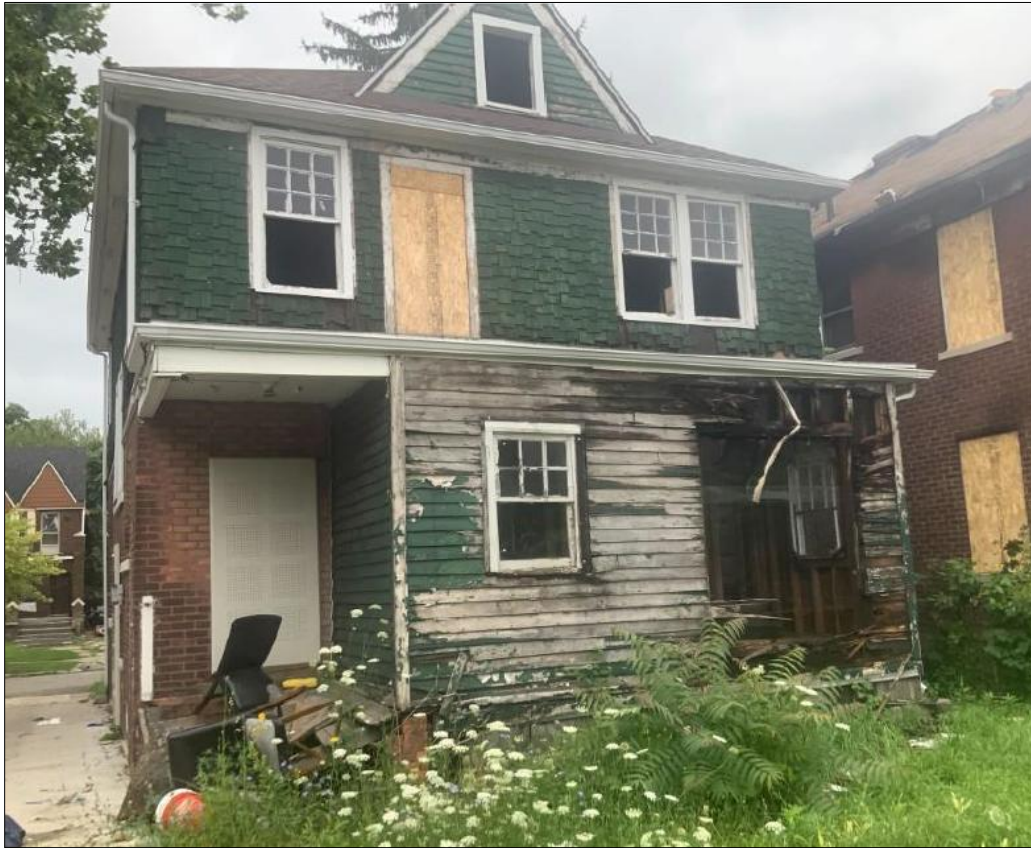
3. The proposed replacement of the original wood lap siding does not demonstrate that the historically distinctive, character-defining material was beyond reasonable repair and replacement in-kind where missing.

Applicant photo. With exception of the deteriorated section of the wall, the historic age wood siding on the remaining walls appeared to be intact and in repairable condition.

5. Wood clapboard siding is commercially available and can be purchased and installed with minimal, if any, additional cost. Wood lap siding at this first floor location would retain the characteristics of an early 20th century structure and match the materiality and dimensional features of the intact historic wood shake siding at the second floor and wood lap siding at the attic/3rd floor dormer wall.

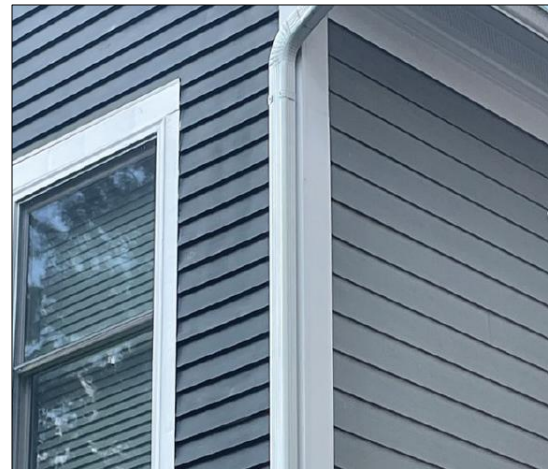
The above photo was copied from Preservation Brief #16 showing the difference in appearance and depth of wood siding and fiber cement siding.

The depth difference of fiber cement and LP Smartsiding is nominal - .312" vs. .354" respectively, so the differential between composite sidings and wood siding would be similar for both manufactured products.

- The manufactured composite product does not match the depth, profile, and shadow lines of the previously installed historic wood siding. Installing the substitute product on walls of a historic feature/location, as opposed to being used on new construction (such as an addition or free-standing structure), would create a loss of authenticity and the physical features and characteristics closely associated with the property’s historic significance would be altered.

- Wood clapboard siding is commercially available and can be purchased and installed with minimal, if any, additional cost. Wood lap siding at this first floor location would retain the characteristics of an early 20th century structure and match the materiality and dimensional features of the intact historic wood shake siding at the second floor and wood lap siding at the attic/3rd floor dormer wall.
