**SR-2 – ADVISORY STAFF REPORT (05-08-2026)**

**ADDRESS:** 15091 PENROD

**APPLICATION NUMBER:** HDC2026-00035

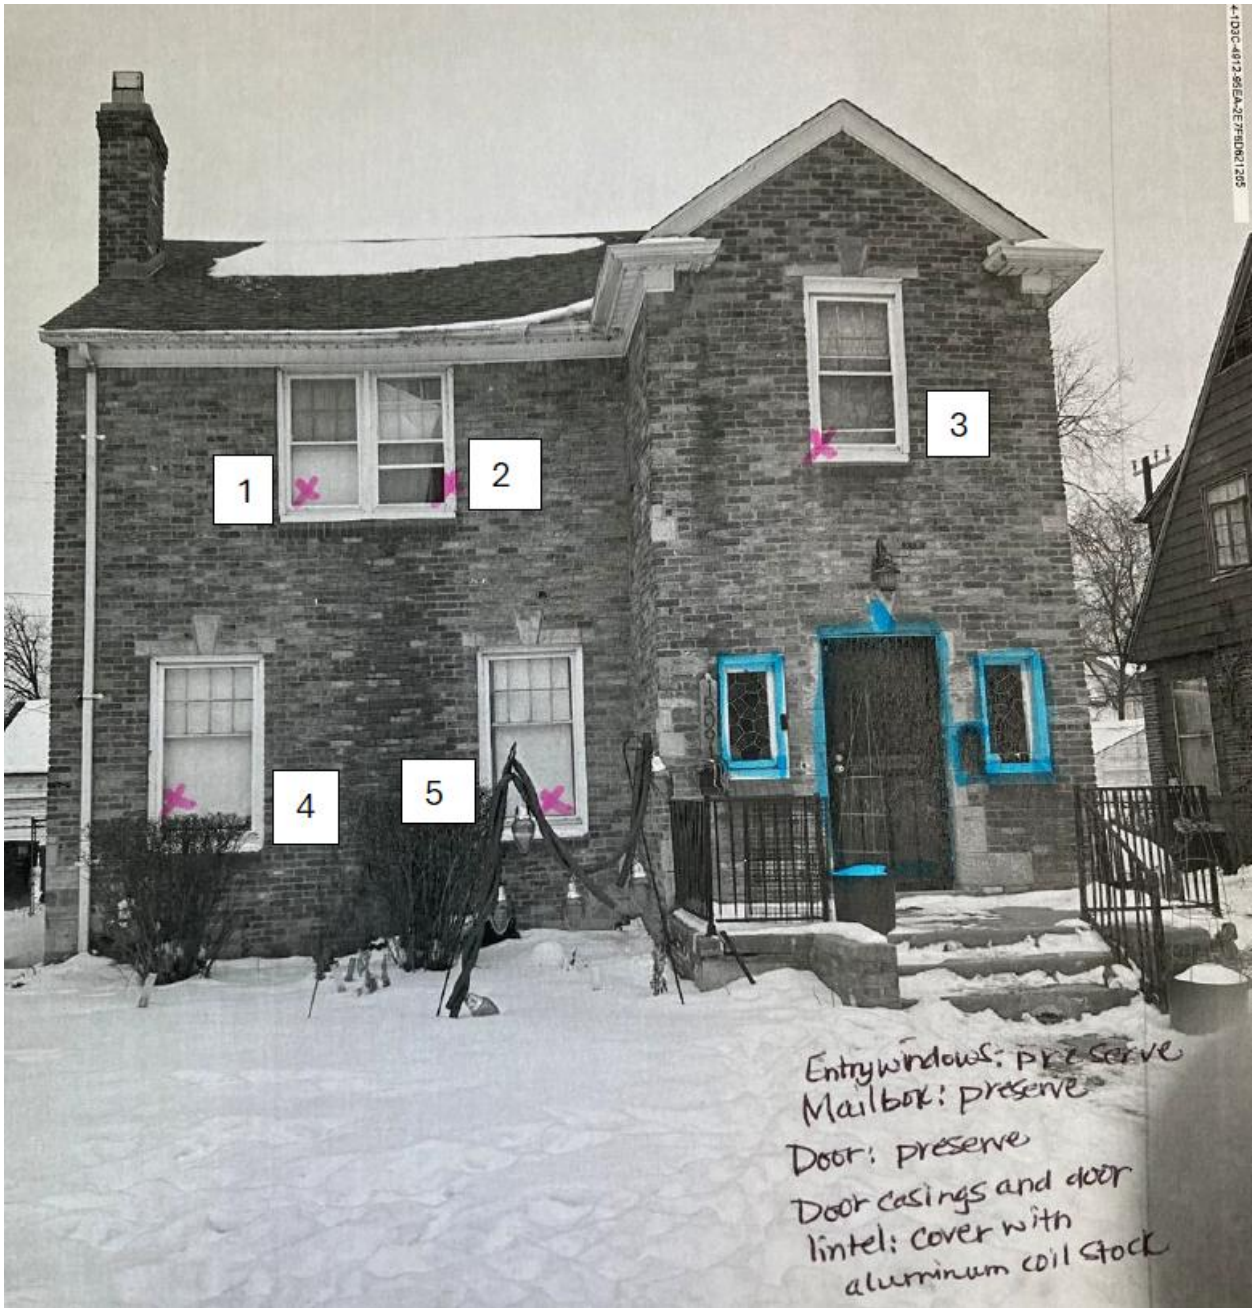
*Front of house, east side, Side A by the applicant's bid sheet.*

- It is staff’s opinion that the 10 windows with divided lights in the upper sashes that are proposed for replacement are historic, character-defining features of the house. Five of these historic windows are on the primary façade, including two cottage-style windows (the upper sashes are shorter than the lower sashes). It is staff’s opinion that the five windows without muntins proposed for replacement may be of historic age, but staff does not find them to be character-defining. Windows 6, 7, 10, and 12 (south side and rear) have proportions that would be typical of other (historic) windows but lack muntins; as a result, it is staff’s opinion that these windows are likely replacements. Window 16 is a kitchen window over a sink, and its proportions look wider and shorter than the typical taller-than-wide historic windows elsewhere on the house. As a result, staff believes this window opening was modified and staff believes this to be a replacement window as well.

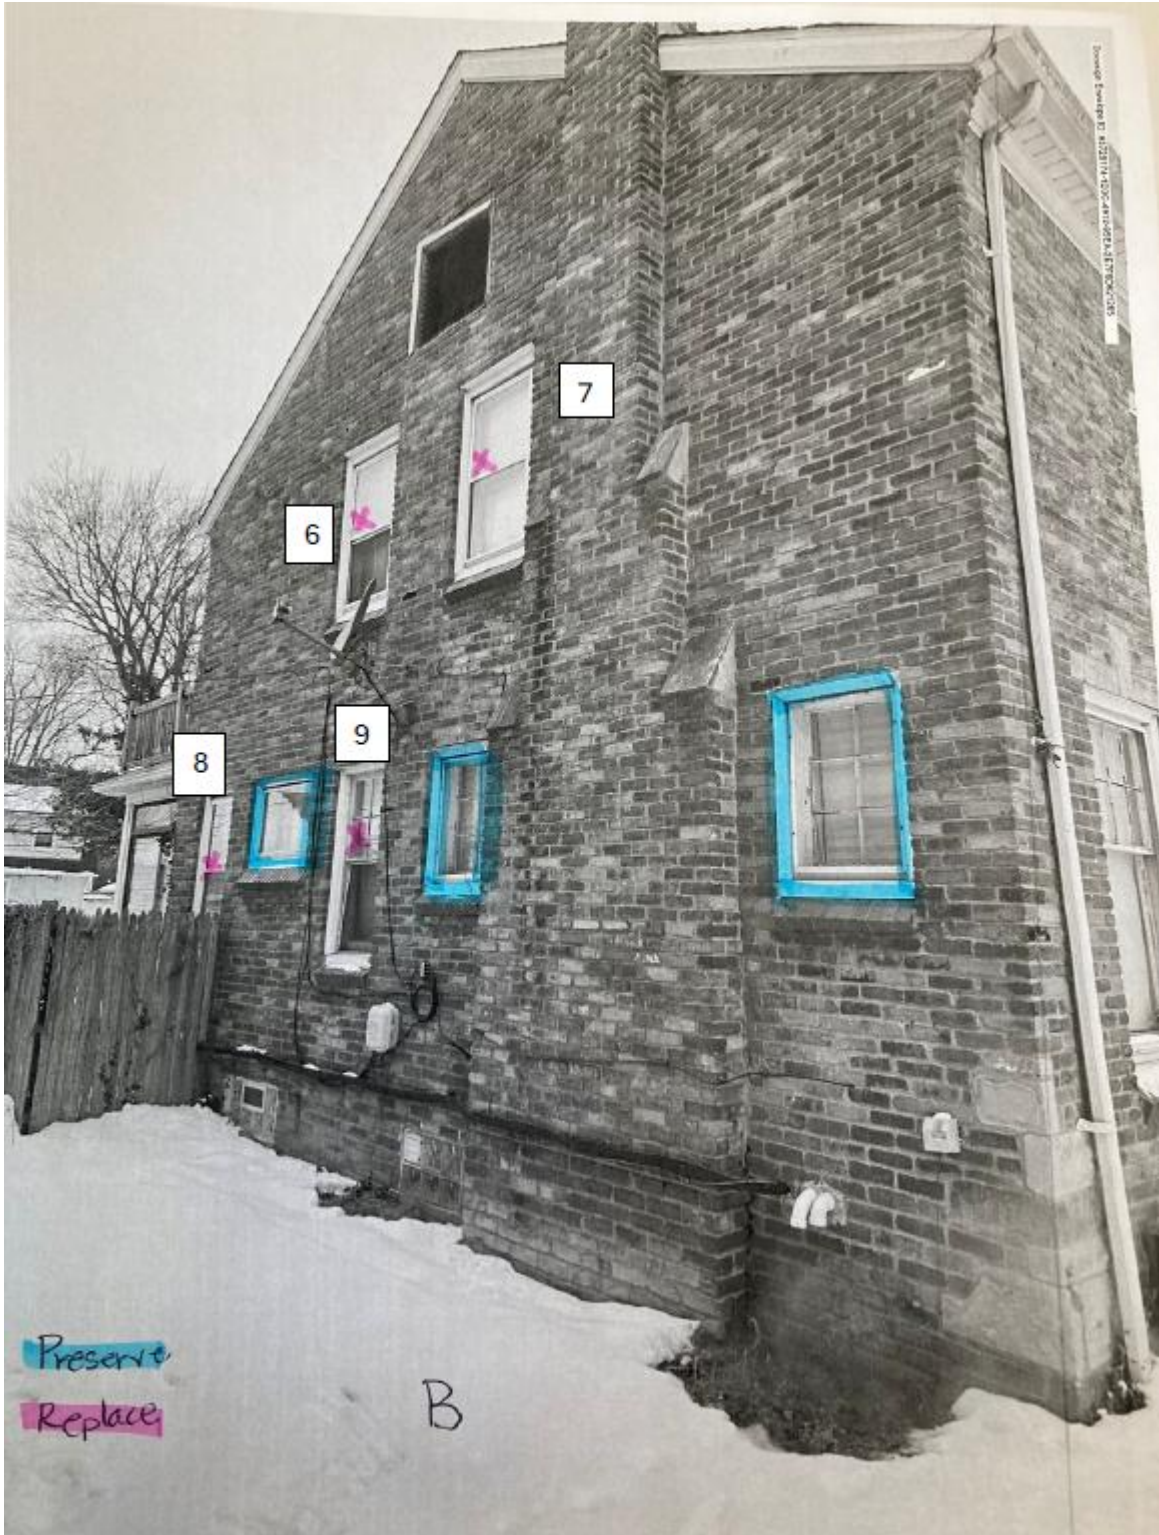
South side of house, Side B on the applicant's bid sheet.

- Of the 15 windows proposed for replacement, 10 are wood with muntins and divided lights in the upper sashes. They all have storm windows installed.
- The other 5 windows to be replaced lack muntins. These windows are Windows 6, 7 (both on Side B), 10, 12, (both on the rear/ Side C), and 16 (on Side D). Staff is not able to discern these windows’ materials with certainty, but several appear to be wood. All 5 of these windows also have storm windows installed.

- By this guidance, for the five non-historic windows, staff finds the proposed replacement windows (wood, aluminum-clad, one-over-one windows without simulated divided lights) compatible with the historic appearance and character of the building. They fill the openings and operate as a wood double-hung would, but replicating the missing window with muntins is not required.

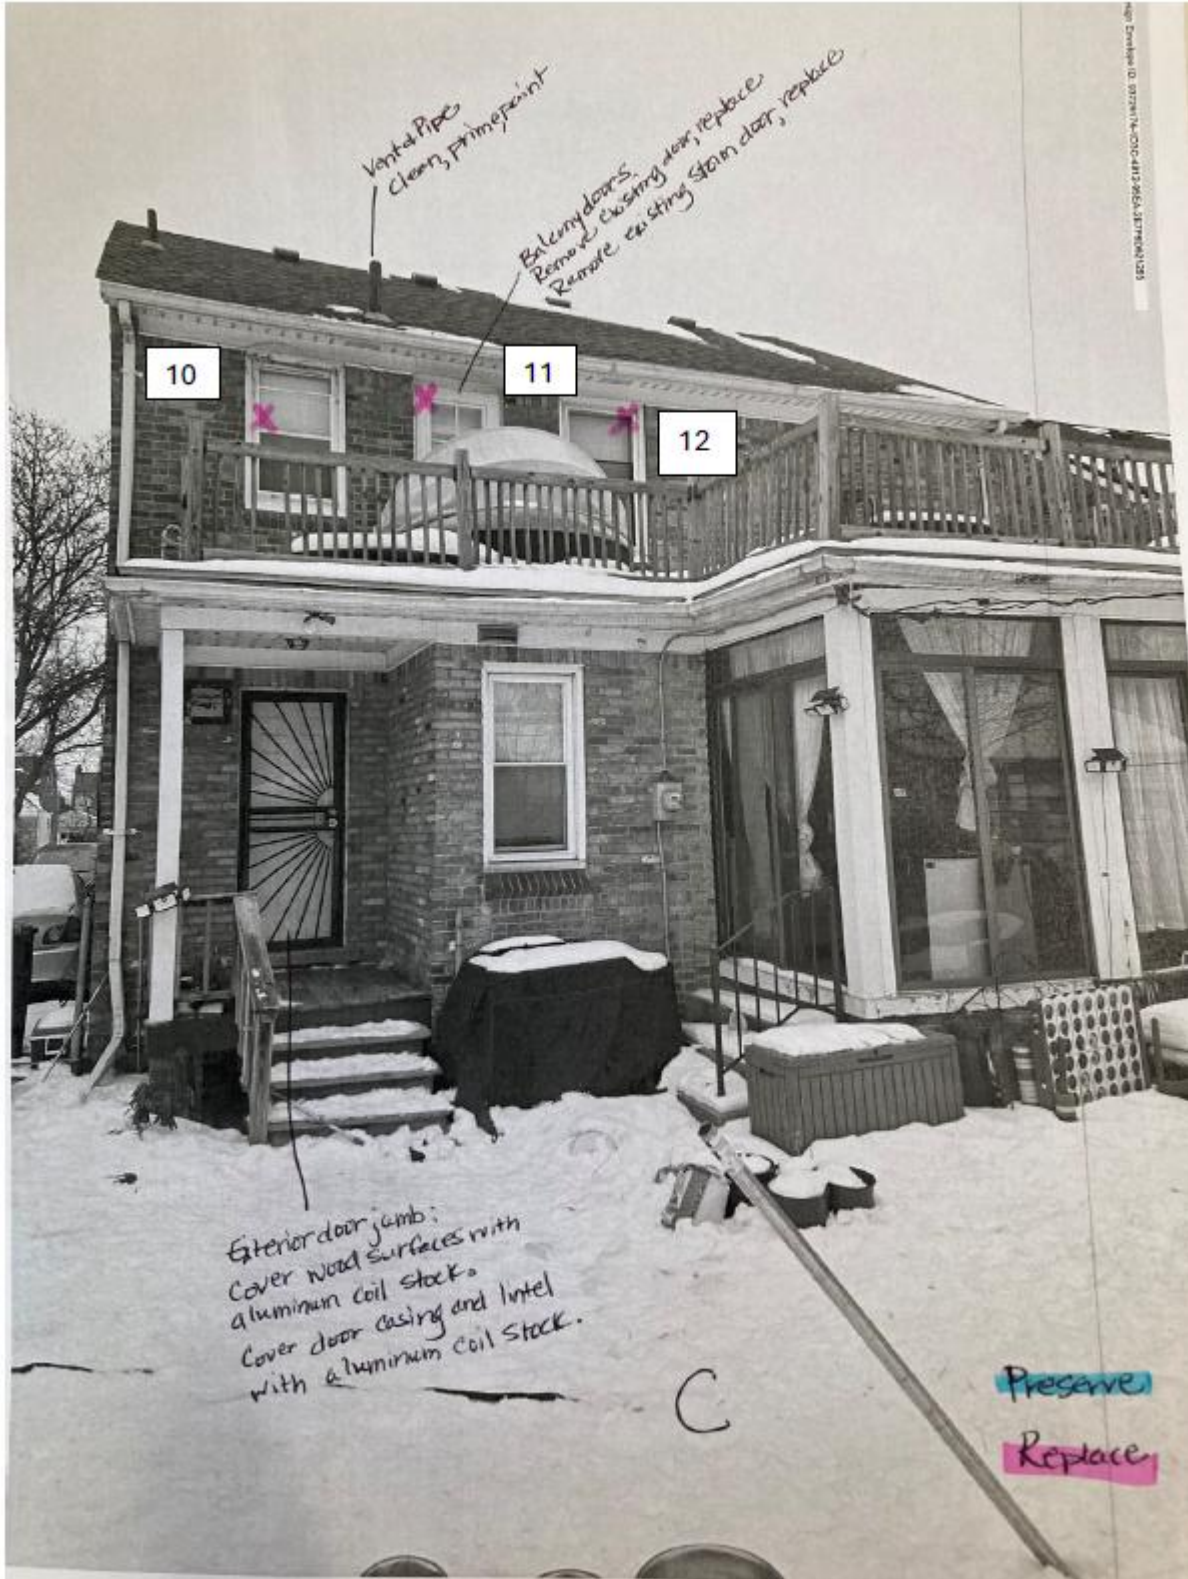
Rear of house/ west side, or Side C on applicant's bid sheet.

- The doors proposed for replacement are on the rear at the balcony, and both are wood.
- Rosedale Park’s Element of Design 10 (Relationship of architectural details) states: “*The architectural elements and details of each structure generally relate to its style.*” It is staff’s opinion that the wood doors proposed for replacement are historic, character-defining features.

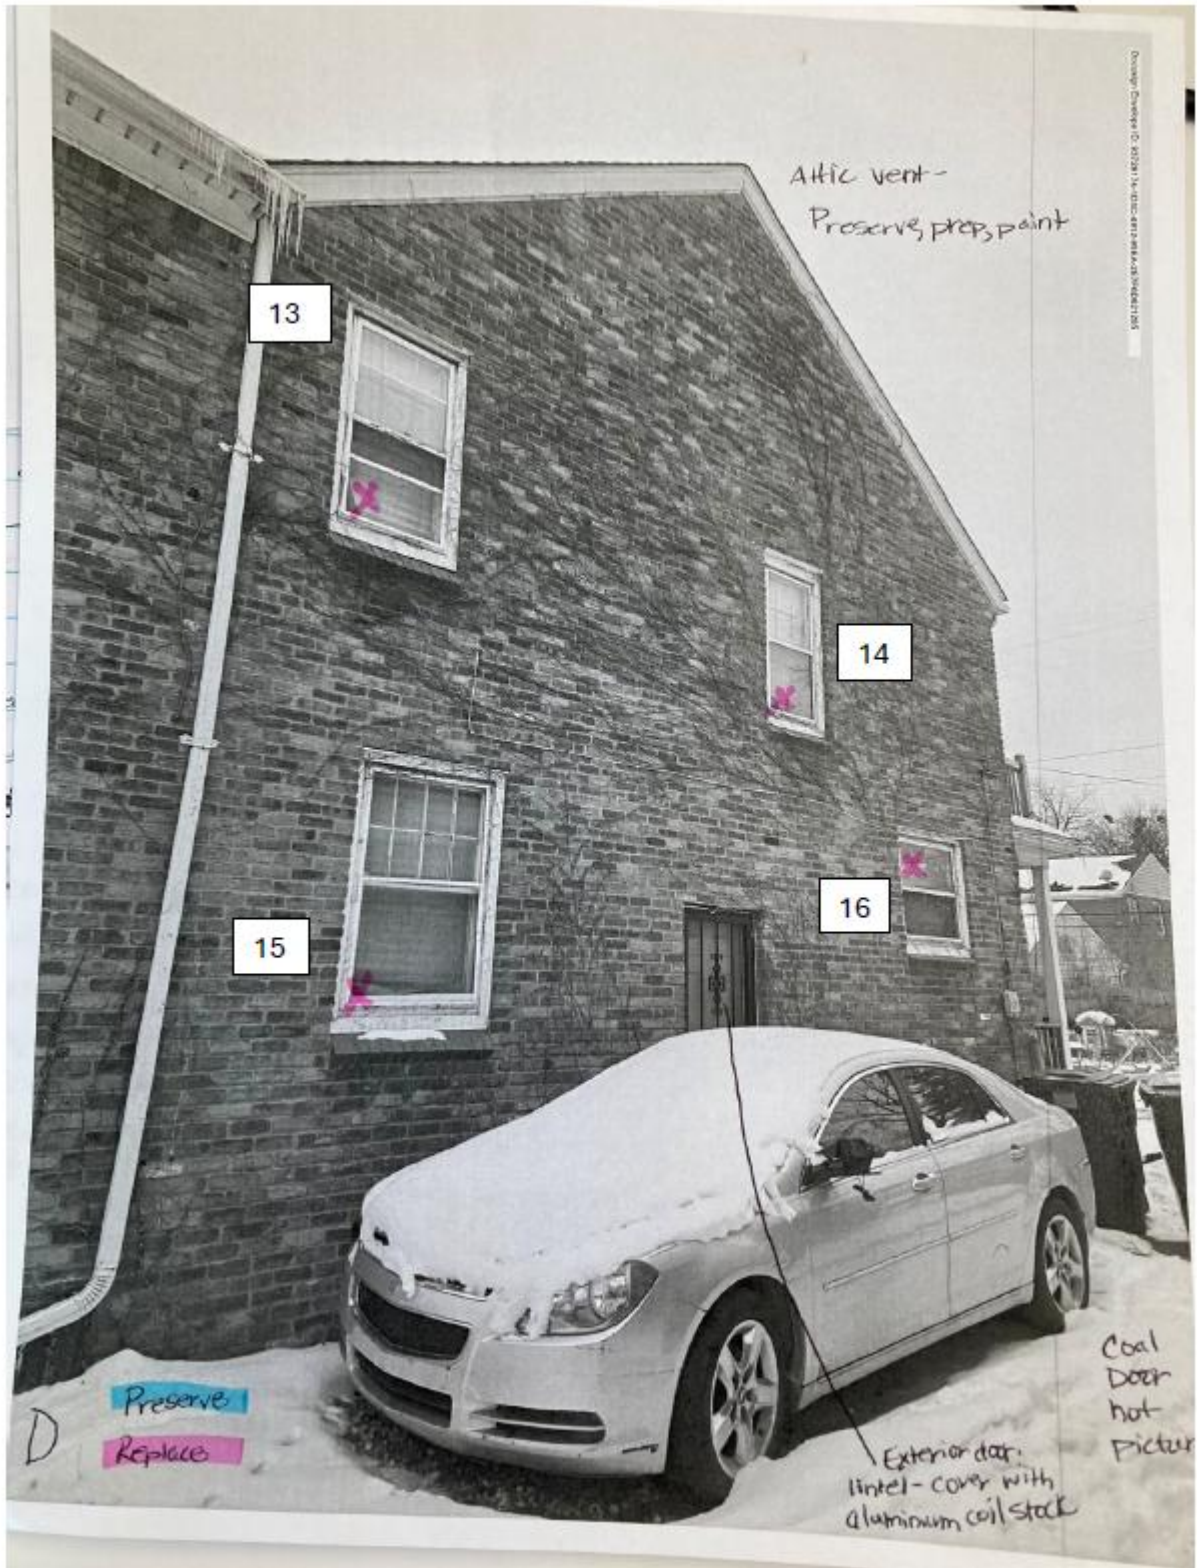
North side of house, or Side D on the applicant's bid sheet.
