SR-2 – ADVISORY STAFF REPORT (05-08-2026)

ADDRESS: 1616 CHICAGO

HISTORIC DISTRICT: BOSTON-EDISON

APPLICATION NUMBER: HDC2026-00139

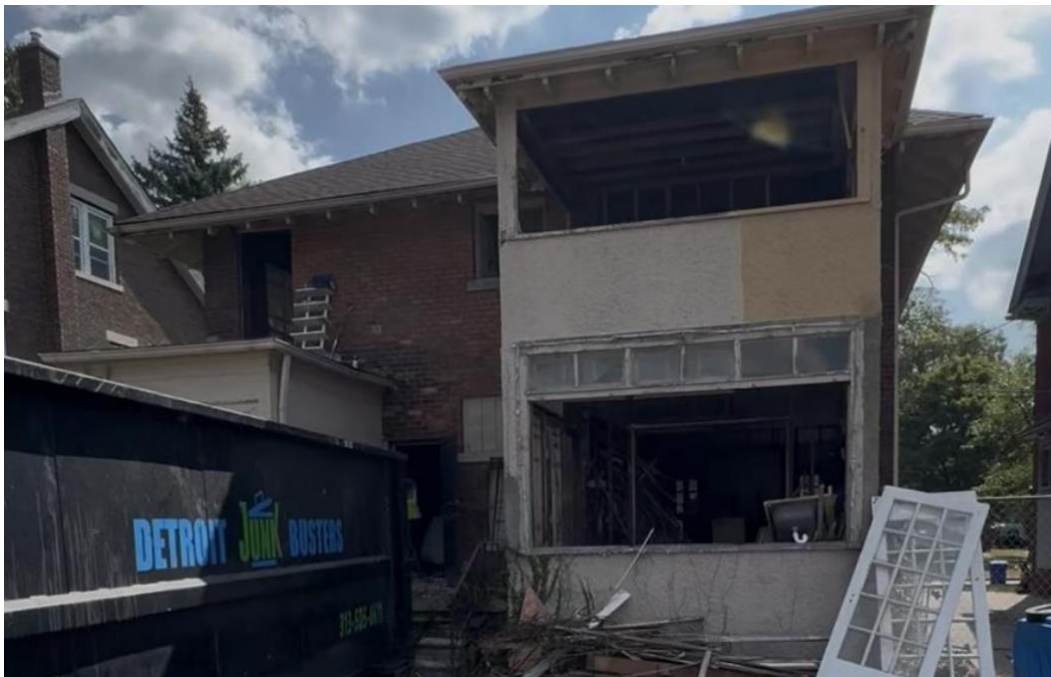
- Recent work completed at the building rear wall without HDC approval includes the following, per the below photo:
 - Removal of an historic-age, two-story wing
 - The installation of a vinyl siding and a vinyl 1/1 window at the location of the former historic-age, two-story wing
 - Removal of historic stucco cladding from the side and rear wall of the one-story wing
 - The removal of single doors at the first and second stories
 - Installation of a set of slider windows at the second story
 - The removal of a 1/1 window at the rear wall of the one-story wing

Rear, showing unapproved demolition of the two-story sunroom wing in progress. Photo by applicant

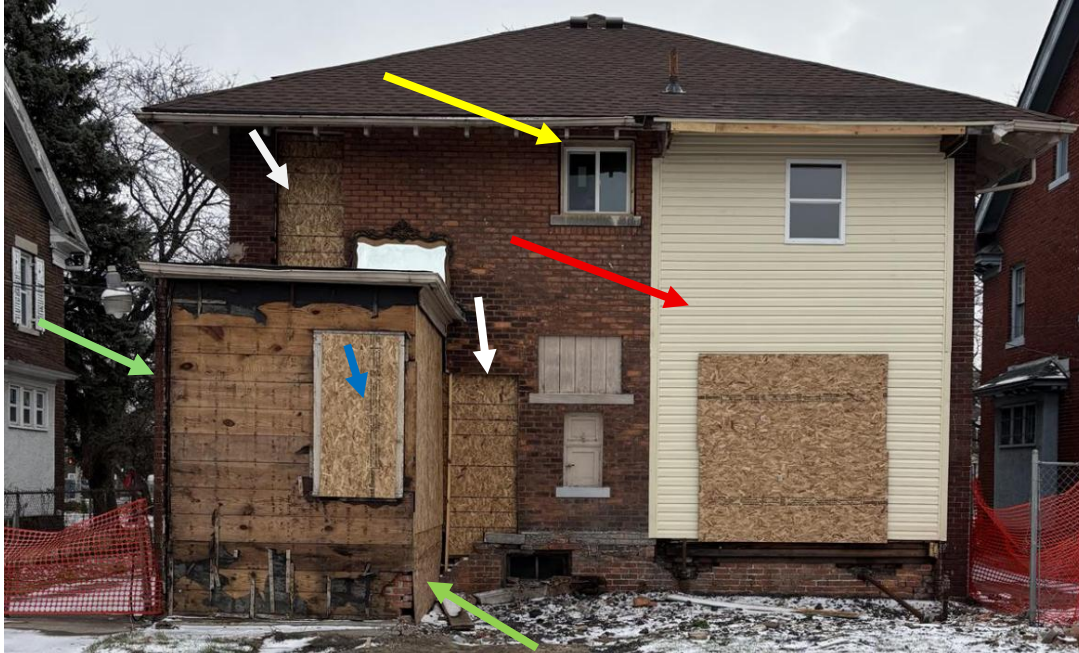
Current appearance of the rear wall after the unapproved work. Note that vinyl siding and a vinyl window has been installed at the wall surface/the location of the former two-story sunroom wing (red arrow). Also, the building footprint has been significantly reduced and the former substantial massing and projection of the wing has been lost. Also, note recently added slider windows (yellow arrow), unclad walls at one-story wing (green arrows), and boarded up window (blue arrow) & doors (white arrows). None of this work received a COA. Photo by applicant

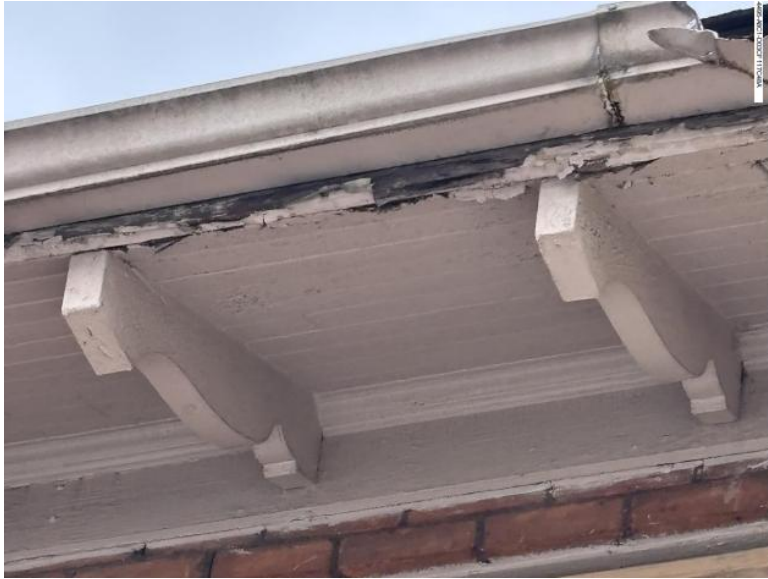
- The original wing had a flat roof while the proposed has a hipped roof
 - The original wing's roof had deep overhanging eaves with decorative wood brackets/rafter tails. Also, the soffit and fascia were wood. The new design proposal does not specify that these original conditions will be matched

Photo detailing conditions at the main roof's eaves/soffit/fascia. Note that a similar detail photo of the eaves/soffit/fascia of the former rear 2-story sunroom wing do not exist as the element was demolished without such documentation. Photo by applicant

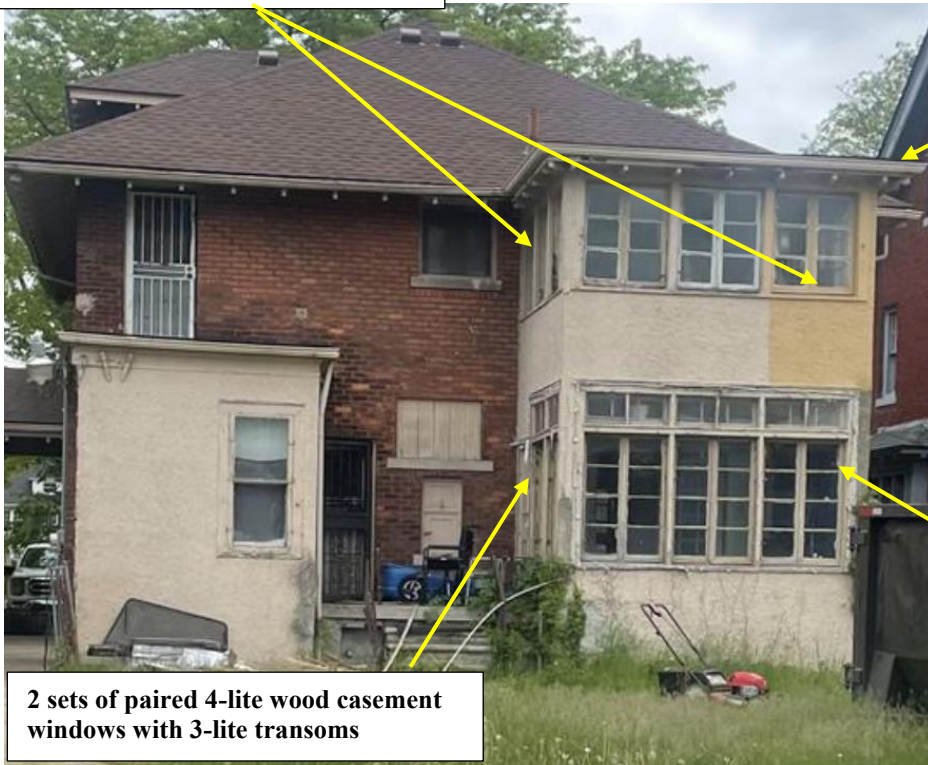
- Per the photo on page 6, the rear wing that was removed without HDC approval was two-stories in height and was clad with stucco. Windows at the first story were historic wood casement units with wood transoms while the second story windows were wood casement units. Consistent with the house’s main roof, the eaves at the wing’s flat roof displayed decorative rafter tails. The doors were the historic wood French doors. Also, the projection and massing of the original wing is lost in the truncated replacement. It is staff’s opinion that this wing was a distinctive, historic character-defining feature of the building.

Flat roof w/rafter tails/brackets

3 sets of paired 4-lite wood casement windows with 3-lite transoms

2 sets of paired 4-lite wood casement windows with 3-lite transoms

Appearance prior to the unapproved removal of the two-story wing, second story window, and one-story wing's stucco cladding at the building's rear wall. While detail photos of its eaves/soffit/fascia do not exist, the area does appear to match main roof's the eaves/soffit/fascia, to include the presence of decorative brackets/rafter tails

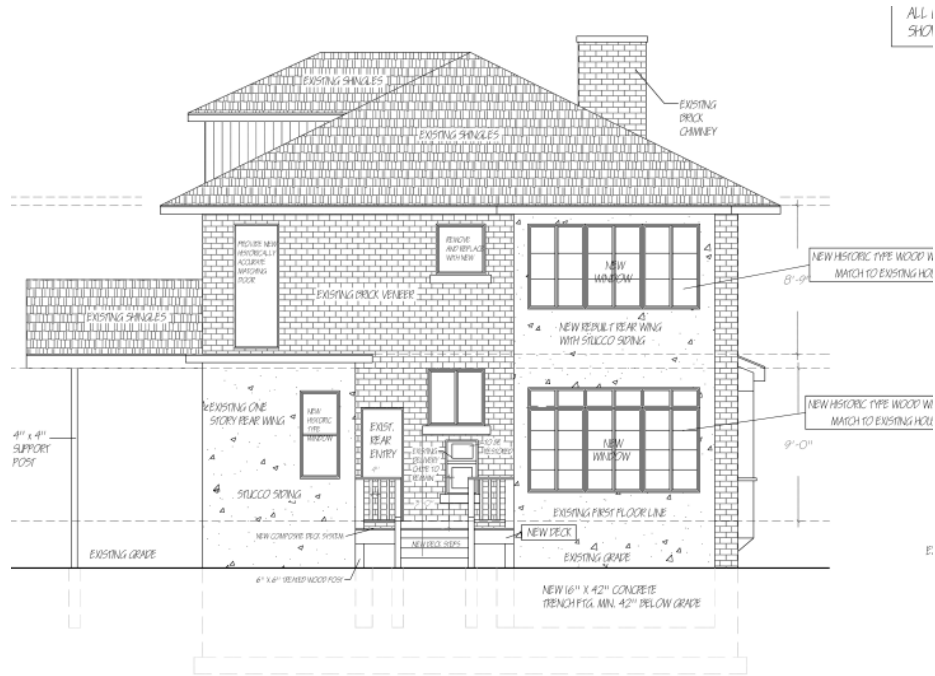
PROPOSED REAR ELEVATION SCALE 1/4" = 1'-0"

- At the original wing's first story, the transoms included 3 lites each. The proposed new design proposes 2-lite transom windows
 - The original windows were wood, with true divided lites. The proposed new windows are wood units, but the application materials do not specify if the windows will be simulated divided lite, true divided lites, or will have muntins between the glass.

Proposed new rear elevation

- While the proposed design for the "rebuilt" rear sunroom wing generally appears to be moving in an appropriate direction, compared to the previous application, it is staff's opinion that the proposed new rear, two-story wing is not an full replication or "restoration" of the original element as the new roof form does not match the original and information is missing re: the detailing and materials at the eaves/soffit/fascia, the specifications for the windows, and the east façade's first story elevation. Staff therefore withholds a recommendation to approve this item until the missing information is supplied and assessed to ascertain how closely the eaves and windows will match the originals. Also, the proposed hipped roof and transom lite configuration at the first story should be revised to match those at the original wing that was demolished without HDC approval.

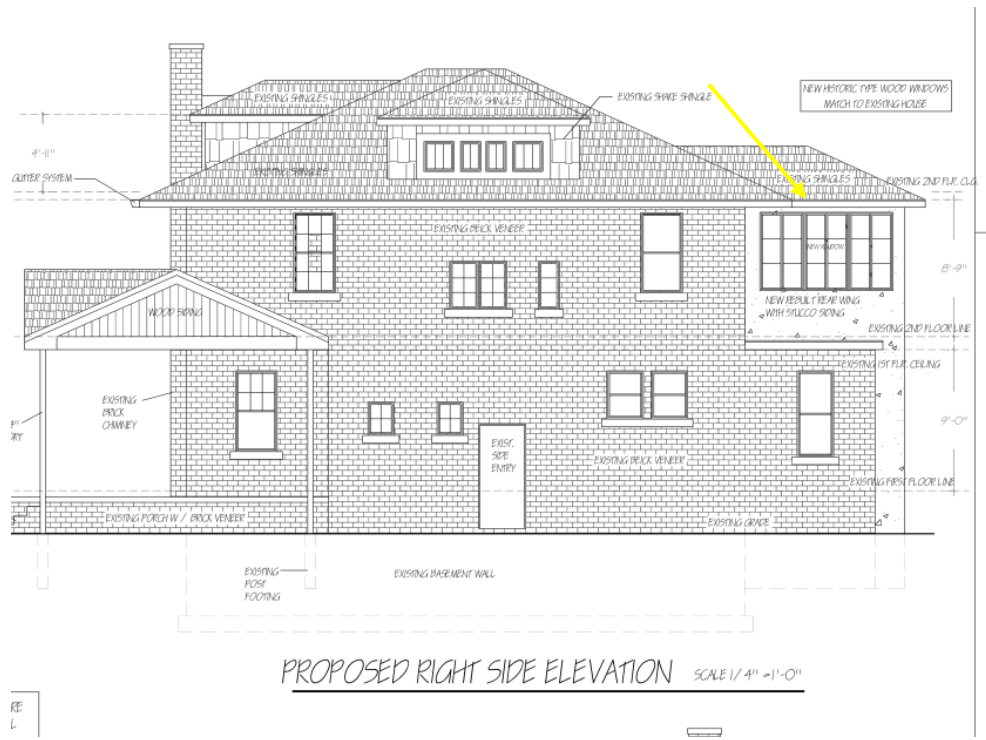
- The current application does not include a full elevation drawing of the proposed wing's east façade/does not depict its first story. Details are limited to the plan's indication that a single wood French door and two sets of wood windows will be installed at this location. However, the lite configuration, operation, presence of transom, etc. is not clear due to the lack of an elevation drawing.

Proposed east side elevation. Note that this drawing only depicts the second story of the proposed “rebuilt” sunroom’s east façade (yellow arrow)/the submitted set of drawings does not provide a full elevation drawing of the proposed “rebuilt” sunroom wing’s east façade.

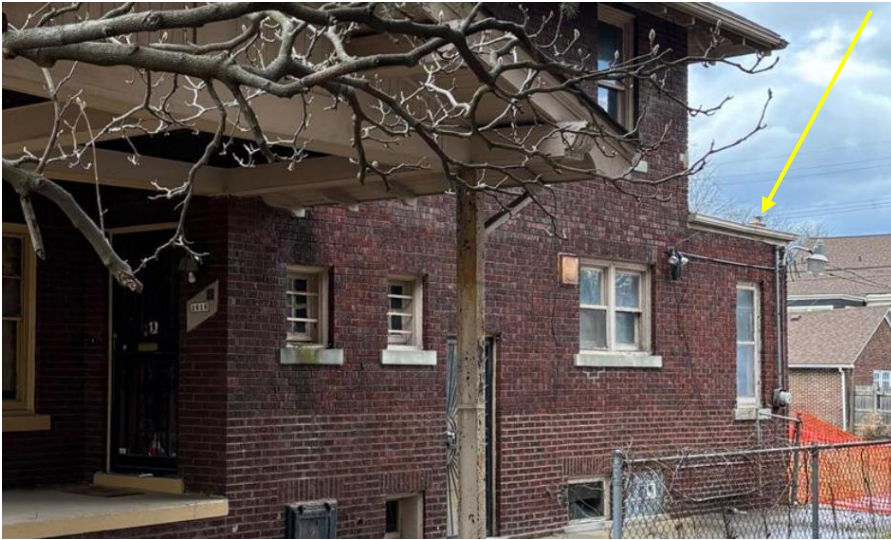
Rear, one-story wing, showing current brick veneer cladding (yellow arrow). Photo by applicant.

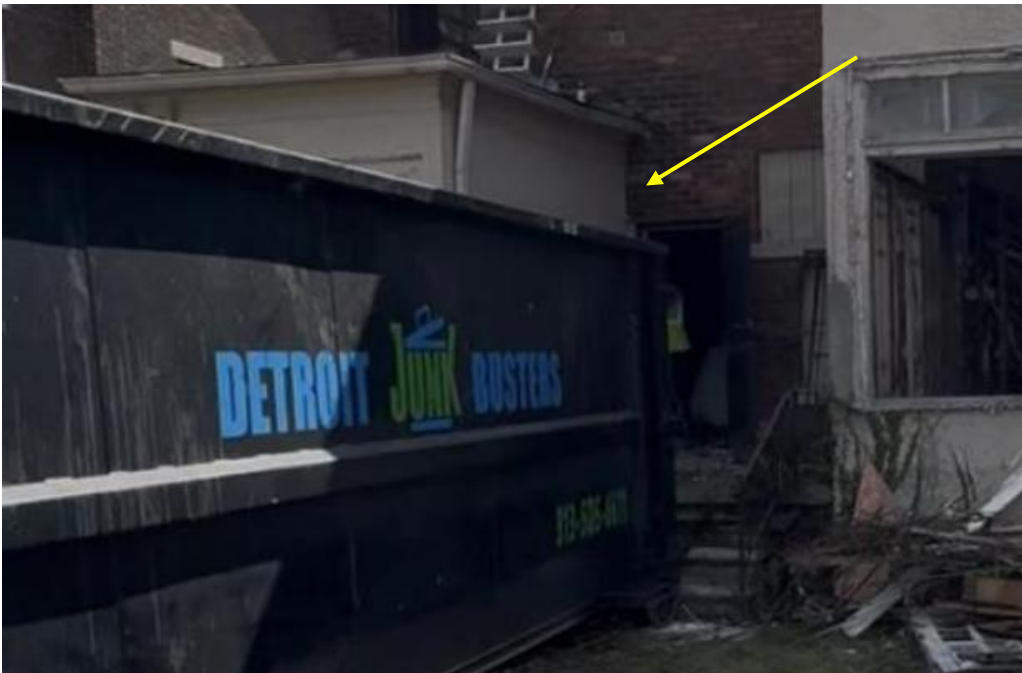
- Per the above narrative and photo of existing conditions, the cladding at the rear and west walls were removed without HDC approval. A photo of the wing prior to the unapproved siding removal indicates that the rear and west walls were clad with stucco. Staff notes that the siding at the opposite/east side wall is clad with a brick veneer.
- The current application proposes to install stucco at the wing’s rear wall, to match the cladding that was removed without HDC approval. Staff supports this work item. However, the application does not speak to the material that will be installed at the wing’s west wall. Staff recommends that stucco be installed at the wing’s east wall to match the historic cladding that was removed without HDC approval.

Rear, one-story wing, showing stucco cladding which was removed from west wall without HDC approval (yellow arrow). Photo by applicant.

1. The west wall of the rear, one-story wing should be finished with true stucco to match the proposed cladding for the wing's rear wall. Staff shall be afforded the opportunity to review and approve this work item prior to the issuance of the project's permit.

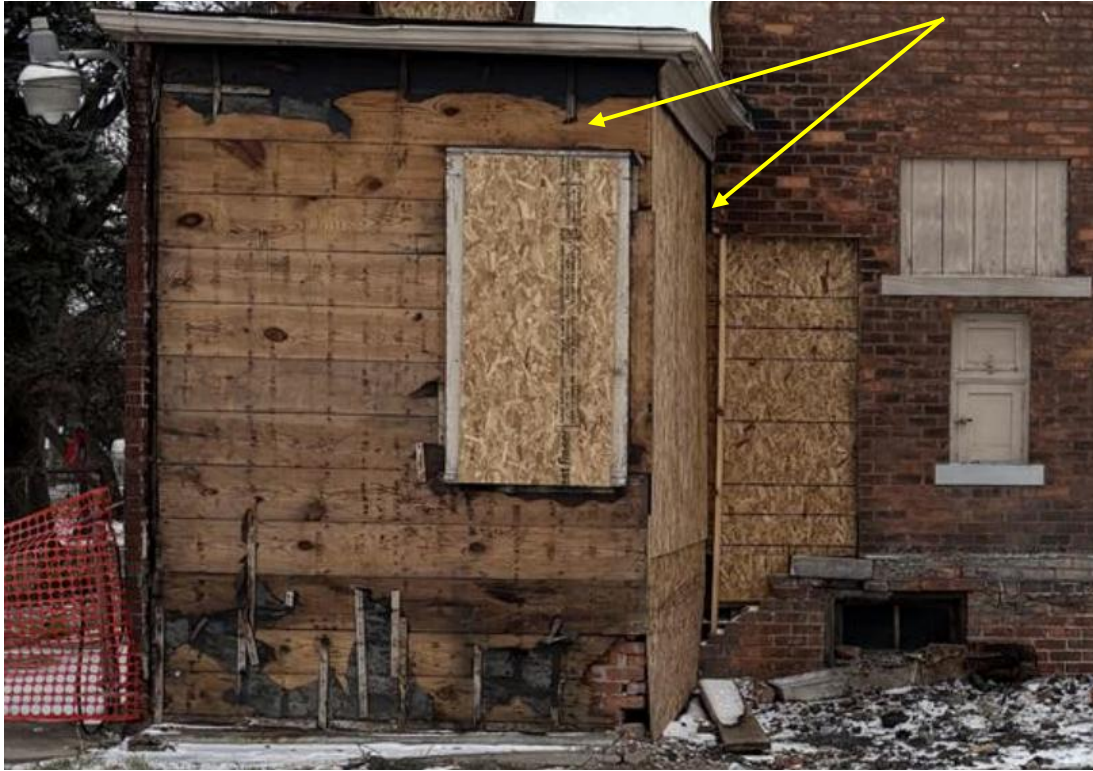
Rear, one-story wing, showing current conditions after stucco was removed from rear and west walls without HDC approval (yellow arrows). Photo by applicant.
