SR-2 – ADVISORY STAFF REPORT (5-08-2026)

ADDRESS: 892 W. BOSTON BOULEVARD (EDWARD FISHER RESIDENCE)

APPLICATION NUMBER: HDC2026-00193

SCOPE: INSTALL LANDSCAPING AND HARDSCAPING, CONSTRUCT POOL

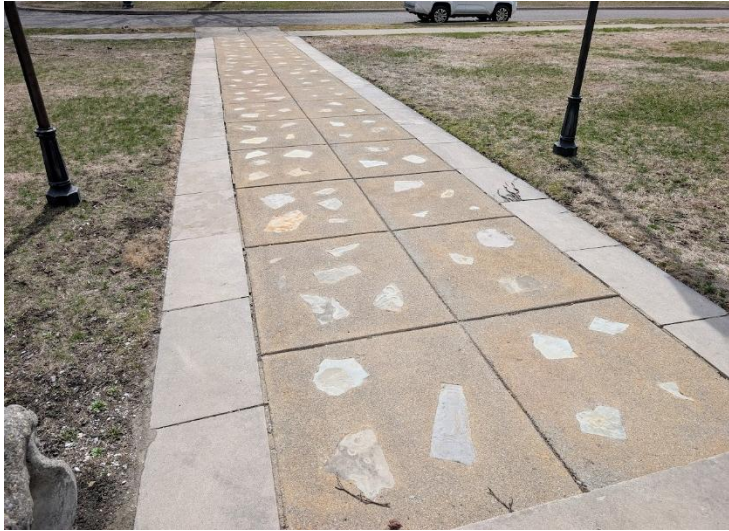
Front walk, current conditions. Insensitive patches are evident. Staff photo, March 2026.

- **Replace front entry walkway**
 - Remove existing concrete and pavers.
 - Install new exposed aggregate concrete in the same width as existing.
 - **Staff analysis:** The existing front walk, in staff's opinion, is a replacement that has been insensitively patched. The historic photo below shows that the original walk had been close in color to the sidewalk, and it appears to staff that it was concrete, without a dyed portion. As such, staff finds that the proposed concrete installation for the front entry walk is a restoration of a missing feature, meeting the Secretary of the Interior's Standards and Guidelines for Rehabilitating Historic Buildings.

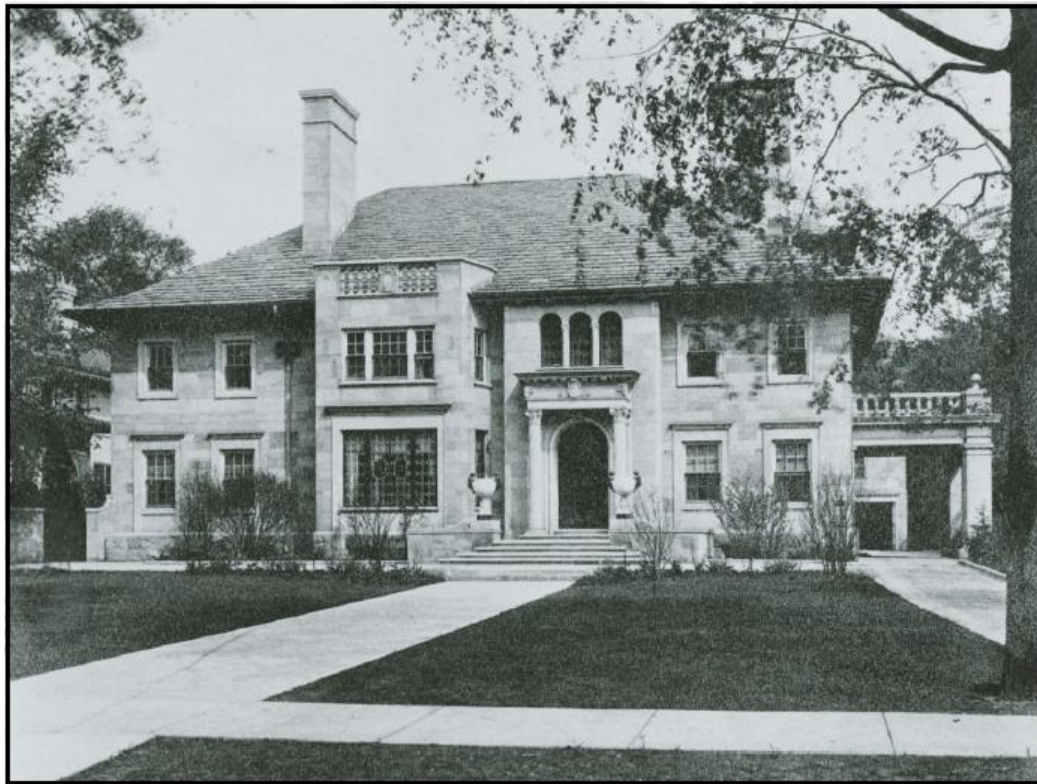
Detail of historic photo above from application materials. It appears to staff that there is a crack in the entry path near the sidewalk, which indicates to staff that this path was concrete and not pavers or bricks (like the drive).

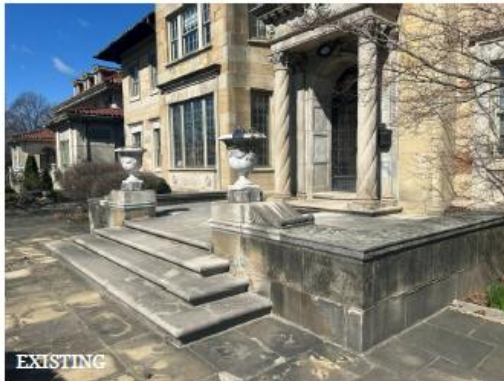
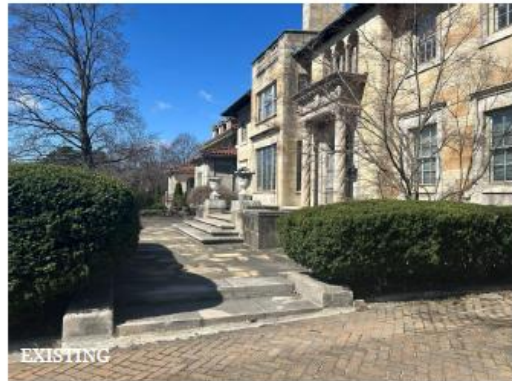
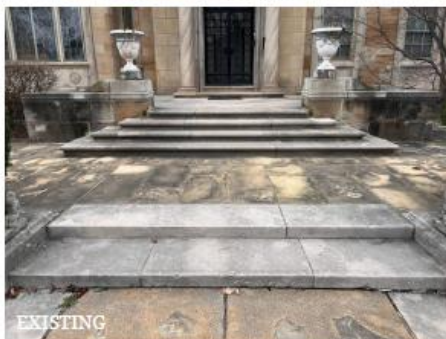
Masonry Staircases, Walls, & Piers

Existing masonry staircases, walls, & piers to remain. Wash and tuckpoint to clean up.

Photos of existing conditions at the front of the house where washing is proposed to remove dirt, and broken or cracked pieces are proposed to be replaced with matching materials. (From applicant materials)

1. The active ingredient in the proposed masonry cleaner is not provided. A test patch will be necessary.
2. A photo of cleaned stone pavers next to proposed replacement paver samples will be needed to confirm color and material match for the pavers before work begins.

3. Any mortar used in the stone repairs needs to match the historic mortar and be softer than the stone.
4. The proposed expansion of the driveway at the front of the house from the sidewalk (where it is currently 9'6" wide) to its proposed widest point (about 15' 2") would substantially alter the historic expression.

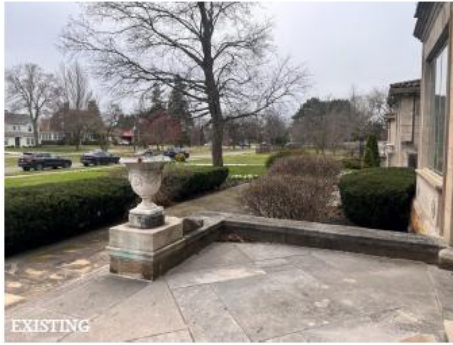
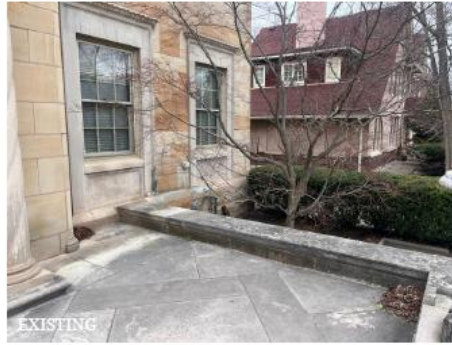
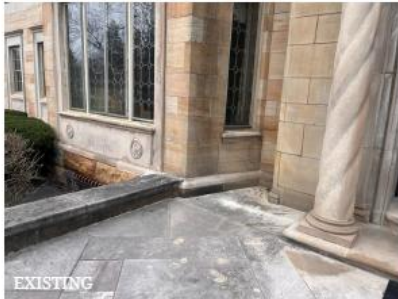
Entry Porch

Existing entry porch flatwork and walls to remain. Wash, tuckpoint, and replace missing pieces. Match with Buff Tayko natural stone.

Photos (above and below) of existing conditions at the front of the house where washing is proposed to remove dirt, and cracked or broken pieces are proposed to be replaced with materials that match historic materials. (From application)

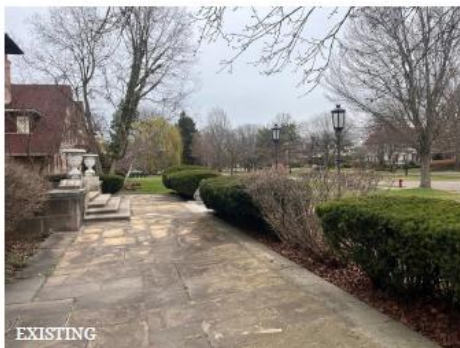
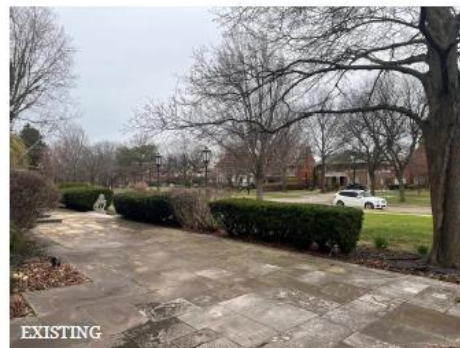
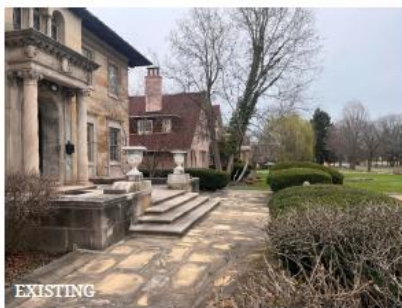
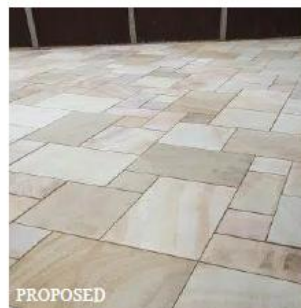
Entry Plaza

Existing entry plaza flatwork and walls to remain. Wash, tuckpoint, and replace missing pieces. Match with Buff Tayko natural stone.

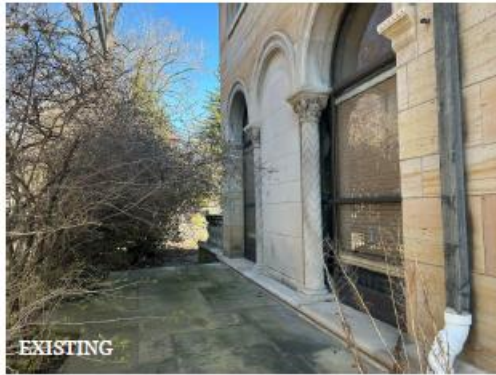
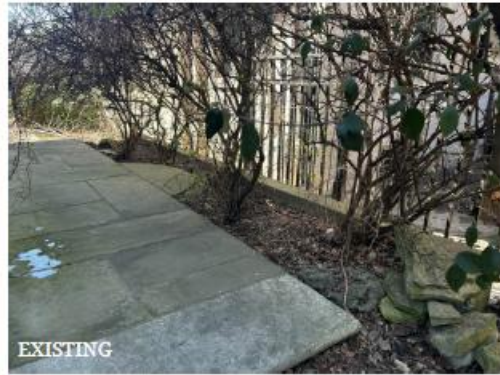
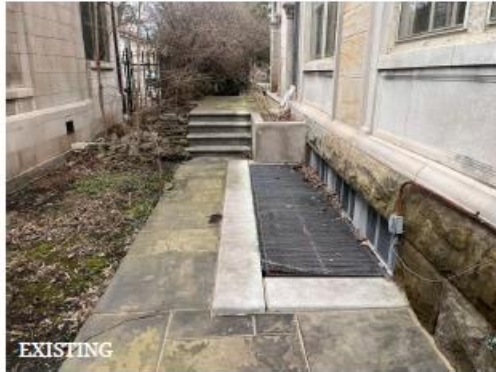
Courtyard Walk

Wash and tuckpoint existing courtyard walkway and steps to clean up.

Photos from applicant materials of west-side courtyard walk (connecting backyard to front yard), above, and the rear yard's upper terrace, below. As in the front yard around the front entry, this stone will be cleaned. Any cracked or broken pieces will be replaced with stone matching the historic.

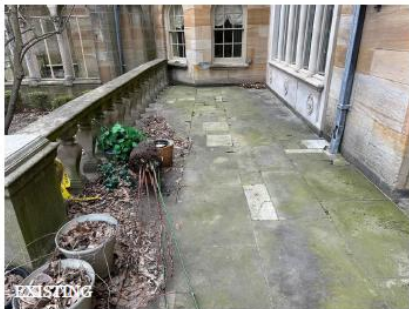
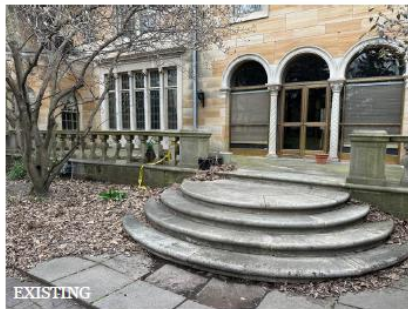
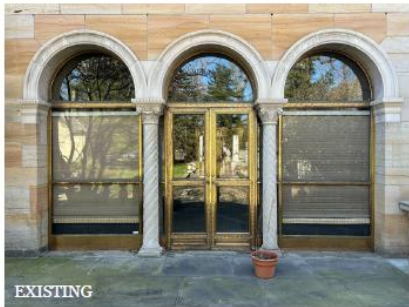
Upper Terrace

Wash and tuckpoint existing upper terrace patio and steps to clean up. Replace missing pieces with matching Buff Tayko pavers.

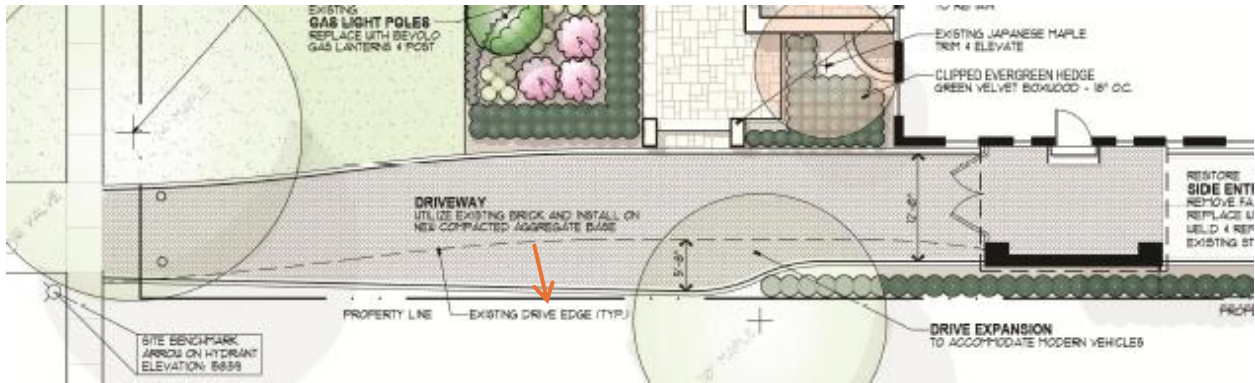
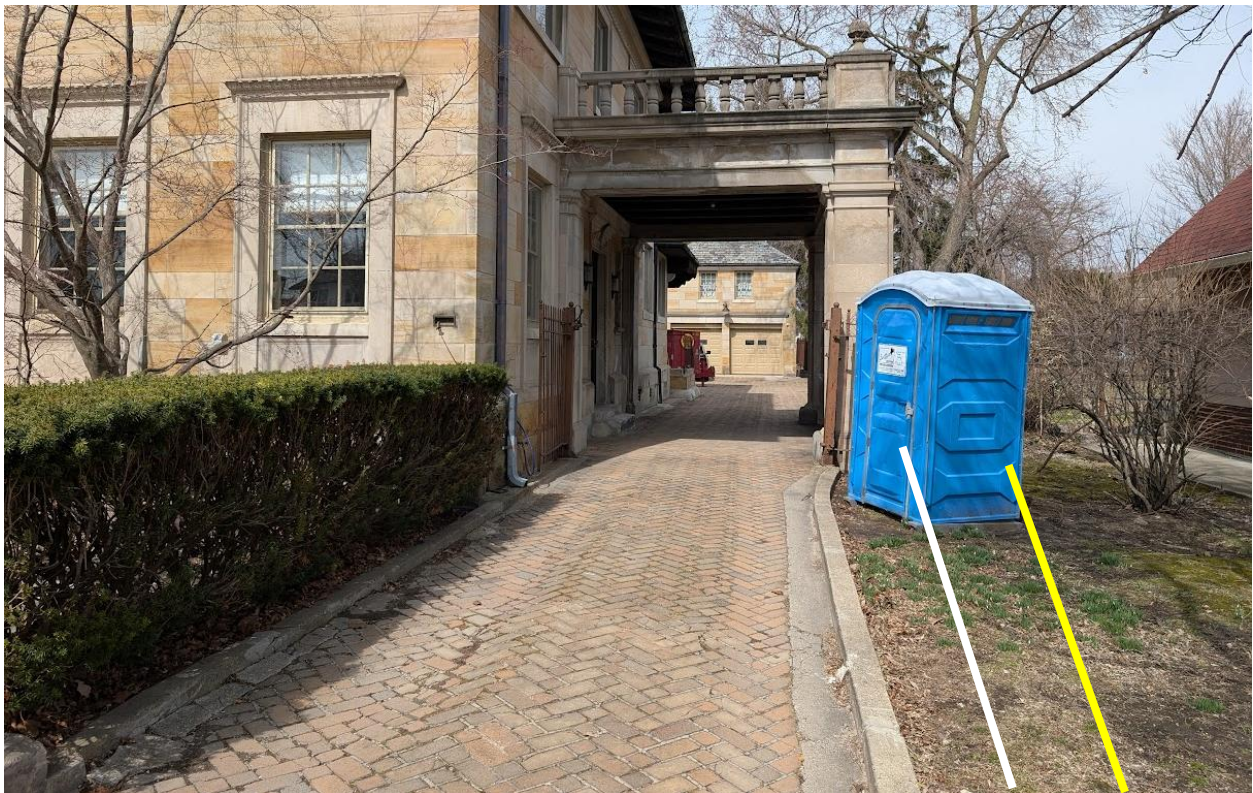
Proposed driveway, from applicant materials. Staff's red arrow indicates the proposed wider drive. The driveway would increase by about 5'8".

The proposal is to widen the drive along its middle, keeping its beginning point at the sidewalk as it is, adding about 5'8" along the middle, and then curving west toward the porte cochere to add about 2.5' to the end point at the porte cochere. Staff drew a white line roughly where the end point at the porte cochere is proposed, and the yellow line is staff's estimate of where the proposed drive would be at its widest point. (Staff photo, April 2026)

- Staff analysis:** Boston-Edison's Elements of Style Element 13 states that "Straight side driveways leading from the street to rear garages are the norm..." and that "These driveways are paved in asphalt, concrete, or brick." The brick driveway is a historic, character-defining feature of the property and it relates historically and functionally to the porte cochere. While the drive is proposed to remain its historic width at its base at the sidewalk, for much of the rest of the visible, front-yard portion of the driveway, it would be 40% wider than the historic width, wider than almost every other driveway on the block, and wider than the porte cochere for much of its length. (Near the porte cochere, the drive would reduce so that the driveway's eastern edge would curve back toward the porte cochere to meet its easternmost columns.) It is staff's opinion that the driveway could be slightly widened and still be compatible and proportional, but it is staff's opinion that the current proposal expands the driveway too much. As Standard 9 states, "The new work shall be...compatible with the massing, size, scale, and architectural features to protect the integrity of the property and its environment." It is staff's opinion that the proposed driveway expansion along the front lawn is wider than would be compatible.

3. Any mortar used in the stone repairs needs to match historic mortar and be softer than the stone.
4. The driveway at the front of the house will be expanded by less than the proposed 5'8". The widened driveway will be no wider than 9' 6" at the sidewalk and 12' along its length and at the porte cochere.

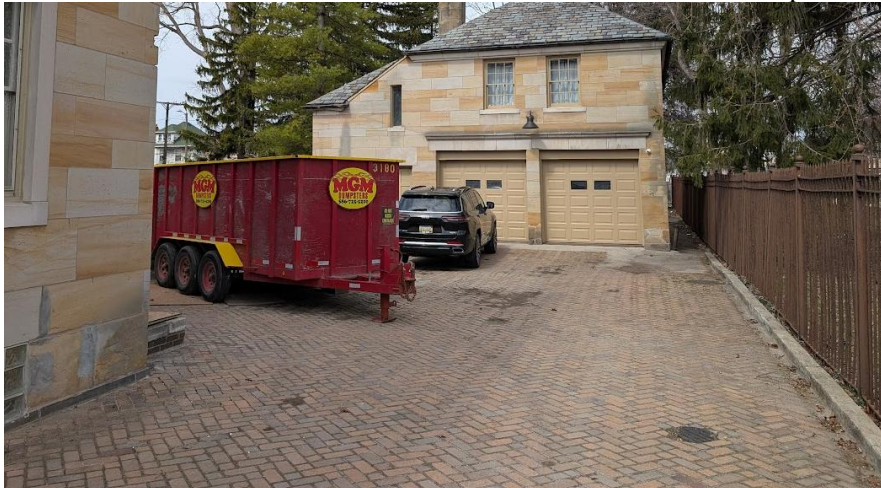
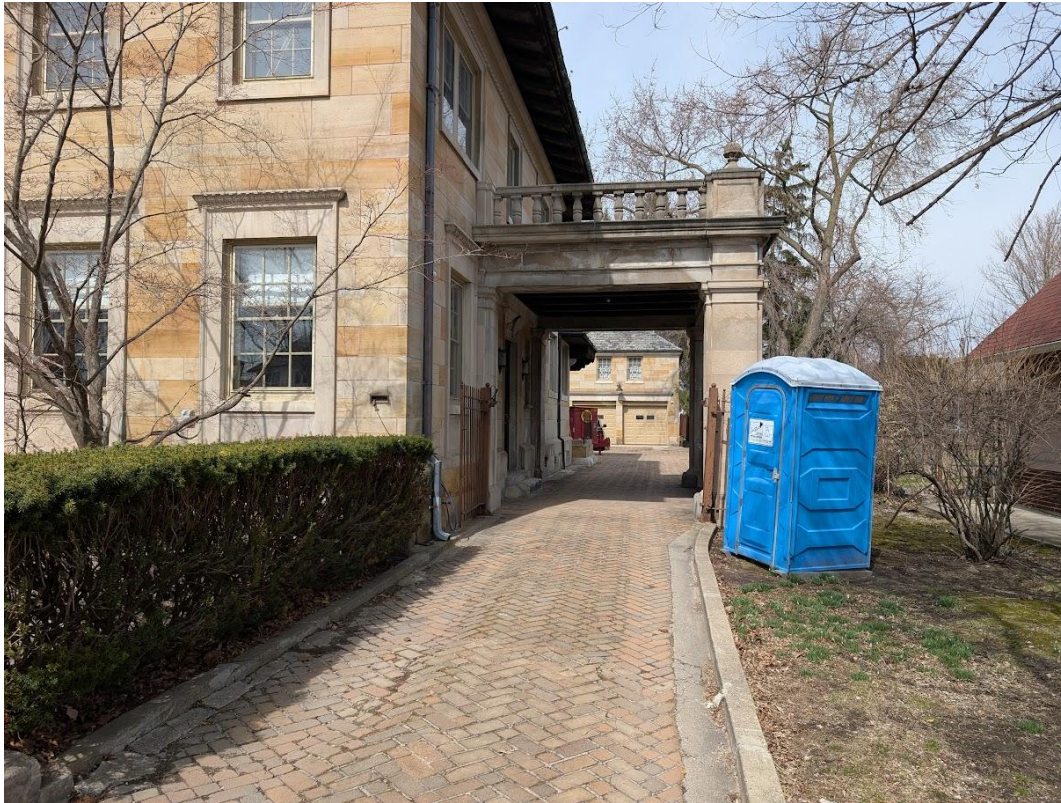
This staff photo from April 2026 shows the width of the rear drive/service court, and the edge of the service court is the eastern property boundary. For much of the front driveway as per the proposal, the eastern edge of the drive would also be the property boundary. Also shown are the service court bricks and these would be removed, used to widen the front drive and replace broken bricks, and replaced with poured exposed aggregate concrete.

Staff photo from April 2026 of a portion of the driveway from the front to the carriage house. The drive is one continuous, character-defining surface from sidewalk to carriage house.

- Porte cochere and its gates remain as they are; re-laid bricks will continue to be the surface under the porte cochere
- **Staff analysis:** Given the property-wide care and attention that the original designers invested in the landscaping, hardscaping, and built elements in order to create a cohesive whole, and given that the driveway is one continuous feature viewed (and experienced) from the sidewalk to the carriage house, these service court bricks, like those of the drive along the front lawn, are also historic and character-defining. The service court bricks indeed play a role in the overall "complete work" represented at this property, and they contribute to a high degree of historic integrity in that part of the yard. These bricks should remain in-situ; any expansion to the driveway should use newer/matching replacement brick.

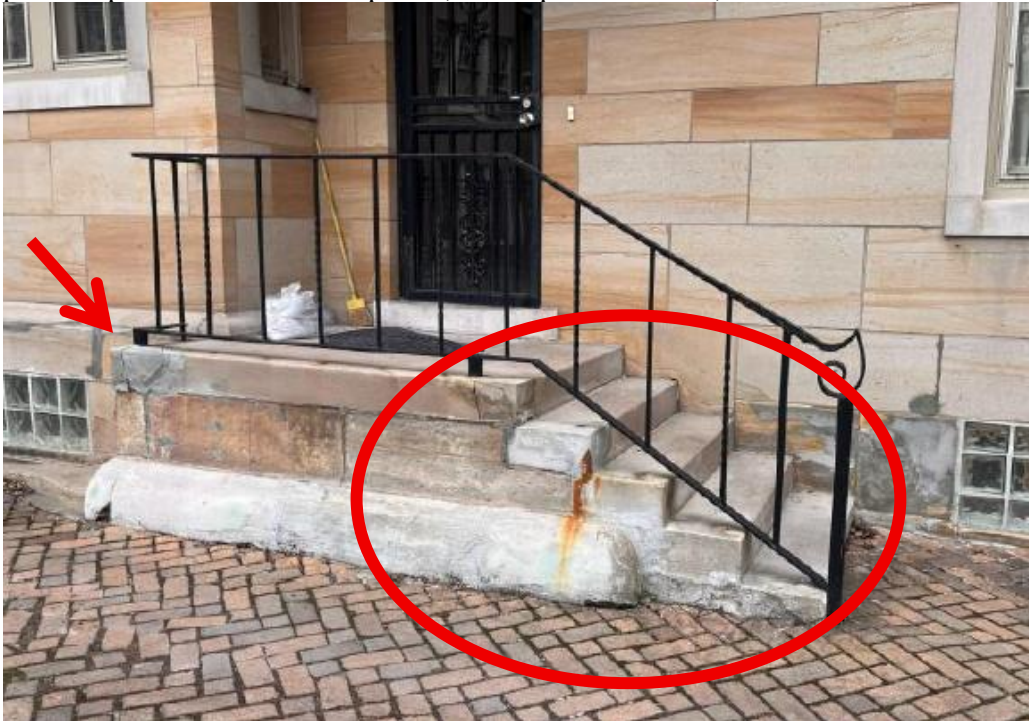
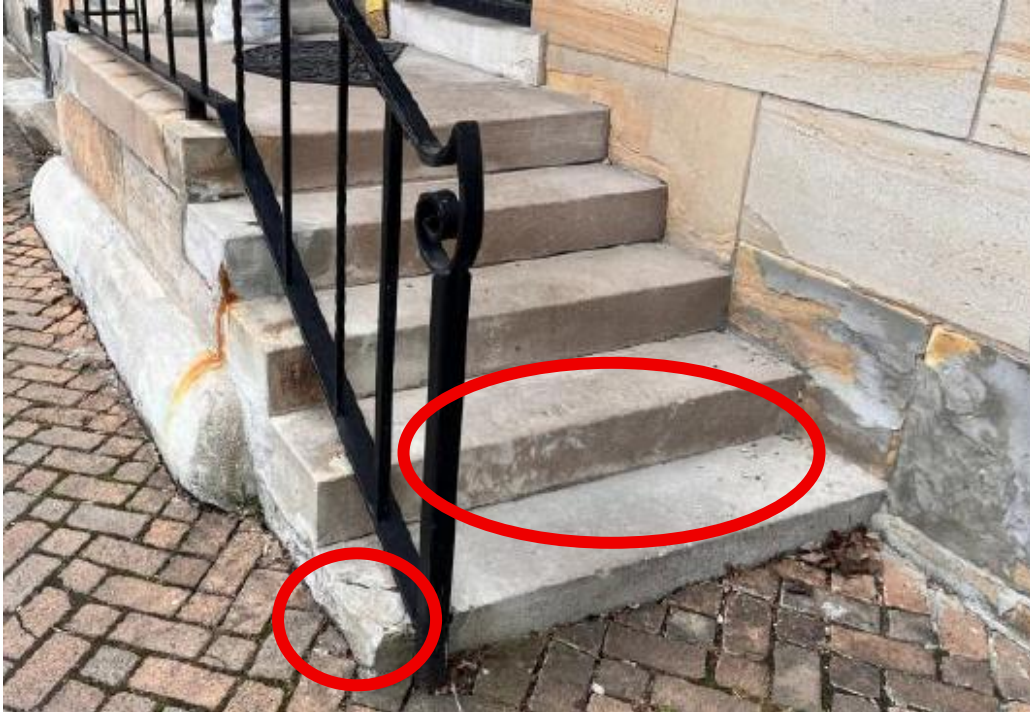
- **Side porch: replace concrete porch and steps with concrete and reinstall existing rail.** Staff analysis: Assuming retention of the historic stone elements (the proposal only mentions work on the concrete), staff considers this an in-kind repair and replacement. The concrete porch cap is cracked in a few places, the steps are cracked, and the treads are deteriorated.

Both photos above, from applicant materials, show deterioration and insensitive repairs on the side porch's cap and steps.

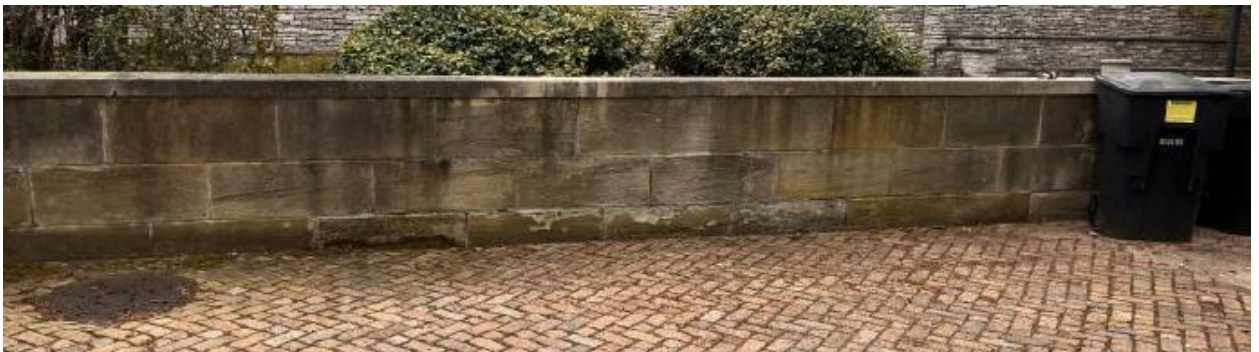
- **Rear yard, service court wall: remove, rebuild, and reinforce using stone to match the carriage house in the same dimensions as existing.** Staff analysis: staff considers this scope item an in-kind replacement that meets the Standards and Guidelines.

Photo from applicant materials of service court wall to be rebuilt with in-kind materials and with the same dimensions as the existing wall. (Dimensions of existing and proposed need to be submitted to staff.) Staining and deterioration is evident.

6. Dimensioned drawings for the south fountain will be submitted to staff and approved before work begins.
7. Dimensions of the current and proposed service court wall will be provided to staff, and a clear photo of the sample replacement material against the existing material will be provided to staff before work begins.

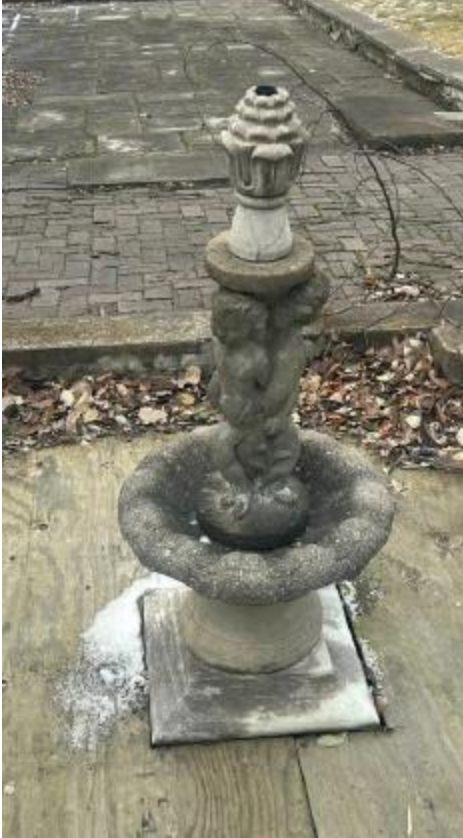
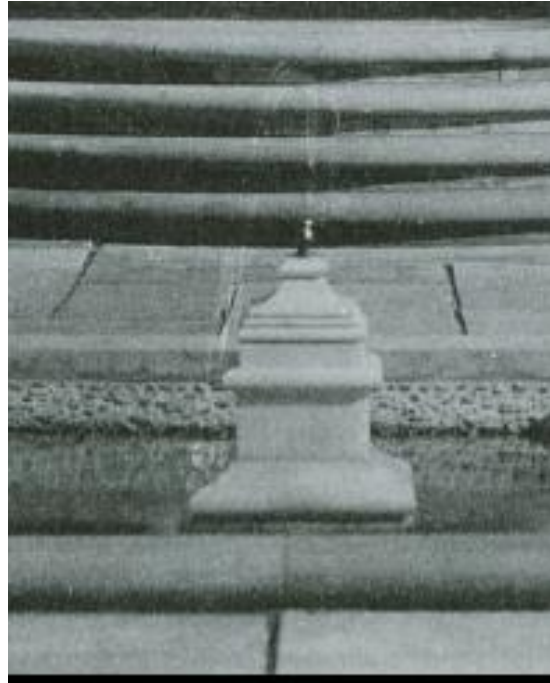
The south water feature: left is the current sculpture and bowl (to be replaced), and on the right is the carved limestone element from a historic photo. The limestone feature is proposed to be replicated. (From the applicant's materials)

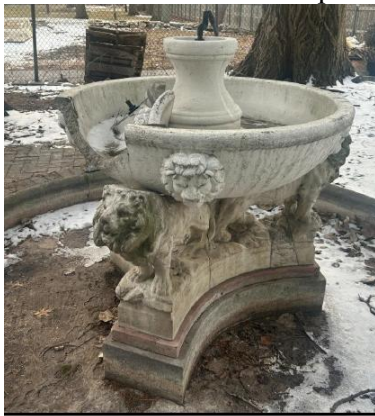
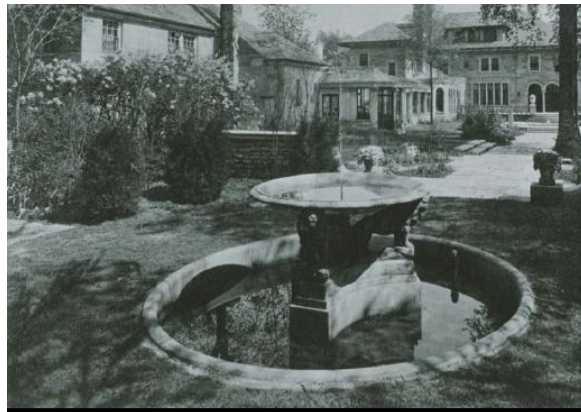
From the application materials, the existing north fountain (left) and the historic north fountain (right). The historic bowl was much flatter and shallower than the existing bowl.

- **Staff analysis:** The careful repairing and restoration of the concrete basins of the fountains so that they are returned to their historic appearance meets the Secretary of the Interior's Standards for Rehabilitation, since historic materials are being repaired and not replaced. It is important that the waterproofing methods proposed for the basins will preserve the concrete over the long term and will not change the concrete basins' color or design. For the north fountain, preserving and repairing the historic base (as proposed) meets the Standards and Guidelines. The proposed replacement bowl does not match the shallower, flatter historic bowl, but is more like the shape of the current (replaced) bowl with more ornamentation. Since the existing bowl is not historic, the Standards allow it to be replaced and require that the replacement is compatible. Assuming that the bowl will properly fit the lions base, staff finds the bowl compatible with the base.
