SR-2 – ADVISORY STAFF REPORT (06-05-2026)

ADDRESS: 100 TEMPLE

APPLICATION NUMBER: HDC2026-00172

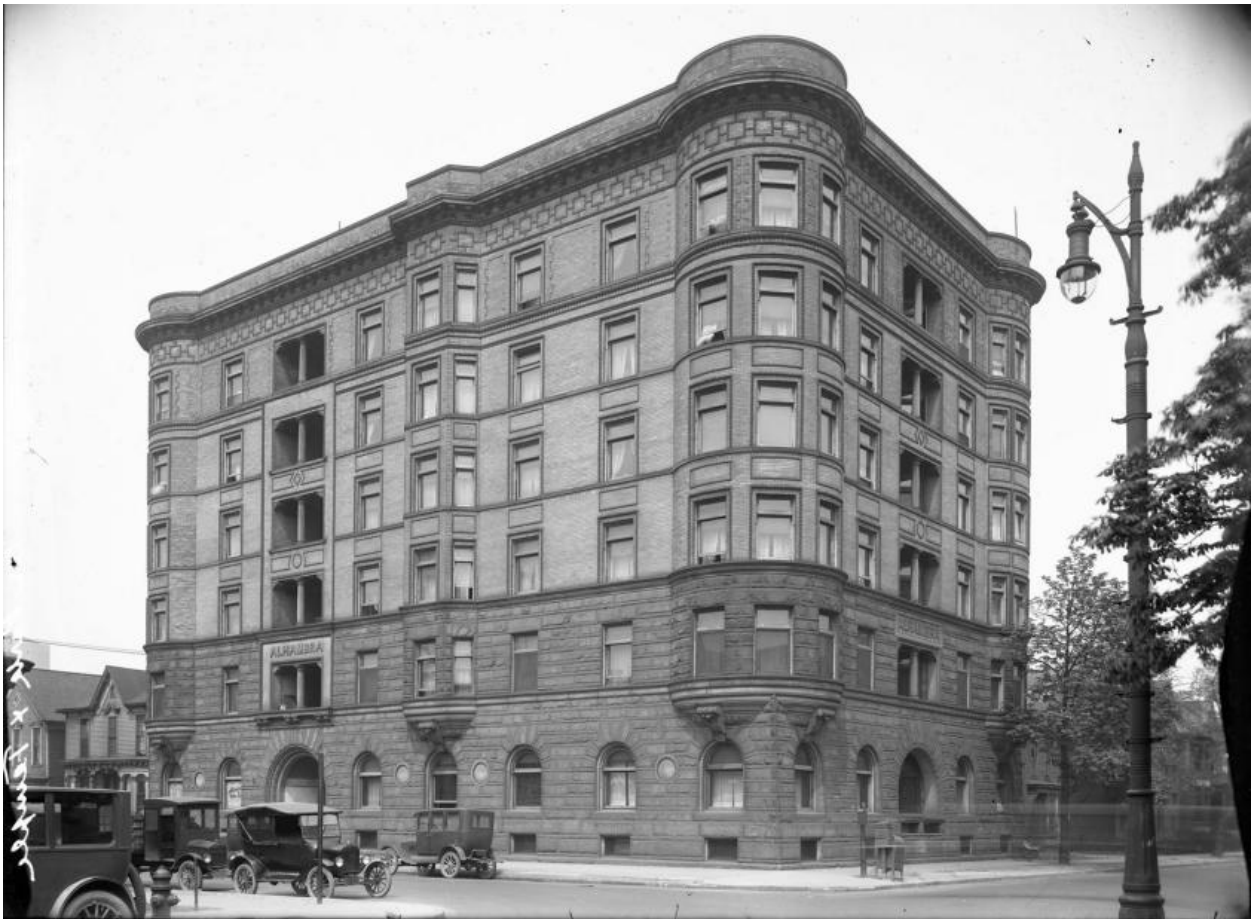
1920s photo from applicant's materials. The long, south side along Temple is shown, along with the short, east end along Park. Fire escapes were added to the Park Avenue façade by the 1970s. A building permit to add a counterbalanced fire escape system to the building was issued in 1940.

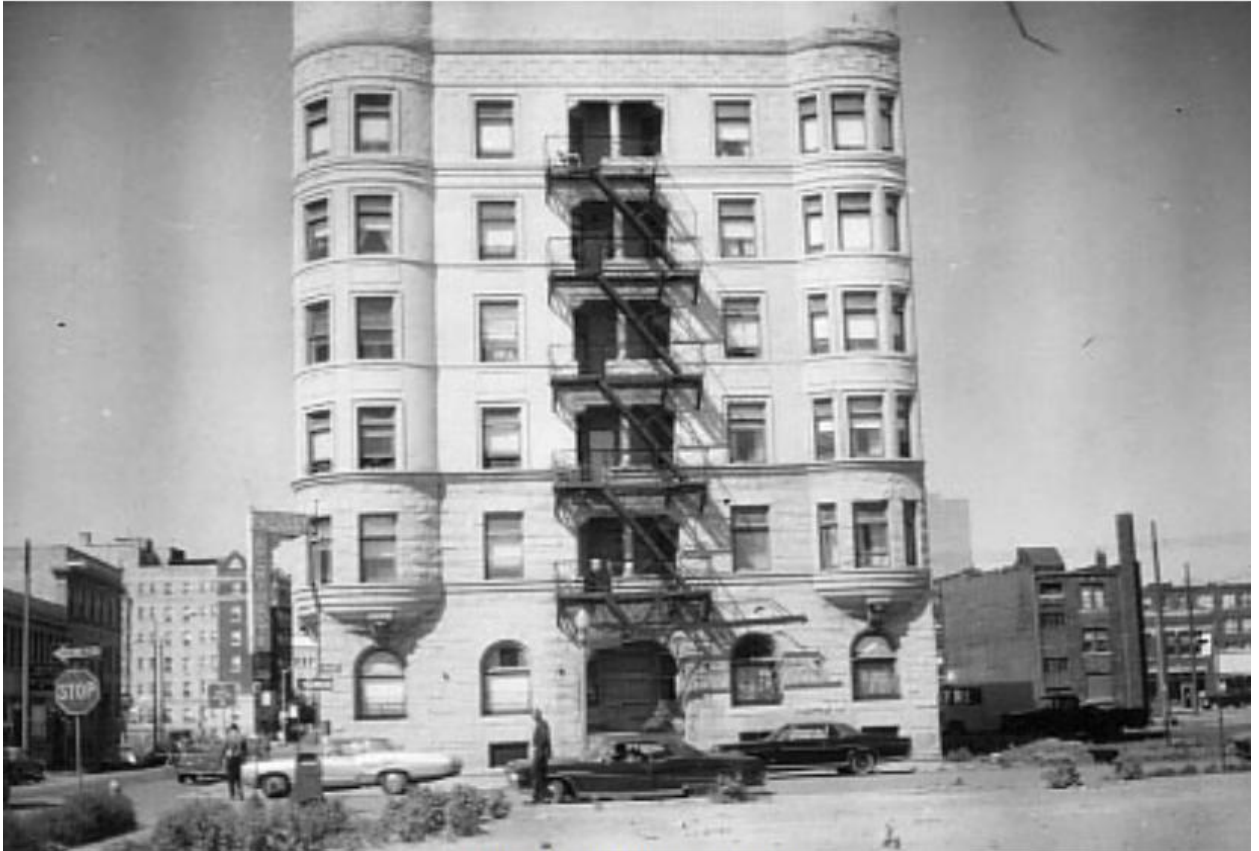
Alhambra Apartments, circa 1976

Counterbalanced stair fire escapes are pictured on the Park Avenue end (the east end) of the building, c. 1976. This counterbalanced system is presumably the same counterbalanced system permitted in 1940, and it looks very much like the counterbalanced stair system present in 2026. (Photo from applicant's materials.)

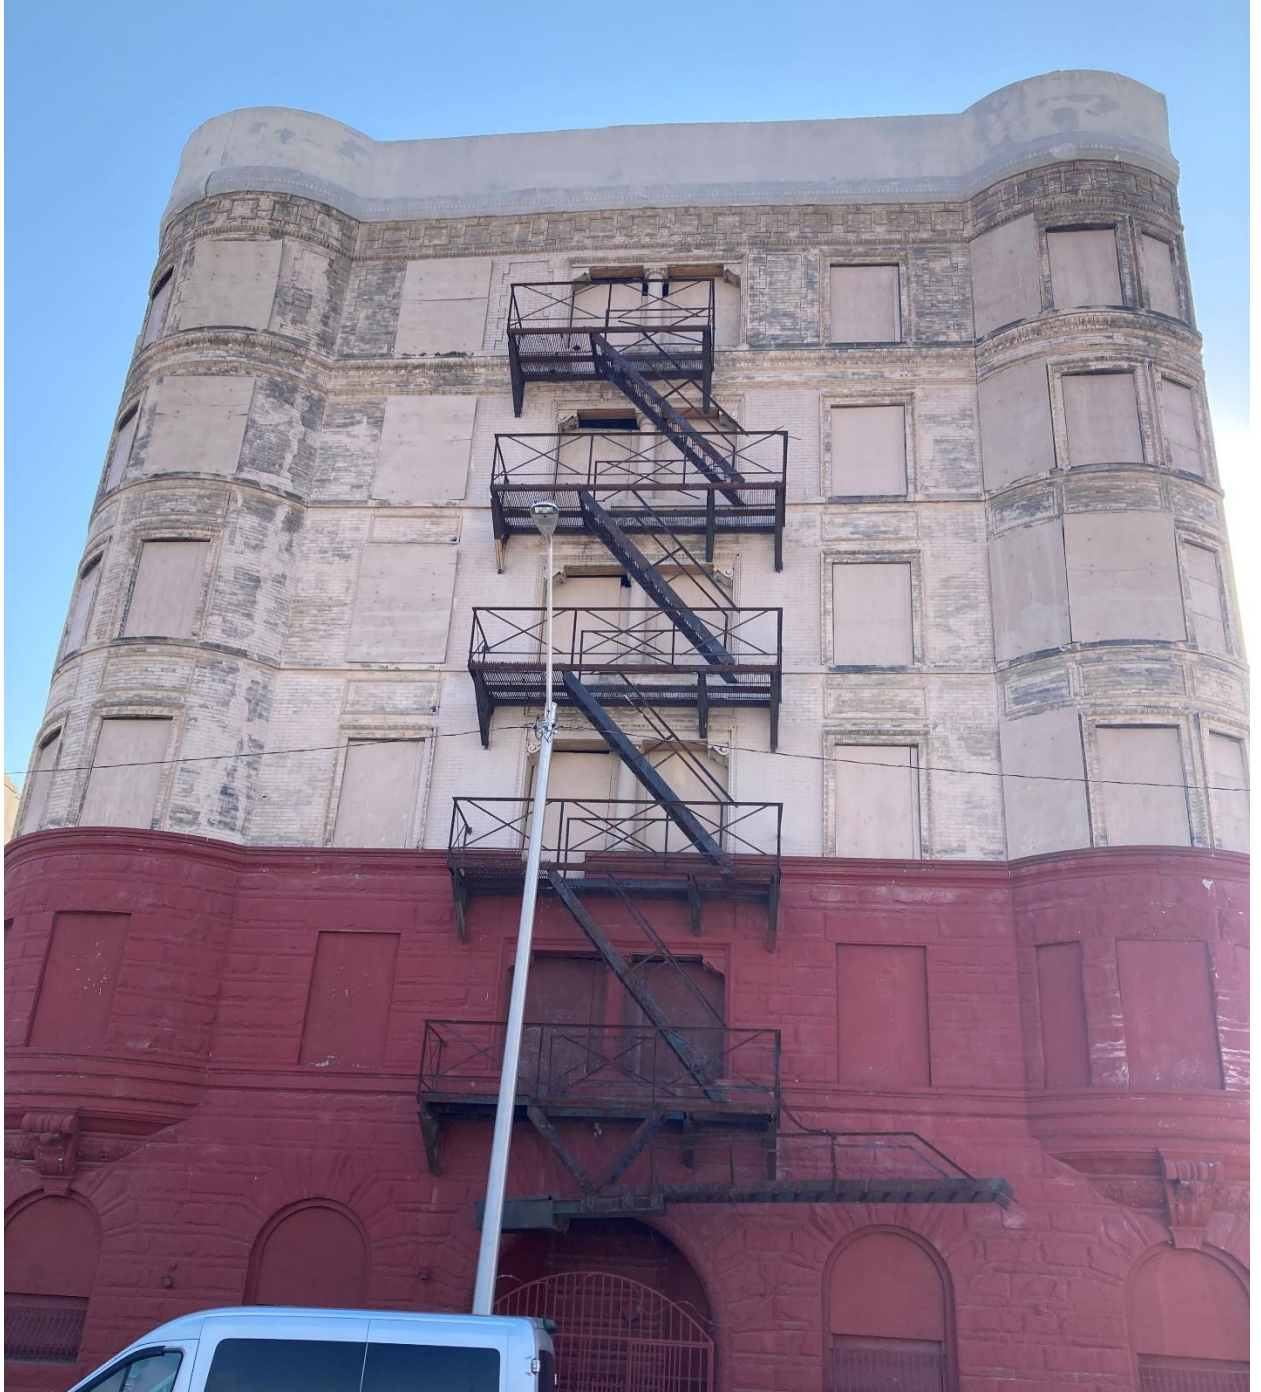
The counterbalanced fire escape stairs on the Park Avenue (east) end of the building. The “Xs” on the balcony railings are not visible in the 1970s photo, but the size of the balconies, the placement of the attachments, the angle of the stairs, the counterweight, and the railing on the lowest section of stair that would pivot to the sidewalk all match the 1970s photo. (Staff photo, April 2026)

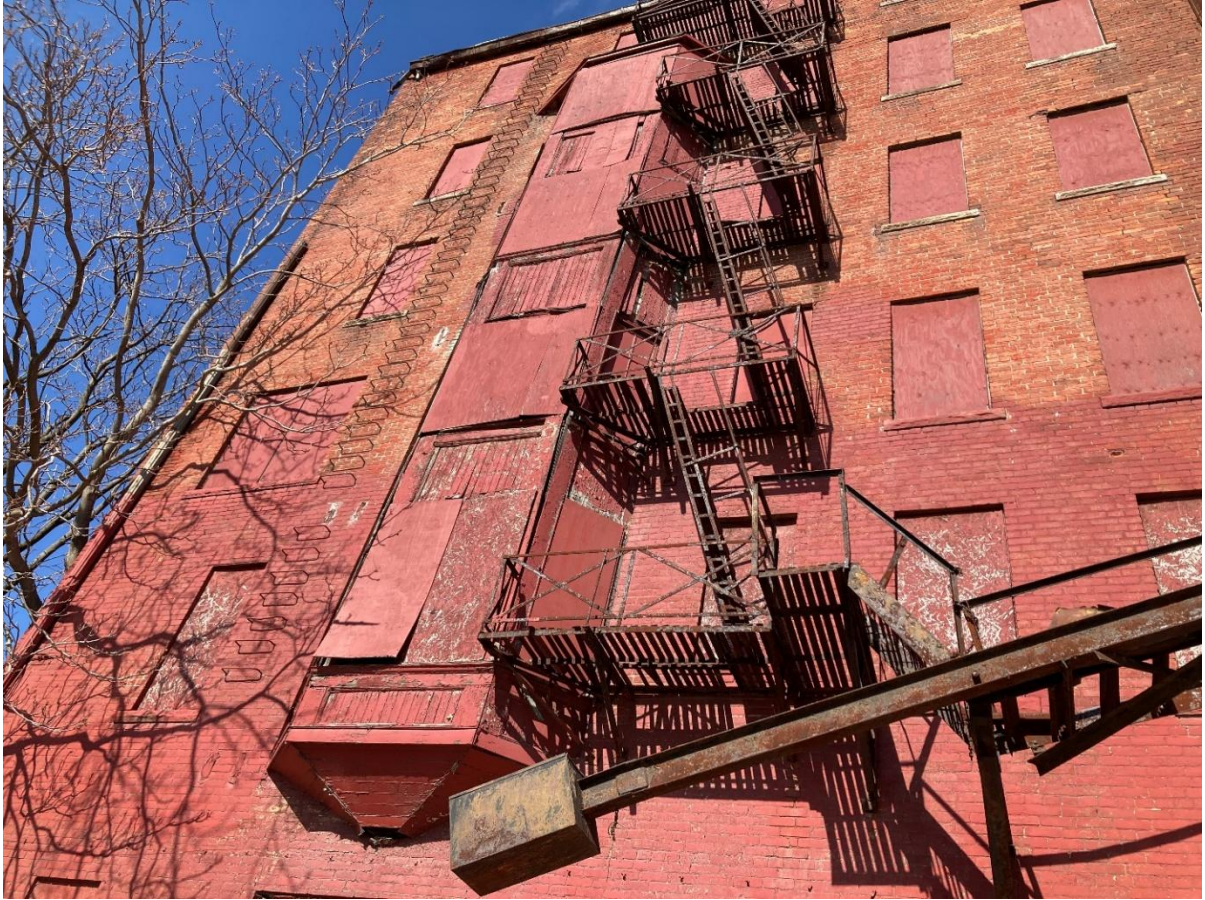
West end of the building. Staff is not certain whether these counterbalanced stair fire escapes were also installed in 1940, but the design of the balconies, railings, and counterweight are all similar to the fire escapes on the east end. The west end's stacked bay windows are also visible in this photo. (Staff photo, April 2026)

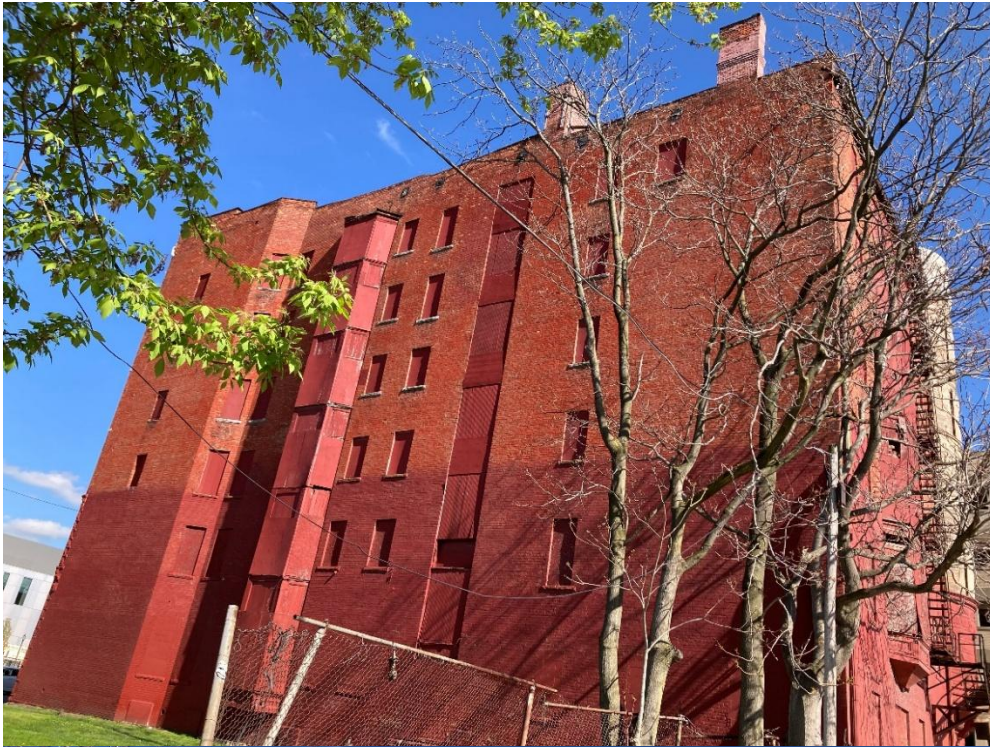
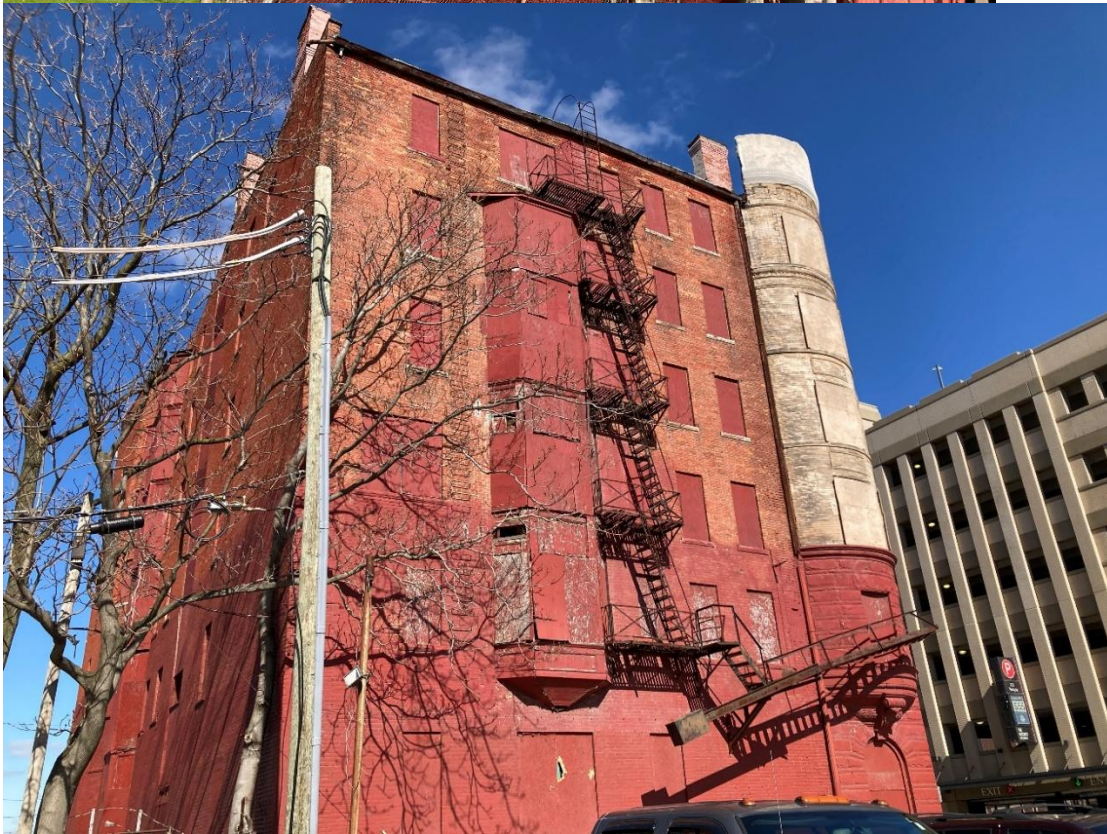
- **DOCUMENT, REMOVE, AND REBUILD BAY WINDOWS ON THE NORTH AND WEST SIDES OF THE BUILDING.** The north and west sides of the building are the secondary sides and are mainly utilitarian but both have multi-story stacked bay windows that are historic and character defining. These windows are proposed to be fully documented for rebuilding and then removed so that structural issues can be addressed. The application states that the windows will be removed and “Temporary painted plywood sheathing will be provided at the bay windows until a tenant has been identified for the building and a full renovation occurs, at which time the bays can be fit with windows, cladding, and trim to match the originals.” The applicant clarified in a conversation with staff June 3, 2026 that the new framing would be erected in the bay window shape, and this bay window structure would be roofed, sheathed, and made watertight and boarded, but the windows, siding, and trim would be added later at an undetermined date, as part of larger rehabilitation efforts.

- If the windows must be dismantled because of deterioration of the floor structure that supports the bay windows, it is staff’s opinion that the rebuilding of these character-defining features should happen immediately after the structural issues are addressed. It is staff’s opinion that removing a character-defining feature—especially a large, highly visible, significant feature—without a plan to replace it very soon after its removal could complicate the ultimate restoration of the feature, should the building be sold or the rehabilitation

The north side (top) and west end of 100 Temple. The multi-story bay windows, covered in painted plywood, are visible on both and are proposed to be removed, reframed, and boarded and then finished at a later time. (Staff photo, April 2026)

1. If the bay windows on the north and west sides must be dismantled because of deterioration of the floor structure that supports the bay windows, these bay windows must be reconstructed as per the measured drawings and photodocumentation immediately after the building's structural issues are addressed.

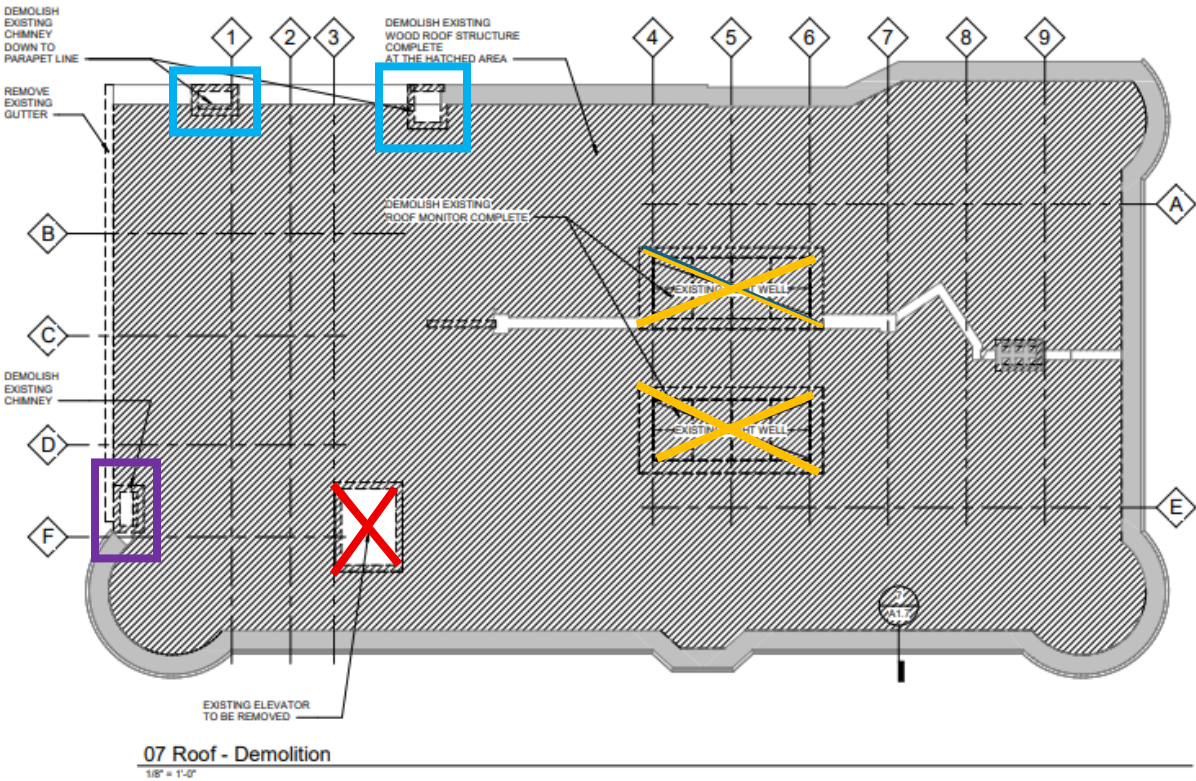
Roof plan showing demolition plans, from applicant materials. Three chimneys are shown; two are to be reduced to the parapet line (outlined in blue) and one is to be demolished (outlined in purple). The existing elevator and penthouse is to be demolished (marked with a red X), as are the existing rooftop monitors and lightwells (marked with gold Xs). The entire wood roof structure is to be demolished and all the wood floors from floors 1 through 6 are to be demolished.

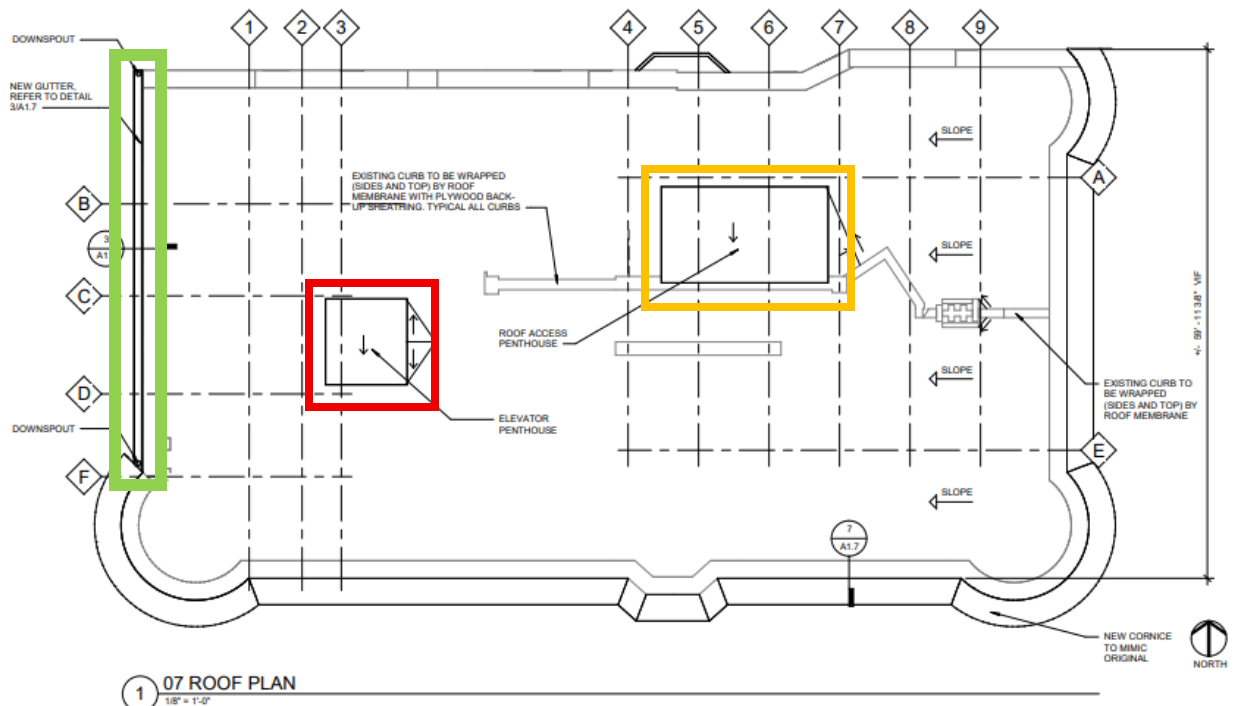
1 07 ROOF PLAN
1/8" = 1'-0"

The new roof plan from applicant materials. The proposed elevator and elevator penthouse are outlined in red and the proposed stair shaft and rooftop access penthouse is outlined in gold. The new roof will be a membrane roof and the gutter and downspouts are proposed for replacement (shown in green).

4. As per the plans and elevations included in the application, the rooftop penthouses for the new proposed elevator and rooftop access are compatible with the historic building in concept. However, more detailed drawings of the existing penthouse and the proposed penthouses, as well as the specifications for the masonry materials to be used to construct the penthouses, must be submitted for Commission review before construction begins.

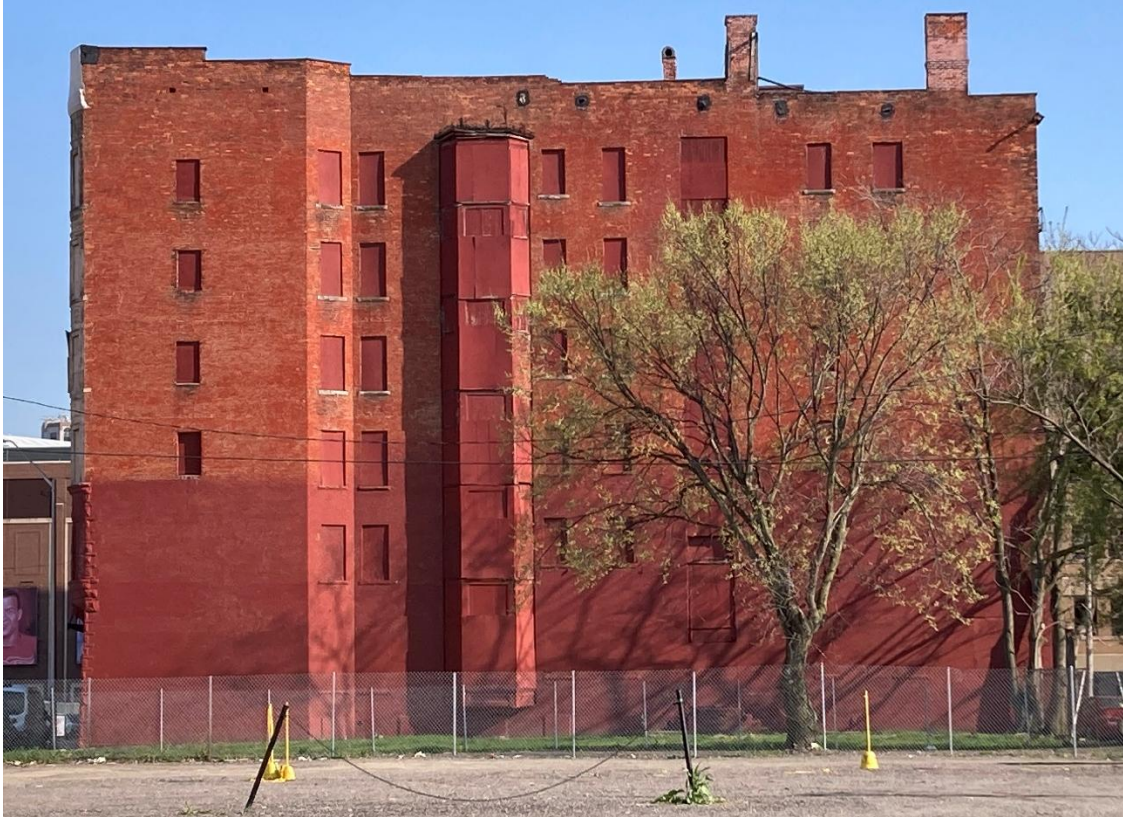
The two chimneys visible here on the north side of the building are proposed to be reduced in height to be even with the parapet height. These chimneys are not visible from the primary facades of the building, and, based on the corbeling of the chimney on the right, it appears that that chimney was originally shorter with corbeling near its original top. During the period of significance, some of this side as well as some of the building's west end would have been obscured by neighboring 2.5-story houses along Temple and Park (see the 1920s photo from the applicant's materials and included on page 2 of this report), but architectural elements above the third story would likely have been visible into the 1920s. (Staff photo, April 2026)

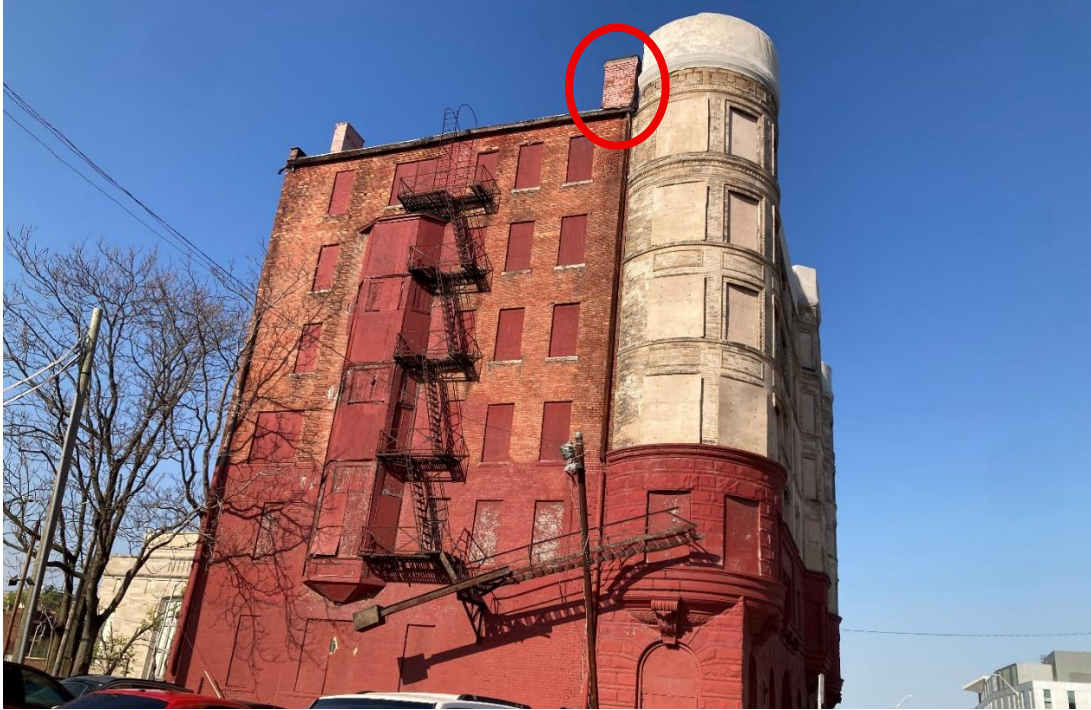
The building's west end shows a chimney near the southwest, turreted corner (staff circled it in red). This chimney is proposed to be demolished. It is not visible from the two primary facades of the building, and it is not clear to staff that this chimney was original to the building. Also on this end of the building is the gutter and portions of two downspouts; the gutter and downspouts are proposed to be replaced. (Staff photo, April 2026)

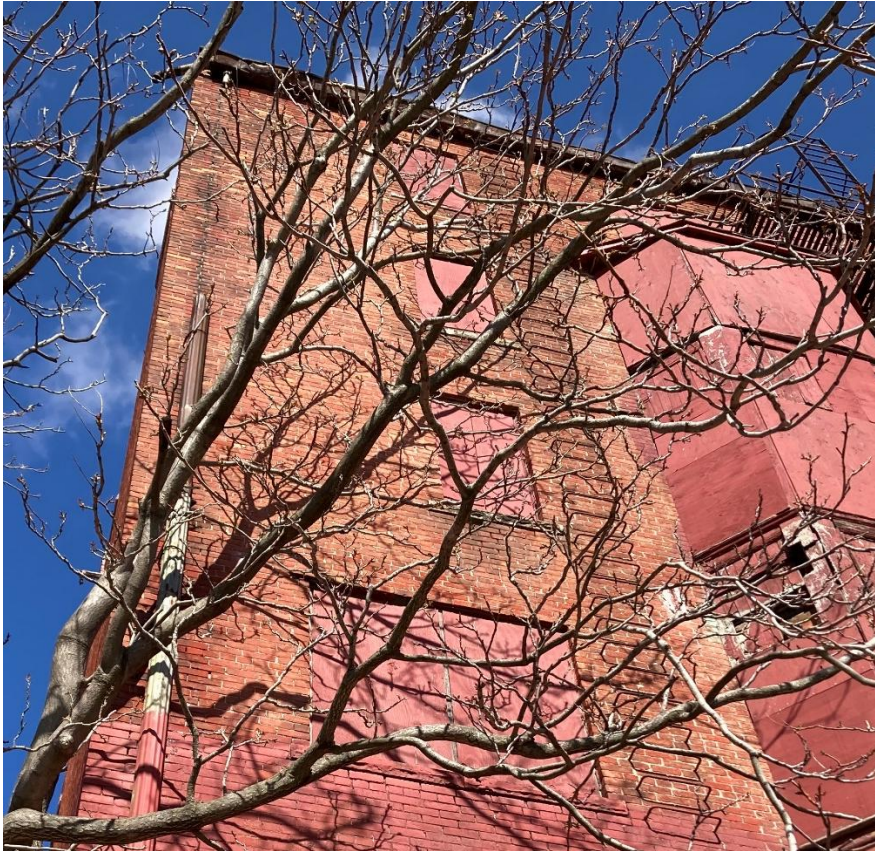
- The existing gutter is a square/box gutter, and there are two downspouts on the west end of the building. The downspouts are metal, fluted downspouts. They are historic features, but are on what was historically the rear of the building, facing the alley. Staff finds them to be historic, but not character defining. (If the downspouts were on a primary façade, staff would find them character defining.) Staff finds that the proposed box gutter is a compatible replacement, as are the proposed smooth, square downspouts.

Existing gutter and downspout on the west end of the building. The gutter looks like a simple box gutter but the downspout is round, fluted metal. This end of the building is secondary and probably would not have been seen well historically because of neighboring buildings, but currently the building stands quite alone and can be viewed from all sides. (Detail, staff photo, 2026)

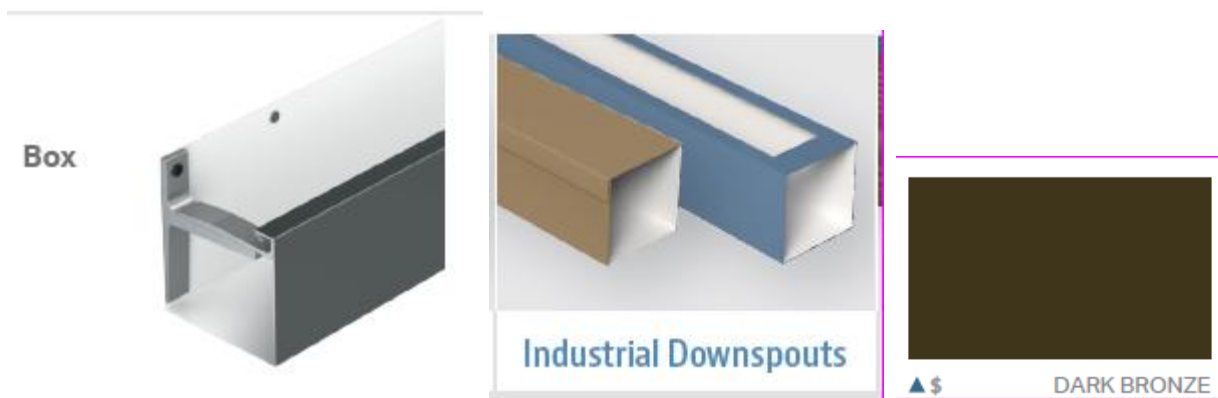
Proposed gutter and downspouts in Dark Bronze. (From application materials)
