**SR-2 – ADVISORY STAFF REPORT (08-07-2026)**

**ADDRESS:** 15014 PIEDMONT

**APPLICATION NUMBER:** HDC2026-00341

**SCOPE:** REPLACE ENTRY DOOR SYSTEM

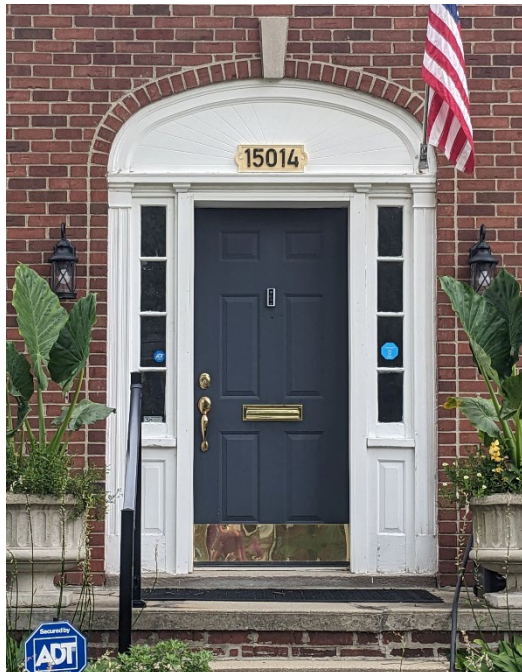
Photo taken by staff on 07/27/2026

- While the main entry door does not appear to be of historic age, the wood mullions, door surround, and sidelights are historic age and are character defining features of the house.

- The proposal, which seeks to replace the original front entry door system, does not demonstrate that the historically distinctive, character-defining wood mullions, door surround, or sidelight windows are beyond reasonable repair.

- Therefore, it is staff's opinion that the original materials shall be retained and repaired, rather than replaced.

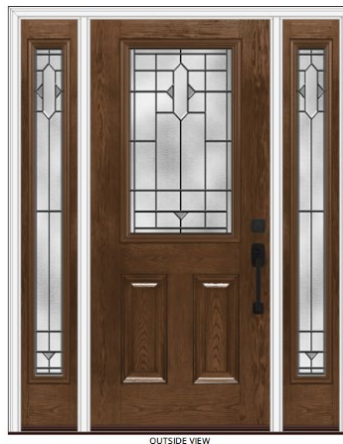
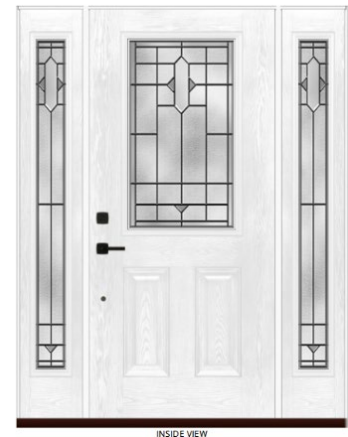
Proposed door, provided by applicant.
