**SR-2 – ADVISORY STAFF REPORT (08-07-2026)**

**ADDRESS:** 14529 GLASTONBURY

**APPLICATION NUMBER:** HDC2026-00358

**SCOPE:** REPLACE FOUR STEEL WINDOWS WITH ALUMINUM-CLAD WINDOWS

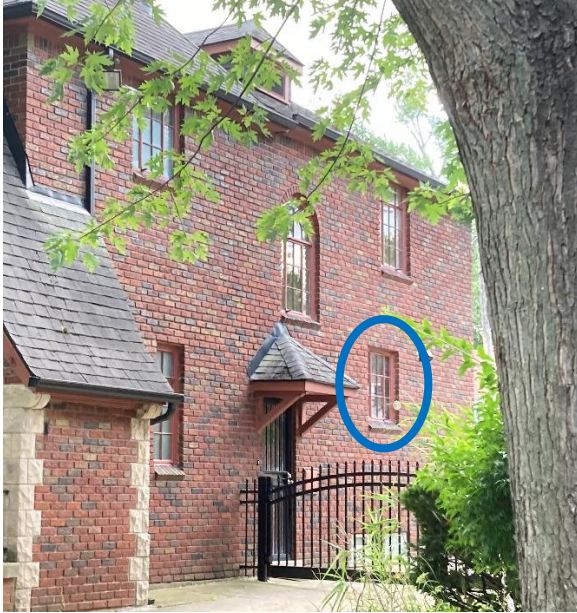
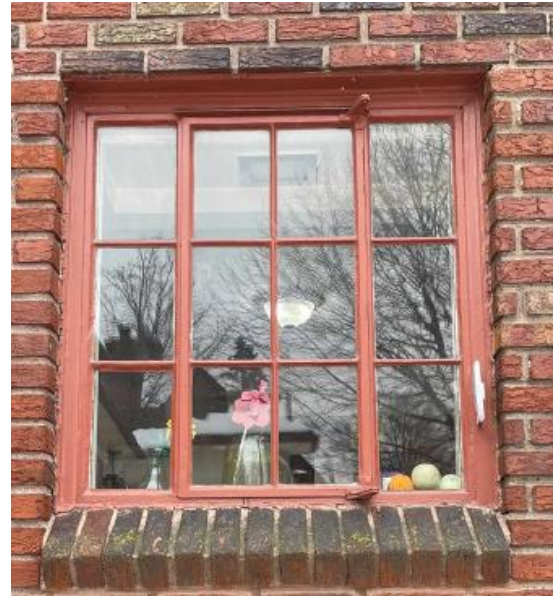
*North side of house, window over sink to be replaced has been circled in blue. (Staff photo, July 2026 on left, applicant photo on right)*

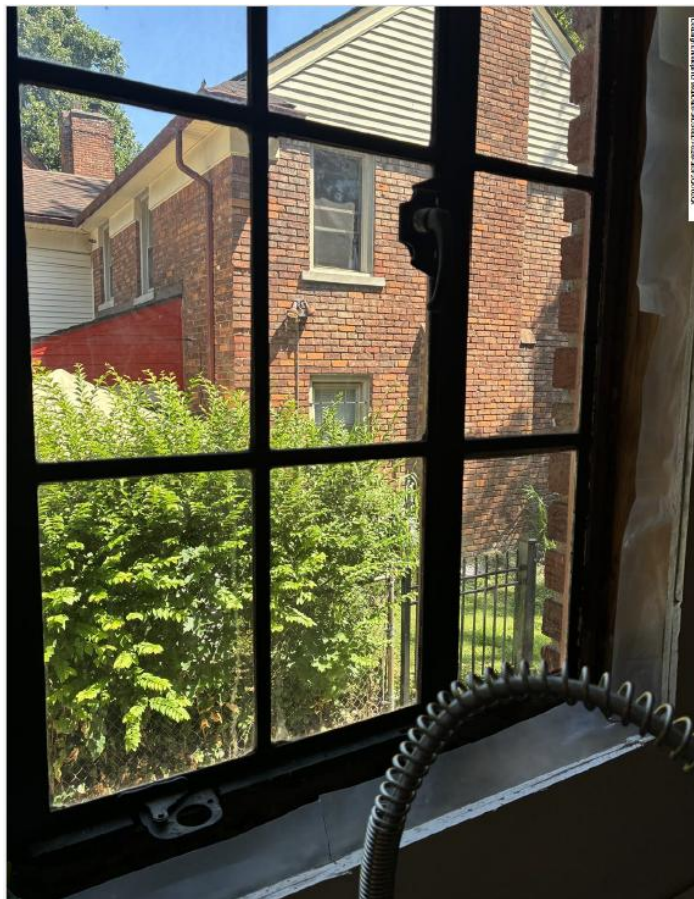
*Interior photo of the north-side kitchen window. It is a centered casement window with fixed windows surrounding it and it appears to staff that a crank may be missing. An awning window is proposed to be installed. (Applicant photo)*

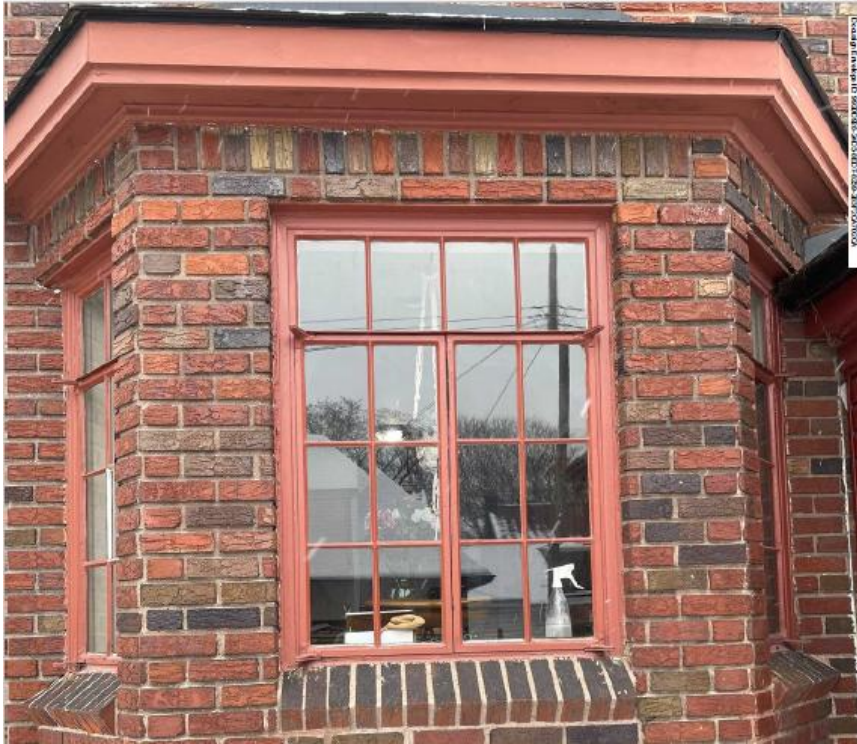
*West side (rear) bay window, applicant photo. Windows to the left and right are single casements, and the centered window is a pair of casements. The row of lights above all operating sashes is fixed. Proposed here is single casements and one central fixed window. (Applicant photo)*

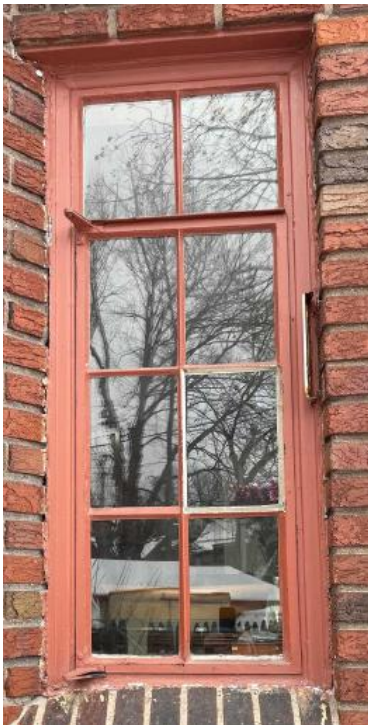
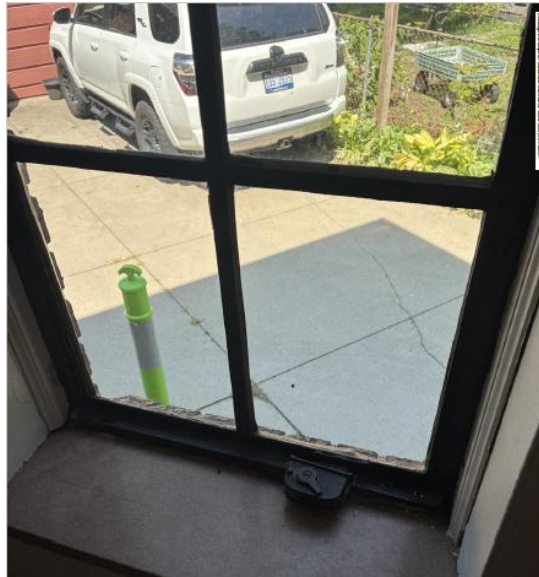
*One of the single casements, exterior and interior. Proposed are single casements. (Applicant photo)*

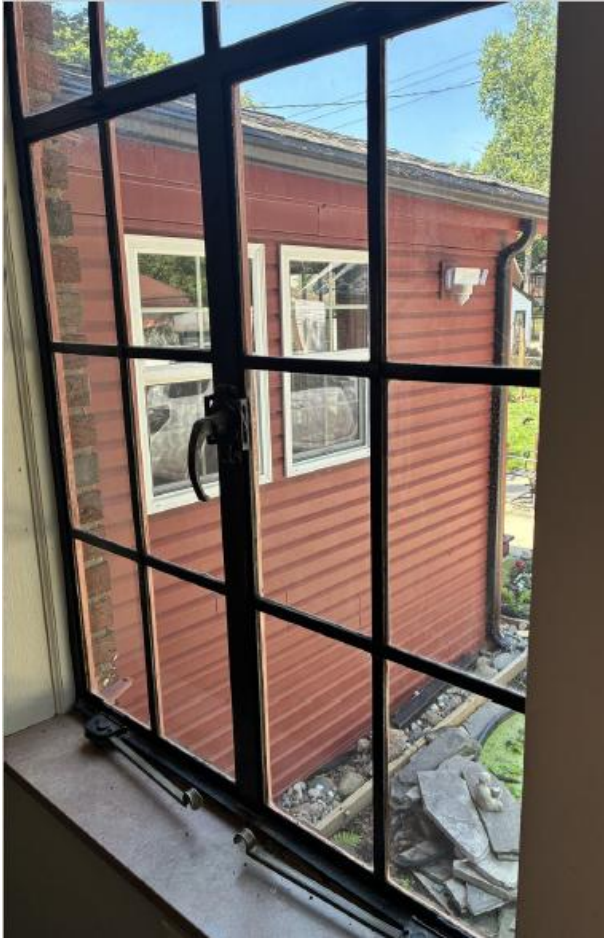
*Applicant photo of the paired casements in the bay window. Proposed is a fixed window.*
