**SR-2 – ADVISORY STAFF REPORT (08-07-2026)**

**ADDRESS:** 3418-3426 JOHN R

**APPLICATION NUMBER:** HDC2026-00381

**SCOPE:** DEMOLISH REAR WALLS, ERECT ADDITION, REHABILITATE THREE UNITS

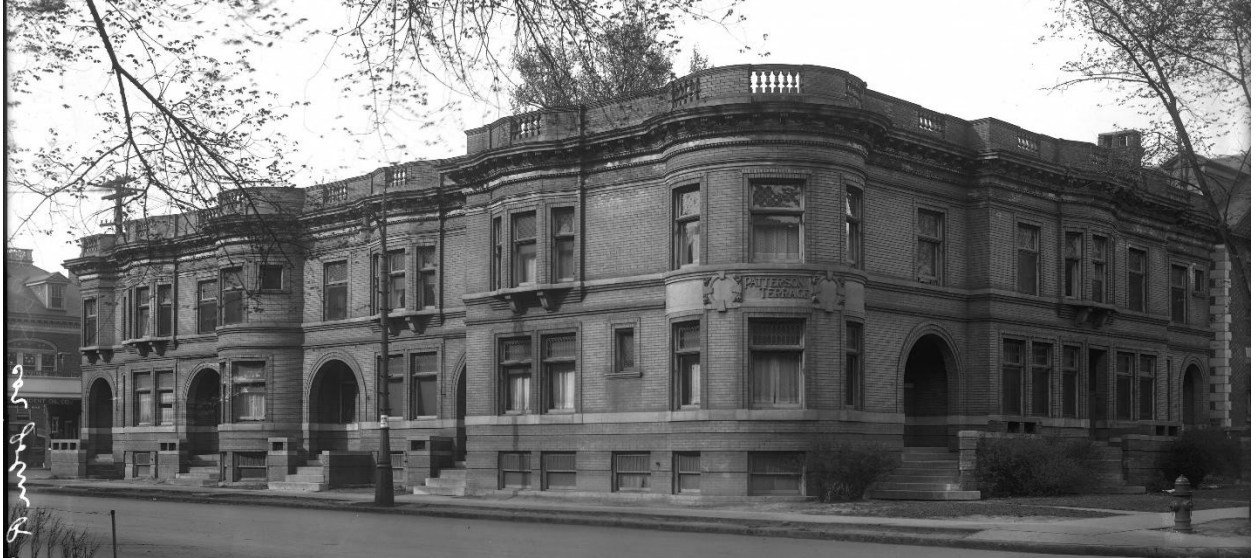
*Undated, historic photo of Patterson Terrace Apartments from PDD’s files. The John R units proposed for rehabilitation are the three units furthest to the left of this image. The fourth John R unit’s doorway (3412 John R) is barely visible here behind the Erskine units, shown to the right of the image. Visible are the building’s cornices and balustrades and cottage-style windows with the upper sashes shorter than the lower.*

- Aluminum-clad wood windows that match adjacent completed townhomes are proposed. In the historic photo from PDD's files above, it is clear that the windows along John R and Erskine were cottage-style windows with the upper sash shorter than the lower sash. The replacement windows in the rehabilitated units to the south retain this configuration. Presuming that the windows along the John R façade will retain this configuration as well, staff finds that the replacement windows meet the Standards and Guidelines for sashes that are missing or are too deteriorated to be repaired. Typically, applications for the replacement of historic windows must include documentation showing that the historic windows are beyond repair. In this case, however, the property suffered a fire and staff has previously recommended to the Commission that wood elements subjected to fire are categorically beyond repair.

2. Where historic windows had a cottage-style configuration, that configuration and those proportions will be preserved in any replacements.
3. For masonry cleaning, the cleaning agent (if any), rinse specifications, and proposed pressure will be shared with staff for review and approval. Photos of proposed replacement bricks next to historic bricks will be provided for staff review and approval. Mortar composition, color, joints, and tooling will match historic.

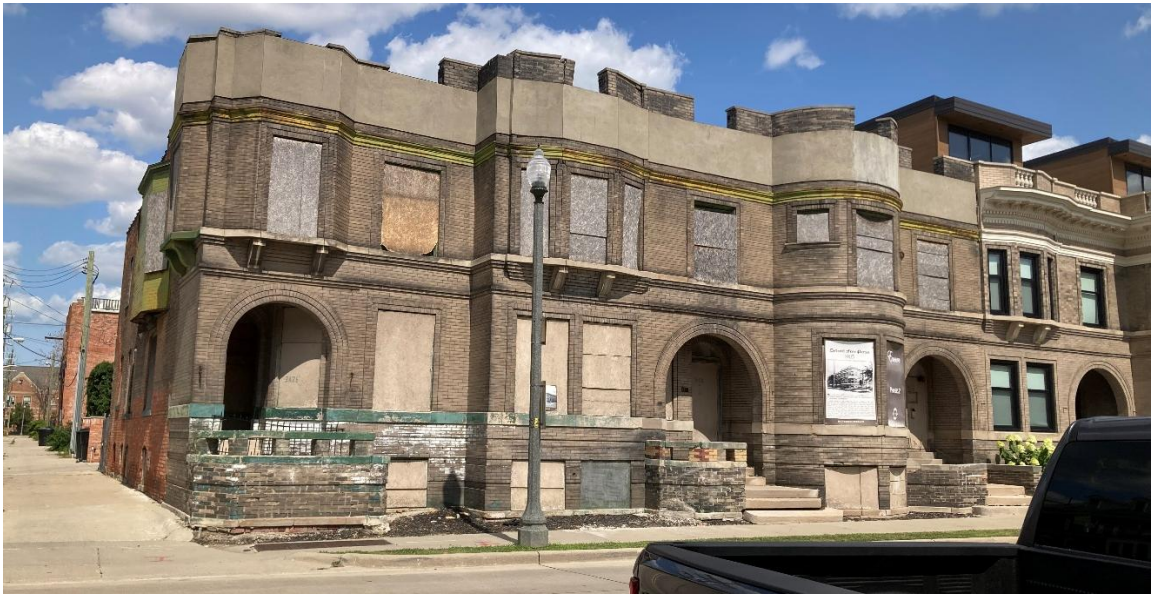
*Staff photo from July 2026 shows the three units proposed for rehabilitation—3426 John R is to the far left, along the alley, 3422 is in the center of the three unfinished units, and 3418 has the sign in its rounded bay window. Completed 3412 John R is visible on the far right of the photo.*

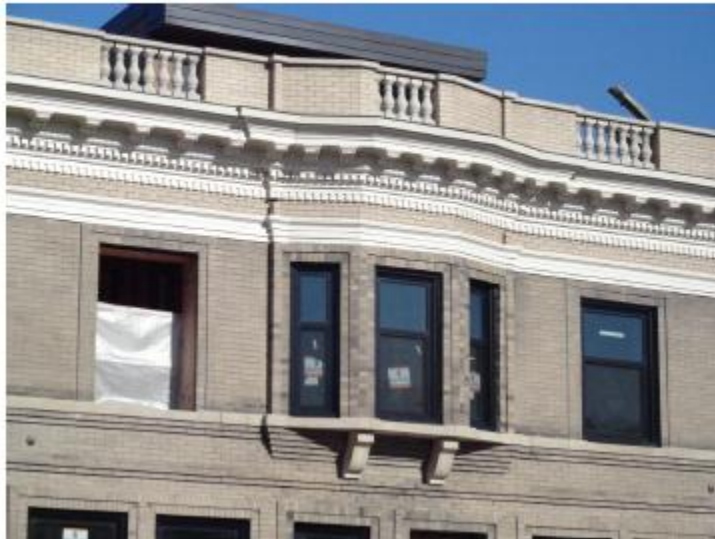
- Restoration of missing historic features is proposed, including restoration of the missing balustrade and cornice. Staff finds that this proposed work meets the Secretary of the Interior's Standards for Rehabilitation ("the Standards") and the Guidelines for Rehabilitating Historic Buildings ("the Guidelines"). Most relevant is Standard 6, which states, "Replacement of missing features shall be substantiated by documentary, physical, or

Install missing limestone balustrades and  
parapet cap match in kind with phase 1  
Rebuild brick parapet cap with matching brick

*Image and text from the application materials. Shown are the restored parapets, balustrades, and cornices from the earlier, completed development phase. The proposed will match these.*

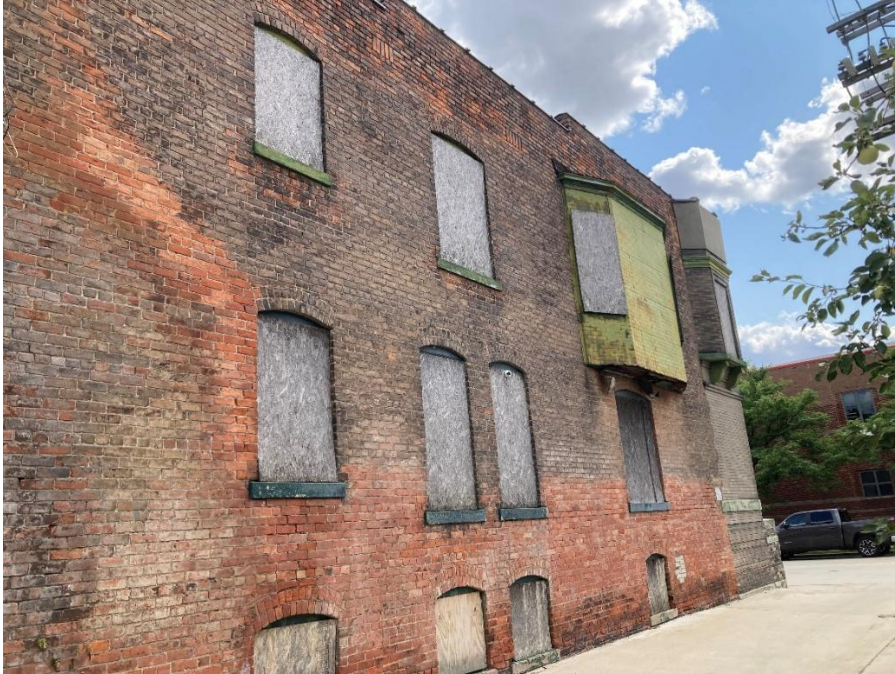
- The north wall, along the alley, is proposed to receive rectangular windows in the arched openings, as the east wall of the completed units along Erskine did. There are dark-painted boards infilling the rounded openings above the rectangular window sashes. Staff does not find that this treatment diminishes the historic character of this building on these secondary, more utilitarian elevations.

*Staff photo, July 2026 shows the north wall, along the alley. These arched openings are to receive rectangular windows, and some of these openings are proposed to be reduced. Additionally, the bay window shown on the red brick portion of the wall is proposed for removal.*

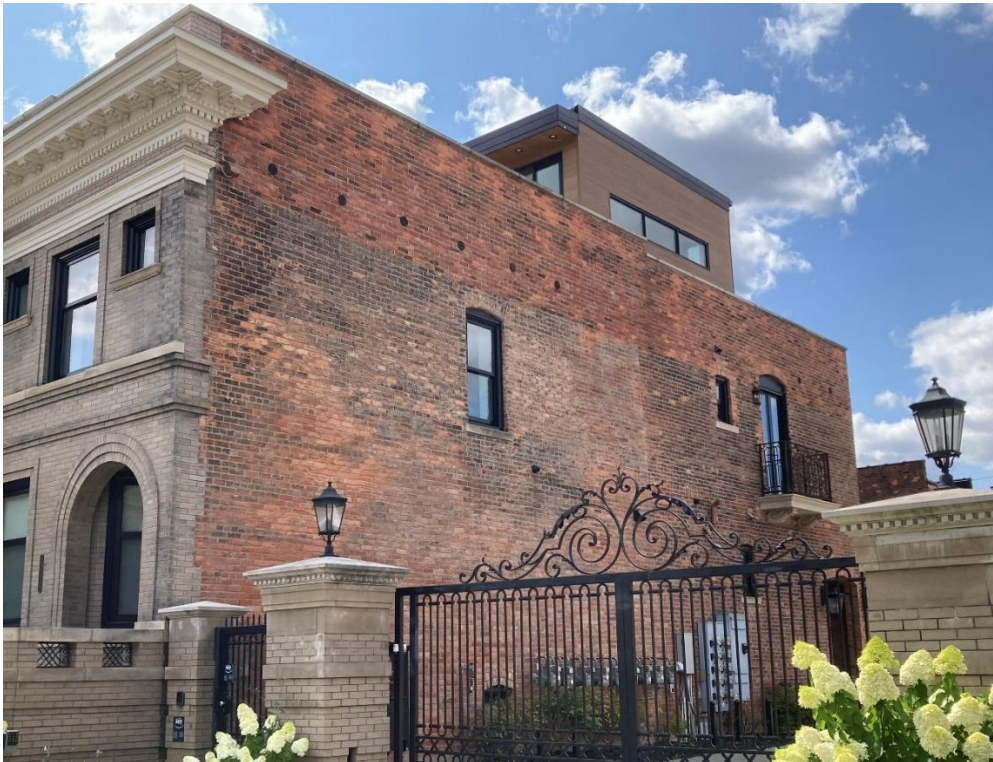
*Staff photo, July 2026, shows replaced windows and doors that are rectangular units in rounded openings on the east side of the rehabilitated units on Erskine, south of the scope area. On these secondary, red-brick elevations, staff does not find that these rectangular units in rounded openings diminish the building's historic character.*

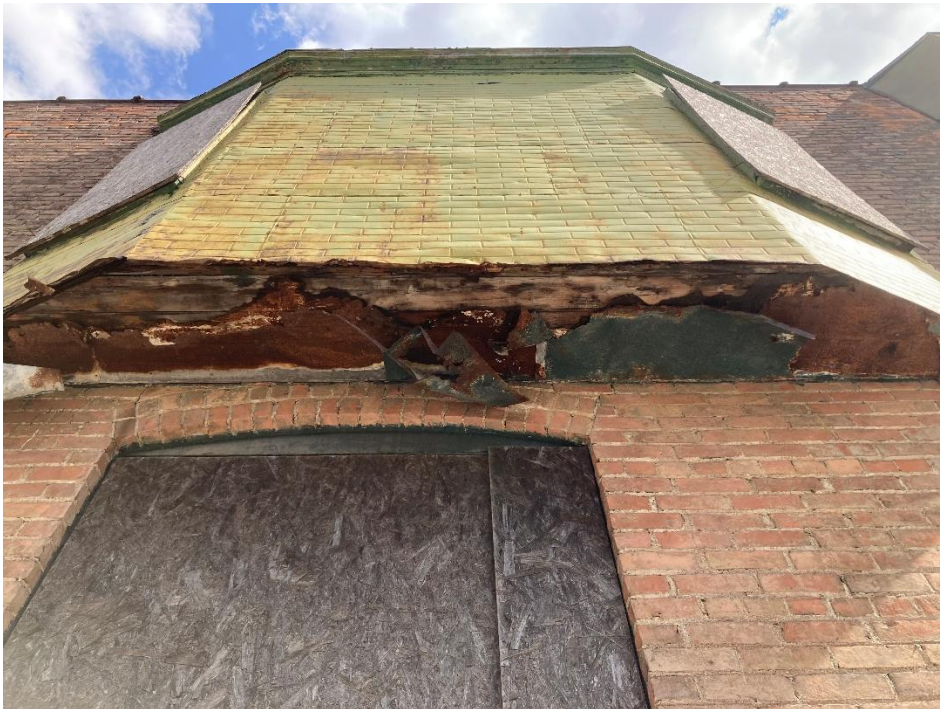
- Also proposed on the north wall along the alley is to: (1) remove the bay window at the second floor to replace it with three individual windows, not in a bay; (2) infill brick around where the bay window had been; and (3) to infill one basement window opening, to partially infill three first-floor window openings to reduce their heights, and to partially infill two second-floor windows to reduce their heights. Staff finds that the building's red-brick walls are secondary instead of primary. The north wall, along the alley, is quite visible from further north on John R, but staff still considers the wall to be secondary. The Guidelines state that it is not recommended to change the number or size "of windows on primary or highly-visible elevations which will alter the historic character of the building." Staff acknowledges that the north wall is highly visible, but, presuming that salvaged brick from the proposed demolition or matching brick can be used for the infill, staff does not find that the proposed alterations will alter the historic character of the building.

*The bay window on the north wall, along the alley, (from below) that is proposed for removal. It is currently covered in metal siding that looks like brick. (Staff photo, July 2026)*

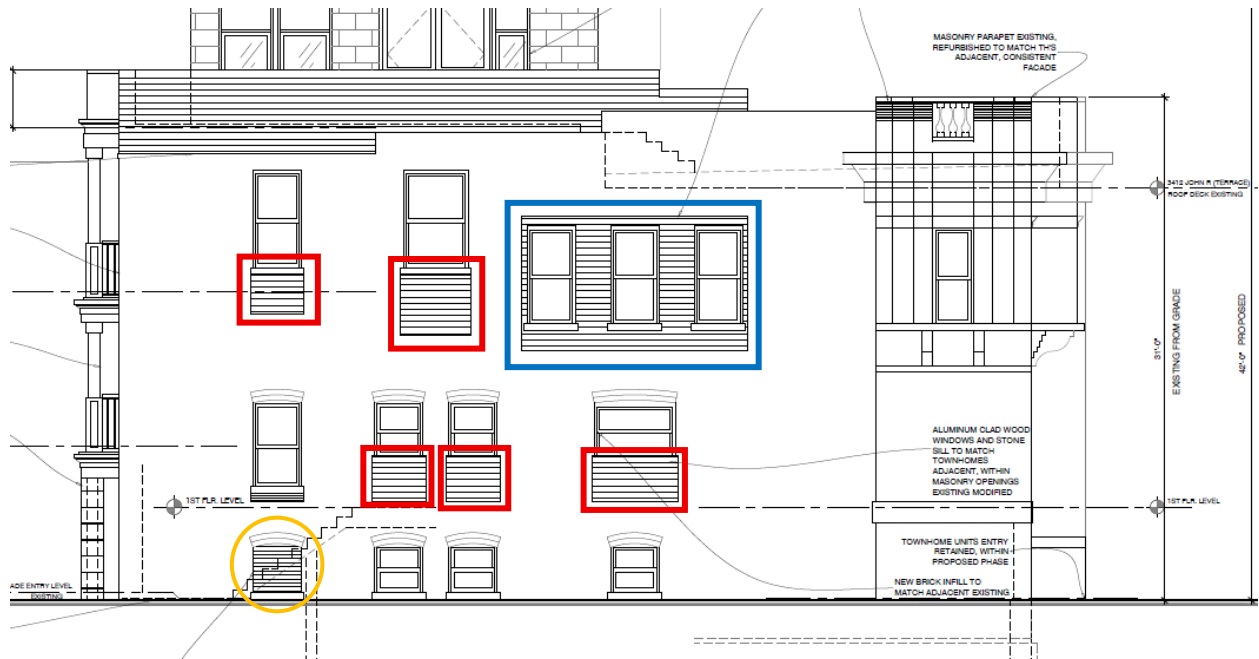
*The proposed north wall alterations, from applicant's materials. Five windows on the second and first floors above the basement are proposed to be reduced in height and infilled with bricks (red outlines), and the bay window is proposed to be removed and infilled with bricks around three replacement windows not in a bay (blue outline). A basement window is proposed to be infilled as well (outlined in yellow). (From the application materials with staff mark-ups.)*

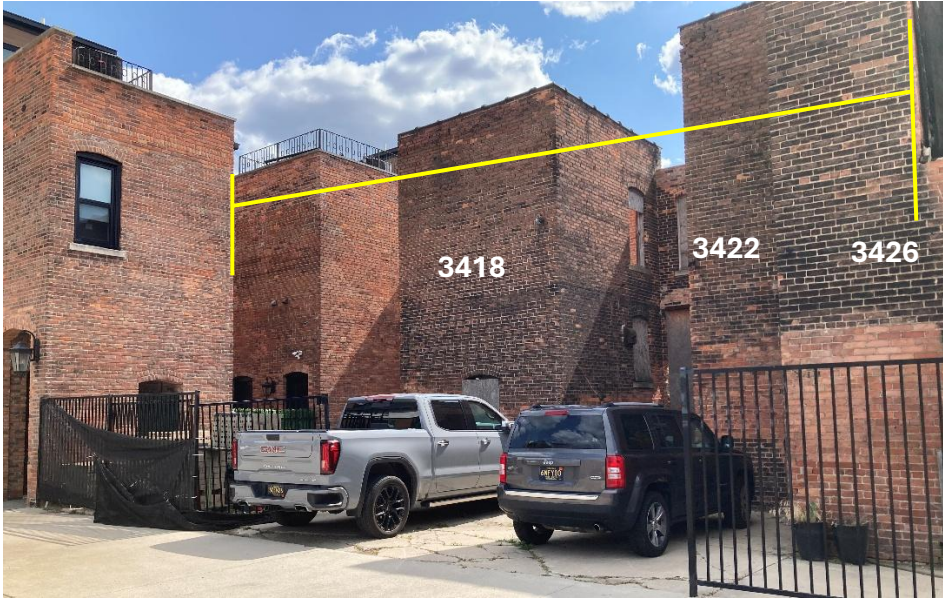
- Also proposed is to demolish the rear and some side walls of 3422 and 3418 John R and to demolish some of the rear wall of 3426 John R as well, all behind the historic façade along John R. This proposed demolition would make room for a large rear addition.

*Existing conditions, rear (east ends) of the units from the alley (from the northeast). The units to the left with metal guardrails around the roofs have been rehabilitated. Discrete volumes for each unit and the inconsistently-sized footprints of each unit are visible. Proposed is to remove the rear and side walls of 3418 and 3422 (and some of 3426) visible here and create one large volume that would span the approximate space between the two yellow vertical lines. The new rear addition would be quite visible from the alley. (Staff photo, July 2026, with staff labels)*

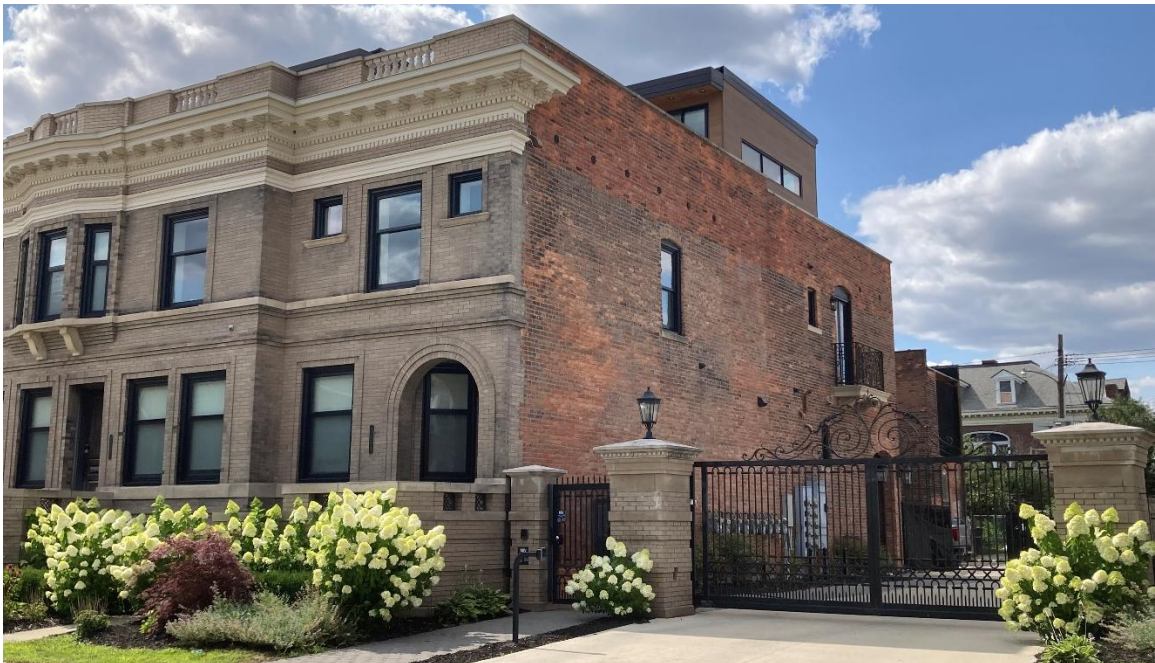
*Existing conditions, east side of the easternmost rehabilitated unit on Erskine, from the southeast, on Erskine. Visible is the balcony and, to the north at the alley end of the site, is the east end of 3426 John R with a large black screen at the third floor. The space between this Erskine unit with the balcony and the east end of 3426 John R would be filled with the large proposed new addition. (Staff photo, July 2026)*

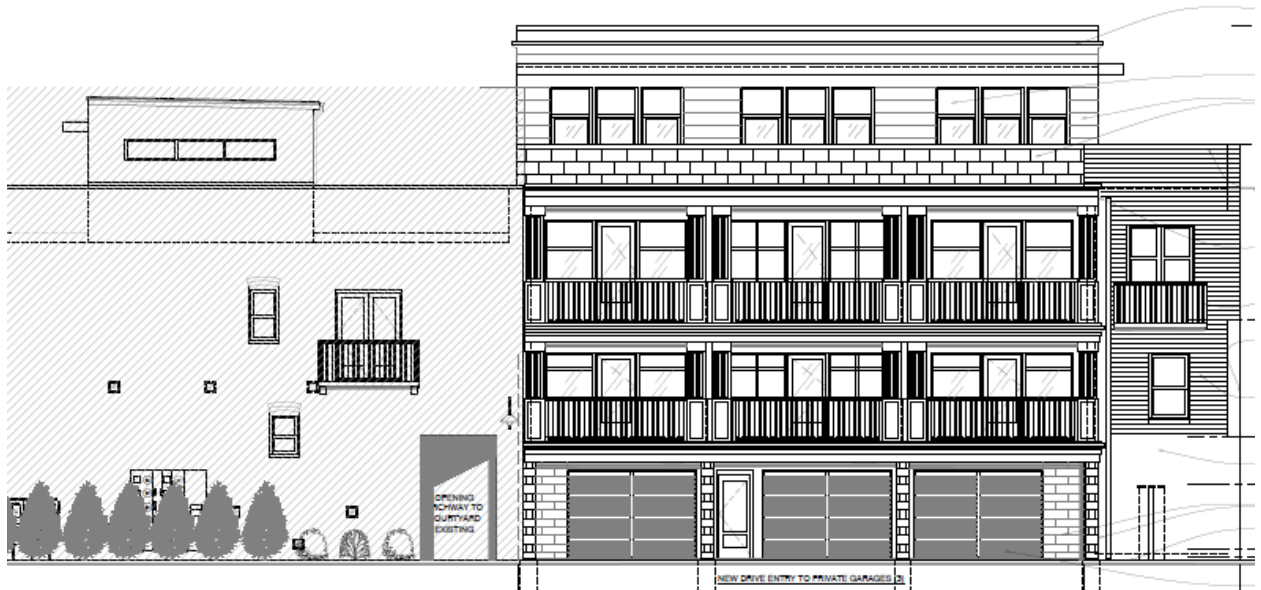
*Proposed addition, east elevation, from the application materials. The east side of the Erskine-facing units with the balcony and shrubs is to the left and the alley and the retained brick wall of 3426 are to the far right. Between the two historic-age red brick walls is the new proposed four-story addition. The addition has white limestone cladding at the fourth floor, aluminum windows and doors in Dark Bronze and polyurethane posts at the third- and second-floor balconies, and dark gray glass-and-black garage doors and limestone-clad piers at the ground level.*

- The proposed rear addition is not only larger and taller than the historic-age, discrete, rear volumes are, but it is also very ornamental. The proposed limestone cladding, fluted and recessed post wraps, and ornate balcony railings all above the patterned garage doors, combine for a large and highly decorated rear addition.

It is staff’s opinion that the proposed new addition is on a secondary elevation, but that it is slightly too tall for the historic building, and that the materials, architectural features, and color are not compatible. There are some limestone-clad buildings on the blocks surrounding the subject building, but the stone is more tan/beige than the proposed product appears (it appears to staff as a fairly bright white), and staff did not observe any similar product that is applied stone tiles. Because this is a rear elevation, it is staff’s opinion that the balcony post designs should be simpler and a non-plastic product (it will be viewed close-up, and even from the ground, the viewer won’t be far away), and that the balcony railings should be simpler. These modifications to the design could help ensure that the rear addition is secondary and subordinate to the historic building. Staff does not find that the proposed rooftop addition overwhelms the building, but the addition does seem tall to staff. The reduction of some height and detailing at the parapet line could help the addition look more in scale with the rear of the building and less visible from the front.

1. The applicant will propose an alternate cladding material and color to more closely reflect the district's Elements of Design and the nearby context in terms of architectural features, materials, and color; the applicant will revise the detailing at the parapet line of the rooftop addition to de-emphasize the addition's height; the applicant will propose simpler balcony posts (in a material other than polyurethane); and the applicant will propose a simpler balcony guardrail, all for staff review and approval, with the goal that the rear addition/rooftop addition will be simplified and more deferential to the historic primary facades.

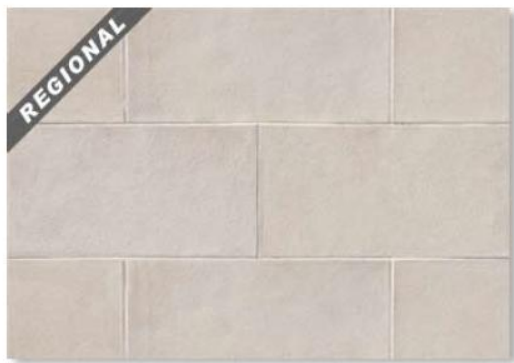
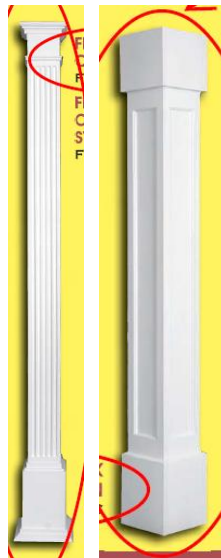
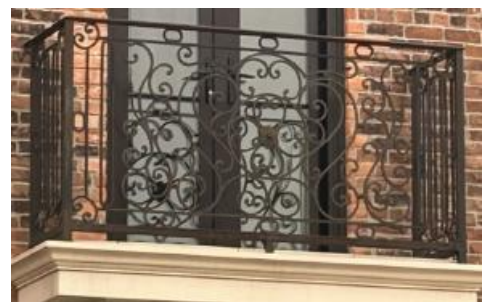
*Smooth limestone veneer cladding in French White for garage piers and base and for all sides of the proposed new rooftop addition (left). Polyurethane post covers for the second- and third-floor balconies: proposed is the fluted post cover (center left) to sit atop the recessed box pedestal (center right). Balcony railings on second- and third-floor balconies are proposed to be modeled after this existing balcony railing.*

district is common brick; other forms of brick, stone and wood trim are common; wood is used as a structural material only east of Brush. Some later buildings have stucco wall surfaces.” The building in question’s addition proposes stone veneer tiles that look similar to blocks. Staff did observe some smooth stone cladding in tan or beige in the neighborhood surrounding the subject property, but staff did not observe stone that looked like blocks or tile, and did not observe any that was quite bright white.

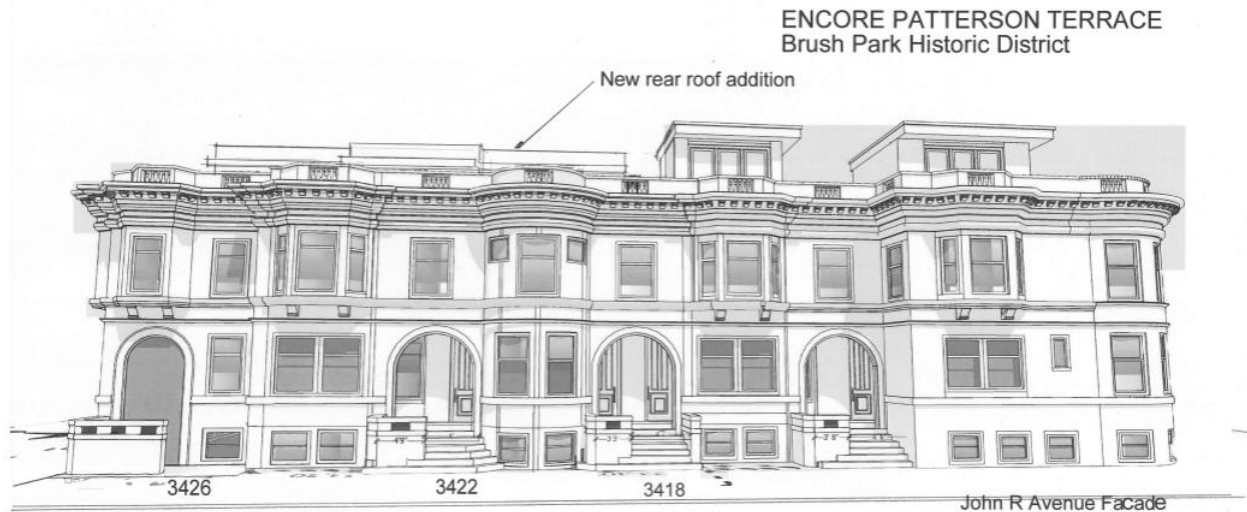
- Staff notes that the rooftop additions that were approved on this building by the Historic District Commission in 2017 in an earlier project phase were smaller and individual additions, as opposed to the combined, three-unit rooftop addition proposed in this application. Staff also notes that the larger addition currently being proposed would be located much further back on the roof than some rooftop additions now in place, and, as a result, would not be as visible from John R as the rooftop additions at 3412 John R and at the corner of John R and Erskine, for example. On August 4, the applicant provided a drawing of the proposed addition in place as viewed from John R and the addition was visible but not as visible as 3412 John R, for example. Staff posted the drawing to the website and copied it below:

*Applicant's drawing of completed west façade of 3418-3426 John R. The proposed rooftop addition is just visible.*
