**SR-2 – ADVISORY STAFF REPORT (09-04-2026)**

**ADDRESS:** 1459 ATKINSON

**APPLICATION NUMBER:** HDC2026-00439

**SCOPE:** REPLACE WOOD WINDOWS WITH ALUMINUM CLAD WOOD WINDOWS,  
REPLACE SIDING AT GABLE ENDS AND DORMER WALLS

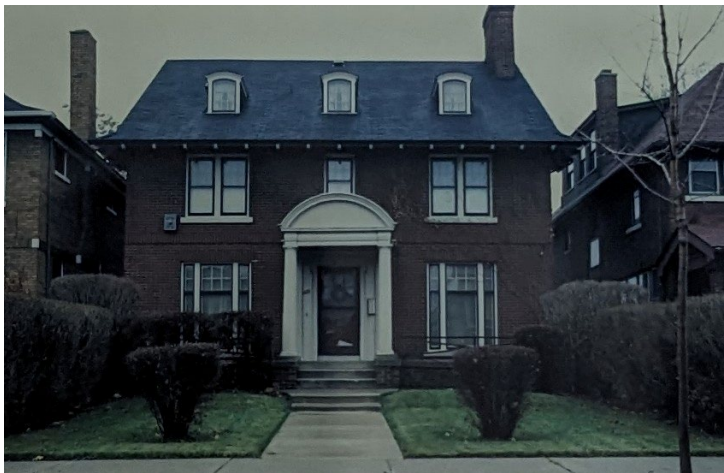
ABOVE: Building Permit Card  
LEFT: Designation Photo 1984

- Atkinson Avenue was designated as a historic district in 1984.
- The house, which was erected in 1916, appears to have retained a majority of its historic-age wood windows.

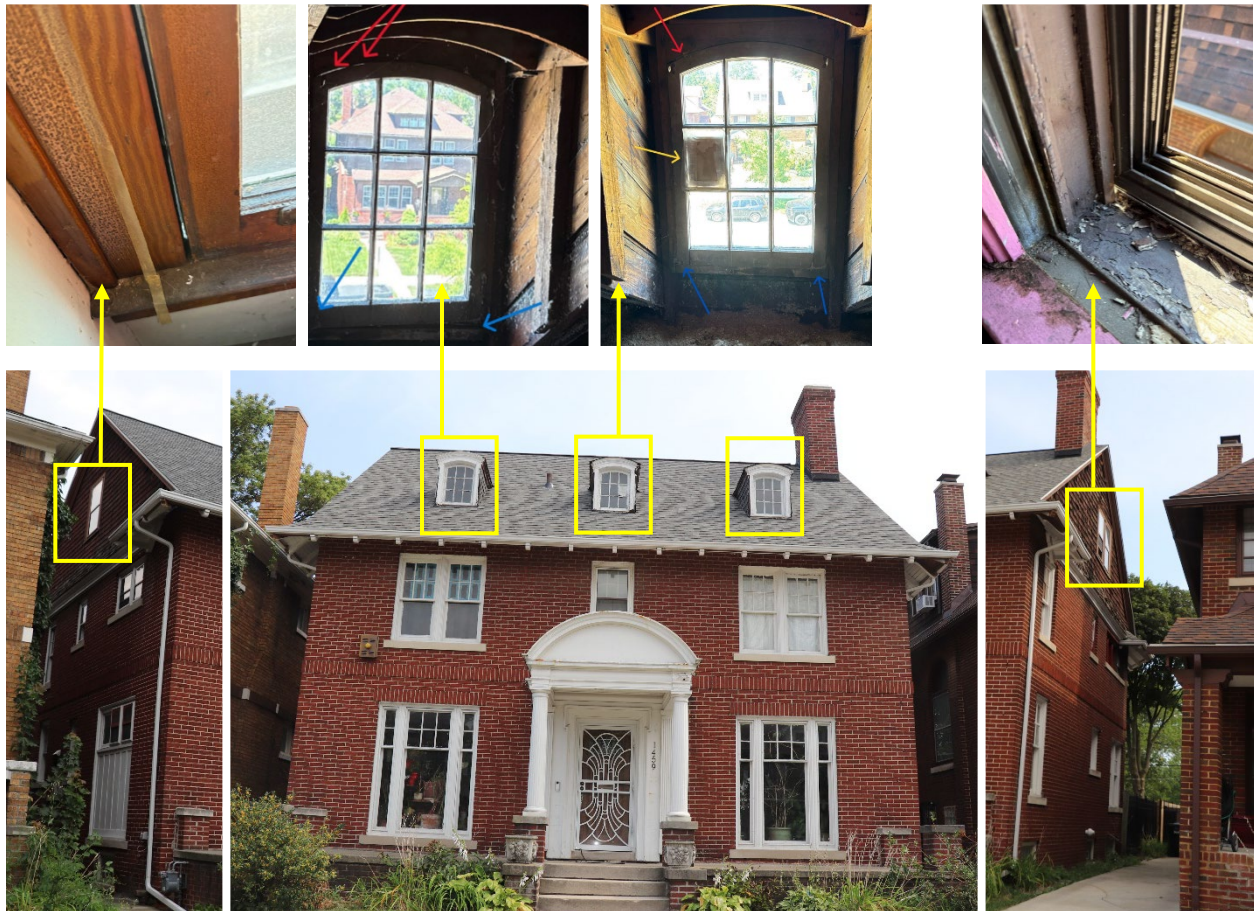
*The above exterior photos were taken by staff on 08/26/2026. The windows proposed for replacement are highlighted in yellow. Interior photos show the windows current condition, provided by applicant*

- The historic-age wood windows are distinctive, character-defining features that add important detail and texture to the building's expression. As the Elements of Design (Sec. 21-2-139) mention "wooden functional trim and window frames and sash are common, and wood is used in many examples as decorative trim as well"

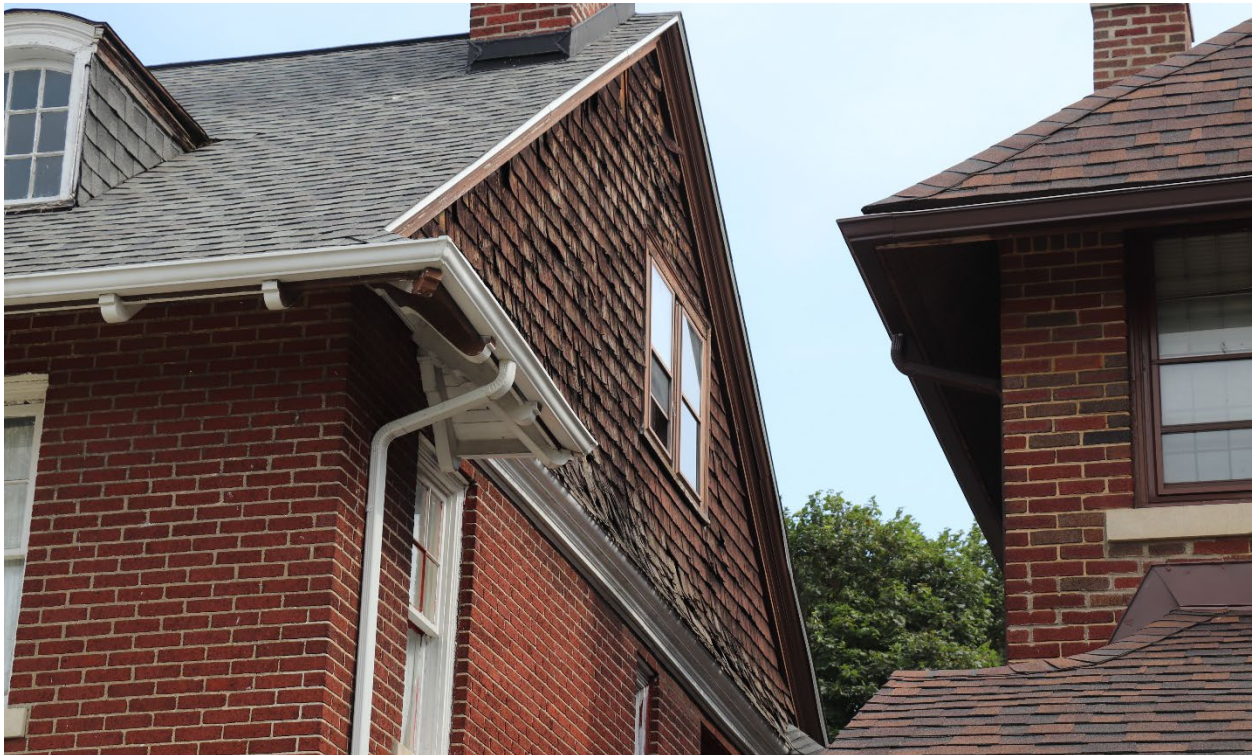
*Photo taken by staff on 08/26/2026*

- Staff has no objection to the \*in-kind replacement of cedar shake siding at the gable ends.
  - *\*“In-kind” is defined as faithfully reproducing original, historic, or documented character-defining features, elements, and assemblies with respect to design, color, finish, texture, craftsmanship, materials, relationship to other elements or spaces, and other visual qualities.*

- Staff has no objection to the removal of asphalt shingles on the dormer walls, which will be replaced with the cedar shake siding.
  - The permit for the replacement of the asphalt shingle roof, dated October 25, 2005, specifies “Remove all roofing including rear flat and **dormer walls**”

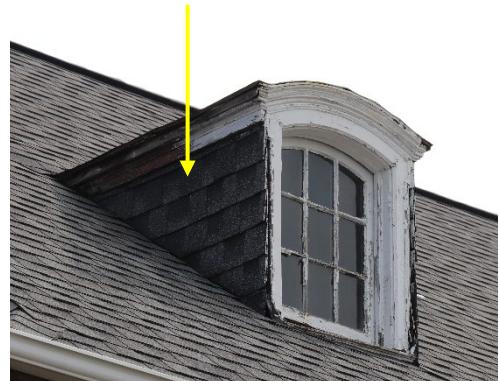
- It is staff’s opinion that the installation of cedar shake at the dormer walls will be an appropriate replacement as it complements the cedar shake siding found on the gable ends and adheres to the district’s elements of design #7, (Sec. 21-2-139) which mentions “Wood sheathing is occasionally used on the attic story and/or dormers.”

*Photo taken by staff on 08/26/2026*
