**SR-2 – STAFF ADVISORY REPORT (09-08-2026) (REVISED 09-08)**

**ADDRESS:** 15067 WARWICK

**APPLICATION NUMBER:** HDC2026-00289

**SCOPE:** DEMOLISH GARAGE, ERECT GARAGE

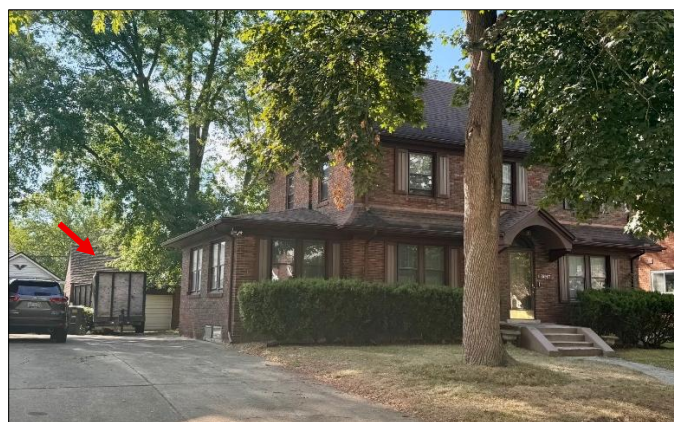
*Staff photo, August 27, 2026.*

- Staff didn't locate a construction date for the existing two-car garage. Since staff can't identify the date of construction and determine if it falls within the district's period of significance, it is staff's opinion that the existing garage, subject of this application, is not a contributing resource to the Rosedale Park local historic district.

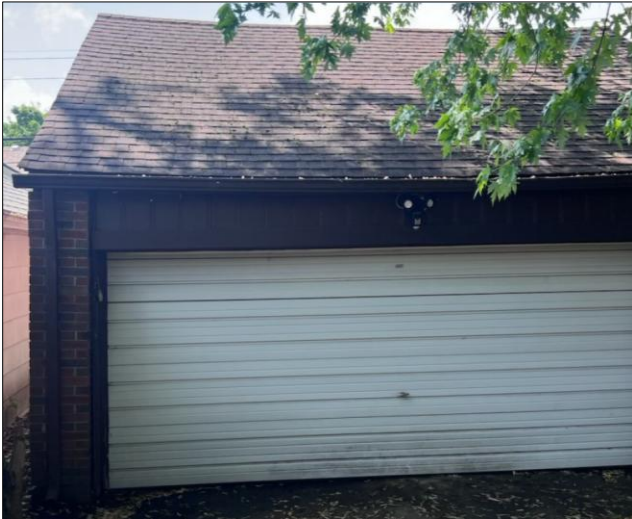
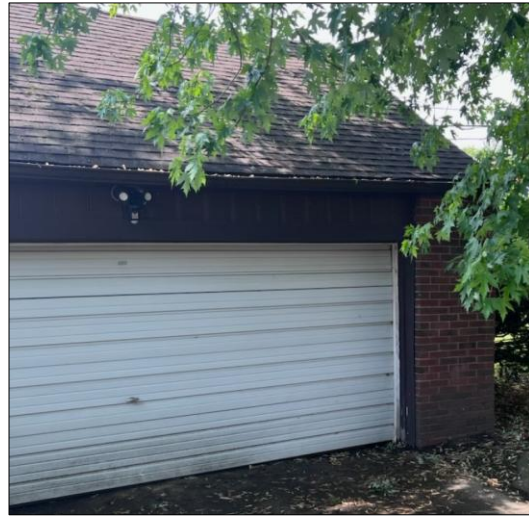
*Front (east wall) of garage*

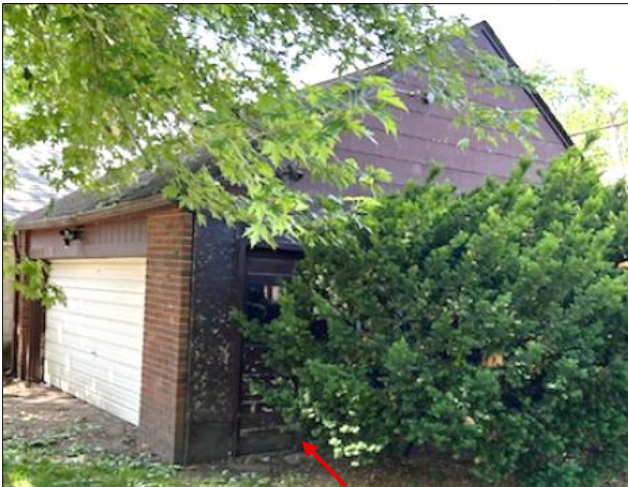
*A pedestrian door is visible near the front of garage*

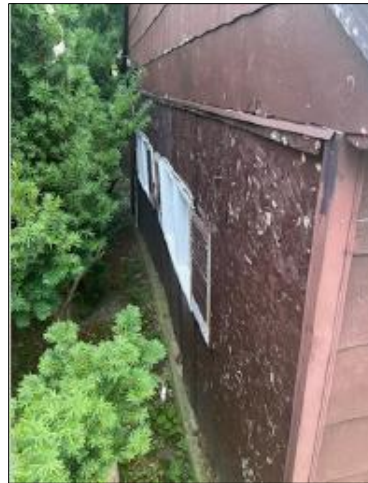
*Side (north wall)*

*Two windows are visible toward middle of wall*

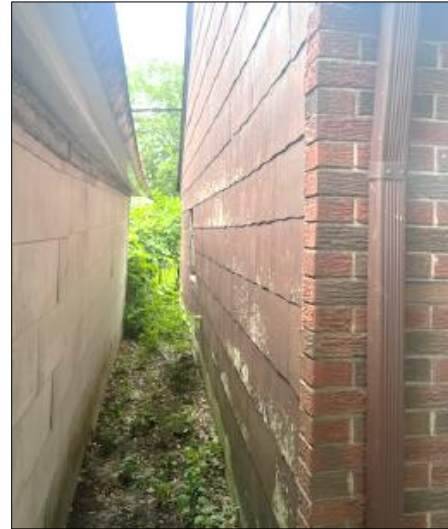
- The existing design is compatible to the house. It has a reverse/side gable roof like the house, and the front walls flanking the overhead garage door are clad in brick that appears to be a close match to the brick on the house, as seen in the below applicant photos.

*Partial view of brick cladding east wall of garage, at south-side wall.*

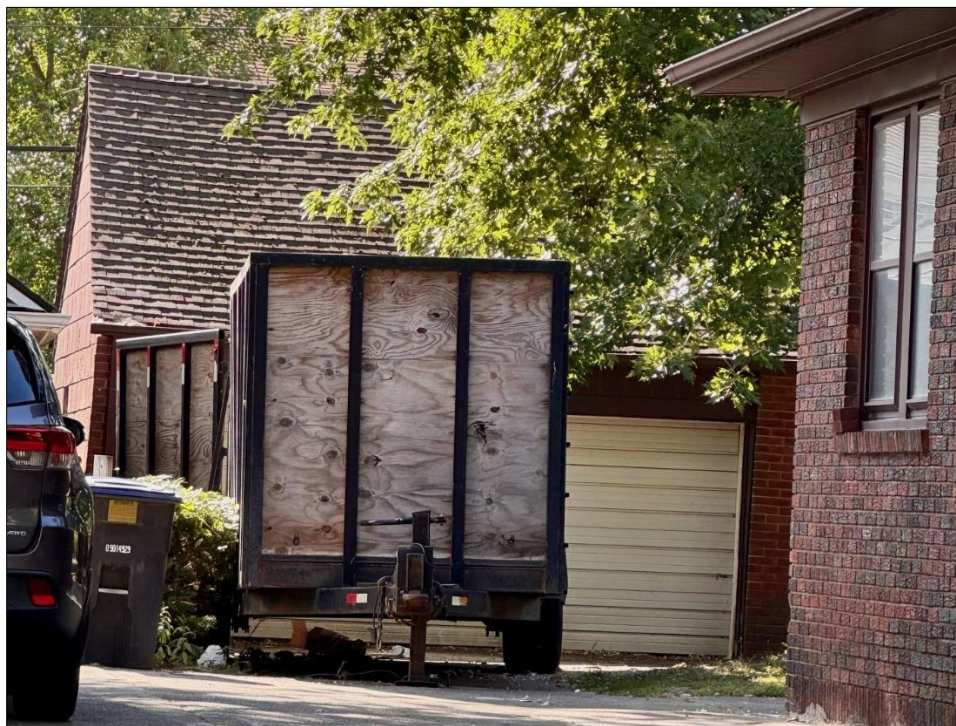
- The wall materials, outside of the brick cladding, appears to be a mid-century composite lap siding that covers the full wall surface at the south-side and rear elevations, and the north gable wall. Painted particle board (or some other pressed wood-like material) covers the north wall below the gable.

*Staff photo of the garage, taken from the sidewalk/end of driveway. August 27, 2026*

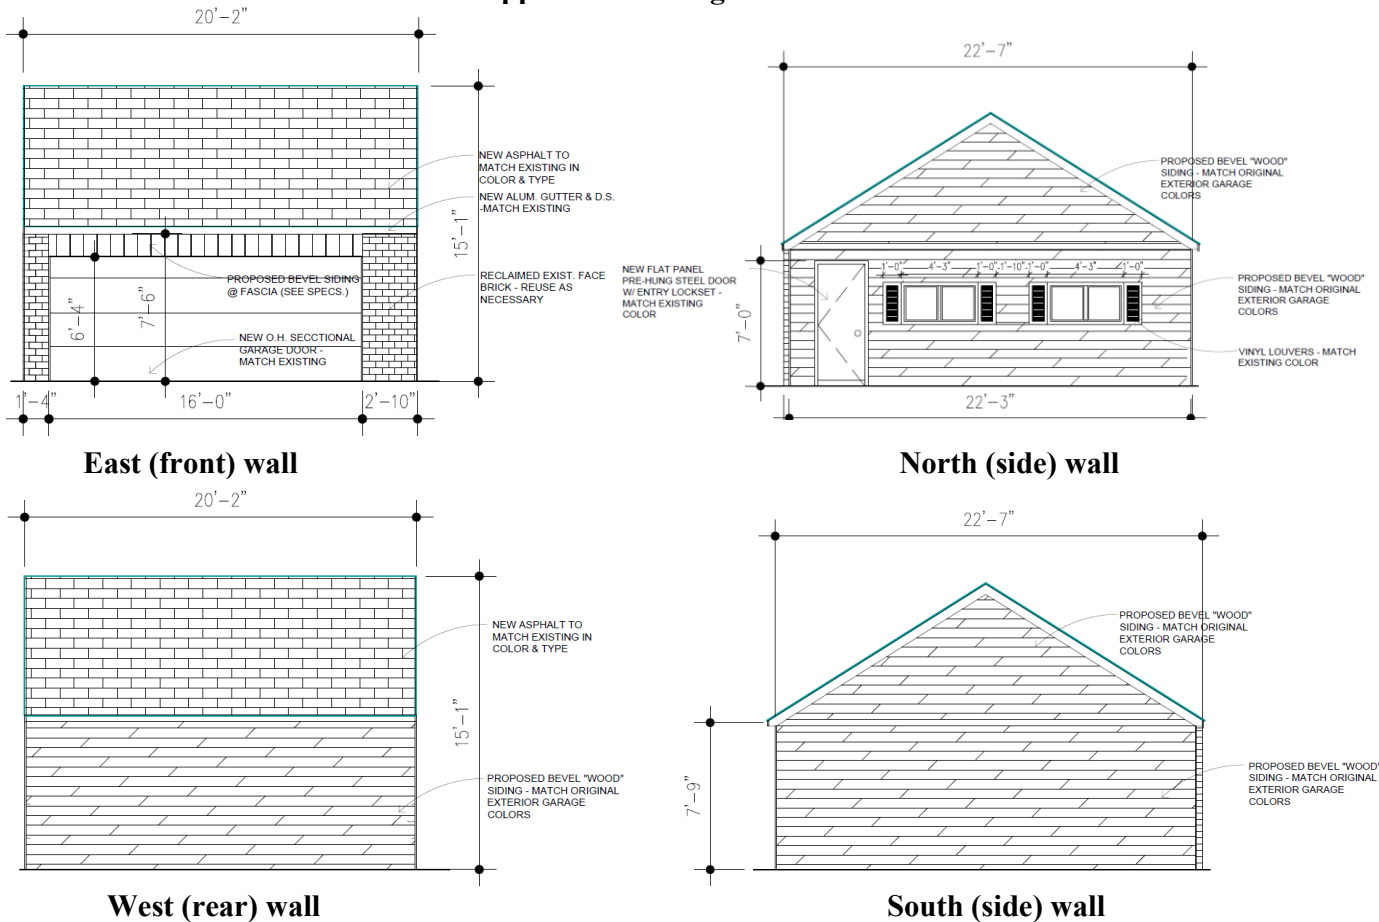
- It is staff's opinion that the dimensions, massing, and overall design of proposed garage offers a compatible design for this property.
- However, there are discrepancies between the drawings and the selected materials and building components.

- The dimensions listed for the east and west walls on the garage floor plan on Page A101 do not match the elevation drawings, site plan, nor the overhead door cut sheet.

- The proposed windows on the north wall are Anderson 400 series vinyl aluminum-clad sliding windows. Sliding windows are a mid-20<sup>th</sup> century product and the horizontal uneven sash depths is not compatible with the property. Casement windows, or double-hung windows offer operability for ventilation while conforming to the traditional proportions, operation and sash placement of the dominant windows within the historic district. The exterior cladding color is not noted. The submitted cut sheet shows a grille pattern, however the drawings show undivided glass. The double-hung windows on the house have a distinctive pattern of 15-over-1, with lead caming. As the garage is new construction and a secondary structure, it is staff's opinion the garage windows should have undivided glass so there is no visual conflict with the complex divided light patterns of the house windows.

- ~~The drawings show the shutters to be exceptionally short, bearing no relationship to the window openings.~~ The shutters on the north elevation drawing have been redrawn to extend the height of the windows, however, the submitted previously submitted cut sheet lists a dimension of 14-1/2" w x 47"h. Staff scaled the height of the windows to be approximately 2'-6"h, and the listed width is 12". The current suggested material is vinyl. The shutters are proposed only for the north wall of the garage which is not visible from the public right-of-way. Rarely has staff seen shutters installed adjacent to garage window openings. There is no requirement for the new garage to match this design feature of the existing garage. Should the Commission consider approving the shutters, a new cut sheet for the correct shutter size should be submitted to staff for review.

- The wall section on Page A101 note that gutters and downspouts will be installed, but the

color is not listed.

- Not all colors are noted, and those that are, are either generically identified (ex., new wood siding “to match original garage colors”), or a non-compatible color is suggested (ex., white for the overhead door). A compatible color scheme for the new garage is to match the comprehensive dark brown palette of the house, thus removing white and/or black colors from the current proposal.

5. Cut sheets for all products will correlate with the revised drawings. Finish colors will be noted on the drawings or within the cut sheets. ~~The color palette will be dark brown, matching the color palette of the house. Paint colors submitted for review must include manufacturer name, paint name, paint number, as well as a visual sample.~~
6. The revised drawings and cut sheets will be submitted to staff for review.
