**STAFF REPORT:** 10-14-2020 MEETING

**APPLICATION NUMBER:** #20-6894

**ADDRESS:** 1991 CHICAGO

**SCOPE:** DEMOLITION / REPAIR WORK OF FRONT PORCH (WORK DONE WITHOUT PERMIT)

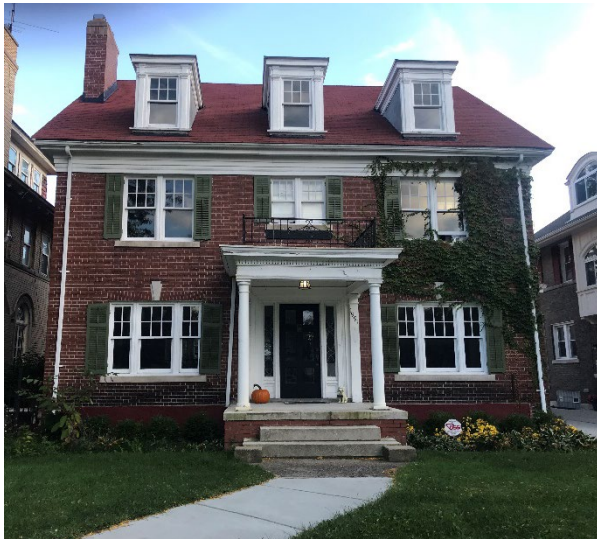
*Site Photo 1 by Staff October 1, 2020, current condition*

- Staff visited the site on October 1, 2020, with a clear view of the front porch and completed work. All work described in the Scope appears to be accurate as described.

- The Boston Edison neighborhood has a number of properties that feature the full-width, winged-porch front entrances and it is staff’s opinion that the former full-width porch was a character-defining feature of the home. The alteration of removing, rather than replacing the winged front porch has altered the character of this façade.

- The remaining wall surface below the first-story windows at the front elevation reveals brick-colored painted scars, which resulted from the removal of the porch base. This wall finish does not match the material composition of the brick wall, nor does it match the *relationship of textures*, as described in the Elements of Design for the Boston Historic District.

- The work undertaken at/proposed for the front porch to include the removal of the side wings and railing at the deck
- The current treatment of the "scars" at the front elevation wall surface below the first-story windows which resulted from the unapproved porch deck removal/replacement

Finally, if the Commission does approve the porch as it remains in its existing condition, without the side deck extensions, staff does recommend that the body do so with the condition that the exterior wall surface "scars" that flank the front porch be repaired by installing brickwork that matches the existing in scale, color, texture and mortar composition.

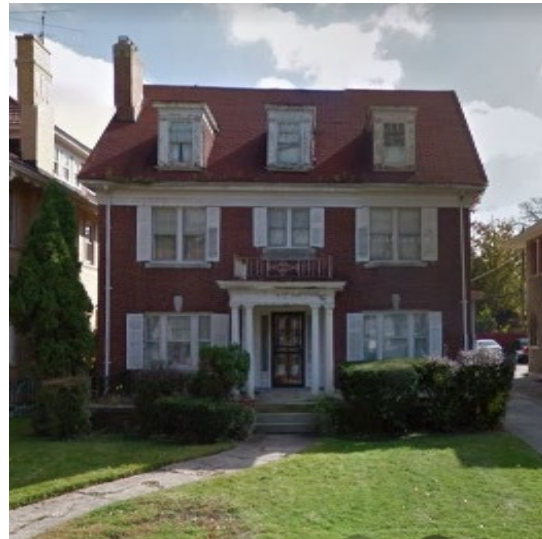
*Site Photo 2 by Google Oct. 2014, condition prior to unapproved porch removal*

- In 2017, roof work was reported as a violation from a former owner
- In July 2019, demolition and repairs for the front porch was found without a permit or COA. As noted above, the front porch alteration included the replacement of the full-width brick/concrete/limestone deck, metal railing, and the four, round wood columns with the current partial-width brick deck and two composite round columns. While other work was completed, which included repair work of the windows, shutters, and front porch light, the focus of this report is on the violation and work completed outside of the permitted area of work. The front porch demolition and alterations were completed in ~~2019~~ 2017.

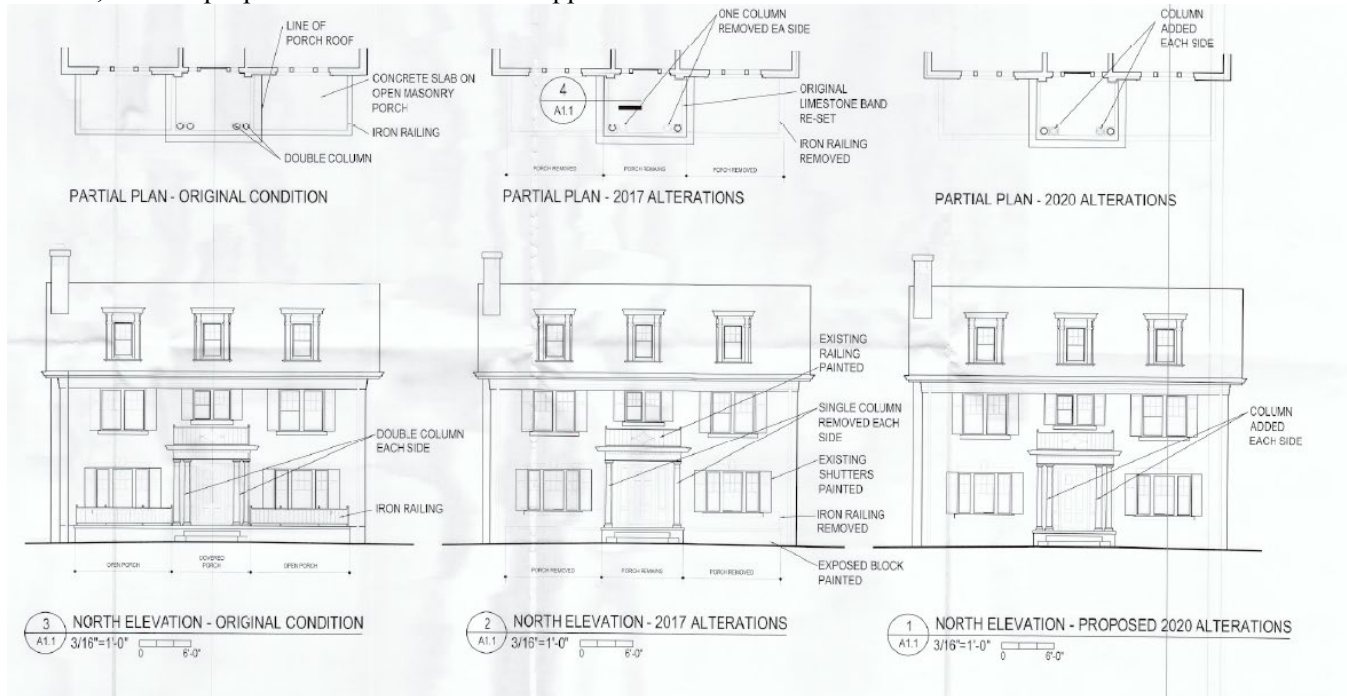
Figure 1 Applicant Scope of Work

The applicant's plan and elevation drawing below shows the original condition prior to 2017, the alterations made in 2017, and the proposed alterations for this application:

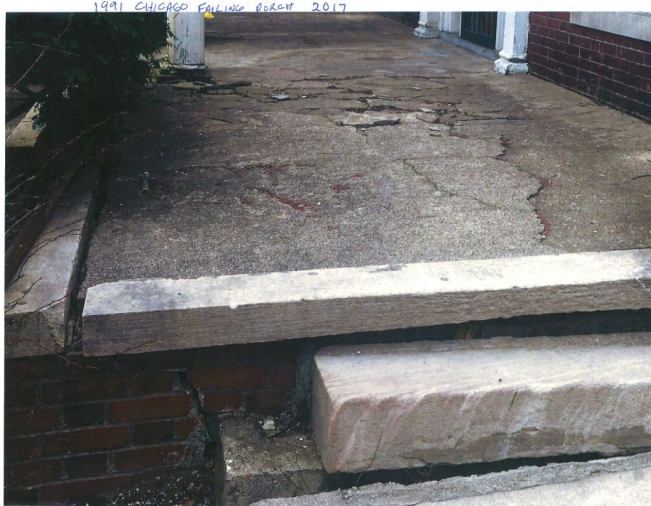
Site Photo 3 by Applicant – BEFORE (2017)

1) Wings of porch removed. The wings were collapsing due to failing footings (See attached photo). The wings could not have been repaired. They would have had to be completely re-built. In order for us to do so we would have had to dig out the old footings and pour new ones and re-build from that point. Rebuilding the wings would have added \$20,000 to the cost of the porch rebuild. This would not have made financial sense considering the value of the home. The main porch's footings were in good shape so we were able to just rebuild the brick work etc. for the center porch. In respect to the old footings, we dug them out and removed to accommodate installation of the new landscaping and grading from the exterior walls of the house. We also used as much of the original porch materials as possible in the re-build which is evident in the photos.

2) Railings on wings of porch removed. The railing was corroded and damaged, but intact, on the left wing but none attached to the right. The vintage of the railing was undetermined.

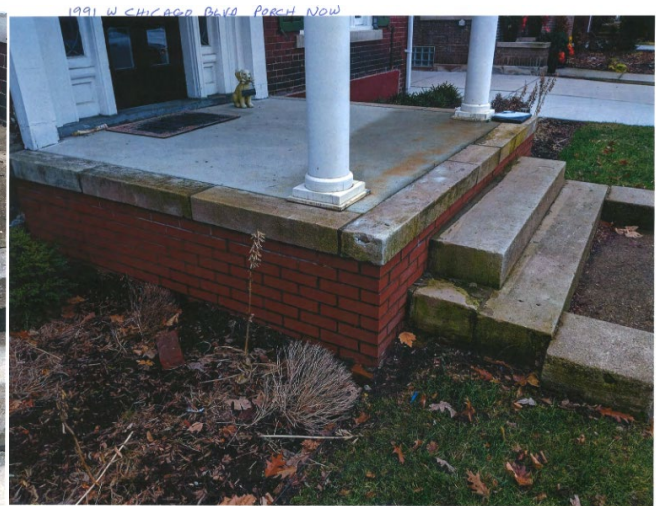
Site Photo 4 by Applicant – AFTER (2020)

- Front porch surface, limestone edge, steps and brickwork
- There is a discrepancy between the application material and what was reported to staff. While the application material shows that the two columns that remain are described as original wood material, staff received confirmation these two remaining columns are actually the new, proposed composite material that is proposed to be duplicated to bring the total to 4 columns at the front side of the porch.

- The proposed composite column additions would generally bring the porch back to its original appearance, concerning column number and configuration, if the applicant uses the material as described in the attached cut-sheet.

- Add 2 additional composite columns so that the configuration of the porch supports matches the appearance prior to the 2017 unapproved work (as shown in plan)
