STAFF REPORT 12-9-2020 MEETING

APPLICATION NUMBER: 20-6986

ADDRESS: 2467 CASS (AKA ATLANTA APARTMENTS)

SCOPE: REHABILITATE APARTMENT BUILDING

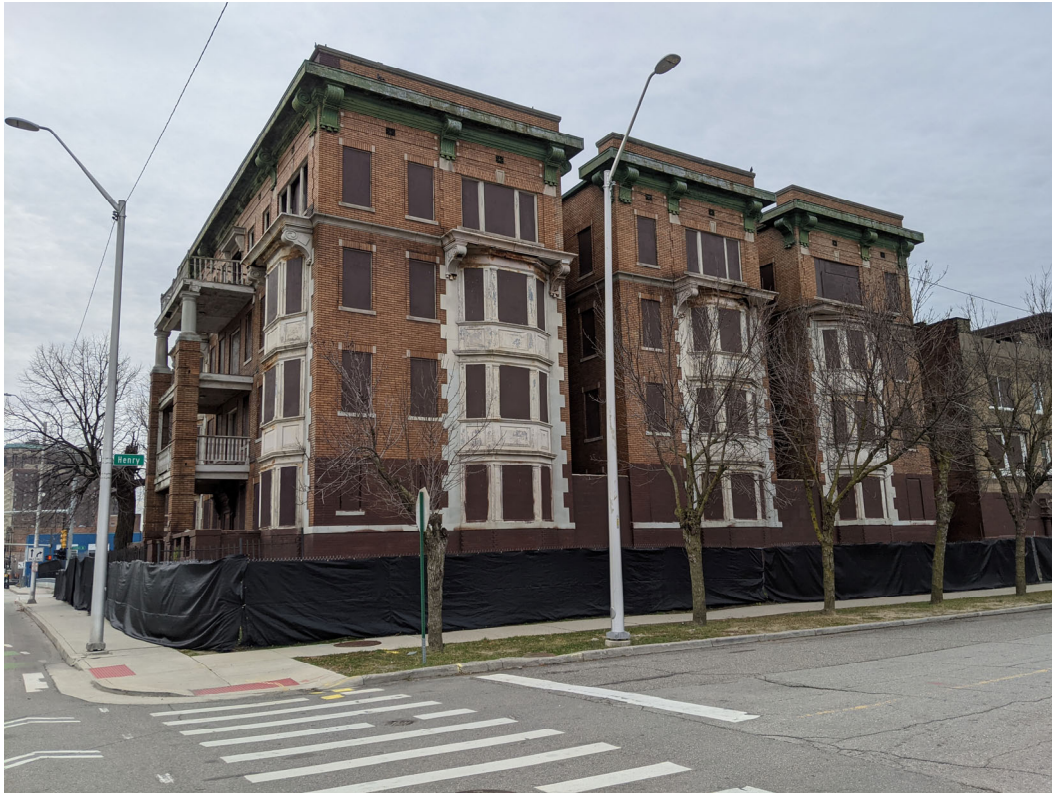
View of the Atlanta Apartments, view to the southwest. Staff photo, November 24, 2020.

The building was already vacant and missing its windows at the time of historic designation. Today, the windows are boarded, but the building otherwise appears to be in fair condition and, despite the missing windows and alterations to the entrance, retains its historic integrity, with areas of deterioration visible.

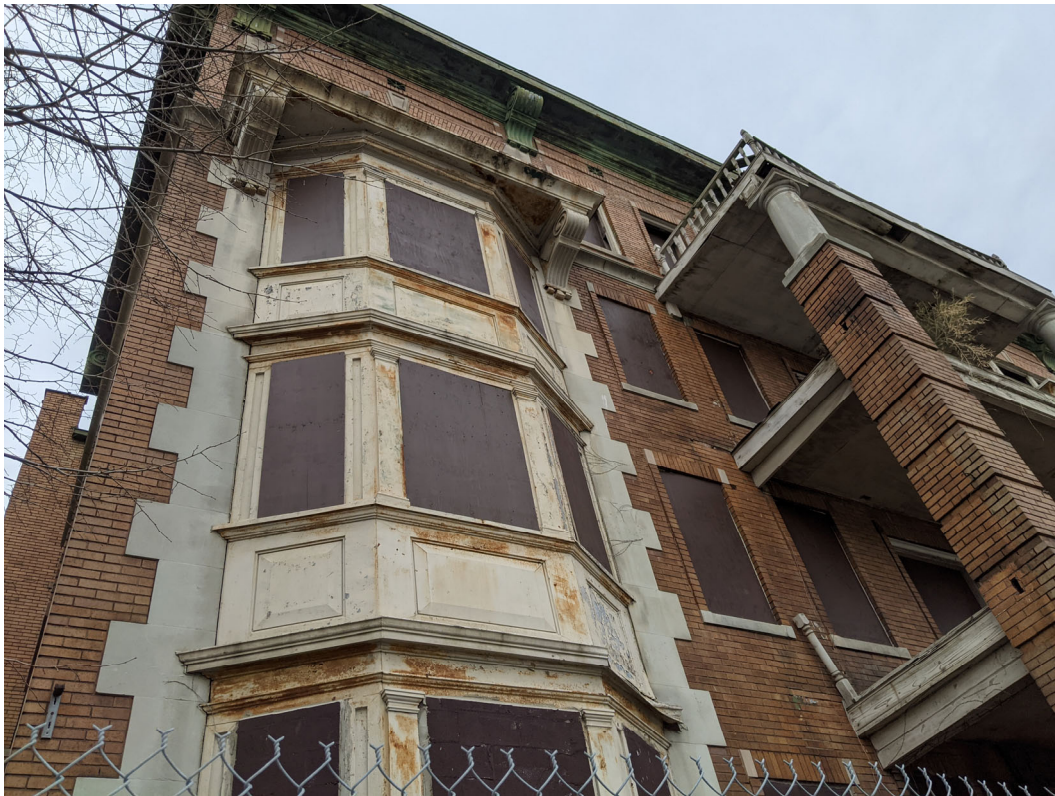
Per the architect, and as confirmed by HDC staff to the extent feasible from the public right-of-way, the brick and stone areas of the building are in fair to good condition, with some locations of cracking, missing mortar, puncture holes, and missing units. The pressed tin cornice and consoles are in fair condition, with some corrosion, flaking paint, and visible damage in some areas. Bracketed hoods over each bay window are in poor condition with corrosion visible. Metal spandrels appear to be in fair condition. The building has a flat membrane roof in poor condition.

Detail view showing conditions at the Cass (primary) facade. Staff photo, November 24, 2020.

- *Inspected for damage*
- *Brown paint to be removed*
- *Masonry cleaned with a light duty detergent and low pressure water rinse*
- *Brick and stone will be repointed, and loose or displaced units will be reset*
- *Repointed mortar will match the color, texture, compressive strength, joint width, and joint profile of the existing historic mortar*
- *Damaged brick and stone will be repaired as necessary*
- *Any units too badly deteriorated to repair will be replaced, with salvaged brick to be reused where replacements are needed before new units are used*
- *If new units are necessary, they will be selected to match the existing in size, profile, color, and finish*

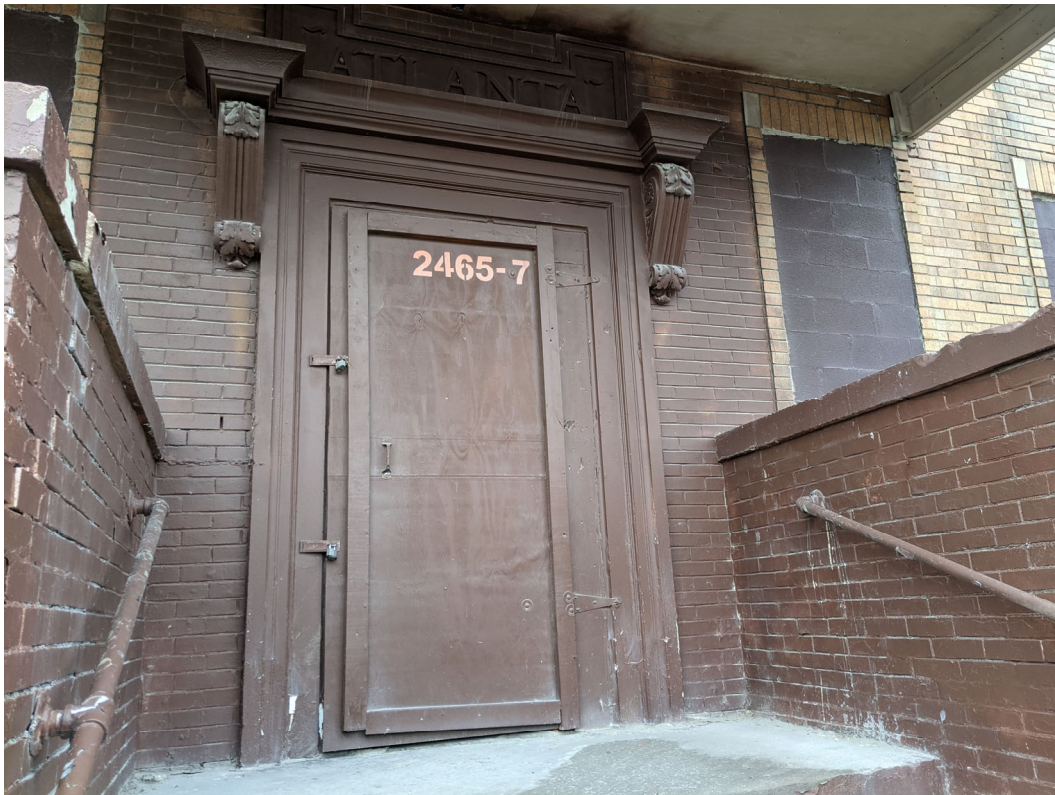
The Cass entranceway has been closed up with concrete block, and there are no historic doorways extant. The light courts (indentations) at the south elevation, and the first bay in from Cass, are faced in a lighter colored brick. The west and the remainder of the south elevations are faced in dark brown brick and feature stone sills at the windowless openings. Most of the bottom of the building, to include the 1st floor and entrance area, has been painted brown, excepting some stone elements along Henry.

Detail view showing main entrance at Cass, note "ATLANTA" name above. Staff photo, November 24, 2020.

- *Remove existing concrete masonry units (CMU)*
- *Install a new glazed panel door compatible with the historic nature of the building (color TBD)*
- *New glazed panel doors at balconies*
- *ADA lift and new entrance door installed in the eastern-most inlet on the north (Henry Street) façade of the building*

- The ultimate design for building signage should ensure retention and display of the stone-carved "ATLANTA" name as a contributing element to the historic character of the building. Staff suggests that, if desired, it would be appropriate to place modestly-scaled additional signage in the landscape in front of the building subject to the Commission's own sign guidelines and staff review.

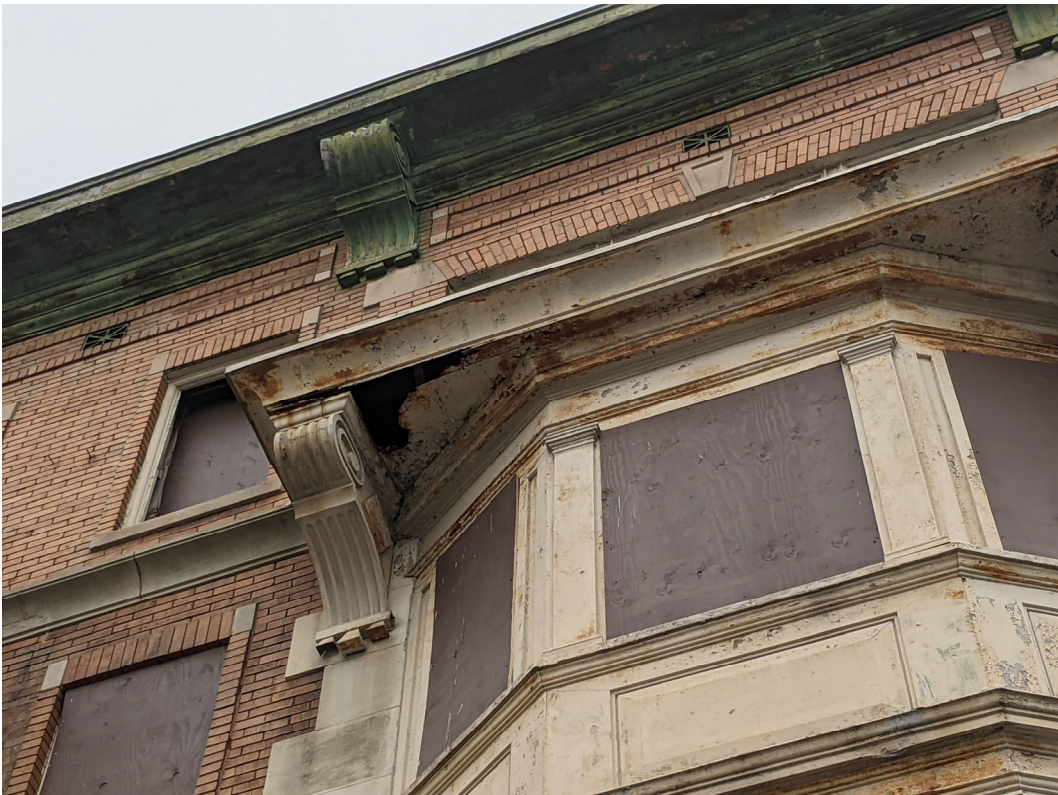
Detail view of metal detailing at bays and cornice, Cass elevation. Staff photo, December 7, 2020.

- *All pressed tin metal work will be retained and repaired and repainted (color TBD)*
- *If any tin work is too damaged to repair, new compatible metal will be used and will be painted to match the adjacent historic material*
