**STAFF REPORT 12-9-2020 MEETING**

**APPLICATION NUMBER: 20-6987**

**ADDRESS: 2447 CASS (AKA HOTEL ANSONIA/GRADE APARTMENTS)**

**SCOPE: REHABILITATE APARTMENT BUILDING**

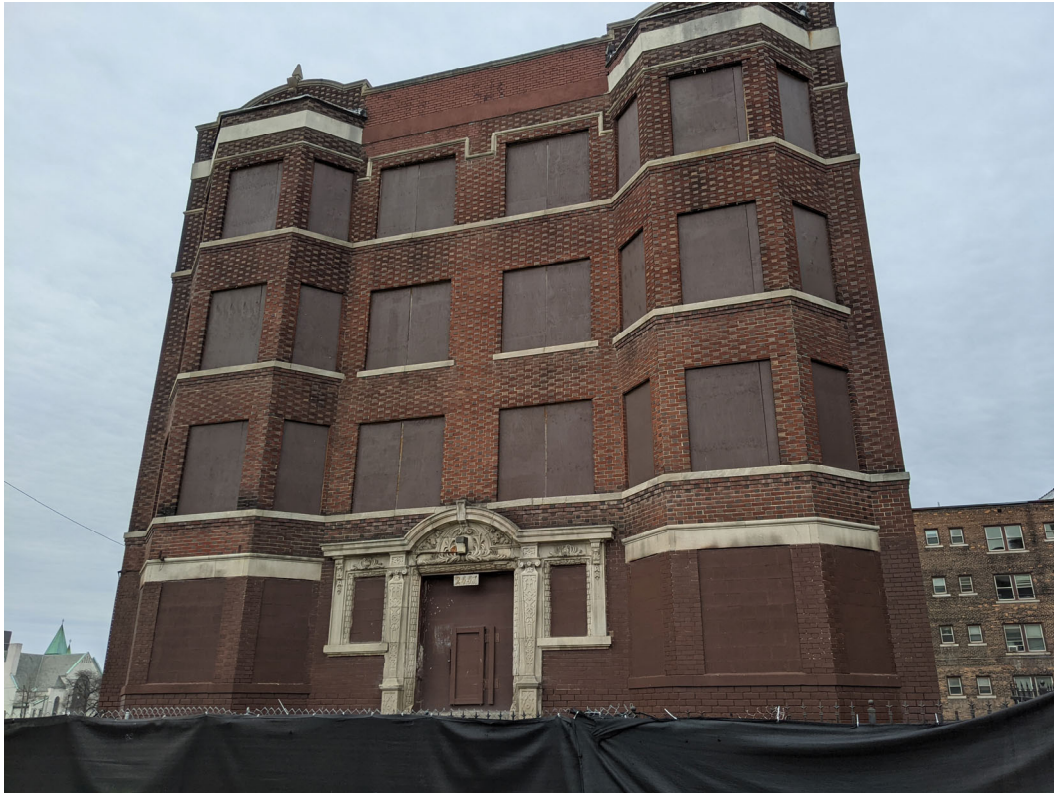
*View to the west of the Cass (primary) facade. Staff photo, November 24, 2020.*

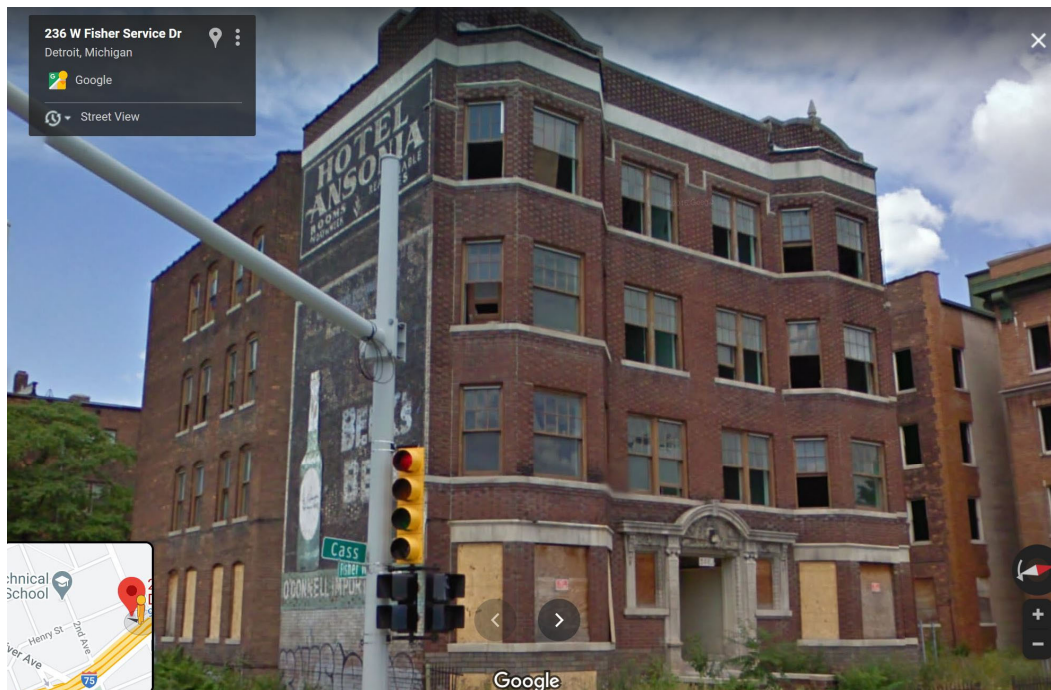
*Google Street View (circa 2009) of the building, showing advertising signs and original windows.*

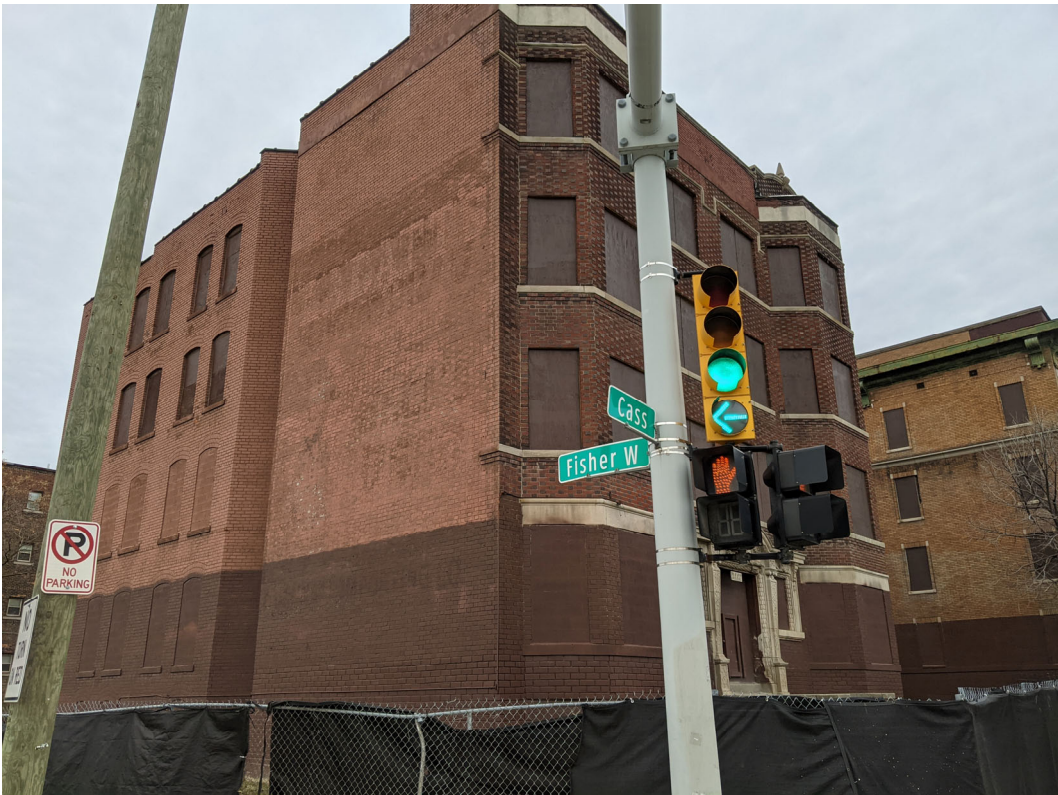
*South (Fisher Service Drive) Elevation today. Note “ghost” advertisement for Labatt’s still visible. Staff photo, November 24, 2020.*

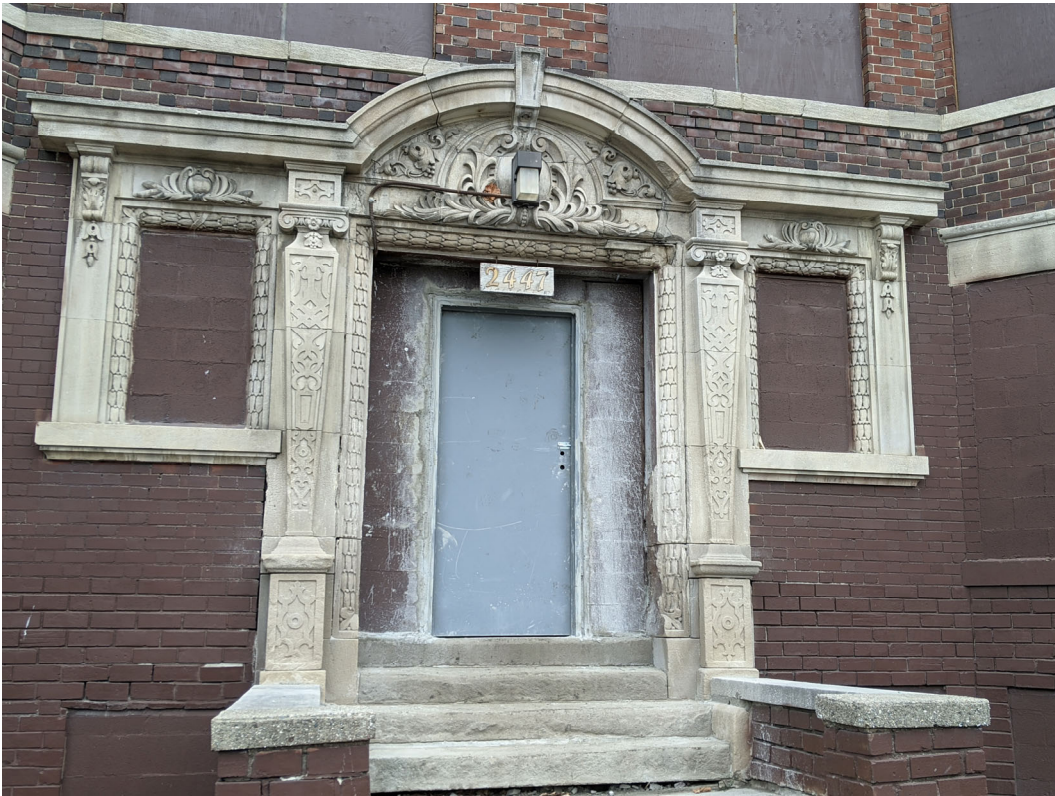
The Cass entranceway, along with its flanking windows, has been closed up with concrete block and has a plain steel door installed for access. There is an insensitively mounted modern light fixture obscuring part of the ornamental stonework over the door. The rest of the basement and first story window openings (and second story openings along Fisher) are also closed with block; those overhead are boarded. The Flemish bond brick wraps around to the north and south elevations, and transitions to common brick near the midpoint on both sides. Most of the bottom of the building, to include the 1<sup>st</sup> floor and entrance area, has been painted brown, excepting some stone elements along Cass.

*Detail view showing main entrance at Cass, note elaborate stone detailing. A new gray door was installed subsequent to the initial staff visit. Staff photo, December 7, 2020.*

- *Remove existing concrete masonry units (CMU)*
- *Install a new glazed wood double door compatible with the historic nature of the building (color TBD)*
- *New solid doors in the west elevation at the fire escape (material/design TBD)*
- *ADA lift to be installed on the back of the building to access the first floor fire escape to provide ADA access to the first floor units*

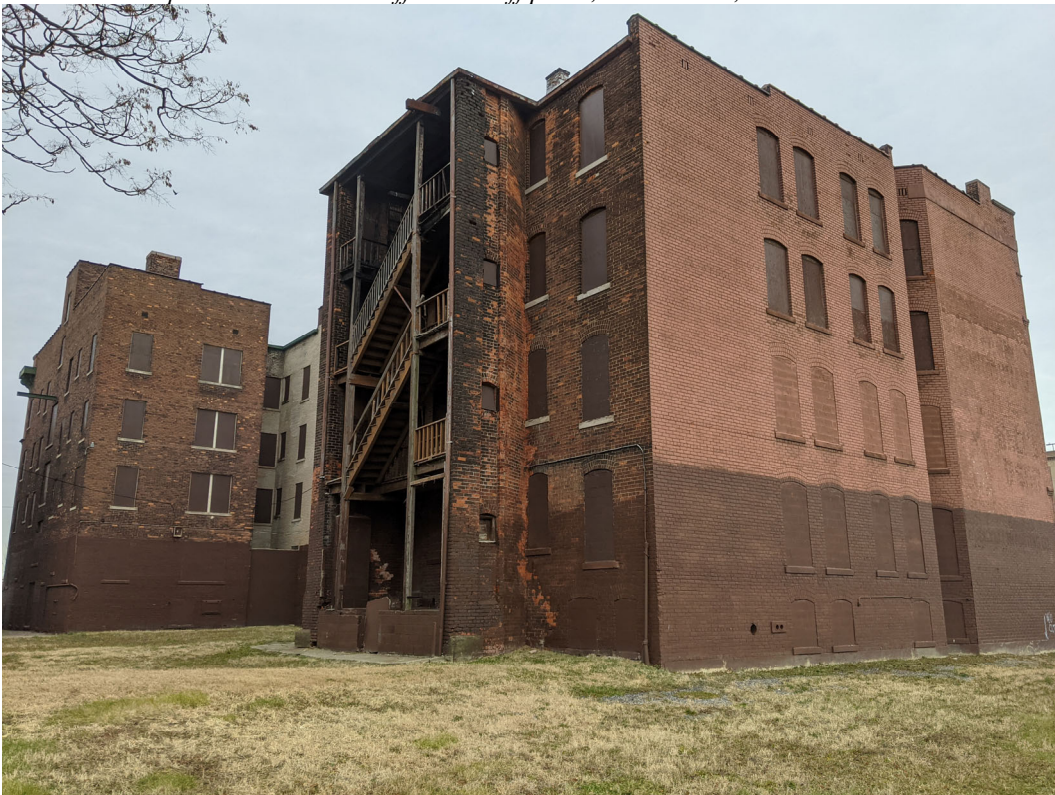
*View of rear elevation, looking northeast. Note exterior stairs. Staff photo, November 24, 2020.*

- *Wood components of existing fire escape to be removed and replaced with new composite wood material. Connections to the building repaired as necessary to ensure structural stability*

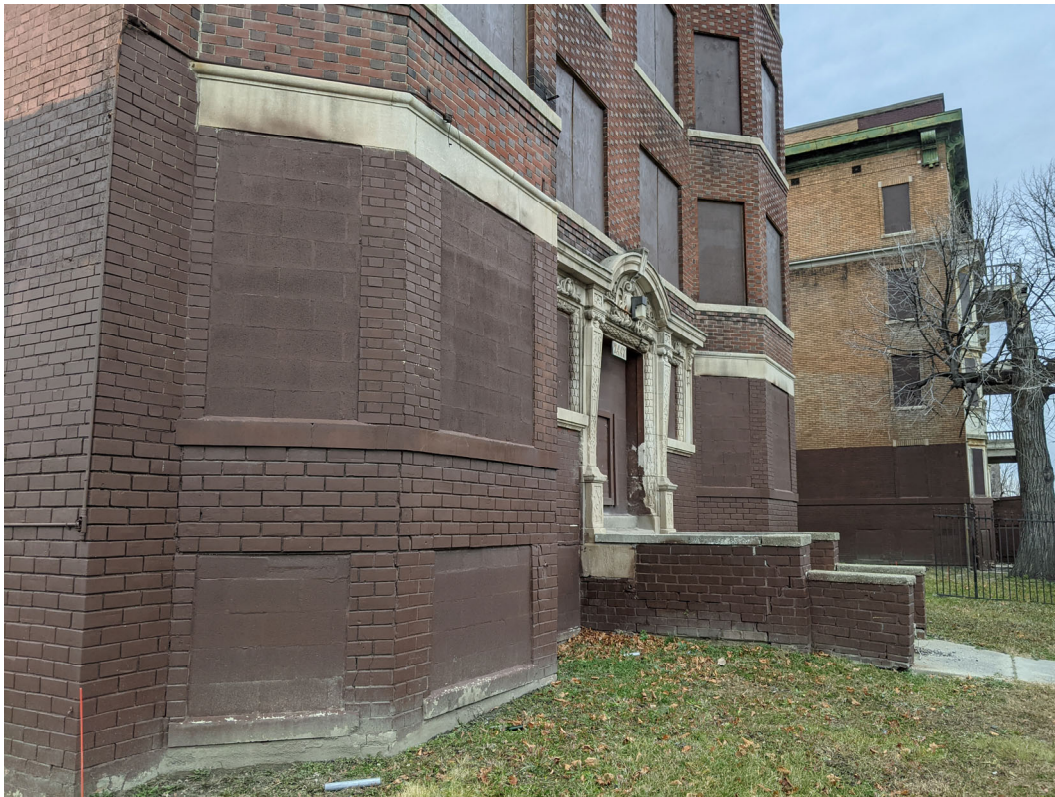
*Detail view of Hotel Ansonia first story, with the Atlanta (2467 Cass) beyond, representing the eastern extents of the Cass-Henry Historic District. Note extent of brown paint. Staff photo, November 24, 2020.*

- No proposed process is given for removing the brown paint applied at the lower level in recent years. Applicant should submit an appropriate paint removal process for staff review.

- *Inspected for damage*
- *Brown paint to be removed* (process not provided)
- *Masonry cleaned with a light duty detergent and low pressure water rinse*
- *Brick and stone will be repointed, and loose or displaced units will be reset*
- *Repointed mortar will match the color, texture, compressive strength, joint width, and joint profile of the existing historic mortar*
- *Damaged brick and stone will be repaired as necessary*
- *Any units too badly deteriorated to repair will be replaced, with salvaged brick to be reused where replacements are needed before new units are used*
- *If new units are necessary, they will be selected to match the existing in size, profile, color, and finish*
