STAFF REPORT: 05-12-2021 MEETING
APPLICATION NUMBER: 21-7211
ADDRESS: 14854 ASHTON
HISTORIC DISTRICT: ROSEDALE PARK
APPLICANT: JASON TRUDGEON, SUNGLO SERVICES
PROPERTY OWNER: THOMAS KEMP
DATE OF PROVISIONALLY COMPLETE APPLICATION: 04-19-2021
DATE OF STAFF SITE VISIT: 04-28-2021

SCOPE: DEMOLISH EXISTING GARAGE; ERECT NEW GARAGE

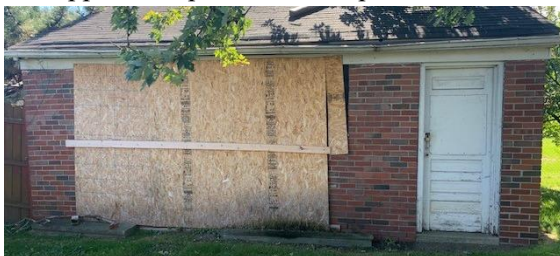
- It appears the glass block windows were in place at the time of designation. Staff does not know if they are original to the garage.
- The applicant’s photos show a portion of the north/side wall gone.

- It is staff's opinion, the structural damage evident on the north, east and south walls offers compelling evidence as to the severe condition of the existing structure.
- The dimensional asphalt shingles on the house look to be brown, but the roofing material selected for the garage is a three-tab dark gray asphalt shingle.
- It is staff's opinion that vinyl siding is not appropriate for use in local historic districts due to its plastic appearance and minimal representation of wood siding.
- The material/placement of window sills was not noted in the scope of work. It looks like the existing sills may be stone.
- The finish for the wood pedestrian door and the roof trim (fascia/freeze board) was not noted.

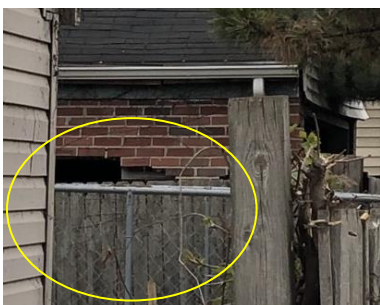
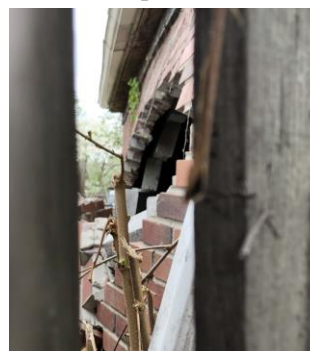
- During the recent site visit, staff observed a portion of the now-collapsed south/side wall. (Photos taken from the service drive sidewalk).
