STAFF REPORT: JULY 14, 2021 MEETING

APPLICATION NUMBER: 21-7360

ADDRESS: 1321 LABROSSE

SCOPE: WINDOWS REPLACED WITHOUT APPROVAL

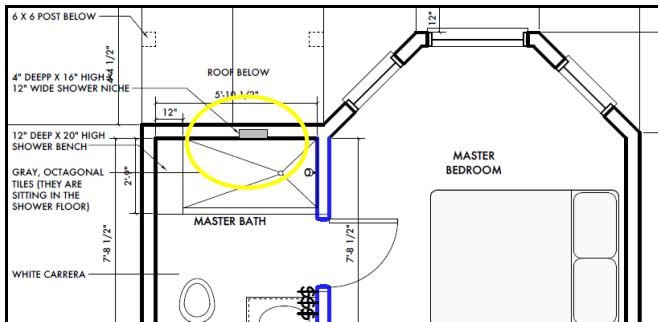
Applicant's 2021 Floor Plan – "Scheme G"

- The second story floor plan ("Scheme G" – included with the applicant's submission materials) shows the front elevation second story window gone, in contrast with the floor plan submitted as part of the 2019 rehabilitation application.

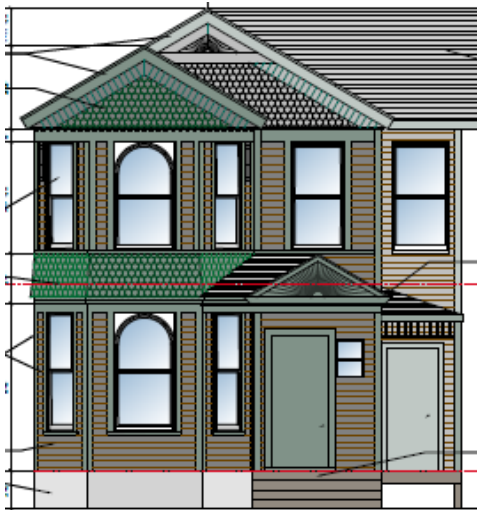
Applicant Rendering

- The façade of this house offers a multitude of patterns and angles, in line with the Queen Anne architectural style. The window opening above the front porch (as shown in the below-left rendering) completed the horizontal line (or rhythm) of windows at the second story, as well as creating a vertical balance with the first story openings. The removal of this window opening created a flat void within this highly detailed façade.

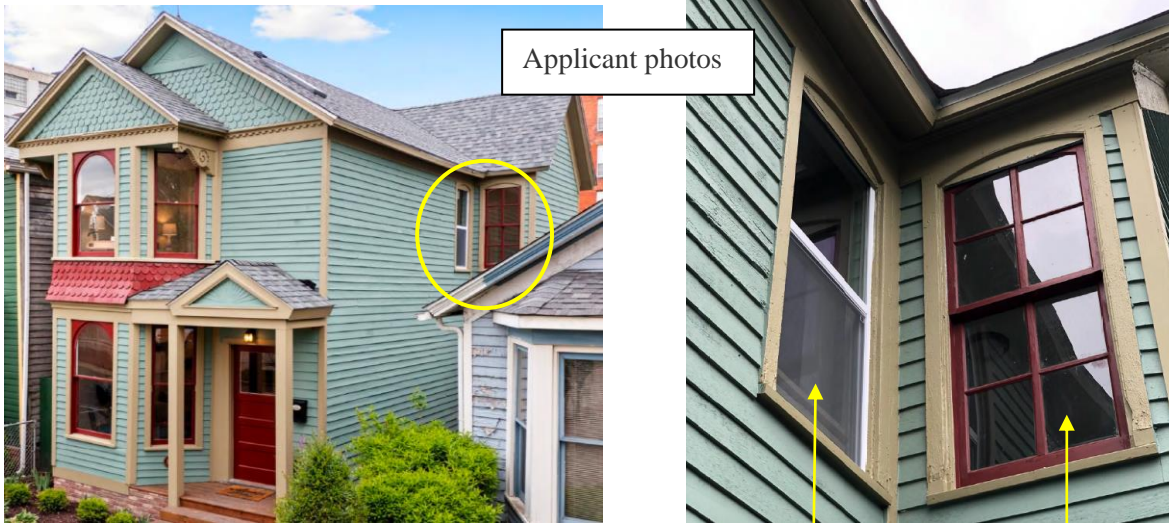
Front and west side elevation

Side Elevation - The white vinyl window immediately adjacent a historic window creates a jarring visual juxtaposition for the two window openings.

Replacement Window Historic window

It is staff's opinion the removal of the four wood windows and installation of vinyl windows and glass block, as well as the removal of the two front elevation window openings, has altered the features and spaces that characterize the property. Staff therefore recommends the Commission deny a Certificate of Appropriateness for the work as proposed because it does not meet the Secretary of the Interior Standards for Rehabilitation and the Elements of Design for the district.

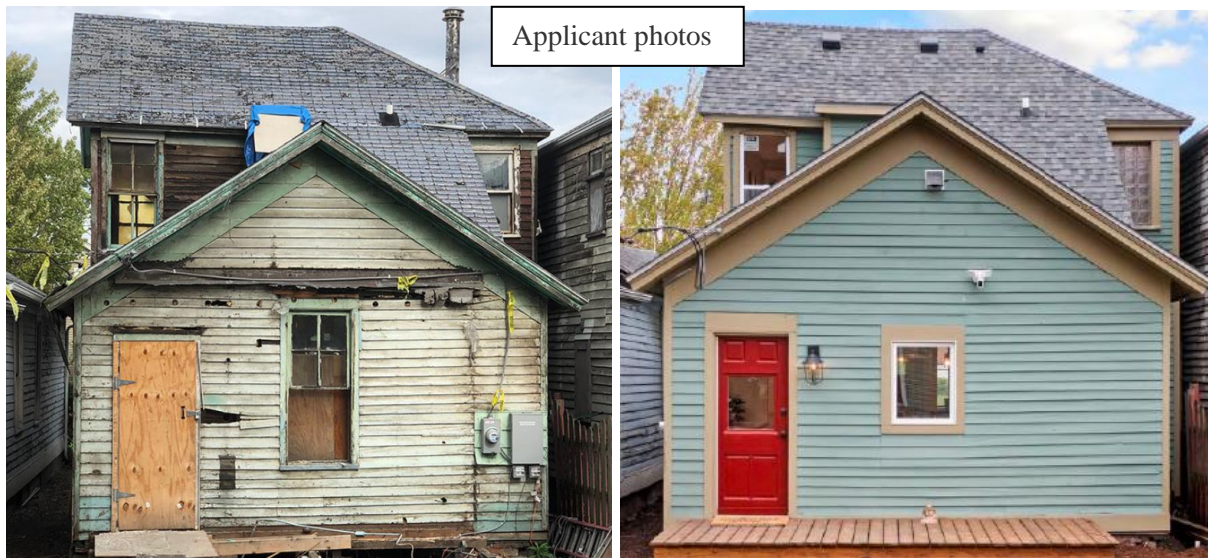
Rear Elevation - The historic windows, due to their wood sash and double-hung operation (with the two taller windows also having a matching muntin pattern), offered a level of uniformity to the asymmetrical rear elevation. As the windows are now different operations, sizes and materials, a discordant appearance to the rear elevation has been created.

Before 2019 rehab

Current conditions
