STAFF REPORT 11-10-2021 REGULAR MEETING

APPLICATION NUMBER: 21-7579

ADDRESS: 2238 WABASH

SCOPE: REMOVE NON-HISTORIC SIDING, REPRODUCE AND INSTALL TRUE WOOD WINDOWS AND OTHER DETAILS

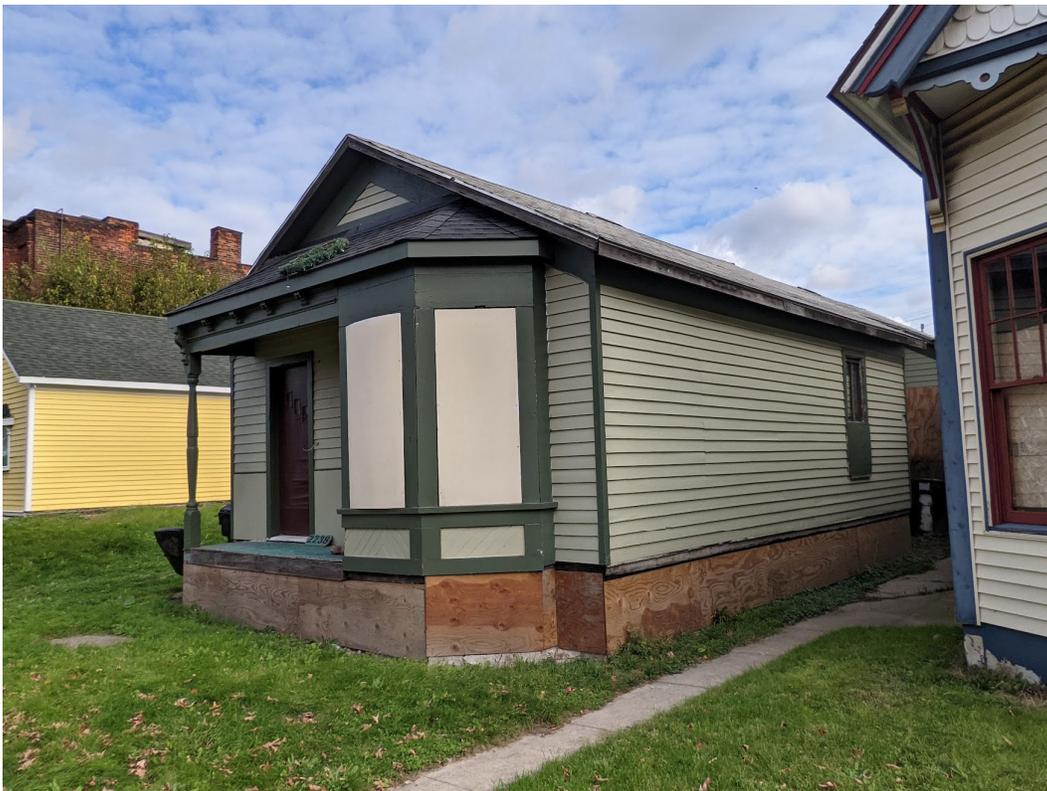
View of existing conditions at 2238 Wabash. The current skirt boards are temporary plywood enclosures. Staff photo, November 2, 2021.

- In many cases, though the decades of concealment obscures original wood character, it ironically helped protect the original materials from weathering. The removal in this case, as has occurred at other houses in Corktown, has revealed a well-preserved original clapboard finish which only required nominal repairs and painting.

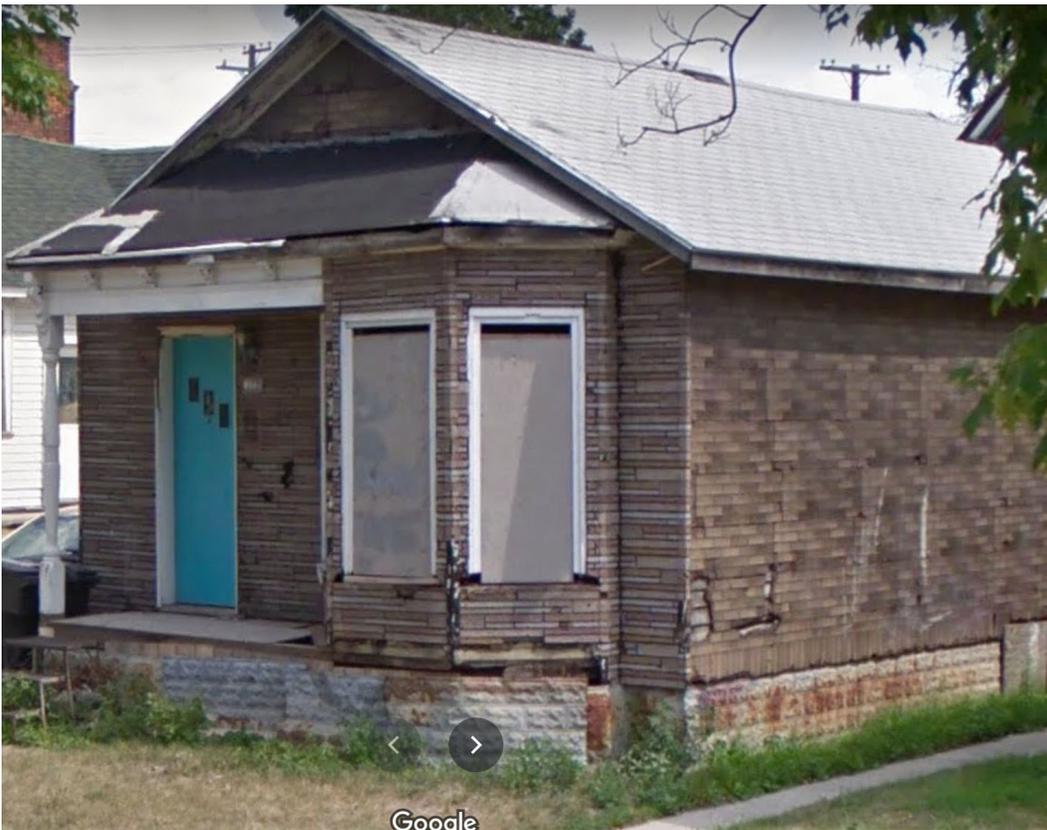
Google Street View shows property with incompatible asphalt siding as it appeared in July 2016.

- The work performed in removing the asphalt siding was done without approval. Additional unapproved work included the removal of the pressed metal skirting around the foundation, which imitated a “cinder block” foundation. The combination of a fake “block” skirting with fake “brick” siding was a common intervention in the mid-century era on older frame residential structures to attempt to move the property upscale, with typically unconvincing results. In almost no cases have such modifications earned their own historic significance or integrity. As such, staff finds that the removal of these incompatible layers was, and is, appropriate.

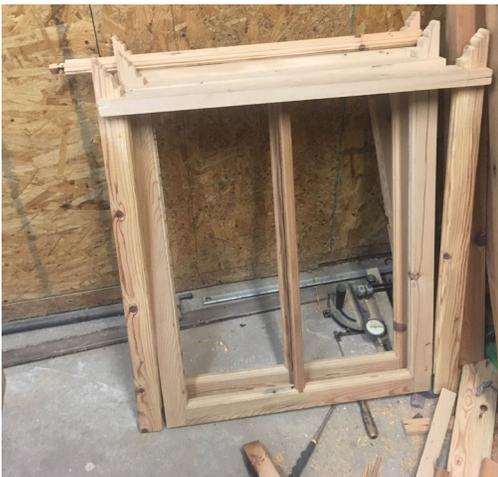
The window sash will be built out of the same exact old-growth long leaf pine as they were at the time. The design and dimensions are identical to within 1/100 of an inch of what the original neighborhood joiner would have specced. I have restored many windows in this neighborhood (and sadly watched many more go), and there is a very specific profile that these windows of this vintage have -- a very slightly elongated ogee -- likely unique to a particular set of moulding planes, but that I have had recreated in various tooling over the years. The ‘horns’ at the bottom of the sash are I believe the best design of the local sashmakers. Were I rich enough to afford the luxury of glass back then, this is the sash I would have picked. This design prevents the racking failure at the bridal joint that is so often used as a reason that windows cannot be saved. My goal is to build windows that could be horribly neglected for a few decades and even then the owner would not be able to justify their removal!

Custom-built wood windows proposed for the house.

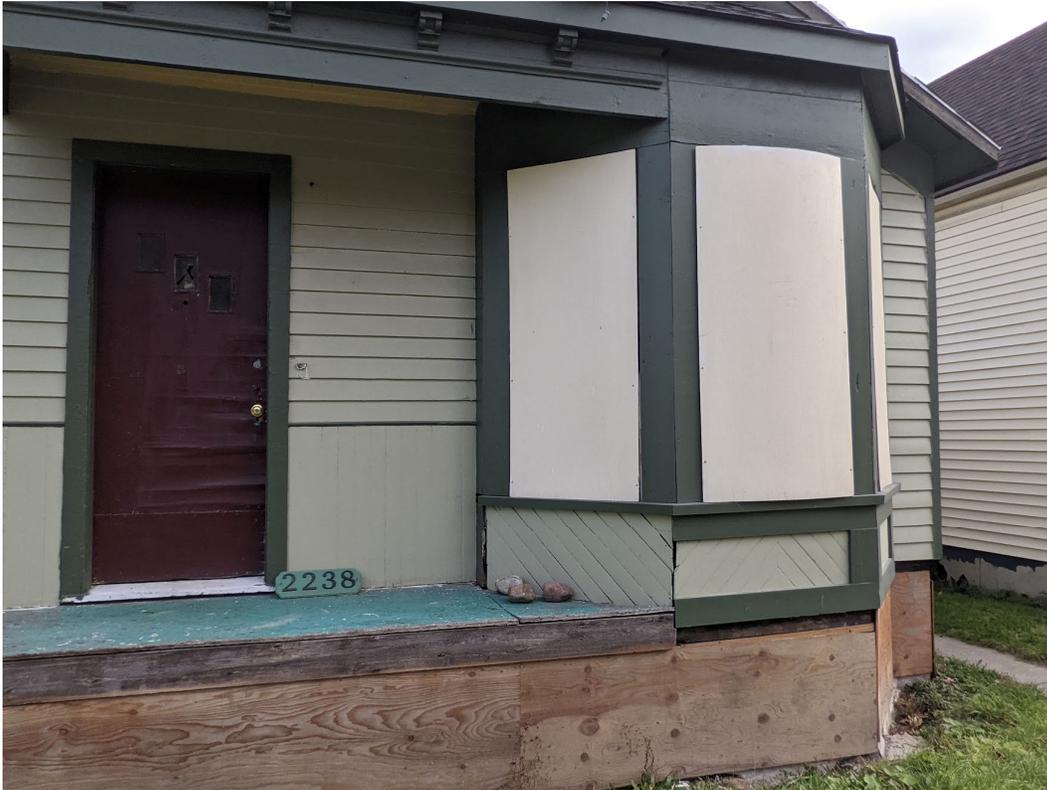
View of existing conditions at 2238 Wabash, detail view of porch and bay window. Staff photo, November 2, 2021.

- Additional restoration work, proposed to be executed in similar reclaimed wood, include roof corbels at

the front façade which are modeled on existing prototypes and positioned via remnant paint lines. This is a textbook approach to proper historic preservation and should be commended.
