STAFF REPORT: 3/16/2022 REGULAR MEETING

ADDRESS: 1068 VINEWOOD

APPLICATION NO: #22-7703

SCOPE: REPLACE SLATE ROOFING WITH NEW ASPHALT ROOFING

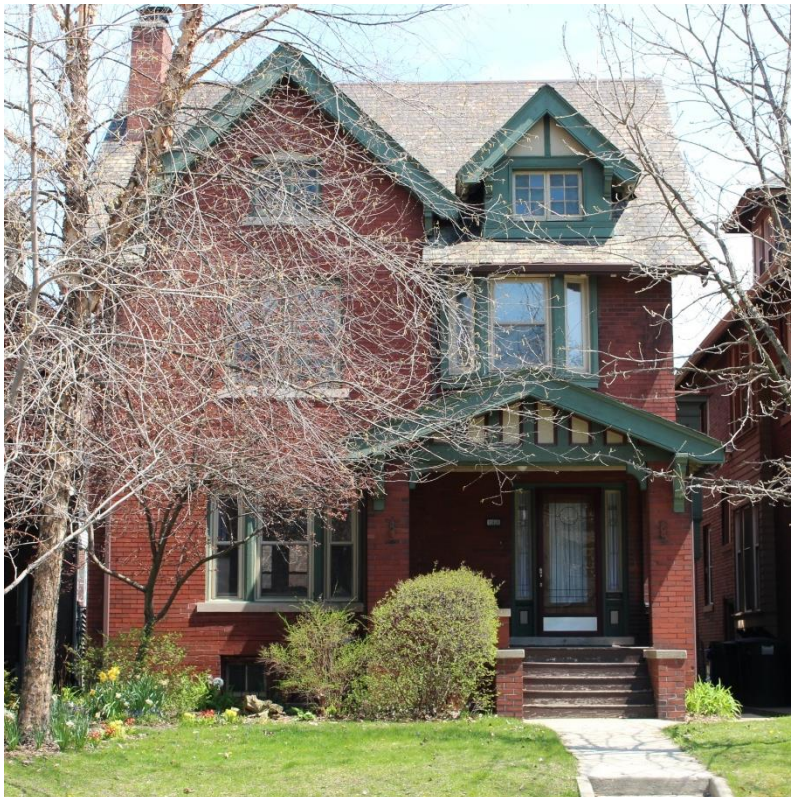
1068 Vinewood, current appearance

- Staff has reviewed the submitted photos. It is staff's opinion that the slate tiles appear to be in poor condition/weathered throughout. Specifically, delamination, chipping, and cracking appears pervasive throughout the slate tile roofing

- As previously stated, it is staff's opinion that the slate roof at 1068 Vinewood is a character-defining feature of the dwelling. It is also staff's opinion that the current slate roof system has reached the end of its serviceable life and therefore merits replacement.

It is staff's recommendation that the Commission approve the issuance of a Certificate of Appropriateness for the project as proposed because it conforms to the Hubbard Farms Historic District's Elements of Design and meets the Secretary of the Interior Standards for Rehabilitation.
