STAFF REPORT: APRIL 13, 2022 MEETING

APPLICATION NUMBER: 22-7706

ADDRESS: 19388 STRATFORD

SCOPE: REPLACEMENT OF VINYL WINDOWS WITH FIBREX WINDOWS AT THE FIRST FLOOR

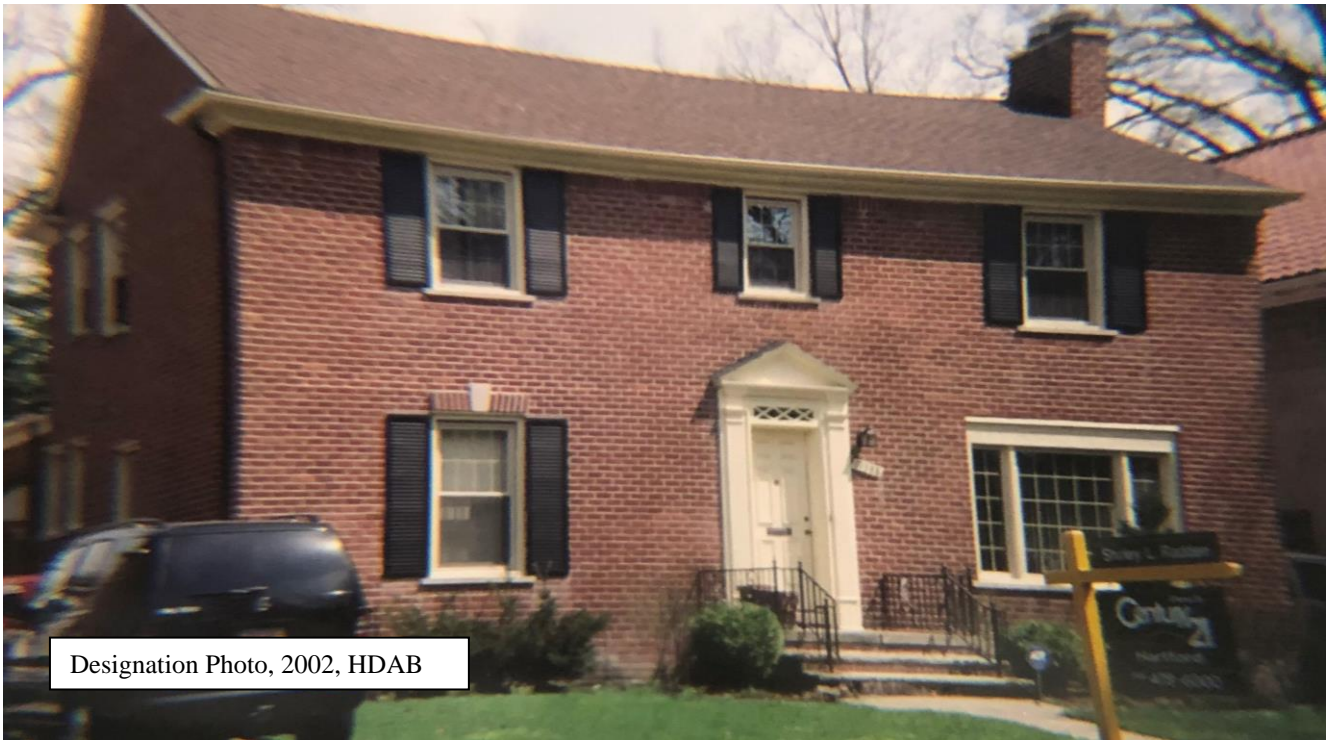
Designation Photo, 2002, HDAB

According to the building card, on file at BSEED, a building permit was issued in November 1953 for the erection of two-story structure and detached garage at 19388 Stratford. Red brick in a running bond pattern faces the front and sides of the house. The centrally placed front entrance is accessed by a small, raised stoop; pilasters and a closed pediment surround are the focal point to the front elevation. The symmetry of the façade is broken up at the first floor by differently sized and detailed window openings, consisting of a single window capped with a masonry flat arch and keystone, and a triple, mullied window unit. The window units are vinyl, and the wood brick mold and trim are capped in aluminum; color: off-white. Replacement windows and capped trim/brickmold were in place at time of designation, as shown on the designation photo on page 2.

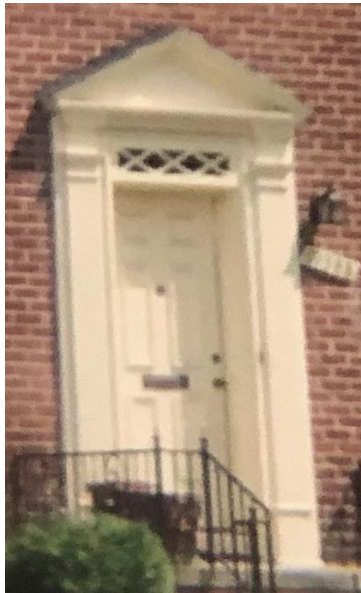
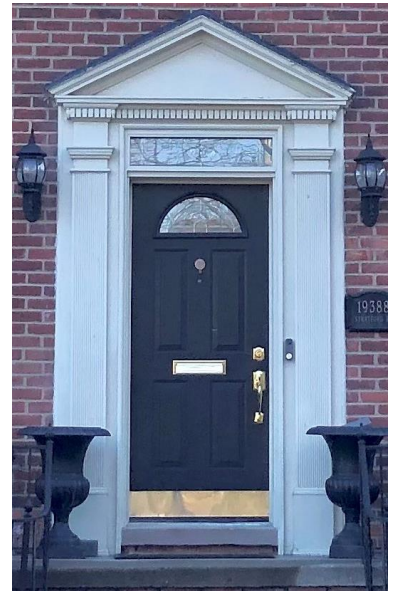
- The entry in the property’s designation photo (near right) confirms a paneled door and cross-hatched true-divided light transom (and matching the design on the blueprint) were in place at time of designation. The photo at far right taken by HDC staff in March 2022, shows a replacement door and replacement transom. HDC staff did not find an approval on file for these alterations. Staff has also noted the concrete front walk and stair treads were replaced with brick (the brick walkway has a stone border).
- Staff does not know when the peaked walls extending past the roof at the second floor were removed, however they were not present in the designation photo and not subject to HDC review at this time.

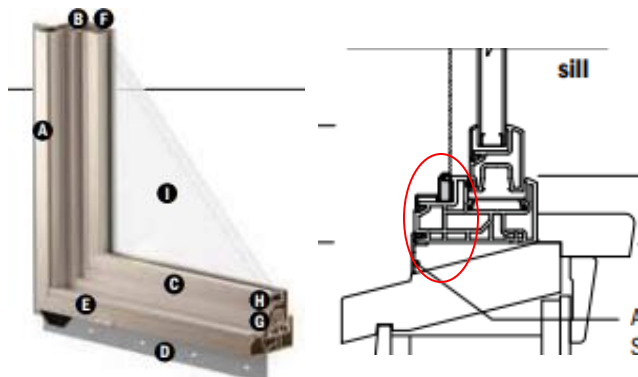
100 Series, Fibrex single-hung unit
This unit has an approximately 2” bottom rail, however it is partially covered up on the exterior by additional window framing.

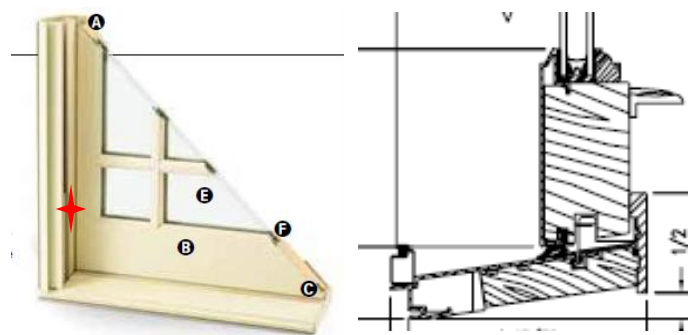
Wood, aluminum-clad double-hung unit
This unit retains a traditional proportion of a historic wood window bottom rail, but has a visible and mis-matched jamb liner within the lower frame (due to the operable upper sash).

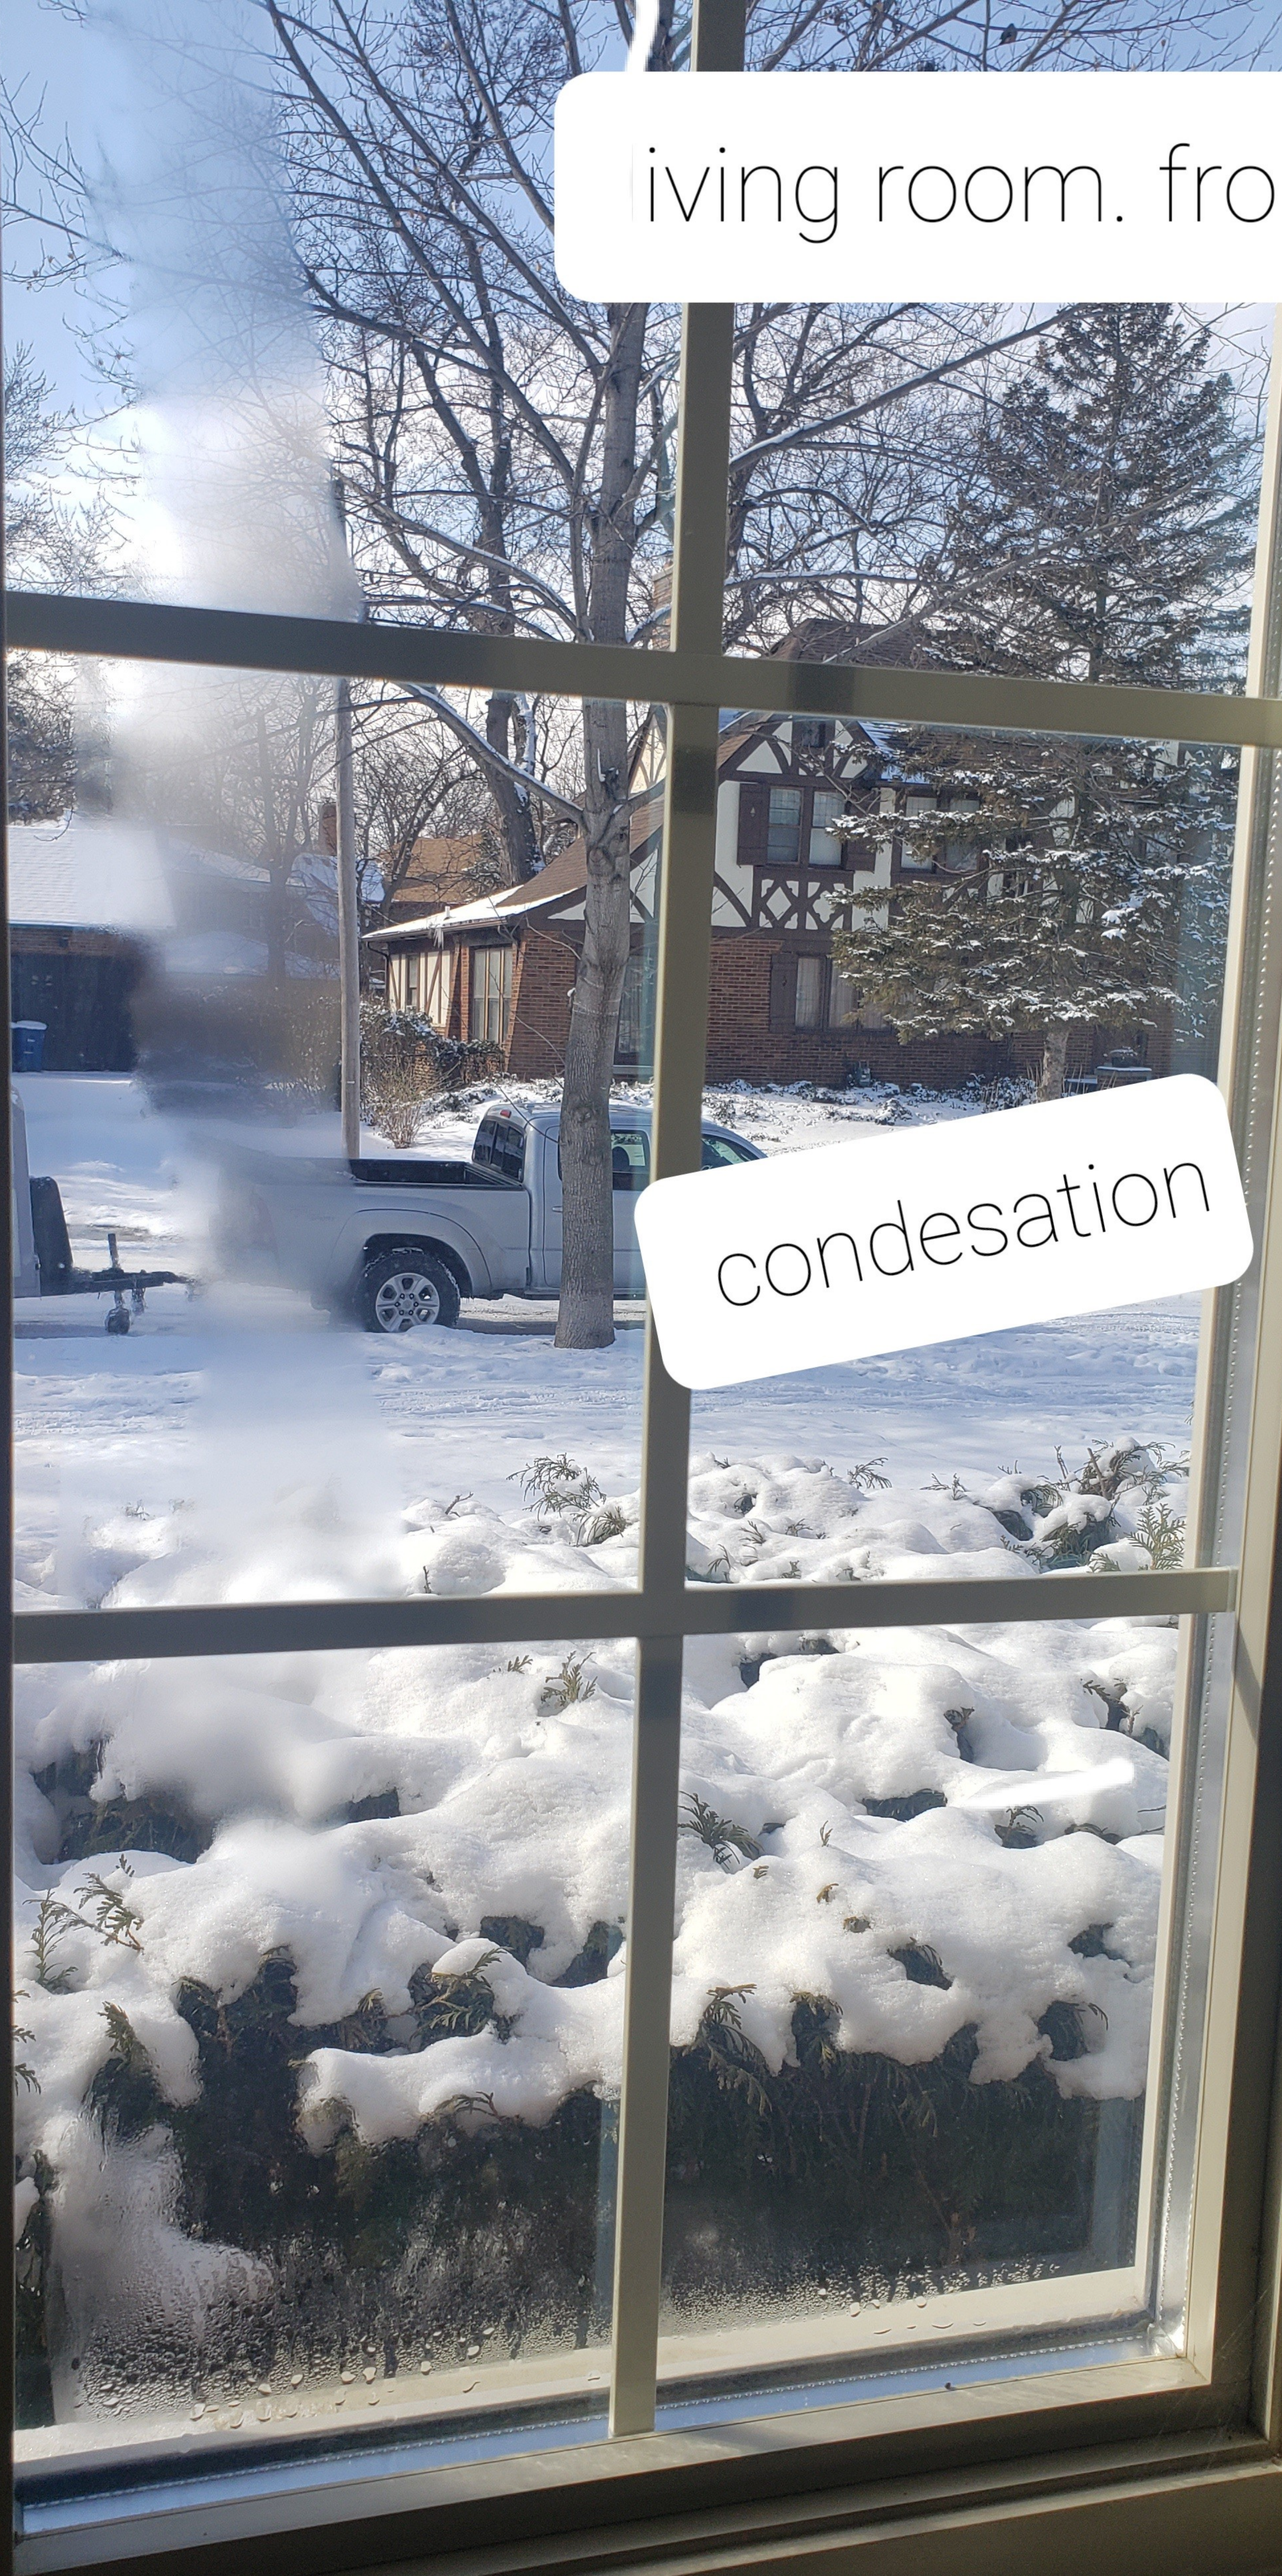
rear kitchen

A photograph of a red wall. On the right side, there is a white window frame with white horizontal blinds. A white, rounded rectangular label is superimposed on the wall, containing the text "rear kitchen". A thin white line curves from the top of the label, arching over the top of the window frame and ending near the bottom left of the frame. There is some peeling or damage to the red paint on the wall just below the window frame.

- Existing vinyl kitchen window will be replaced with an Andersen 100 series single hung window, sandtone interior and exterior, tempered bottom sash, sculptured BTG (between the glass) grids 1 H (horizontal) 3 V (vertical) colonial style. Standard hardware. Exterior window wrap black. 47" x 60"
