STAFF REPORT: JUNE 8, 2022 MEETING

APPLICATION NUMBER: 22-7847

ADDRESS: 2235 LONGFELLOW

SCOPE: REPLACE ASPHALT SHINGLES ON DORMERS WITH VINYL PRODUCT

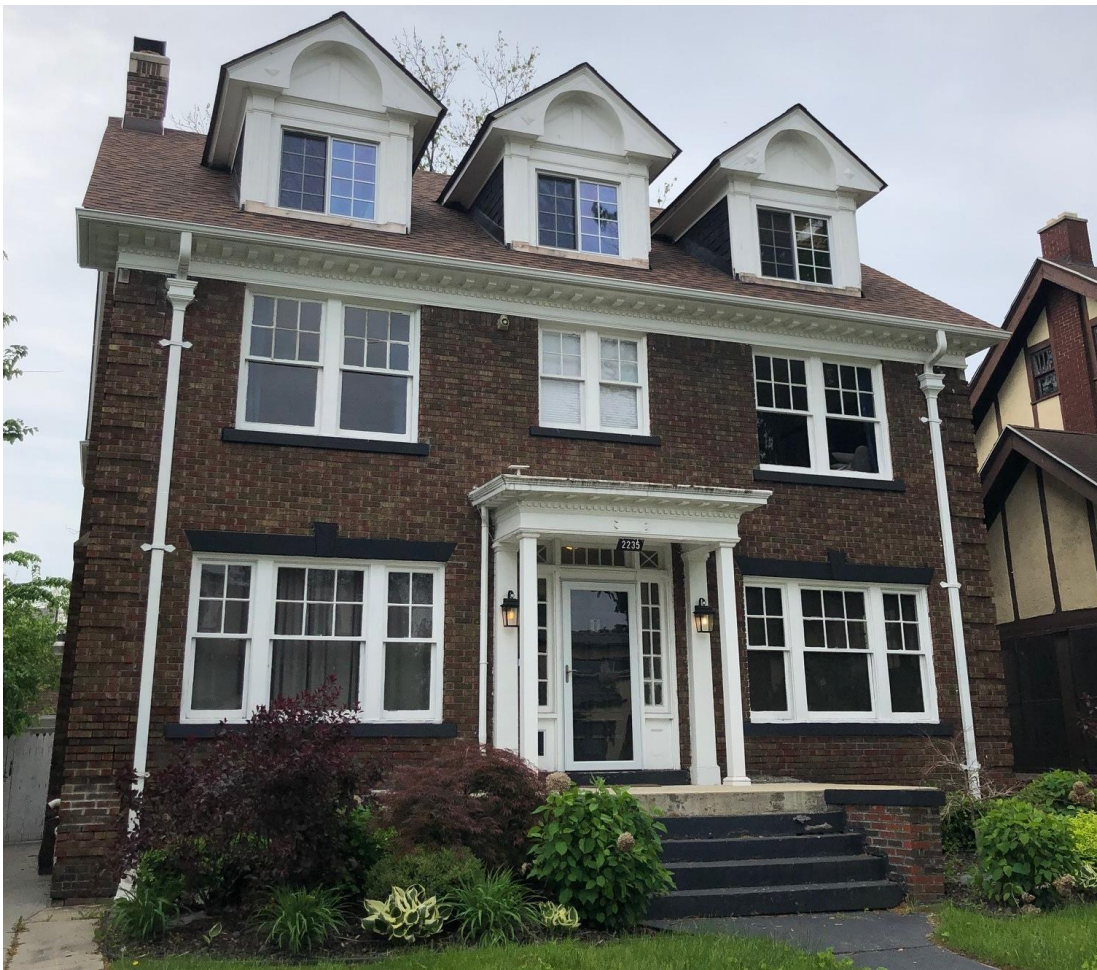
Staff photo, May 25, 2022

The dominant window on the house is a wood double-hung unit of varying widths and upper sash muntin patterns, however grouped casement windows are located on the side and rear elevations (leaded glass units on the east elevation and wood muntin units on the west and rear/south elevations). The front elevation dormers have vinyl sliding replacement units; the dormer walls on the front and rear elevations are faced with black asphalt shingles.

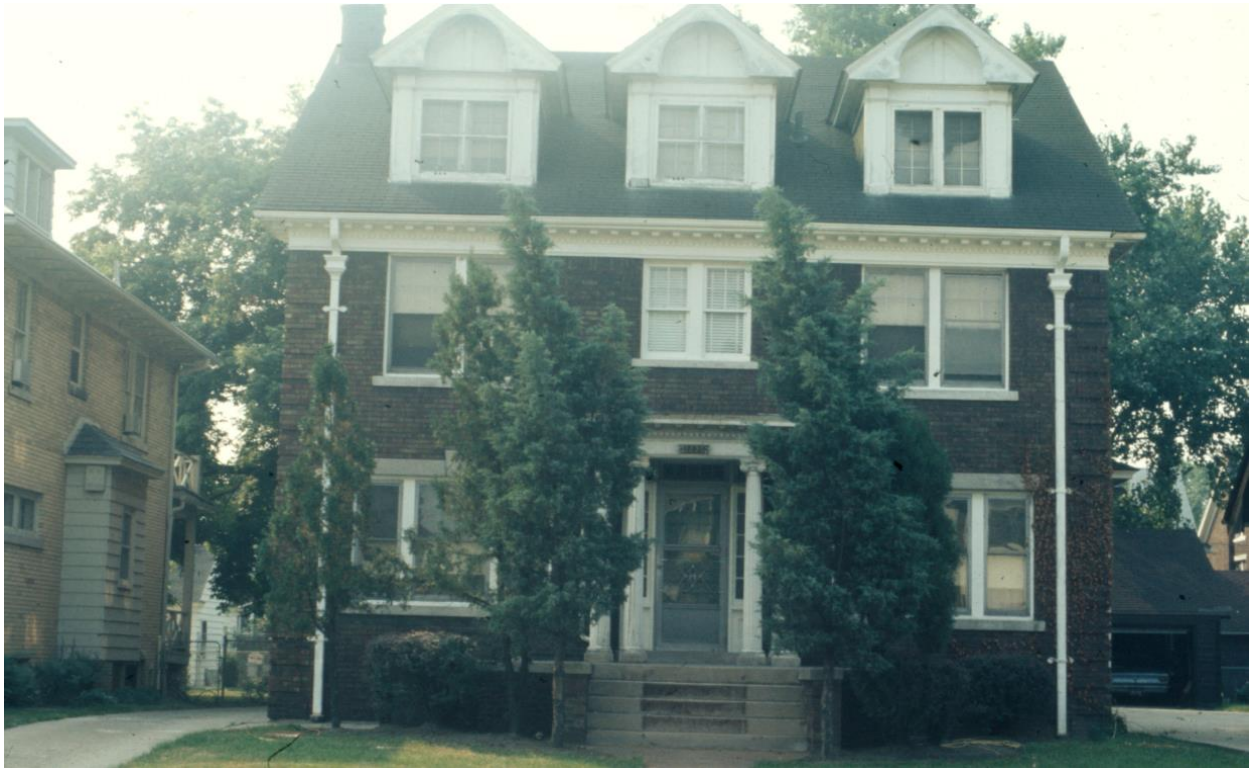
Designation photo, 1974, HDAB

- The Boston Edison Historic District was established in 1974.
- While the house’s original roof and dormer walls were likely covered in slate or cedar shingles, staff does not have physical or visual confirmation on the original roofing and dormer materials for this house. As seen below, a black asphalt shingle roof was in place at time of district designation.

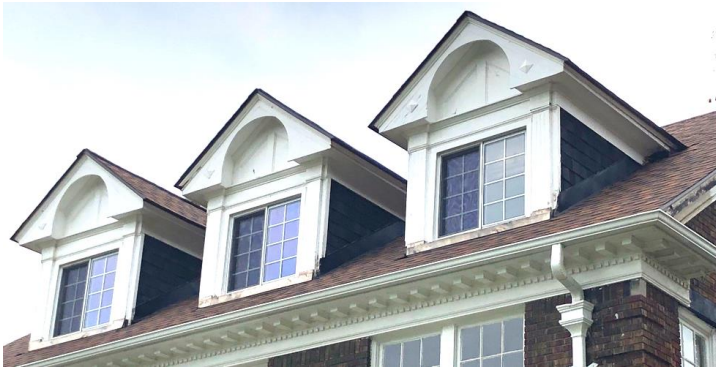
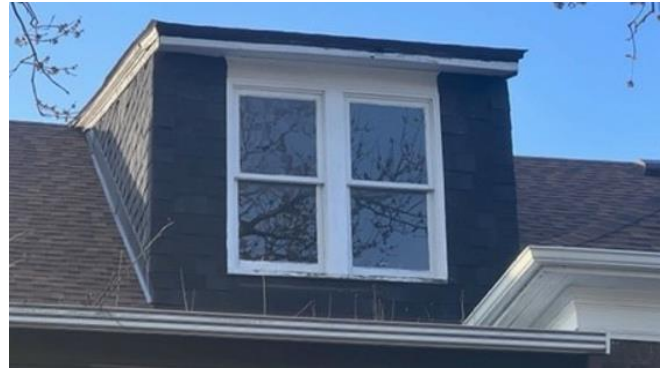
- The asphalt shingles on the rear shed dormer wrap the corners, whereas historically (and architecturally speaking), this dormer would have a frieze board and possibly corner trim.

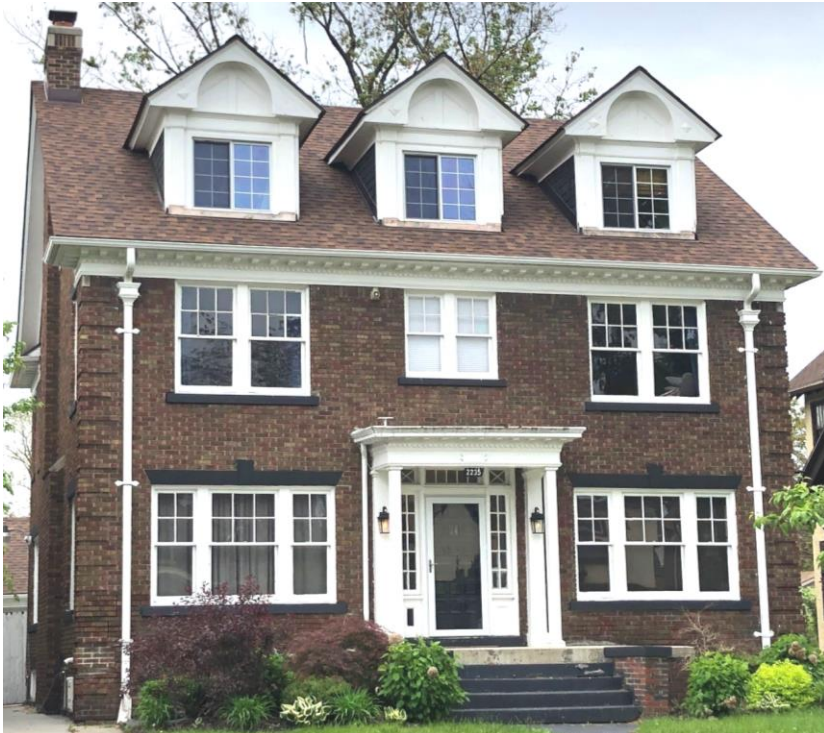
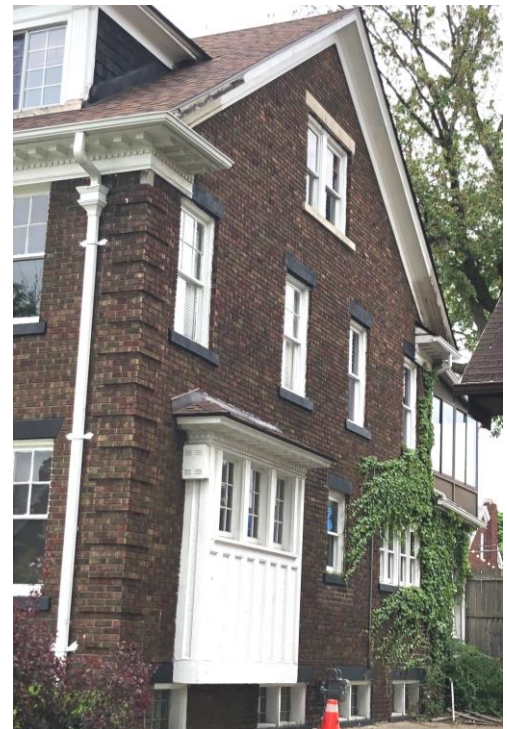
Staff photographs

- Alterations made to the front and sides of the house include the vinyl sliding window units (with between the glass muntins) in the dormers and painted black stone lintels and sills. The 2017 staff report identified the dormer windows as a violation, but the painted stone is noted now as a violation. While the color falls within the color system for the house, stone should remain unpainted; furthermore, the dark color against the dark brick causes the stone to almost disappear.

- Architectural components still in place (which are often gone or severely altered) include the downspout collector boxes and the exterior cladding and small windows on the side wall bump out. The applicant claims the existing front door is not original to the house, but staff determines it is an appropriate style and appears to have been in place at time of designation. Overall, the house retains an exceptionally high level of historic architectural detailing.

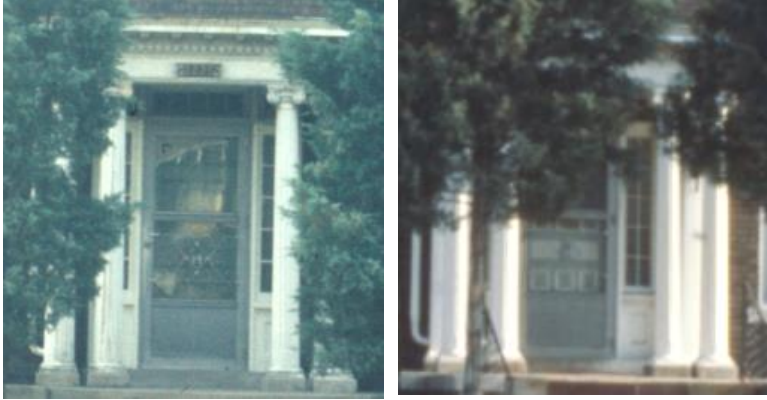
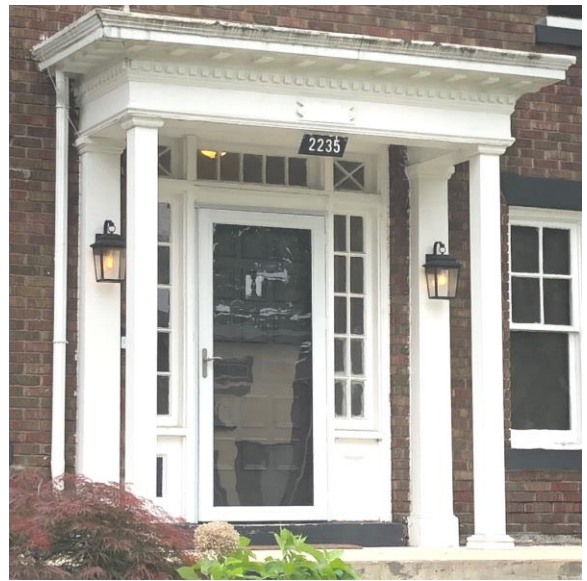
Staff photo of existing conditions of front entry

- The existing portico columns are not original to the house. Ionic fluted double columns, as seen in the 1974 (below left) and 1980 (below right) HDAB photos were removed at an unknown time. The square, trimmed out columns, painted to match the existing trim, were erected as part of the 2017 rehabilitation and included within the Certificate of Appropriateness (#17-5345).

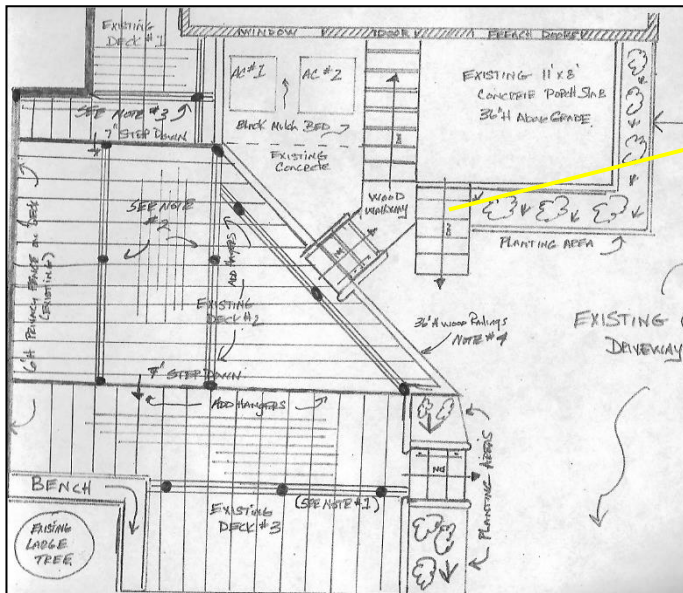
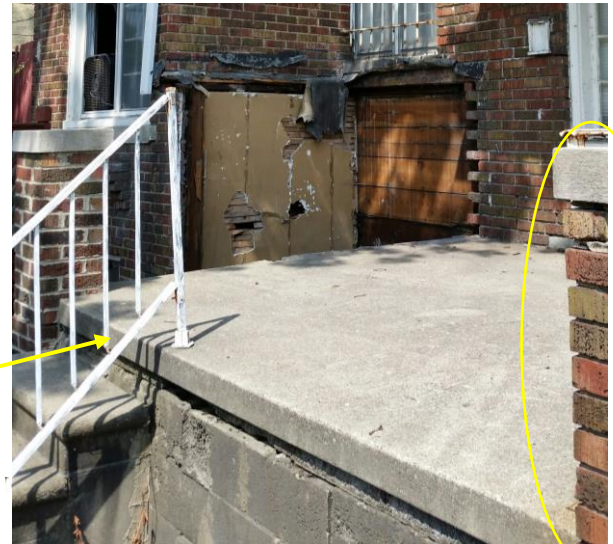
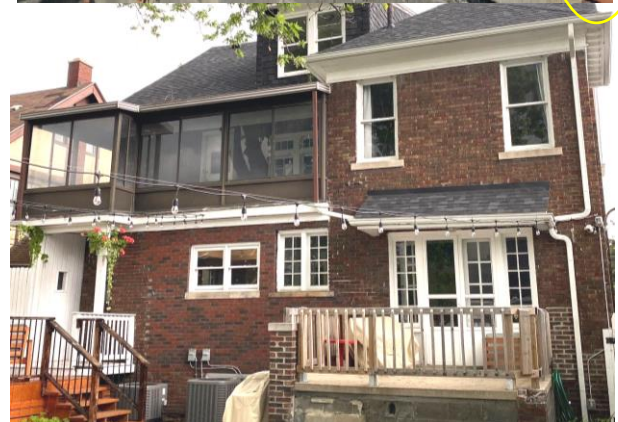
- Also approved in the 2017 application, at the rear elevation, was the removal of a small kitchen extension (it was located where the small, mullied double-hung windows are now). Other alterations made to the rear that were not part of the approved scope of work include the removal of a corner masonry pier for the raised deck, and the installation of a contemporary, unfinished deck railing.

Above and Top Right: Rear yard drawing and photo from 2017 application.
Right: 2022 applicant photo of existing rear elevation
