**STAFF REPORT: JUNE 8, 2022 MEETING**

**APPLICATION NUMBER: 22-7849**

**ADDRESS: 1437 VINEWOOD**

**SCOPE: REPLACE WINDOWS**

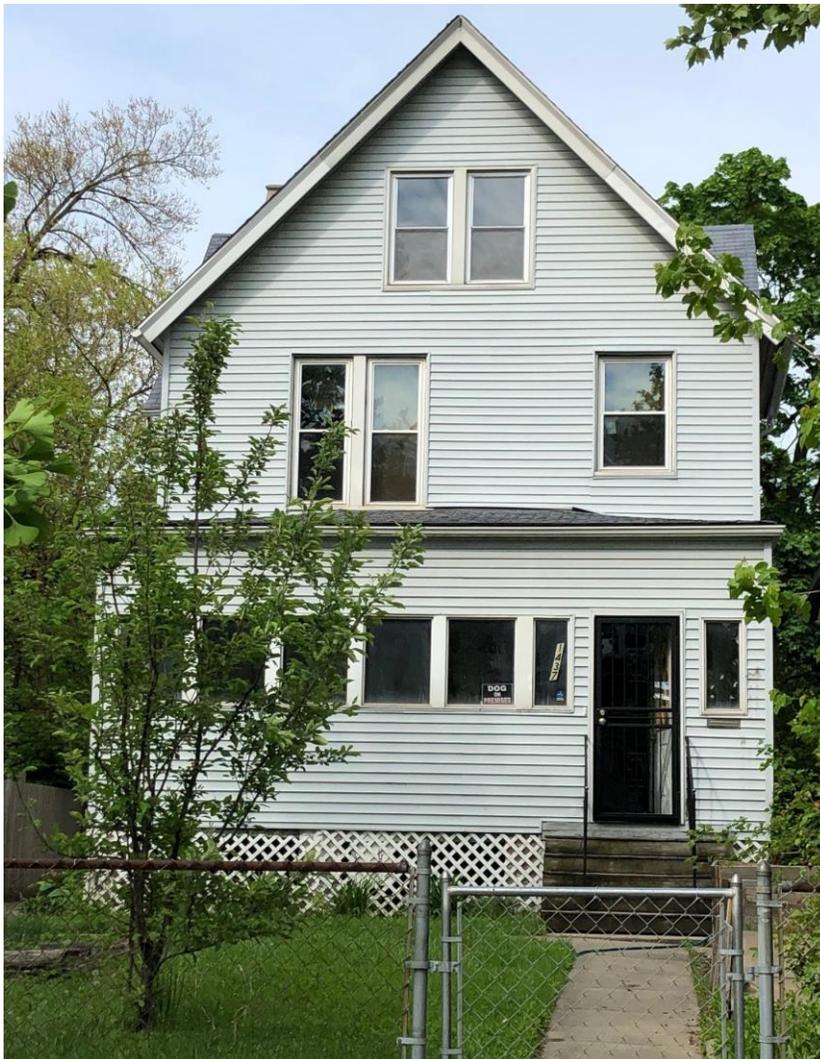
*Staff photo, May 25, 2022*

Erected circa 1908, this structure has a cross-gable roof which allows for full-size windows at the third floor on each side of the house. The exterior walls (including the enclosed front porch) are covered in vinyl siding, and most of the windows are vinyl sash. The concrete front walk is at the northern side of the lot and leads to the off-center door which is accessed by a set of wood stairs. A driveway, extending from Vinewood to the detached garage at the southeast corner of the rear yard, fills the space between the house and the southern property line. The front and north sides of the front yard are enclosed by a chain link fence; a gate is located at the front walk.

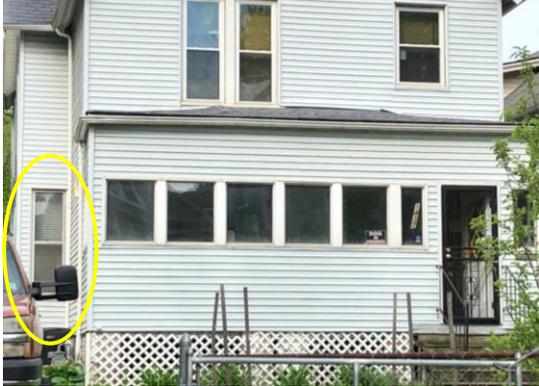
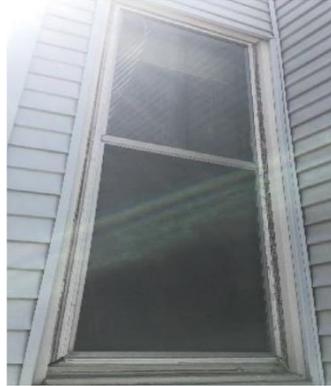
Front/East elevation

- One double-hung unit, one-over-one sash, is to the left of the enclosed porch.

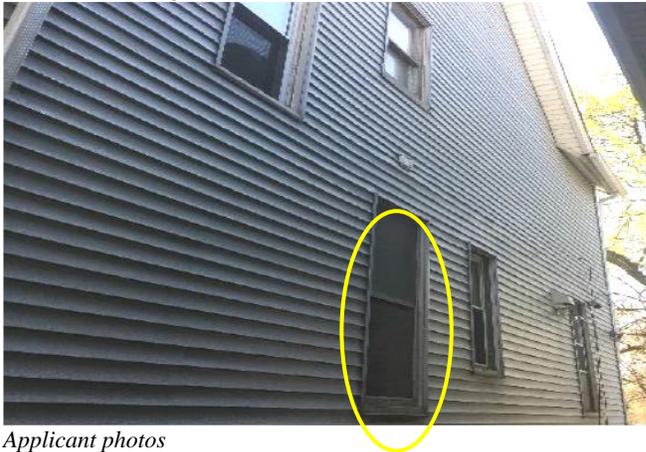
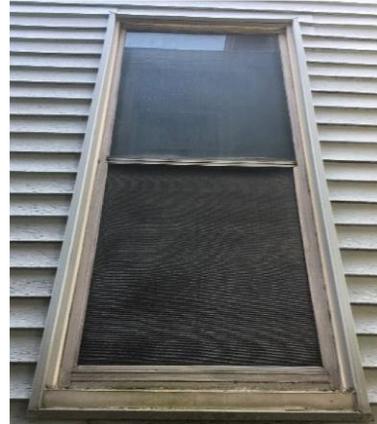
Side/North elevation

- One double-hung, one-over-one, window is near the front of the house.

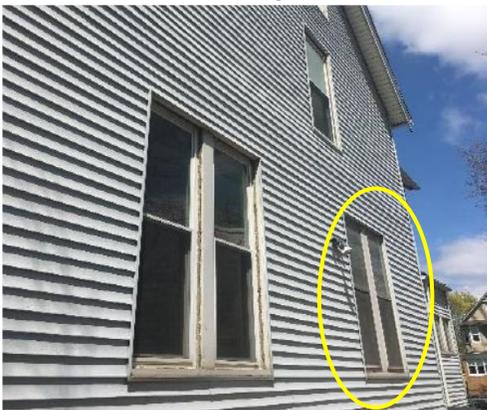
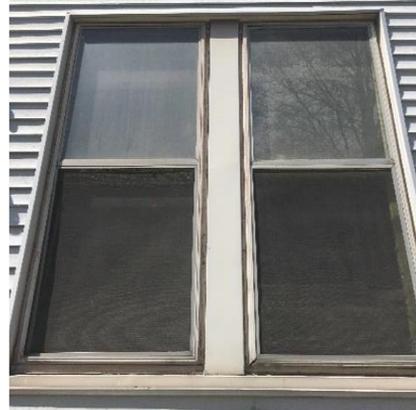
Side/South elevation

- Two mulled double-hung units, each with one-over-one sash, are near the front of the house.

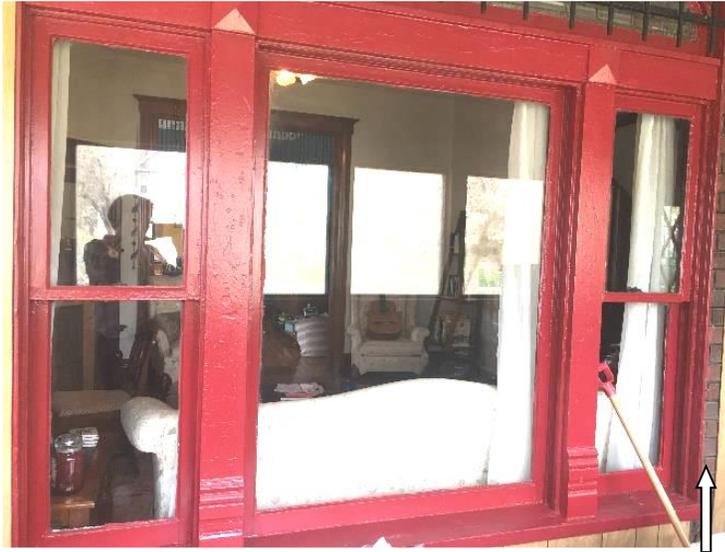
*Applicant photo*

- The Hubbard Farms Historic District was established in 2001.
- The applicant included in the scope of work a triple mullied wood window opening, consisting of a central picture window flanked on each side by one double-hung, one-over-one, unit. This opening is located inside the enclosed front porch. The HDAB photo, above right, shows the porch was enclosed prior to the district's designation. HDC staff considers this an interior window, and therefore, does not fall under the Commission's jurisdiction. However, staff recommends the applicant retain the window opening, as well as the historic wood window sash, should the owner (or future owners) seek to restore the porch to its proper historic expression in the future.

*Insulbrick*

- Architectural features related to the window openings may remain under the vinyl siding, however the applicant looked under the vinyl siding at two different areas of the house and confirmed it was installed directly over Insulbrick. Some Insulbrick remains visible on the inside wall of the front porch (identified in the above photo), however most of it has been covered over with paneling. It is staff's experience, when reviewing houses where the Insulbrick has been removed, most (if not all) of the protruding trim originally on the house is gone as a flat surface was needed for the Insulbrick installation.

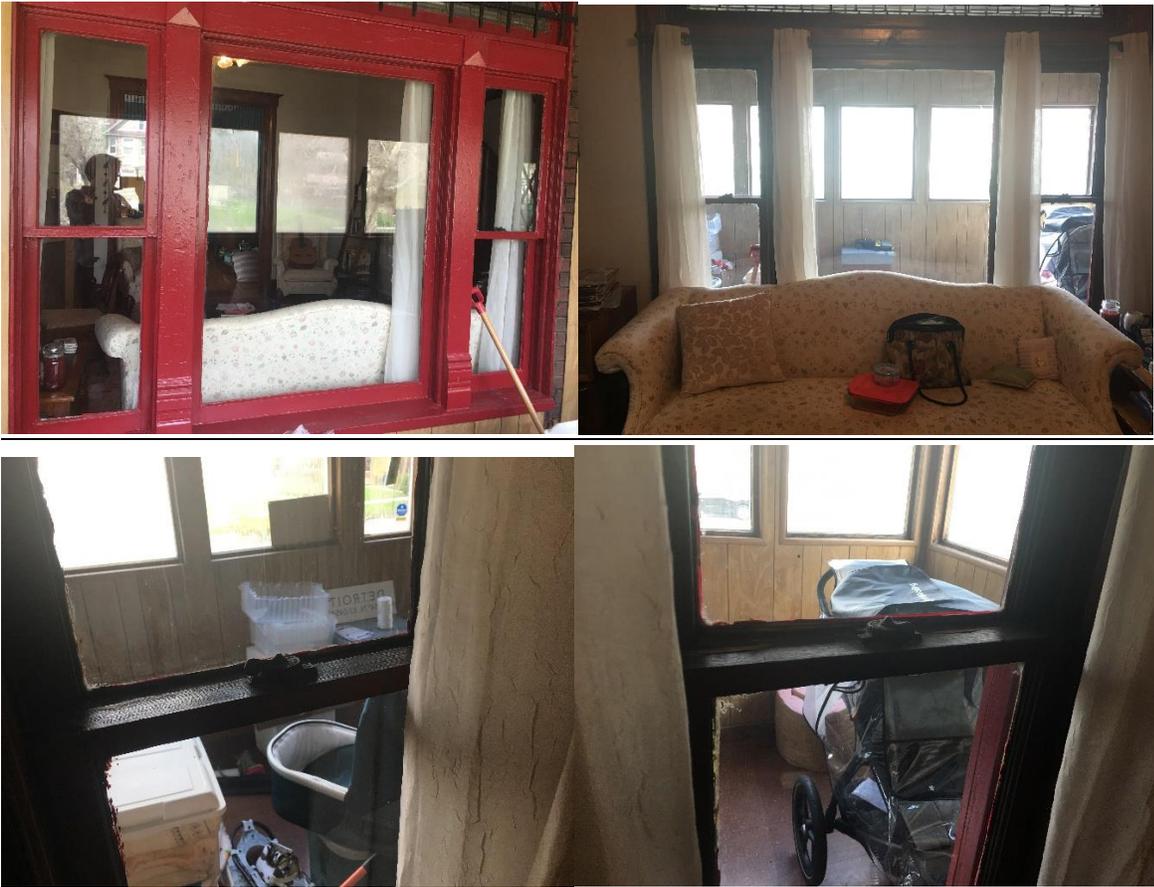
3 windows to be replaced inside covered porch on front of house (Northeast Side)

- Replace 1 wood, picture window inside covered porch on front of house (Northeast Side) with 1 vinyl, picture window.
- Replace 2 wood, double-hung windows inside covered porch on front of house (Northeast Side) with 2 vinyl, double-hung windows.
- Replace 1 wood, double-hung window on southeast side of house facing front of house (Northeast Side) with 1 vinyl, double-hung window.
- Replace 2 wood, double-hung windows on southeast side of house facing southeast side with 2 vinyl, double-hung windows.
- Replace 1 wood, double-hung window on northwest side of house facing northwest side with 1 vinyl, double-hung window.

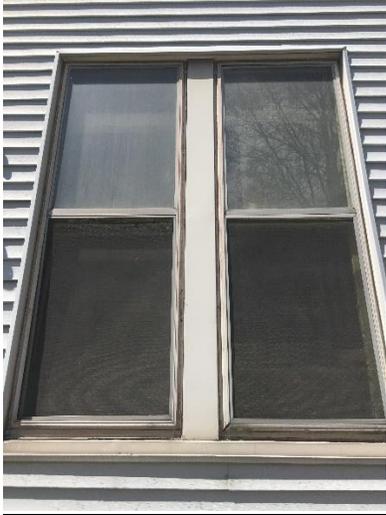
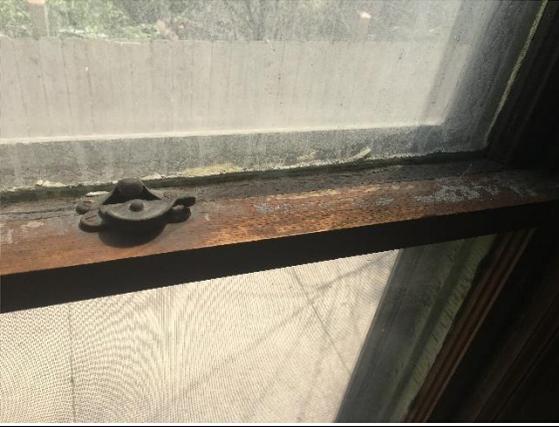
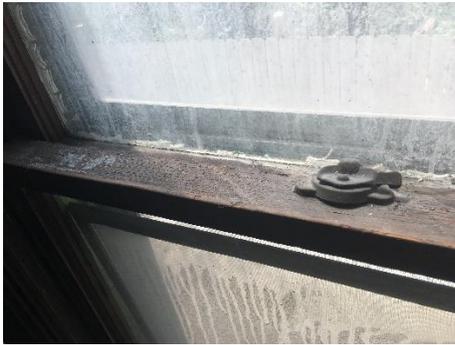
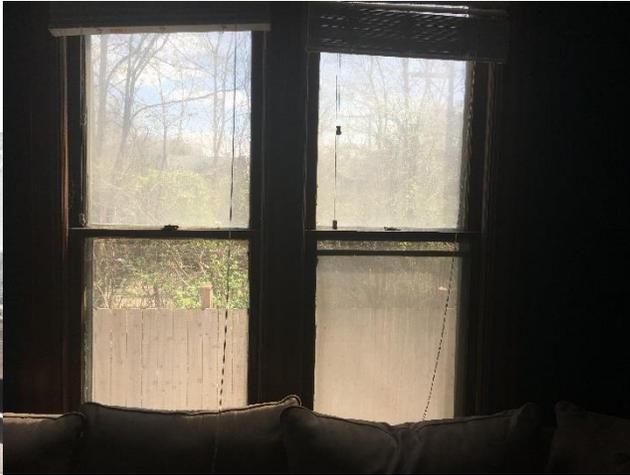
2 windows to be replaced on southeast side of house facing southeast

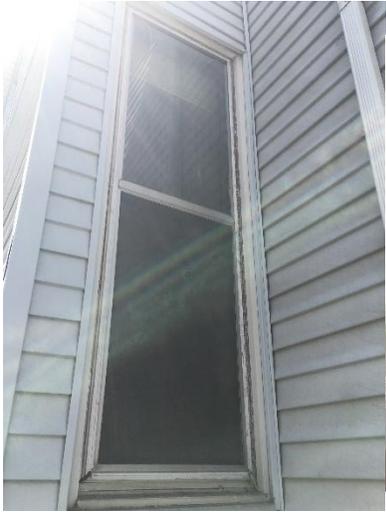
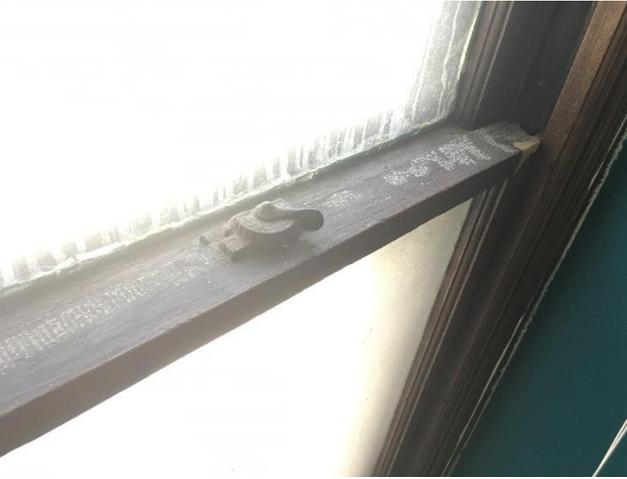
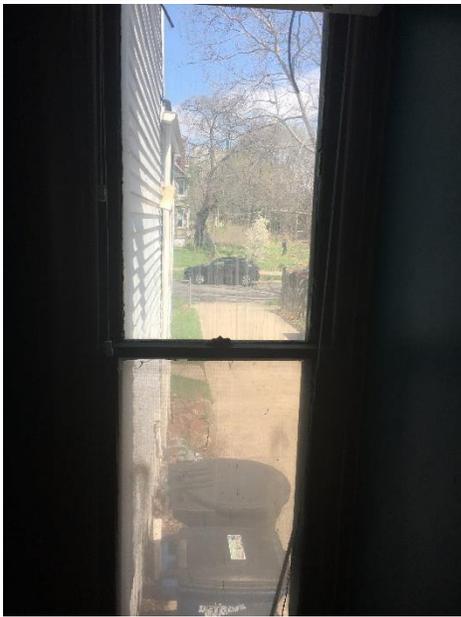
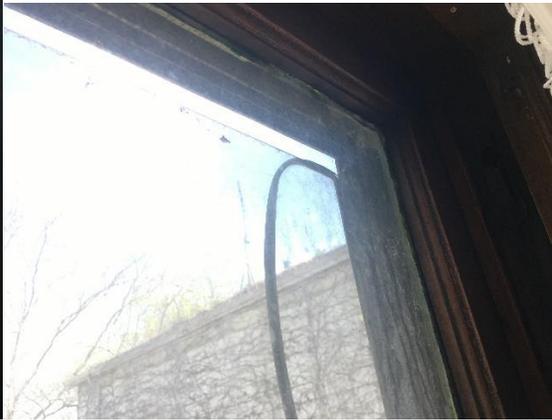
1 window to be replaced on southeast side of house facing northeast

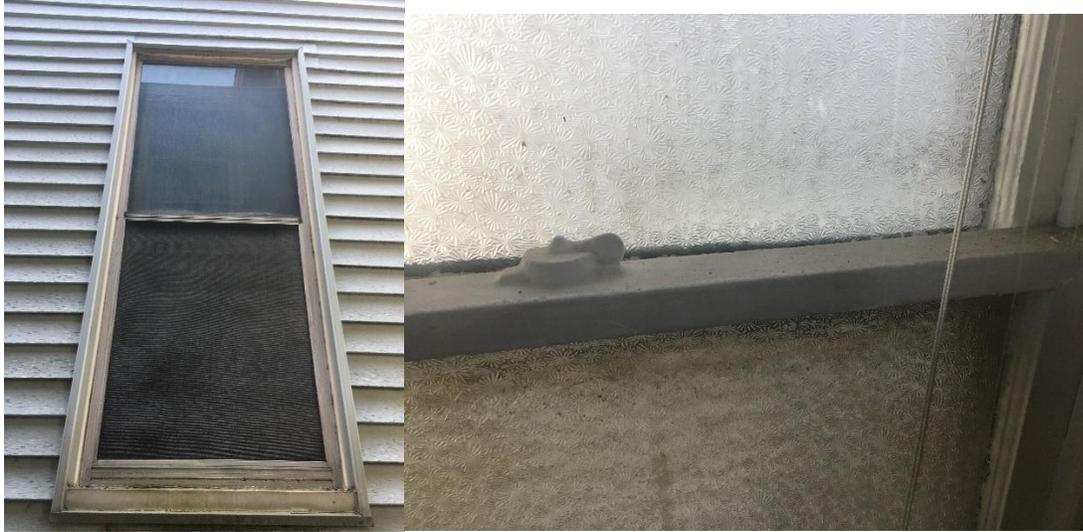
1 window to be relaced on northwest side of house facing northwest side
