STAFF REPORT: JUNE 8, 2022 MEETING

APPLICATION NUMBER: 22-7850 VIOLATION NUMBER: 22-592

ADDRESS: 1814 – 1820 CHURCH

SCOPE: REPLACE WINDOWS (WORK COMPLETED WITHOUT APPROVAL)

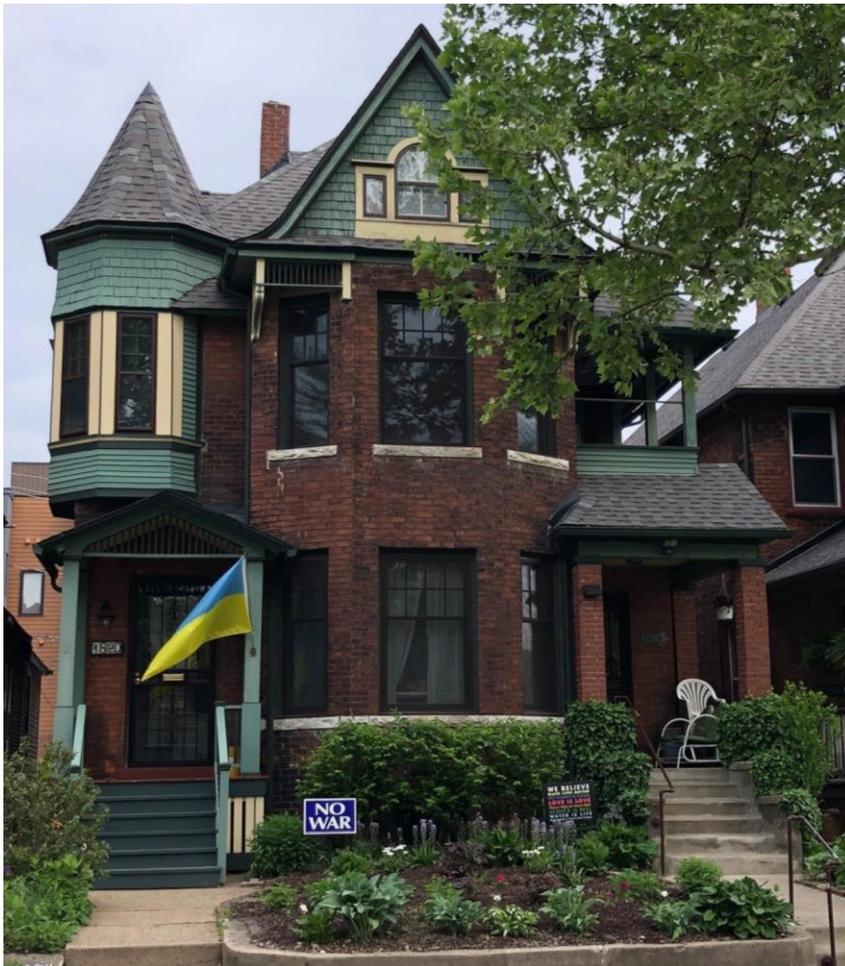
Staff photo, May 25, 2022

Erected circa 1895, this 2-1/2 story structure has an asymmetrical front elevation which creates two distinctive facades for the two-family house. The raised entrances, at either front corner of the house, are designed with different roofs (front-facing gable vs. shed), supporting columns, porch floor and steps (wood vs. masonry) and placement of the front door. This architectural division continues at the second floor with one front corner having an open porch while the other side has a polygonal tower with conical roof. The building is balanced by a central two-story protruding wall that is capped by a Palladian window within a front-facing dormer that is accentuated by decorative corbels and spindle work. The house fills most of the lot, with only a few feet between it and the neighboring houses.

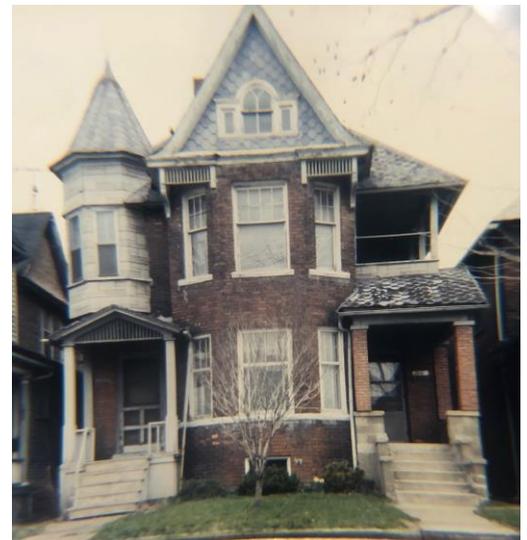
- The Corktown Historic District was established in 1984.
- At the time of district designation (HDAB designation photo at right), Insulbrick siding covered the wood clapboard and shake siding. The repair of the historic wood siding, coupled with the multiple-colored paint palette, emphasizes the textured wall surfaces and exterior ornament of this late 19th century house.

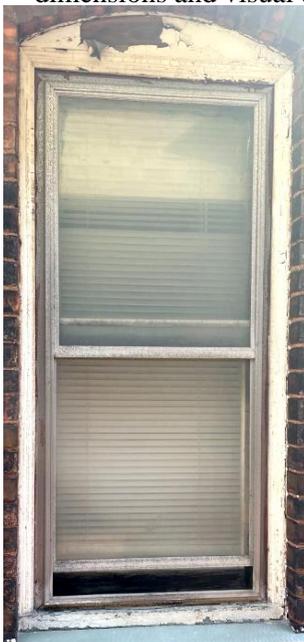
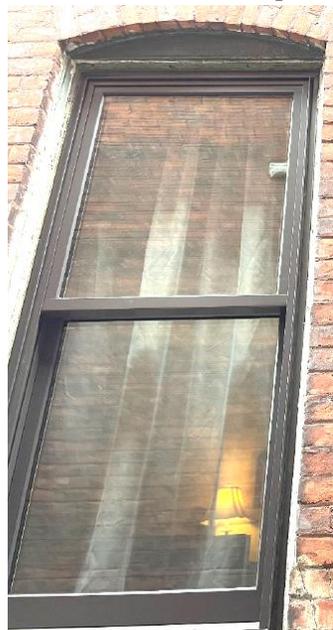
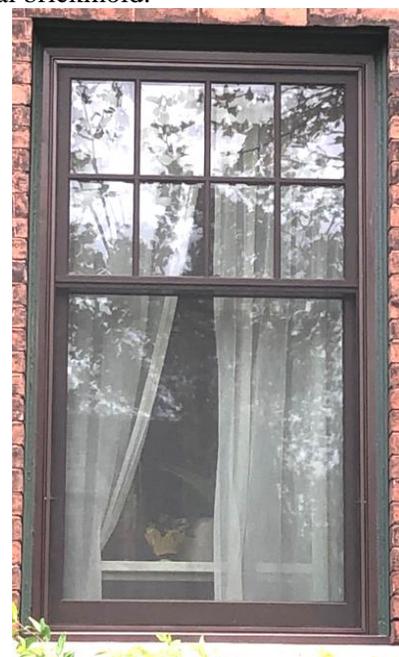
- The applicant provided a photograph of an existing wood window with an aluminum storm frame (below left), as well as a photograph of one of the recently replaced window units (center). The original opening retains the wood brickmold (wood framing) around the window sash. Brickmold fills some of the depth between the outer masonry wall and window unit while adding additional detail to the opening. The recently installed window does not have brickmold in place, so the window appears to sit very far back within the masonry opening and the dimensional framing of the sash has been lost. The double-hung with divided light upper sash (below right), taken by staff, shows a previously replaced unit with a narrow brickmold applied to the sides and top of the sash. While offering some detail, the narrow brickmold is only noticeable due to the contrasting paint color and does not match the dimensions and visual balance (within the full opening) of the original brickmold.

It is staff's opinion the replacement of the existing windows with replacement units will alter the features and spaces that characterize the property. Staff therefore recommends the Commission deny a Certificate of Appropriateness for the work as proposed because it does not meet the Secretary of the Interior Standards for Rehabilitation and the Elements of Design for the district, specifically Standards:

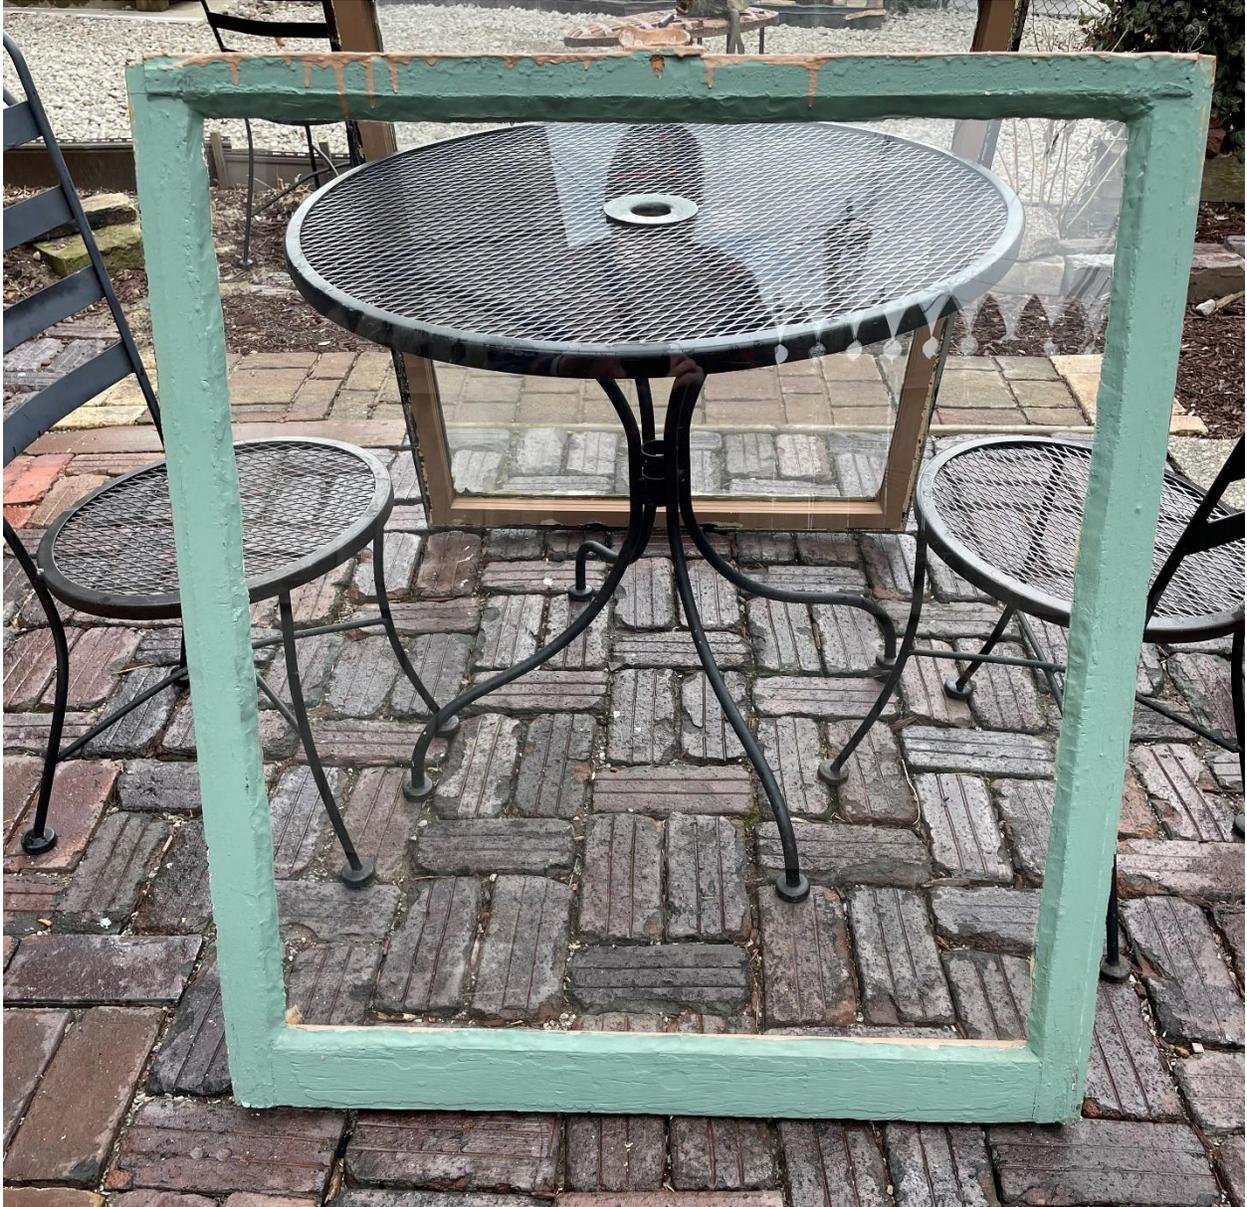
1814 Church, Old Double Hung Top Sash

- The first floor, 1814 Church, dining room windows that were replaced on the east wall, were original to the house that was built in 1901. Wooden then aluminum storms were added sometime later during the history of the house. The condition of double-hung originals as seen in accompanying photos are with significant decayed wood, non-functioning window weight systems, mostly inoperable for opening and closing, with several layers of paint, much of it lead based, with acid-etched and cloudy single-pane windows, all of which make the Marvin replacements the most cost effective, energy efficient, ambient noise reducing and environmentally responsible option.
