STAFF REPORT: 8/10/2022 REGULAR MEETING

APPLICATION NUMBER: 22-7956

ADDRESS: 1427 ATKINSON

SCOPE: REPLACE EIGHT WOOD WINDOWS WITH ALUMINUM-CLAD WOOD WINDOWS

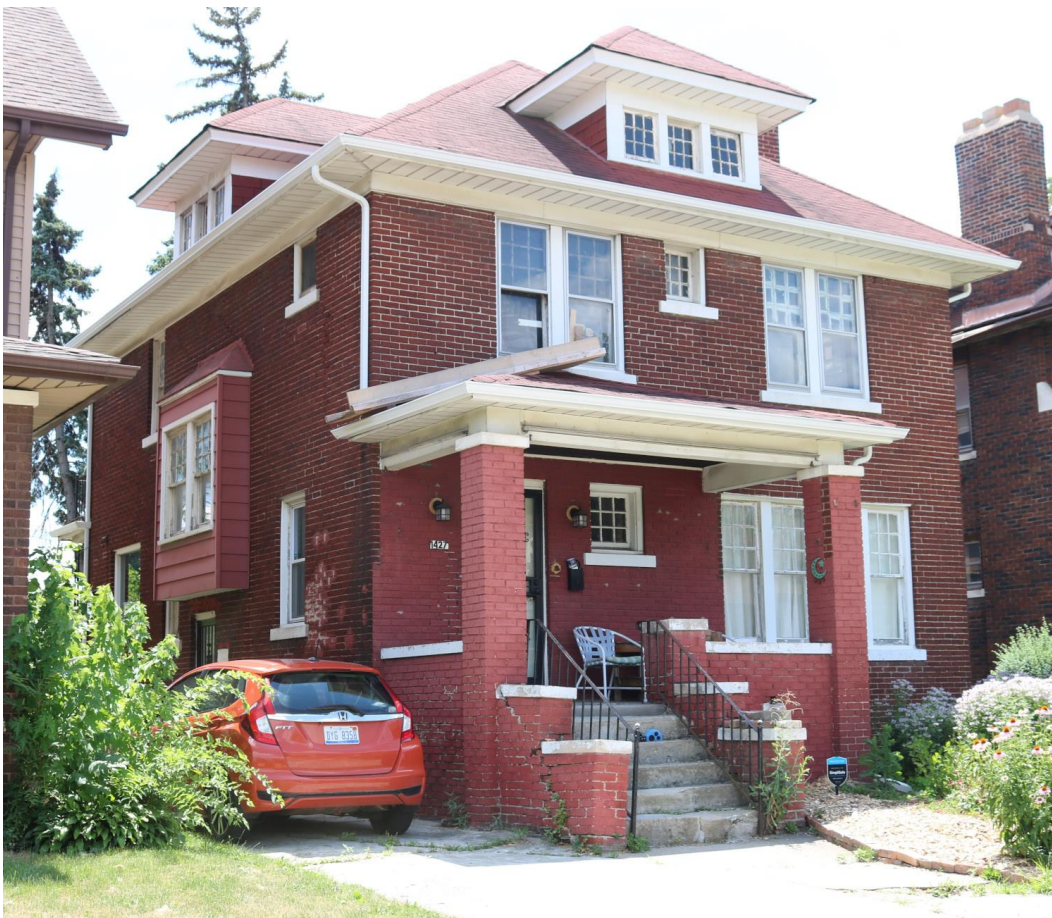
1427 Atkinson Ave. is a two-and-a-half story, red brick, foursquare house built in 1914. It faces north onto Atkinson Avenue in the Atkinson Avenue Historic District. The house is comparable to the other houses in the district in age and scale. It bears minimal architectural ornamentation; nine-over-one sash windows and nine-light casement windows are prominent features. Some of the windows are covered by storm windows.

July 2022 photo by staff.

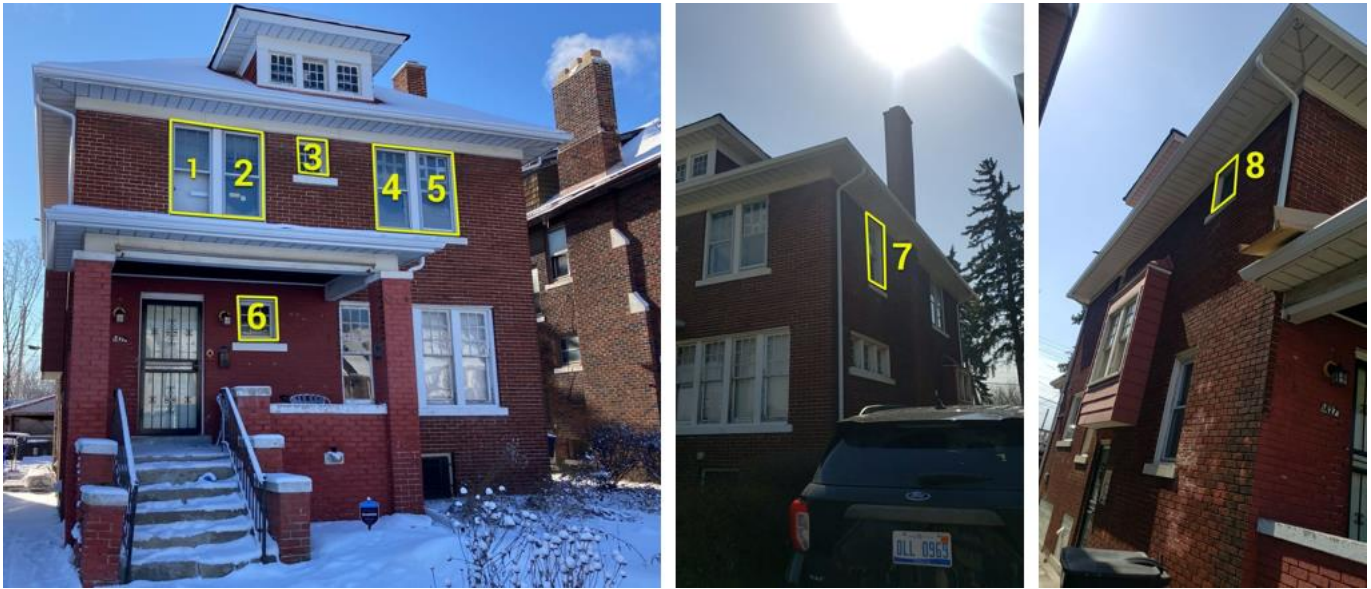
Eight windows proposed for replacement.

- The existing windows appear, based on architectural style, to be original to the building, and are stated to be original by the applicant. The applicant further asserts that the existing windows have been “painted numerous times,” that “most do not open and close properly” and that they are “extremely energy inefficient.”
- Regarding the degree of deterioration of the windows, staff observes, through photos provided by the applicant as well as an exterior site visit conducted July 22, 2022, that windows show clear signs of having been painted over numerous times, a condition which will impair their ability to operate and seal properly, thus decreasing their functionality, aesthetics, and energy efficiency. These conditions are typical maintenance needs of old windows and are repairable.¹

- The building’s windows are both historic (original to the house) and distinctive (as suggested by the Elements of Design) and have not deteriorated beyond repair. The Secretary of the Interior’s Standards for Rehabilitation, cited below, direct that they be retained and preserved or repaired.

Staff recommends that the Commission issue a Denial of the proposed work as it does not meet the Secretary of the Interior’s Standards for Rehabilitation, in particular:
