STAFF REPORT: SEPTEMBER 12, 2022 MEETING PREPARED BY: A. DYE

**APPLICATION NUMBER: 22-8012**

**ADDRESS: 1556 BAGLEY**

SCOPE: REHABILITATE DWELLING, ERECT REAR DECK

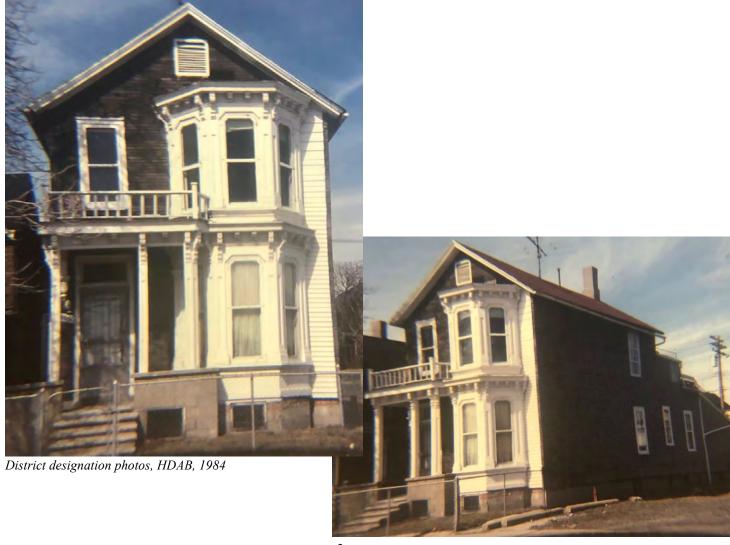
The first photo documentation the city has on file for the property is the 1984 district designation photos which show the existing front porch in place. Staff believes the existing concrete porch was erected after 1950 and before 1984, however the wood porch columns are likely elements of the original porch.

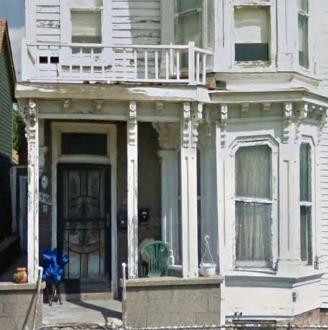
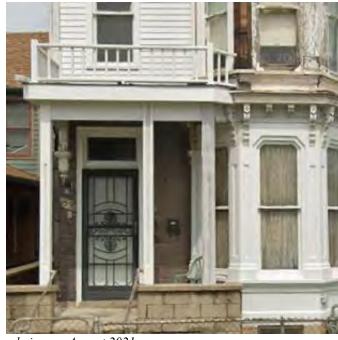
■ When reviewing Google street view images, staff noted the historic decorative brackets at the front porch were removed between November 2020 and August 2021. The posts and brackets are distinctive character-defining features and tie in directly to the continuing bracket details at the adjacent bay window. Staff informed the applicant of this work done without approval; this scope of work was not added to this application.

Google image, July 2018

Google image, August 2021

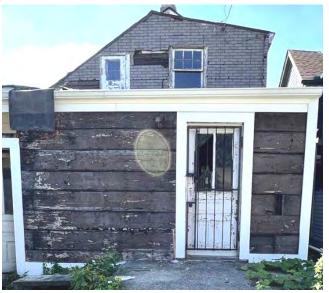
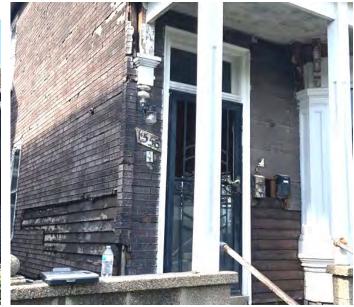
• Visible in the district designation photos is "Insulbrick" siding (asphalt fiber siding with a brick appearance) covering the exterior walls. It appears the window casings were not covered.

• The Insulbrick has fallen off (or been removed) in certain areas and uncovered the original wood clapboard siding that appears to be in good condition.

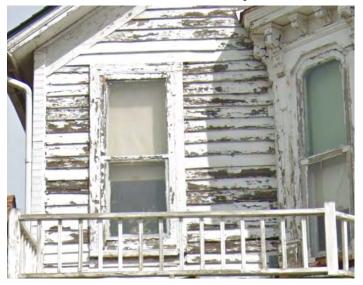
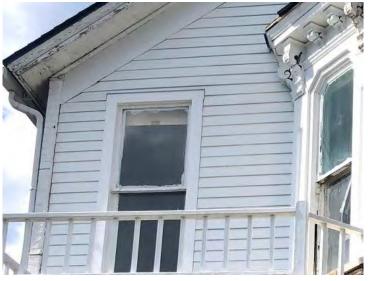
These before and after photos demonstrate changes to the historic appearance of a house by the installation of new materials. Above left: Google image, May 2019. Notice how the window casings sit in front of the wood siding. Above right: Staff photo, August 2022. It appears as though new siding was applied to this portion of the wall (between November 2020 and August 2021. The new siding is narrower in height than the old siding (there are eight clapboards spanning the upper sash in the before picture, but now there are ten). The window casing has been capped, not only losing the straightforward dimensionality of the 19<sup>th</sup> century window casing, it also now in line with the new siding, so the dimensionality of the entire window opening has been lost.

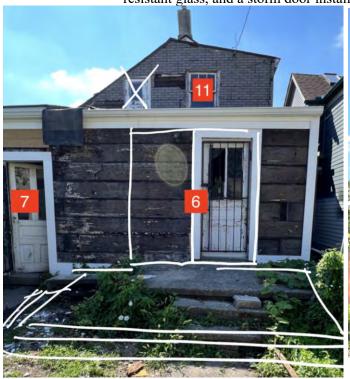
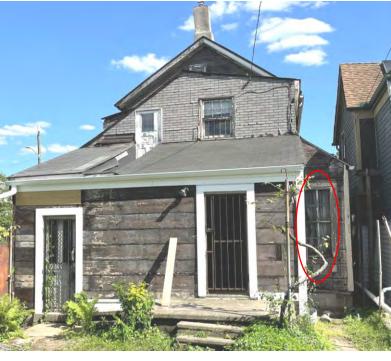
The outlines illustrate the approximate change to the rear wall for the sliding door, as well as the  $10' \times 13'$  wood deck with steps extending down on east and north sides. Door #7 is to be replaced with a half-panel/half-glass steel door.

• Staff believes the remaining wood entry door, as it is intact, could be repaired and retrofitted with impact resistant glass, and a storm door installed.

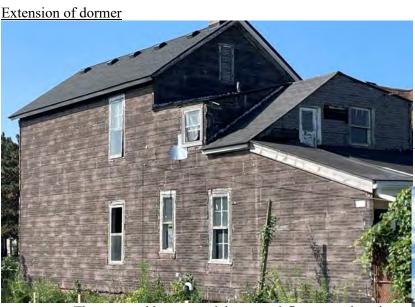
The proposal is to extend the second-floor east elevation wall to the edge of the upper roof, increasing the headroom and square footage of the bathroom. Staff doesn't believe this new construction will diminish the historic architectural integrity of the house, as the footprint of the historic addition remains intact, along with the existing window opening.

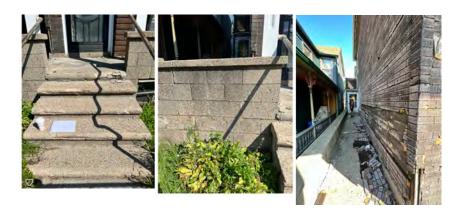
#### FRONT PORCH

The existing front porch is built from cinderblock for the walls with a cement cap and also with a cement floor. This porch is suffering structurally and is sinking and cracking causing a hazard. After further consideration we decided this will be made structurally sound from underneath by getting access in the basement, then the floor will be re poured in cement. The original footprint of the porch and stairs will remain as it is now. The cinderblock walls of the porch will be tuck pointed and repaired. This will all be painted white to match the exterior. The stairs up onto the front porch from the street are also currently cement with exposed wires and cracks. We will re build these steps with 13 inch steps and 7.5 inch risers and these will be poured with new cement as well. The existing railing is wrought iron and is solidly attached to the footings and the house. We will keep this in place and paint it to match exterior.
