STAFF REPORT: 10/12/22 REGULAR MEETING PREPARED BY: T. BOSCARINO

APPLICATION NUMBER: 22-8047

ADDRESS: 1991 CHICAGO

SCOPE: REHABILITATE FRONT PORCH, RECONSTRUCT REAR PORCH

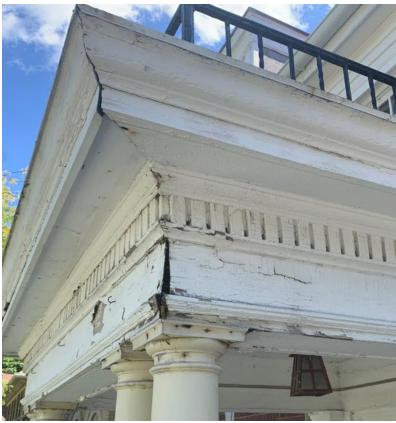
One of several deteriorated front porch areas. Photo by applicant, cropped by staff.

The applicant proposes to "remove all crown moulding, dentil trim, fascia boards, frieze boards, and bottom plates" and replace them with new wood, custom milled to match the dimensional qualities of the removed elements. The columns are to be temporarily removed to facilitate the work, and to be evaluated and repaired if needed.

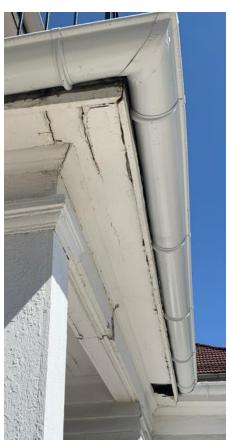
- Staff observes, from site visits and from photos provided by the applicant, that some elements of both
 porches, as well as fascia board on the rear porch, are loose and detached and may be subject to water
 infiltration and rot.

Fascia board on rear porch. Note area of missing material. Photo by applicant.

• Staff suggests that repair or replacement of the damaged fascia board on the rear porch, described in the application and shown in photos provided with the application, constitutes "ordinary maintenance" (Sec. 25-2-2).
