STAFF REPORT: OCTOBER 12, 2022 MEETING PREPARED BY: A. DYE

APPLICATION NUMBER: 22-8049 **ADDRESS**: 15135 FAUST AVENUE

HISTORIC DISTRICT: ROSEDALE PARK

SCOPE: DEMOLISH GARAGE

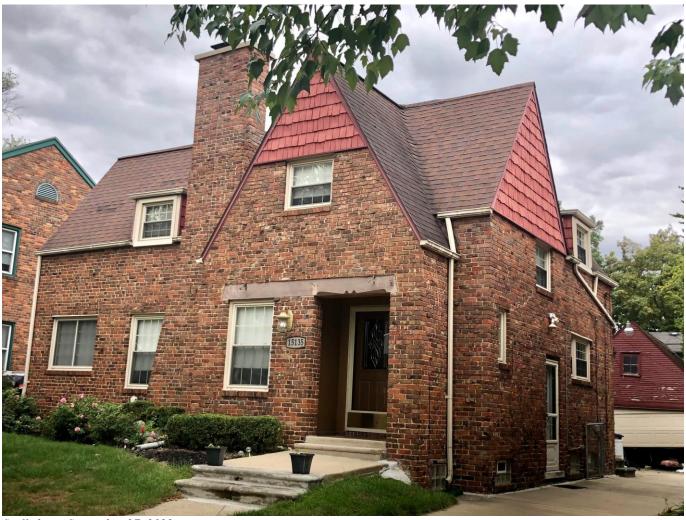
Staff photo, September 27, 2022

15135 Faust is located on the west side of the street, four lots south of Fenkell Avenue. The 1-1/2 story dwelling is faced with variegated brick in red, brown, and black tones. The cross-gabled roof (covered in asphalt shingles) is further accentuated by the painted wood shake shingles within the front and side elevation gables. The wide, front-facing chimney with a subtle decorative brick pattern and carved wood lintel spanning the recessed, raised front entry and adjacent window opening are additional distinctive character-defining features. Vinyl replacement windows of varying operation (single-hung, casement and slider) were in place prior to the historic district designation and do not contribute to the historic architectural character of the house.

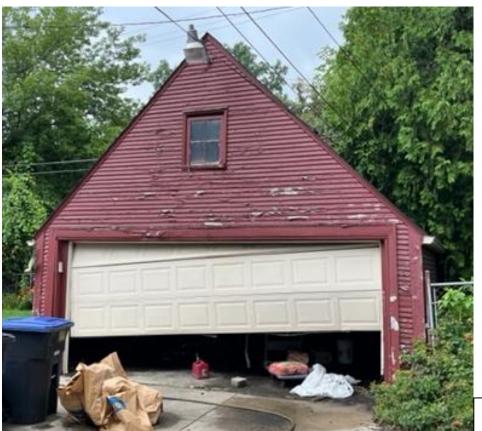
Applicant photo

A detached garage is located at the northwest corner of the lot and is accessed by a driveway extending from Faust. The wood framed structure has narrow wood clapboard siding, and three wood sash casement windows have a 2-over-2 or 2-over-3 window pattern. A single overhead paneled steel door fills the majority of the front elevation's lower wall, and wood siding fills the gable above.

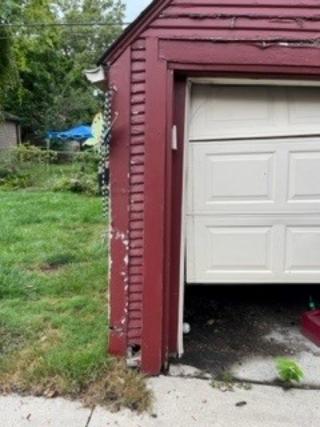
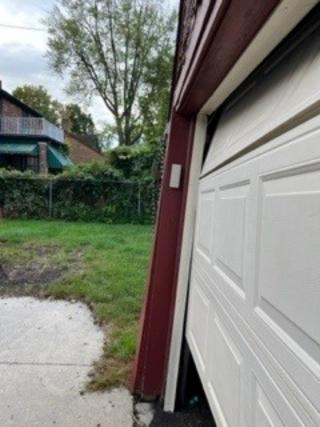
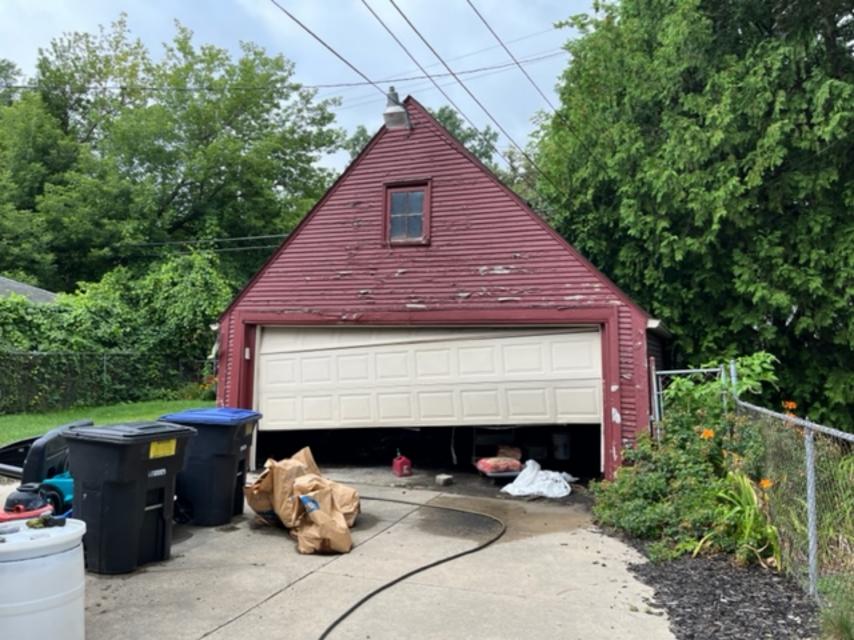
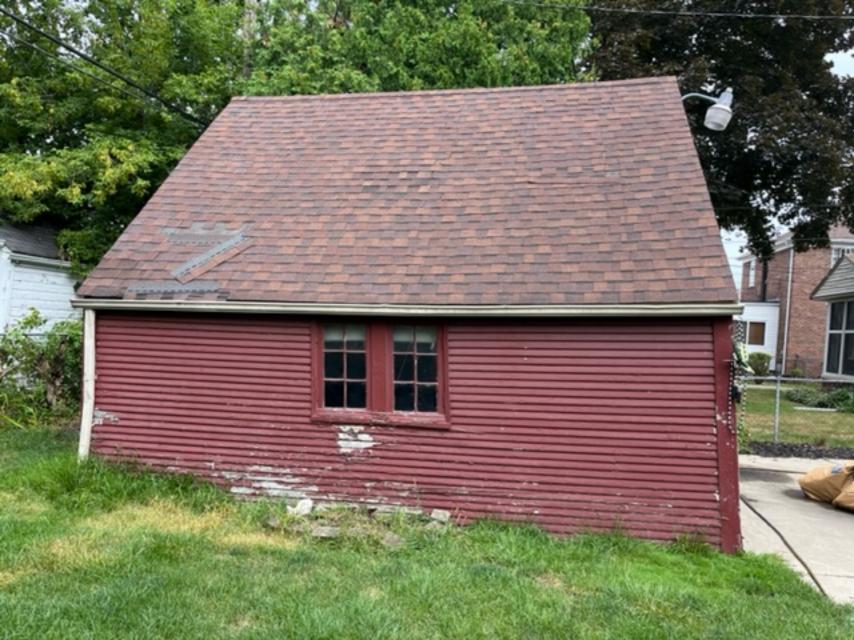
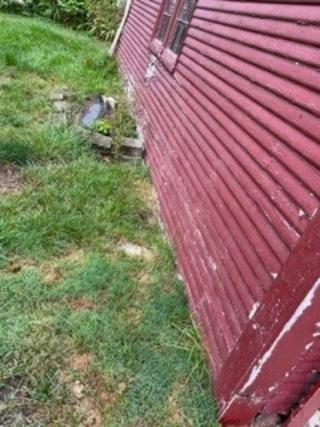
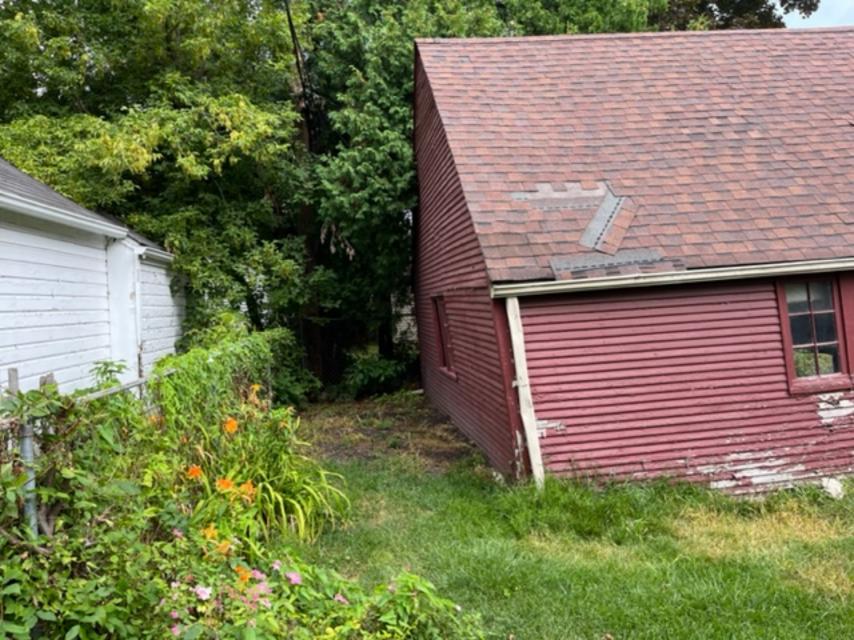
• The submitted photos show two walls are leaning, and staff agrees the interior lower wall construction shows a high level of deterioration. However, the remaining walls, roof and windows are intact. Staff questions if the

Hello Audra, this is Charles Voden with Voden Construction. In regard to the condition of this garage, I didn't submit a quote to repair because in my opinion it is not possible to repair. There are no sill plates left on the walls and no visible foundation. This garage has been repaired numerous times over the years and is now beyond repair. It is leaning badly in two directions and is about to fall over. My client would like it removed from his property this year and would like to build a new one in the next year or two. I will send additional photos in my next correspondence shortly hereafter.

walls can be repaired through the installation of new sill plates and additional vertical framing. Adding in the refurbishment of the wood siding, windows and roof, and a new overhead door, the cost of the rehabilitation might be less expensive than the combined cost for this proposed demolition and future erection of another garage, especially when wood/fiber cement siding and wood/fiberglass windows are considered, as the Commission doesn't often approve vinyl siding and vinyl windows for new construction.
