STAFF REPORT 11-16-2022 REGULAR MEETING

APPLICATION NUMBER: 22-8093

ADDRESS: 226 ARDEN PARK

SCOPE: ERECT 2ND STORY GARAGE ADDITION, REHABILITATE FRONT AND REAR PORCHES, REPLACE DRIVEWAY

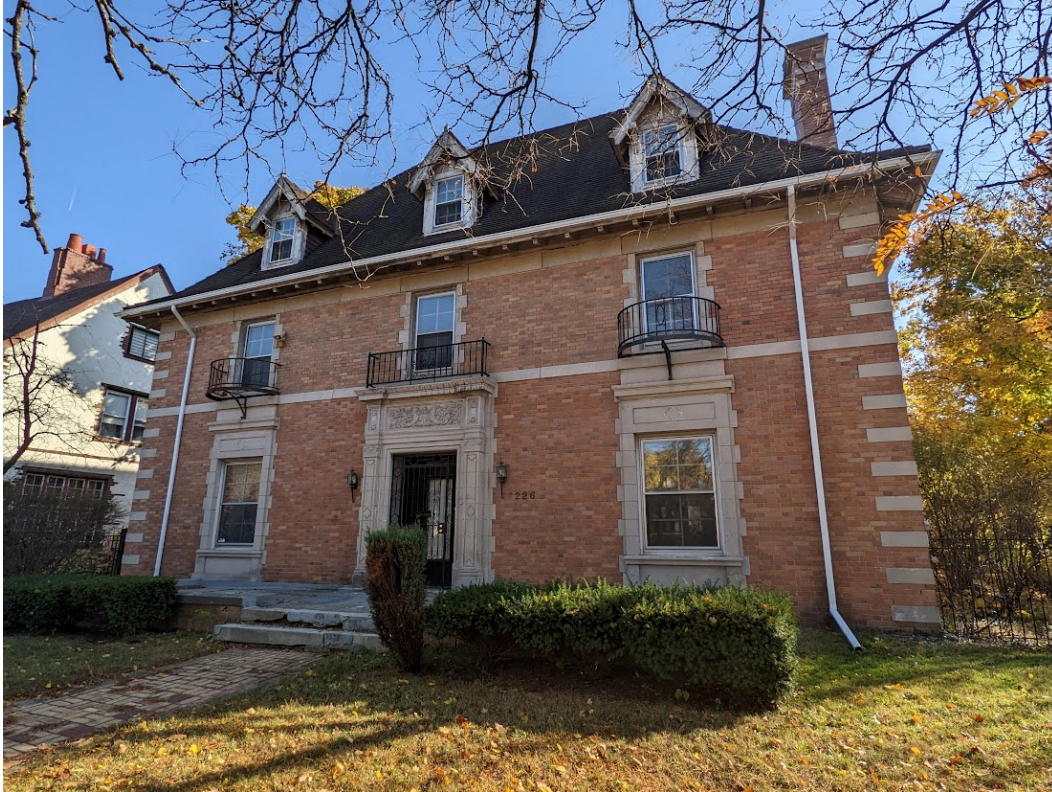
View of 226 Arden Park. Staff photo, November 1, 2022.

The property, located on the south side of the second block east of Woodward (between John R and Brush), features two closely related and contributing historic structures. The main house is a brick mansion with French Renaissance-style design elements including substantial limestone ornamentation and quoining at the building's corners. The sharply pitched hip roof features flared eaves, and is studded with deep gable-fronted dormers aligned with the openings below, creating a balancing vertical emphasis to the composition. Ornamental iron rails are featured at the second story windows. The primary expression is of restrained yet robust elegance. The exterior appears to be in generally good condition, with some deterioration at the porch. Historic landscaping has not been maintained.

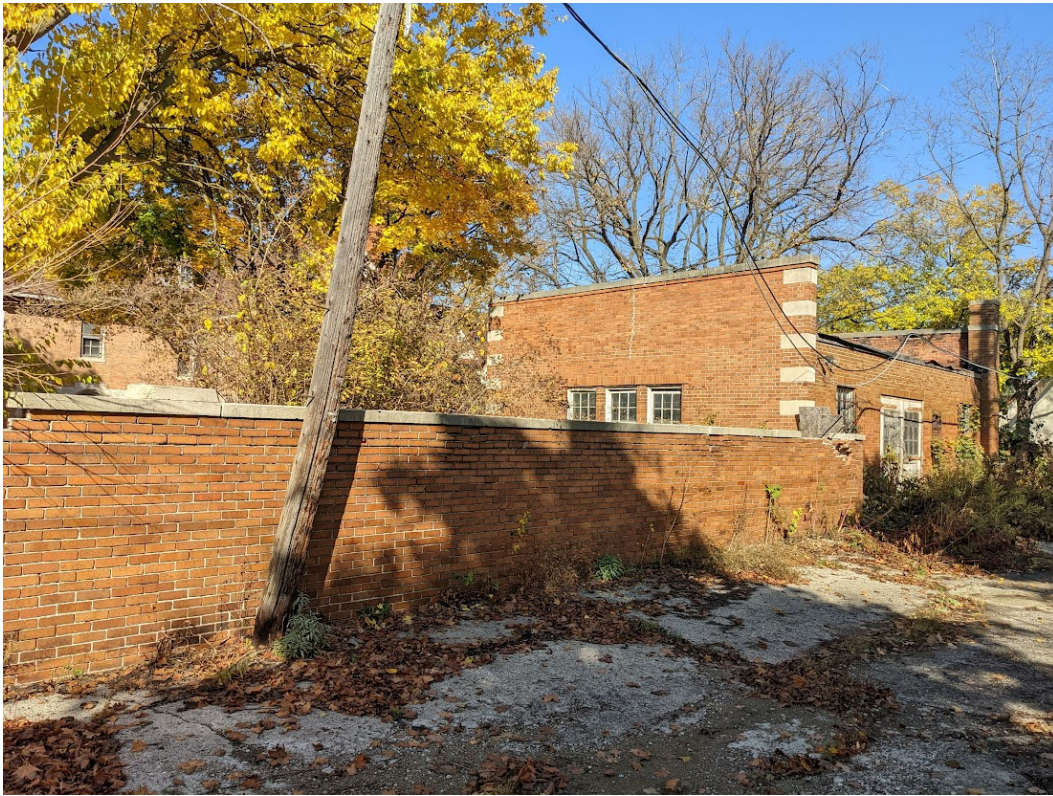
The existing garage, at the rear of the parcel, takes several design cues from the main house, including brick and stone ornamentation. It features original wood windows in apparently fair condition, with original garage door at alley. The more prominent street-facing elevation has lost more integrity, with modern garage doors and other incompatible infill elements installed decades ago. The former pitched roof of the garage is no longer extant, having deteriorated and been replaced at some point with a flat substitute. Overall, the garage is in poor condition.

View of the garage and garden wall, from alley. Staff photo, November 1, 2022.

- The existing garage windows shall be repaired. Should additional field inspection suggest infeasibility of repair, applicant shall submit additional documentation to staff, who may approve replacement consistent with the window product submitted in this application, or other window found appropriate by staff.

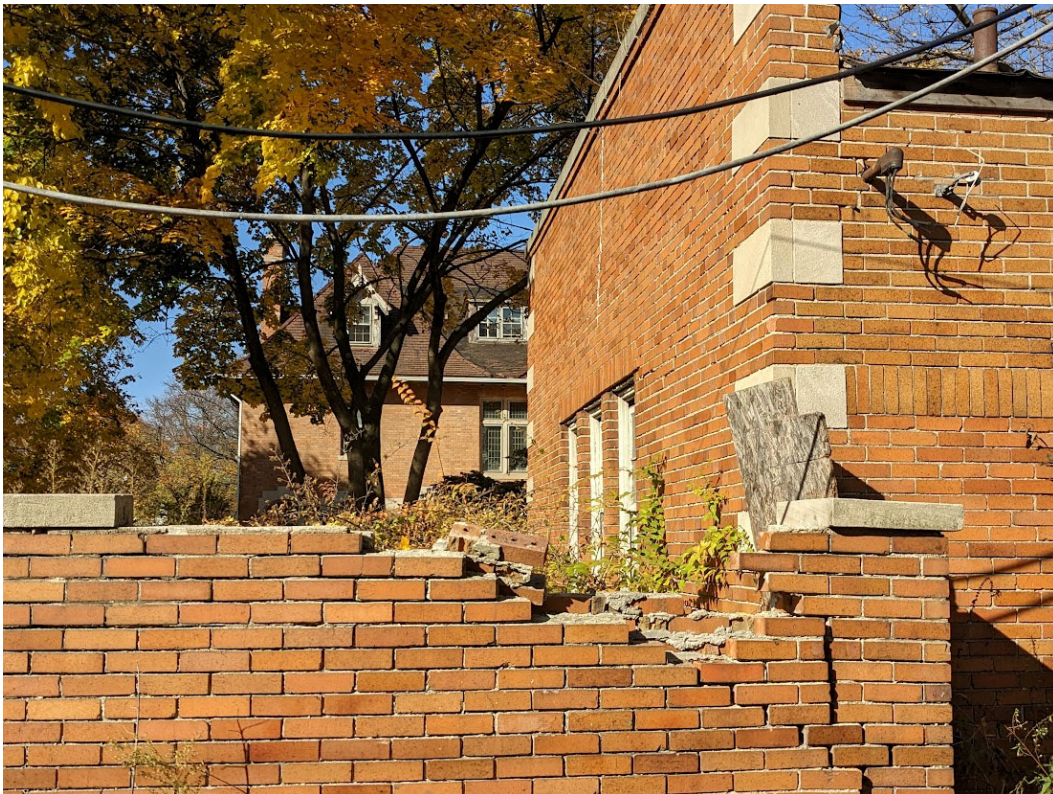
Detail view of same, showing main house beyond. Staff photo, November 1, 2022.

The adjacent brick garden wall enclosing the rear property line, matching the brick used on the buildings, is in very poor condition with active loss of brick.

- Other exterior rehabilitation scope, including the porches, driveway, and garden wall, addresses urgent maintenance and repair concerns and is proposed for execution in a historically appropriate manner.

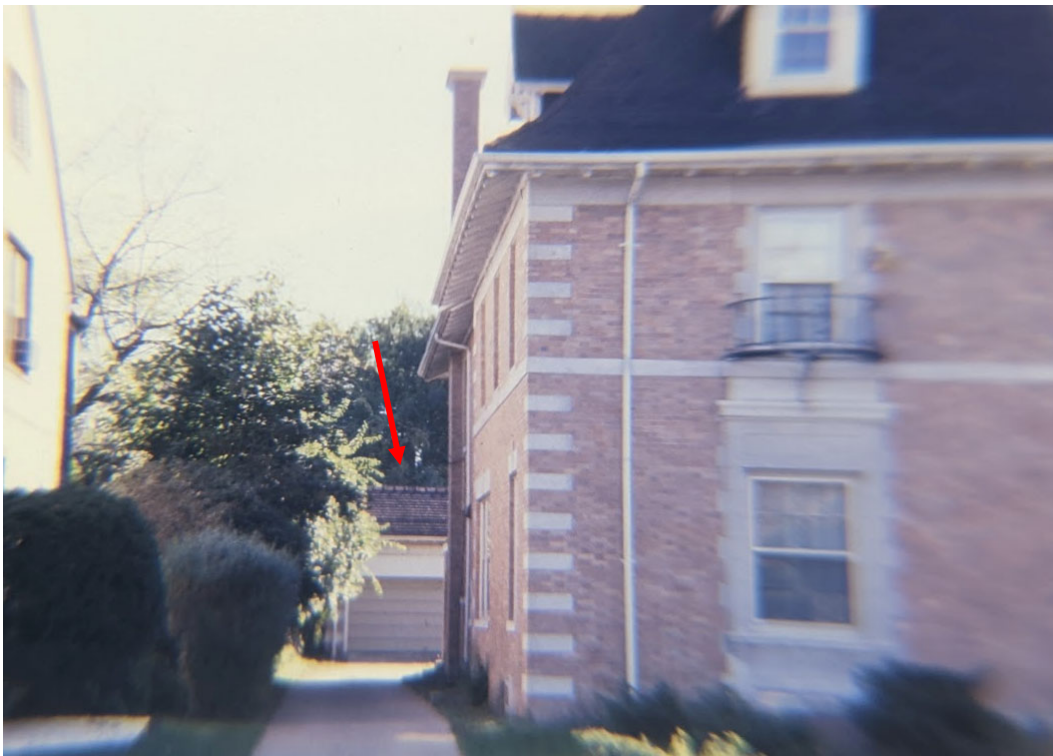
Historic Designation Advisory Board, designation photo, October 13, 1981. Note garage's original roof type, material, and geometry..

- The original garage roof evident in the 1981 designation photo is no longer present. Though there is no record of an approval for its removal, circumstantial evidence suggests the roof suffered from a long period of decay and either collapsed or was removed at some point, and replaced with the current “lid” in the mid-1990s. Given that the integrity of the original roof is lost, and that second stories on garages were common in the historic period (especially when accompanying houses of substantial size as carriage houses), staff assesses that the proposal would be historically appropriate. The design and details of the proposal, while akin to contemporary residential construction, are well-considered and consistent with a rehabilitation approach to existing character-defining materials and historic fabric found across this historic property. The historic base of the garage will continue to be readable, and a large majority of its historic features and elements are perpetuated.
