STAFF REPORT: 11/16/2022 REGULAR MEETING

APPLICATION NUMBER: #22-8094

ADDRESS: 19434 STRATFORD

SCOPE: INSTALL LANDSCAPE FEATURES, CONSTRUCT NEW DRIVEWAY (WORK DONE WITHOUT APPROVAL)

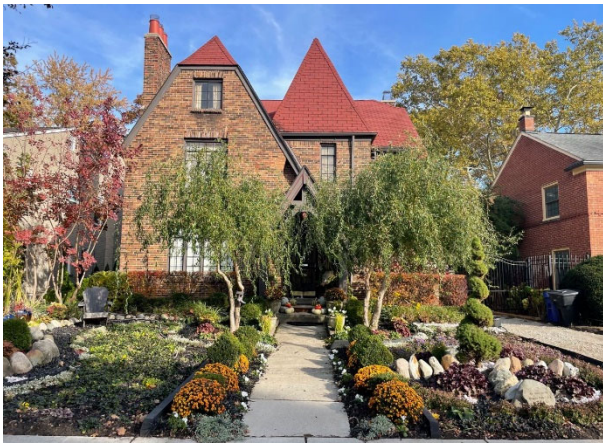
Site Photo 1, by Staff October 24, 2022: (West) front side.

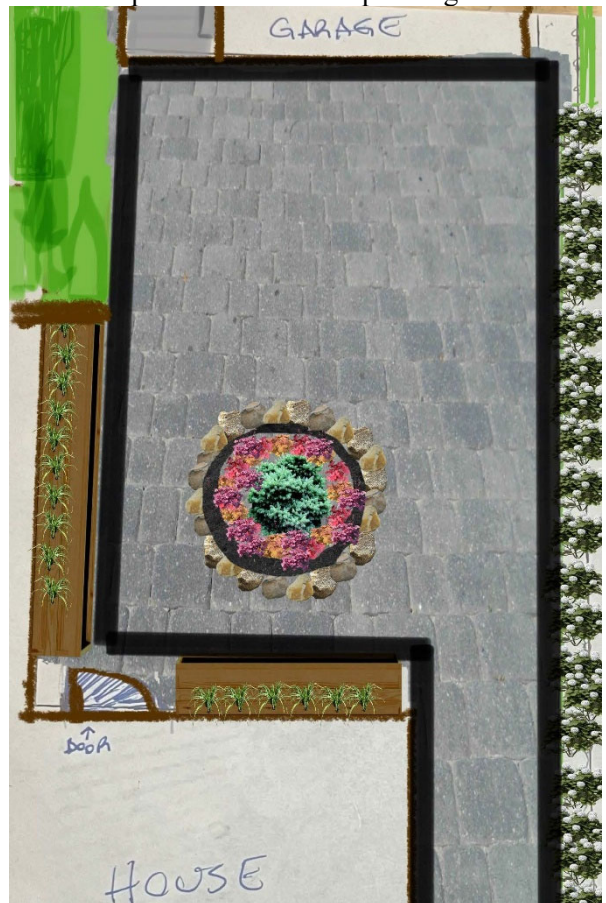
Figure 2, by Applicant: Proposed rear yard

irrigated lawns with other materials, staff observed that the rear yard expansion of the driveway, **the garbage/recycling pad**, and turn-around greatly increases the amount of impervious paving surface that may affect the management stormwater run-off. (See Site Photo 6 and Figure 2.)

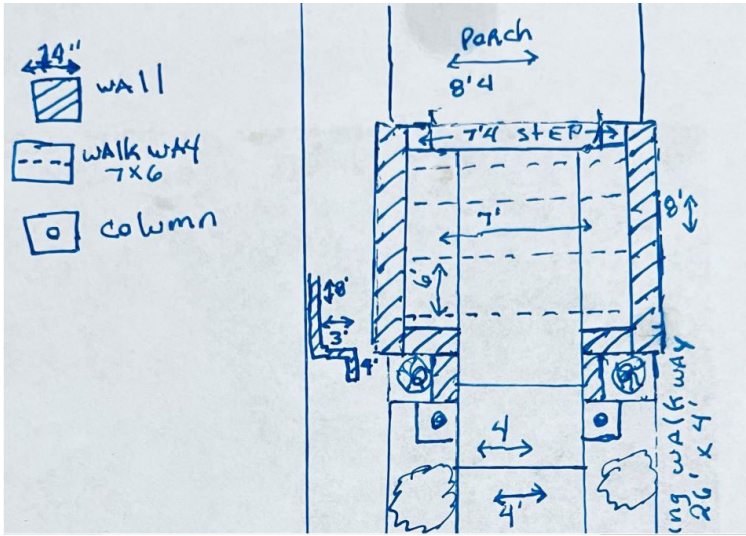
Figure 3, by Applicant: Proposed front walkway

- The applicant work with staff to adjust the design of the driveway and walkway with the following changes:
 - Maintain the walkway's historic width.
 - Maintain the driveway to a width no wider than 10' until it approaches the garage, and then to be no wider than the garage itself.

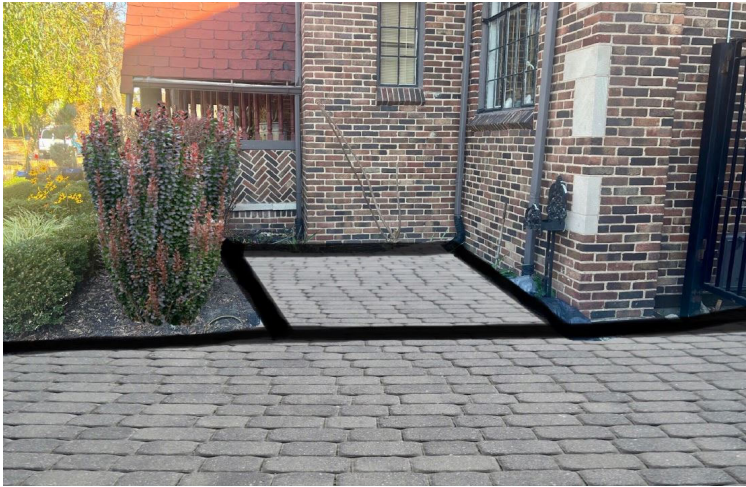
Figure 6, by Applicant: Southwest corner of house, showing proposed garbage/recycling storage pad

- **It is staff's opinion that the recent added concrete pad in the front yard is also inappropriate as the function for the use of storage of materials, even partially screened during a portion of the year, is not an appropriate location and would more readily be stored in the back yard, out of public view.**

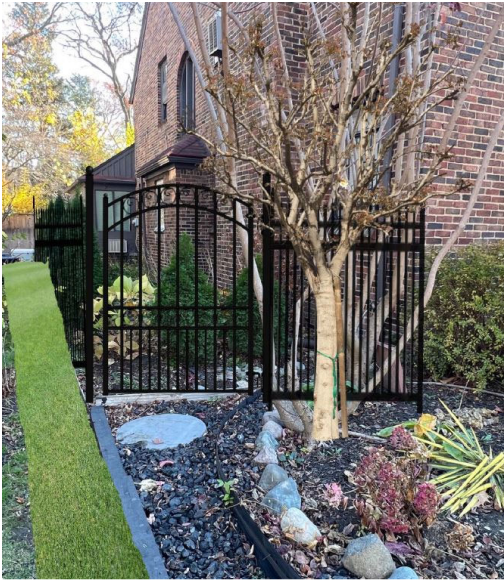
Figure 7, by Applicant: Northwest corner of house showing proposed iron gate and fence.

- To have both the walkway and driveway be of material that is either concrete (non-stamped, non-color treated), brick or stone.
- **The applicant work with staff to confirm the following for the proposed iron fence:**

- **A site plan that shows that the fence does not project past the front face of the house.**
 - **A product sheet that confirms the dimensions and materiality of the fence and gate.**

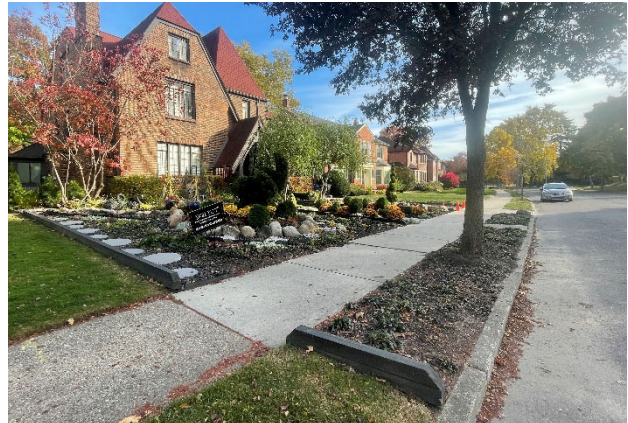
- Staff observed that the driveway was already removed, and grading work has begun to increase the width of the driveway footprint.
- Staff also observed that the front yard landscape planting has been complete for some time and observed that front yard, black-painted wood beams were not securely embedded in the ground both on the neighboring lot line and in the berm: there appears to be no footing or subsurface beams to keep the beams from heaving and lifting from the ground. (see Site photo 4)

- Staff observed that the steel edging is readily visible. Although the applicant states that adjacent plants will eventually hide this edging, staff observed that the plants are mostly the type that will not be present during off-season months and the edging is a visual component that adds yet another material type in the landscape in addition to the wood beams, stones, boulders, and concrete blocks. It is staff's opinion that this mixture of materials and plant types detracts from this historic property by introducing a landscape that lacks *legibility* and *cohesion*. In other words, the former lawn and its support of the Walls of Continuity in the Elements of Design of Sherwood Forest unified the relationship of this property to its historic surroundings but is now occupied by a range of landscape materials that collectively creates a *new primary element*, which no long supports the Tudor architecture nor the cohesion of this property's landscape with its neighbors. Staff recommends a reduction in the number of types of materials, particularly edge materials, to support greater cohesion and legibility in the design of this historic landscape.

Site Photo 4, by staff, October 21, 2022: (West) extent of landscape and wood beams not secured in ground.

- The applicant work with staff to introduce some areas of lawn in the public berm and front yard and to issue more appropriate material in the landscape that reduces the number of edge materials to create a more cohesive and legible design.

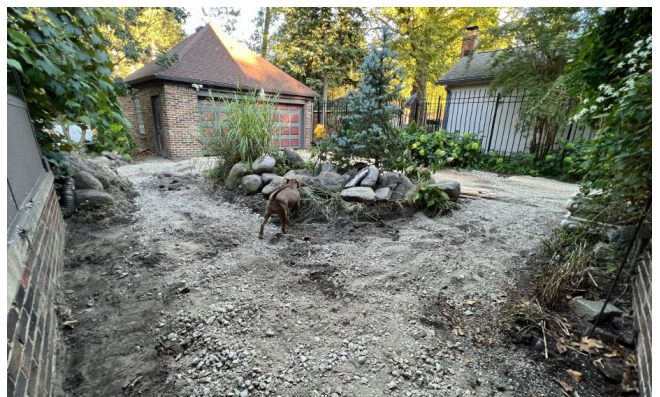
Site Photo 6, by Applicant October 2022: (East) showing rear yard conditions and locations of proposed turn around space, center planting bed and side raised planter (right).
