STAFF REPORT: 11/16/2022 MEETING

ADDRESS: 1915 LONGFELLOW

APPLICATION NO: #22-8107

REPLACE WINDOWS*, INSTALL EGRESS WINDOW, & INSTALL DOOR

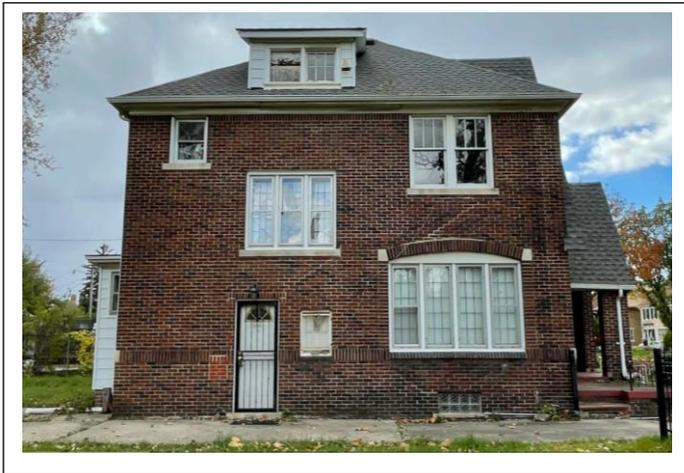
Side/east elevation, prior to unapproved work

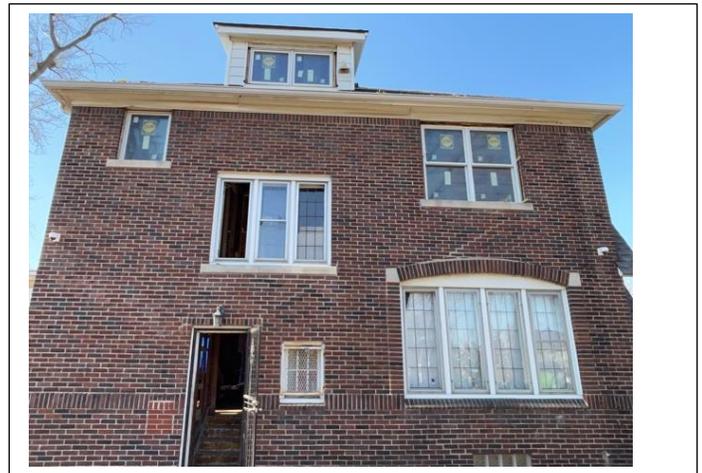
Side/east elevation, current appearance

- Side/east elevation (original windows)
 - Single wood casement window at first story
 - Set of four, wood casement windows with leaded glass at first story
 - Set of three, wood casement windows with leaded glass at second story
 - Set of two, double-hung wood windows (3/1) at second story **(REMOVED/REPLACED)**
 - One double-hung wood window (1/1) at second story **(REMOVED/REPLACED)**
 - One 6-light wood casement at dormer. Second window opening at dormer was missing sash **(REMOVED/REPLACED)**

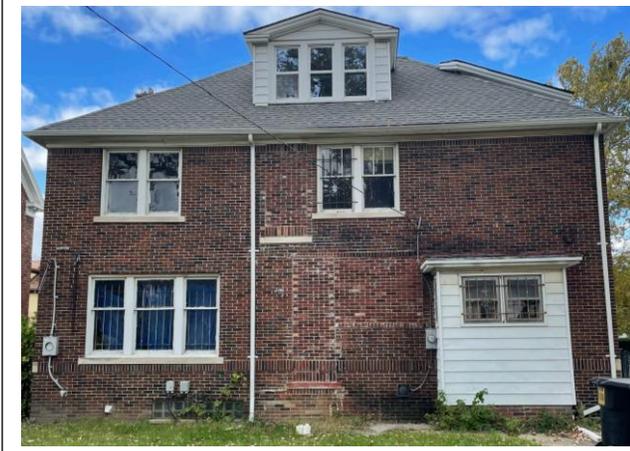
Rear/south elevation prior to unapproved work

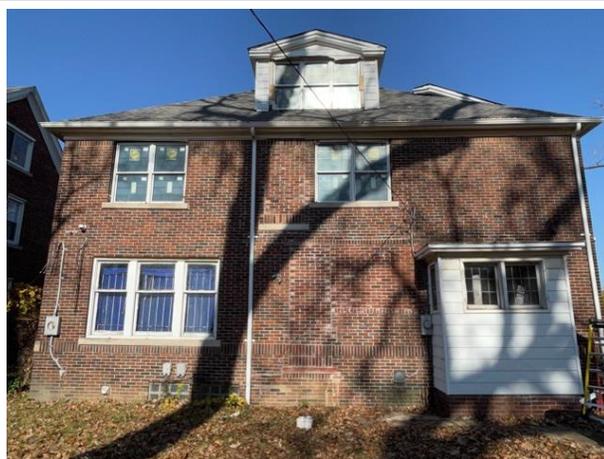
Rear/south elevation following unapproved work

- Rear/south elevation (original windows)
 - Set of three double-hung wood windows at first story
 - Four wood casement windows with leaded glass at first story projecting bay
 - Set of two, double-hung wood windows (3/1) at second story **(REMOVED/REPLACED)**
 - Set of two, double-hung wood windows (1/1) at second story **(REMOVED/REPLACED)**
 - Three, 1/1 double-hung windows at dormer. Either vinyl or wood. **(REMOVED/REPLACED)**

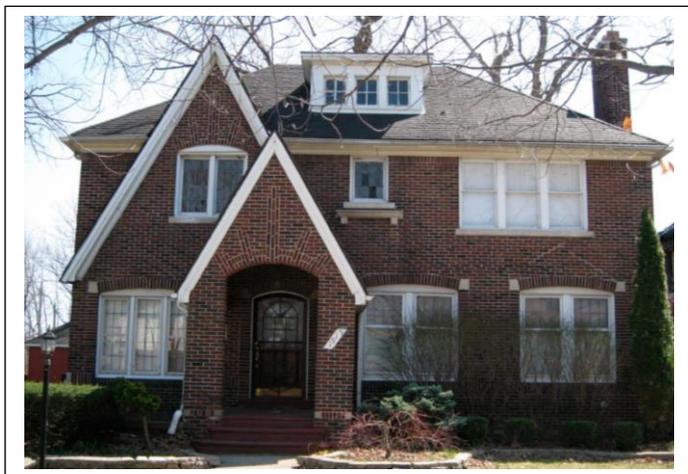
Front/north elevation prior to unapproved work

- Front/north elevation
 - Set of three, wood casement windows with leaded glass at first story
 - Two sets of paired, double-hung wood windows with leaded glass in top sash at first story
 - Set of paired wood casement windows with leaded glass at second story **(REMOVED/REPLACED)**
 - Single wood window (casement or fixed) with leaded glass at second story **(REMOVED/REPLACED)**
 - Set of three, double-hung wood windows (3/1) at second story **(REMOVED/)**
 - Three, four-light wood casement windows at dormer **(REMOVED/REPLACED)**

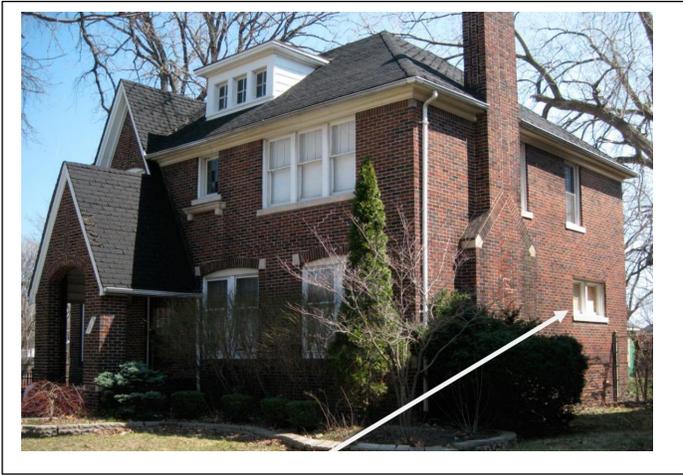
Side/west elevation prior to unapproved work

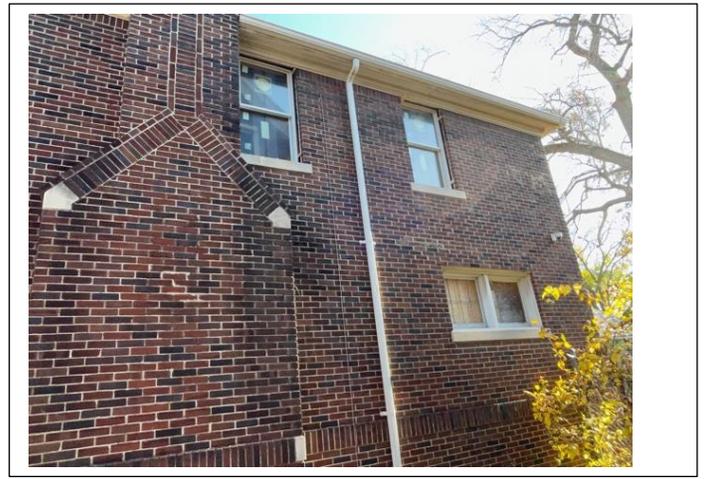
Side/west elevation following unapproved work

- Side/west elevation
 - Two wood casement windows with leaded glass at first story
 - Two double-hung wood windows (1/1 each) at second story
(REMOVED/REPLACED)

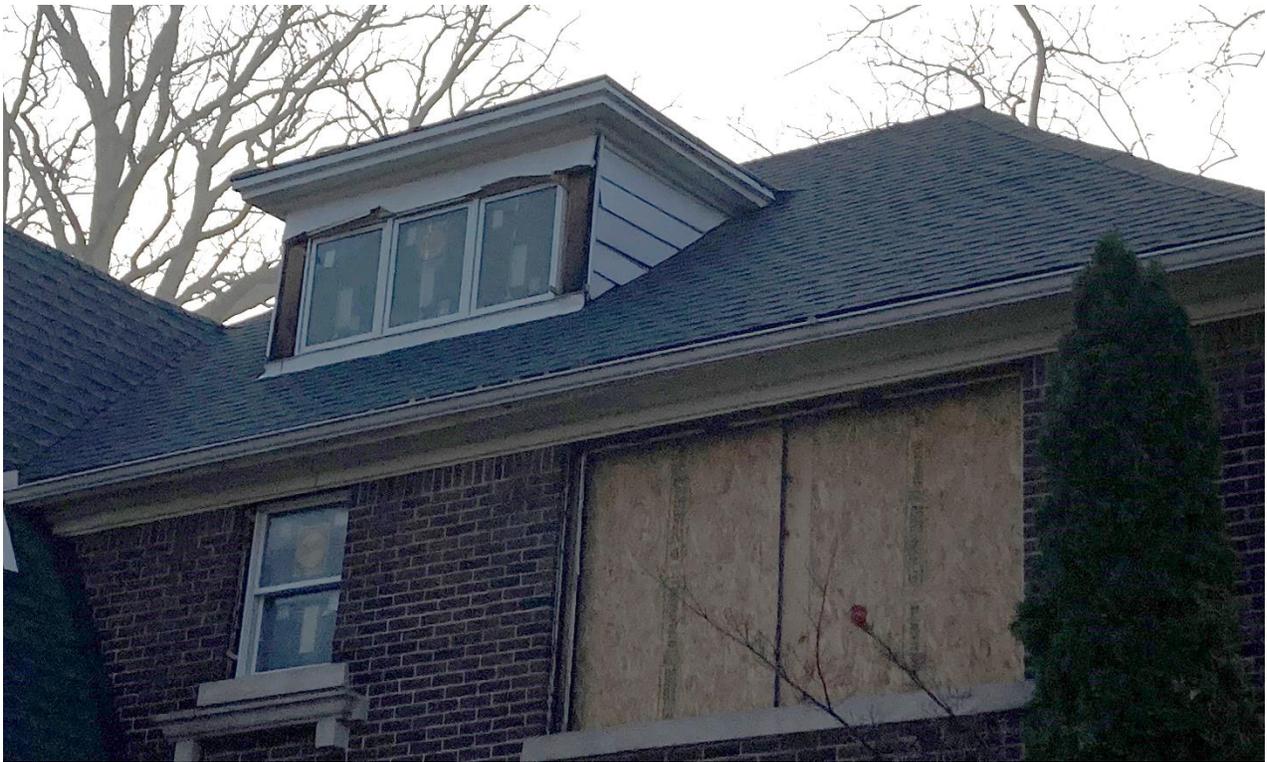
Front elevation dormer

- The dimension/profile of the trim (to include brickmould and mullions) associated with the new windows is generally thinner than the historic/existing. This has resulted in the each new window displaying a larger area of glazing vs the original (see the photos appended to the end of the report)

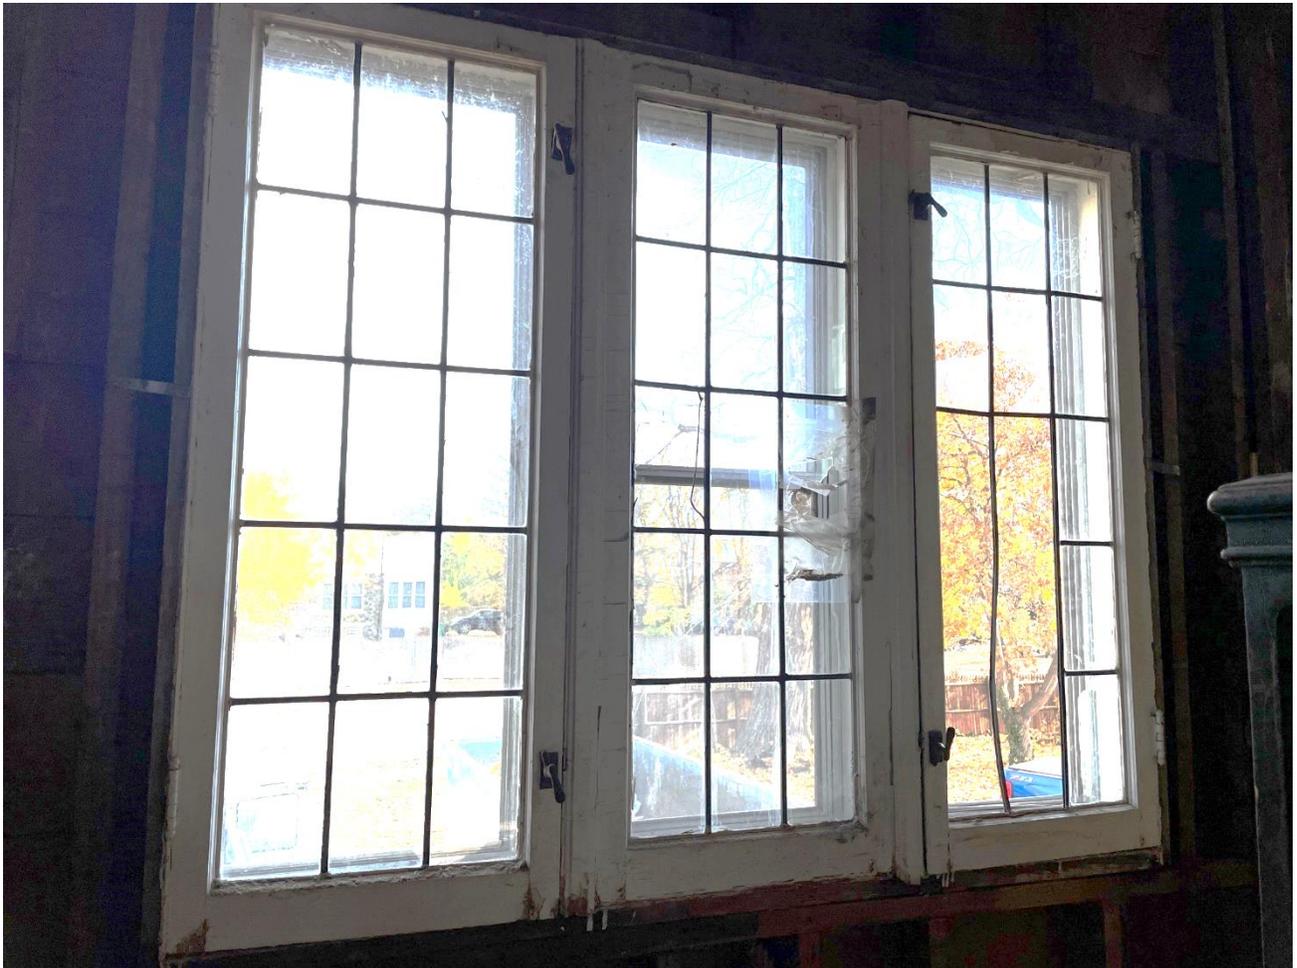
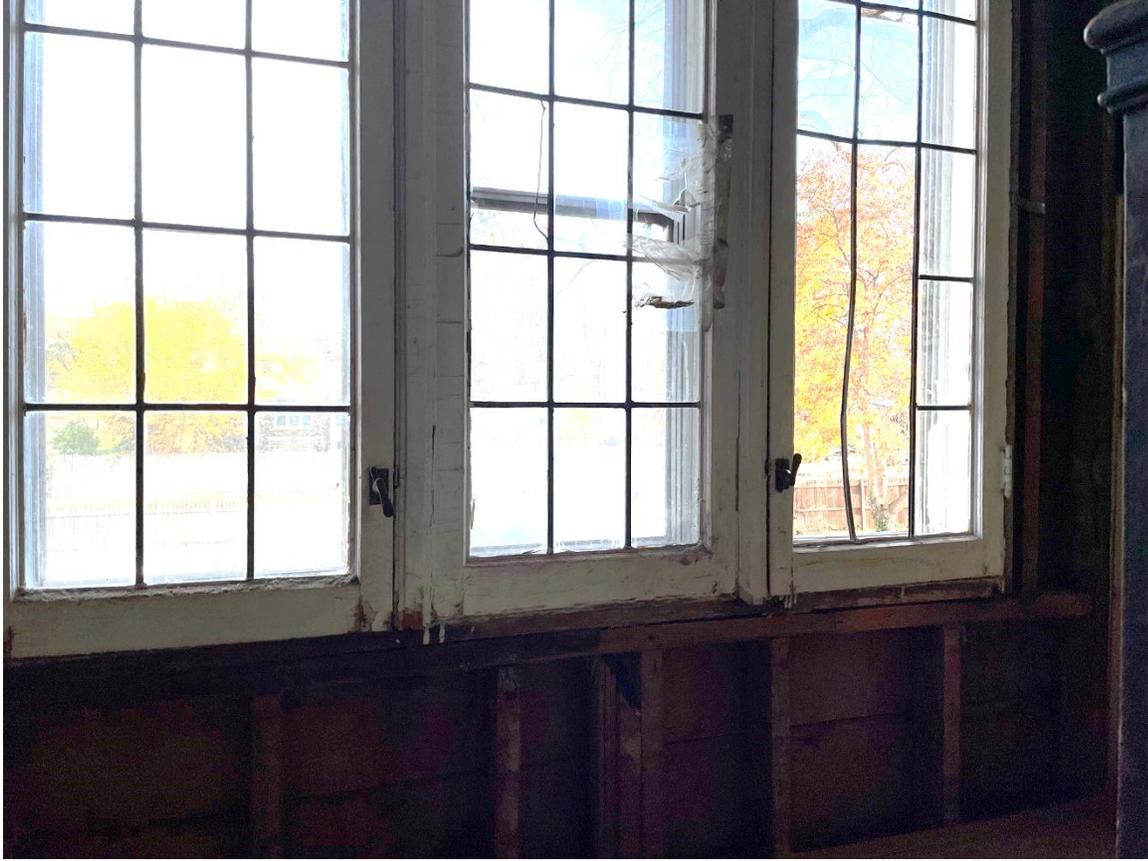
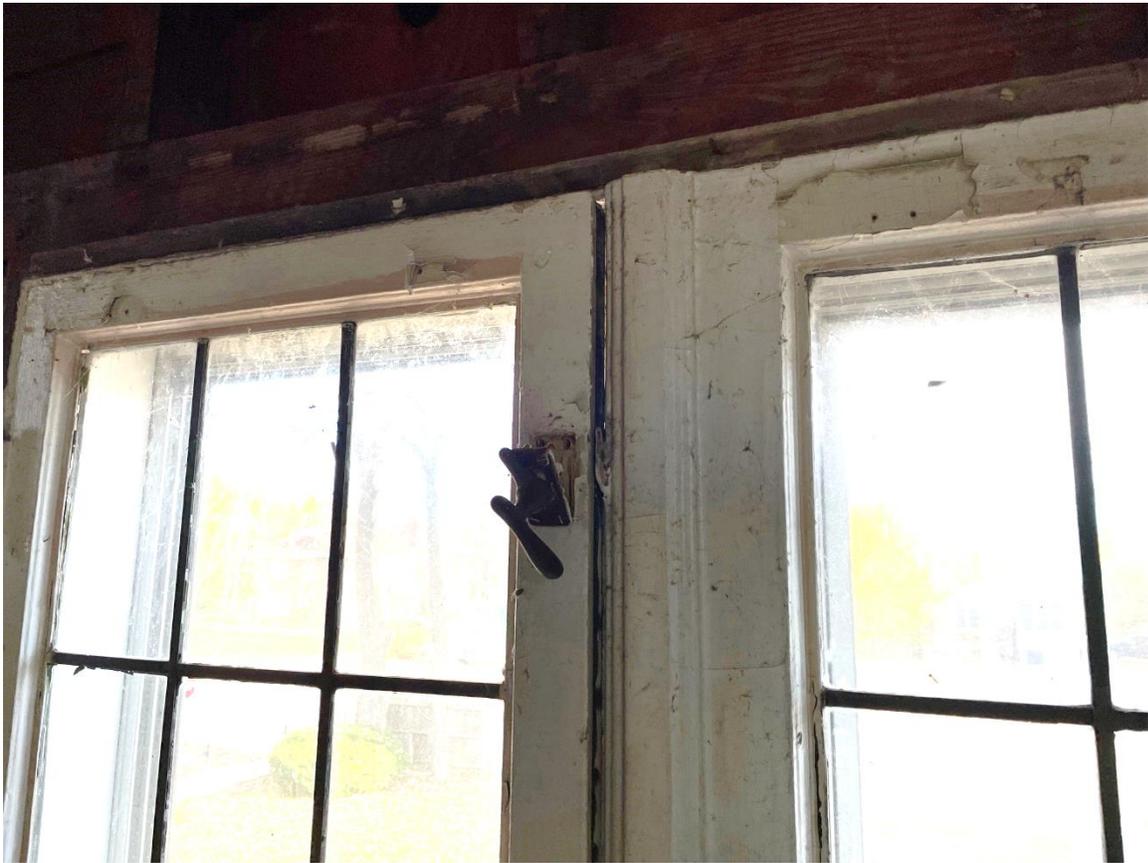
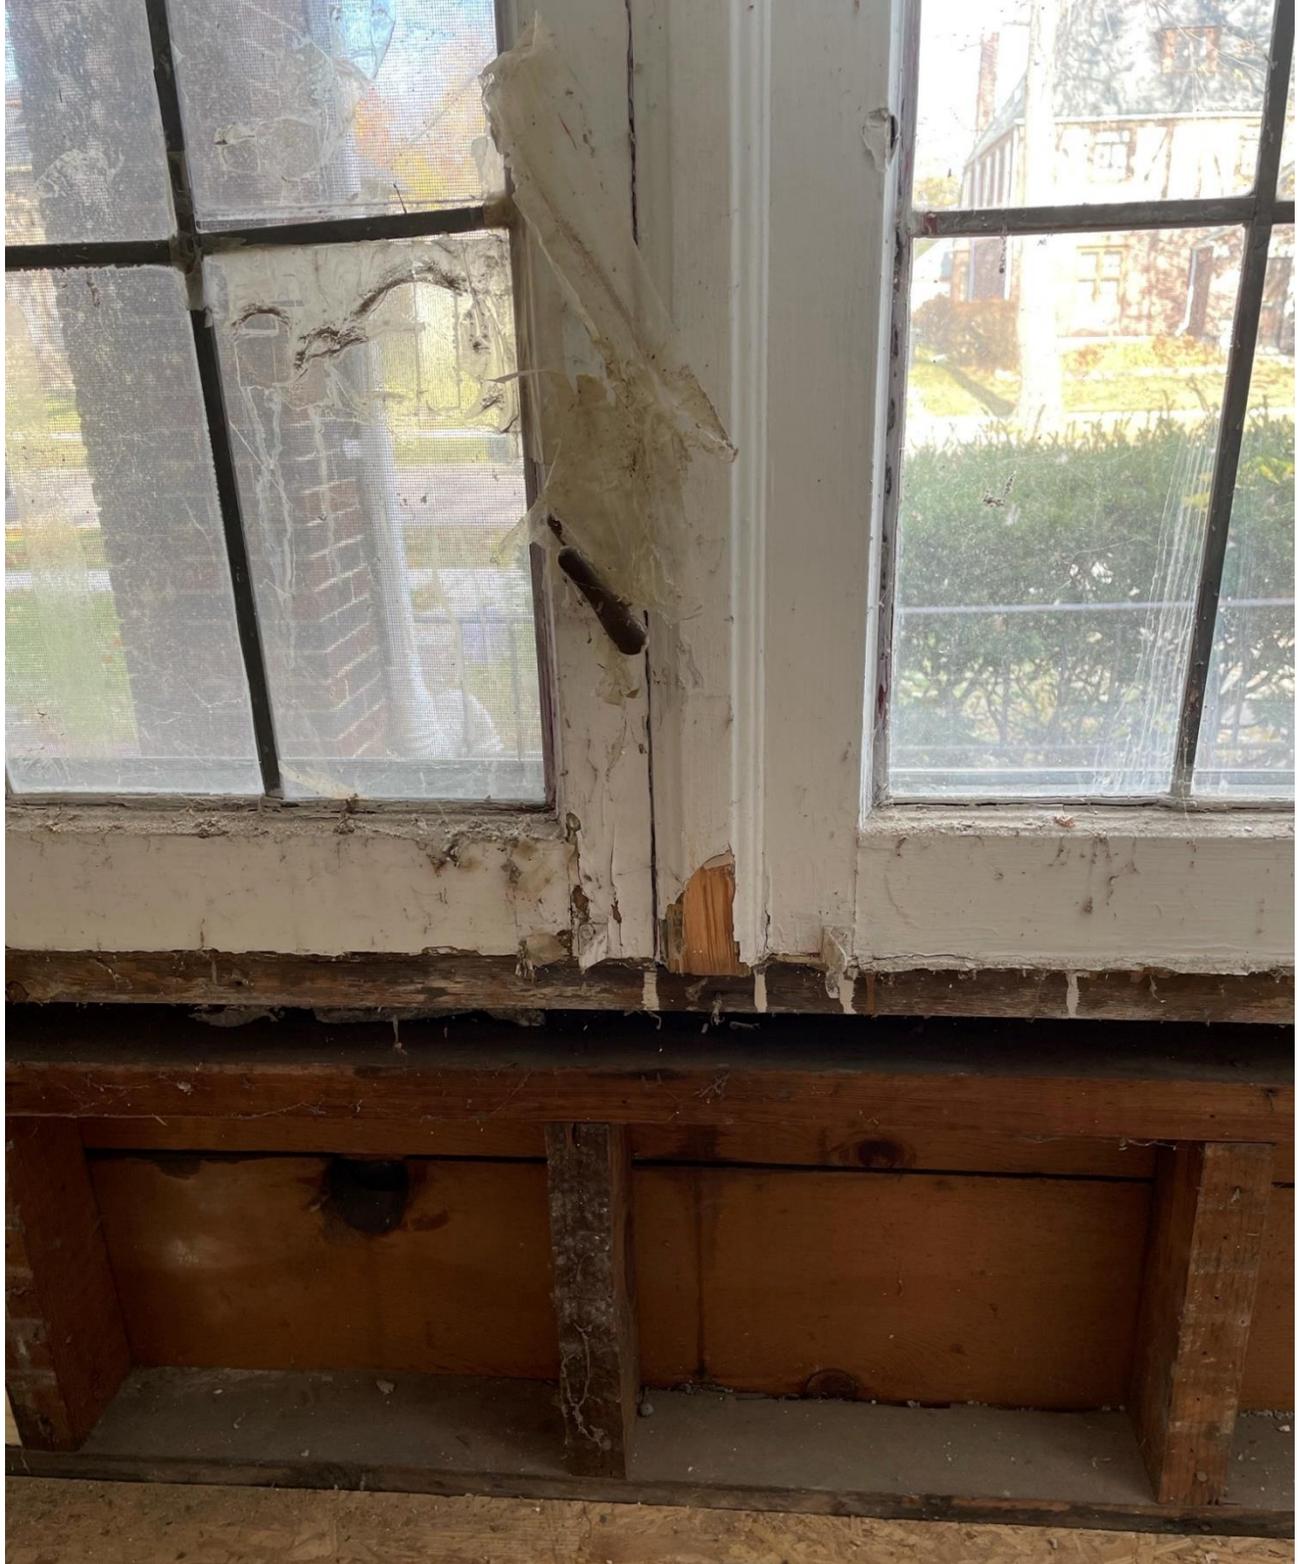
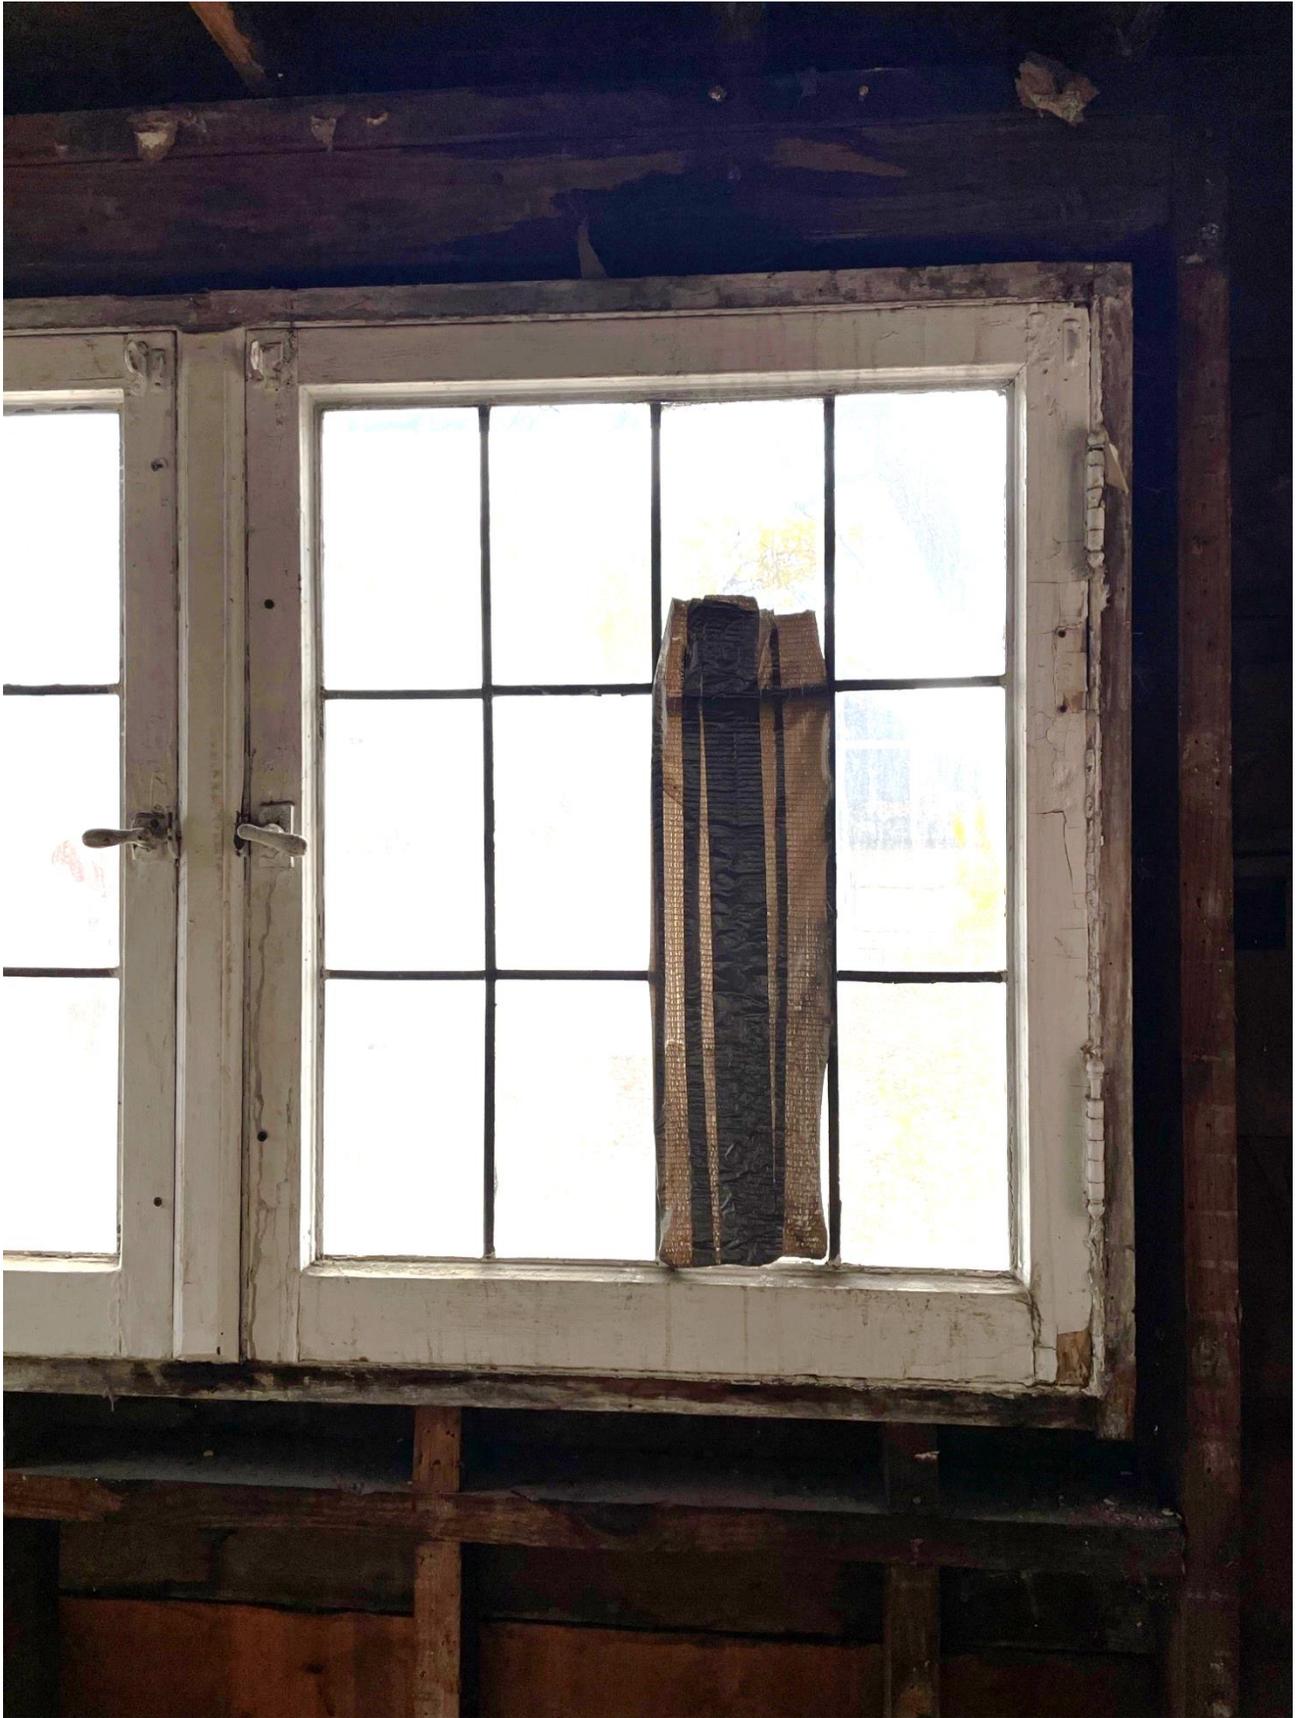
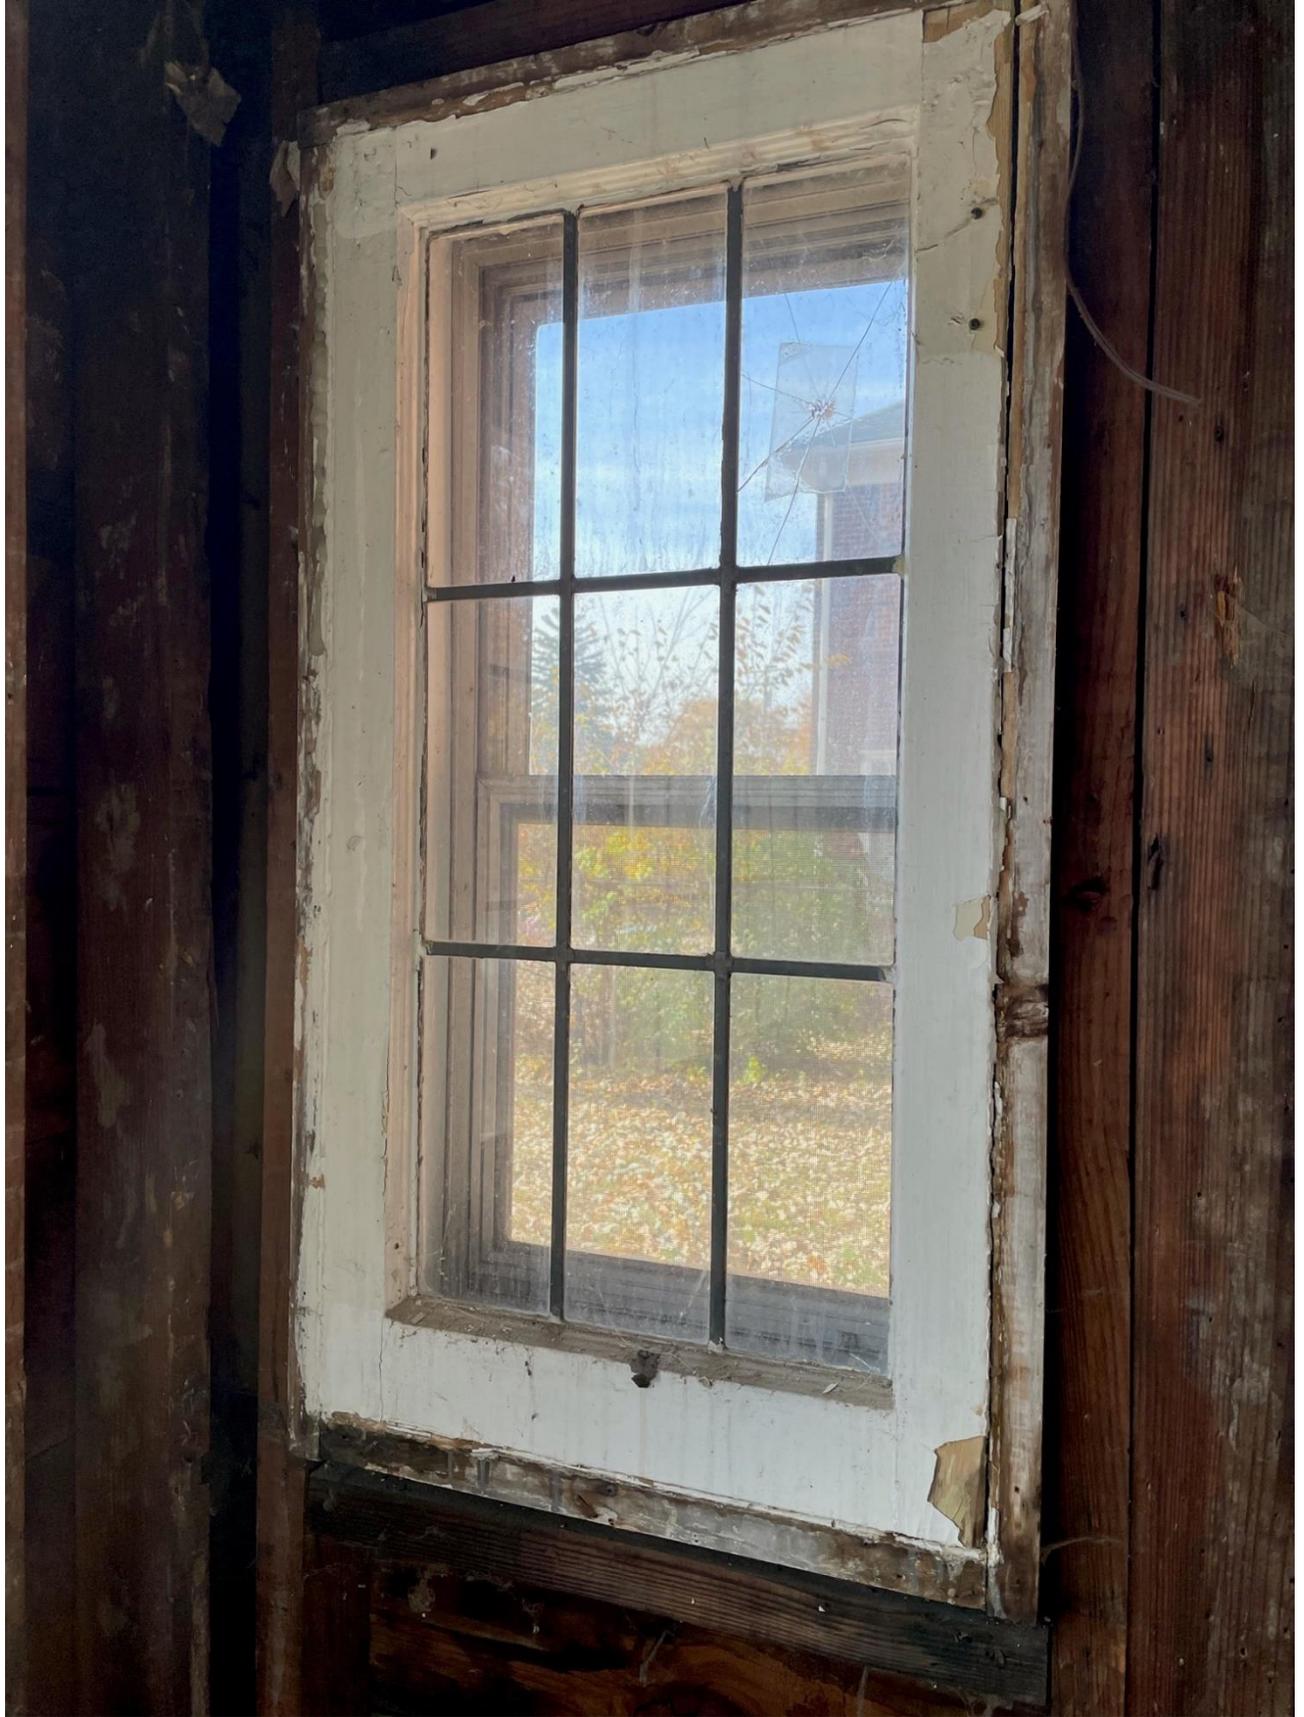
The following interior photos of the remaining historic windows that are proposed for removal:

- See the photos of the remaining historic windows at the end of this report. It is staff's opinion that these windows are in fair condition and can be repaired
