STAFF REPORT: NOVEMBER 16, 2022 MEETING

APPLICATION NUMBER: 22-8102

ADDRESS: 14894 GREENVIEW

SCOPE: REPLACE STEEL WINDOWS WITH VINYL WINDOWS

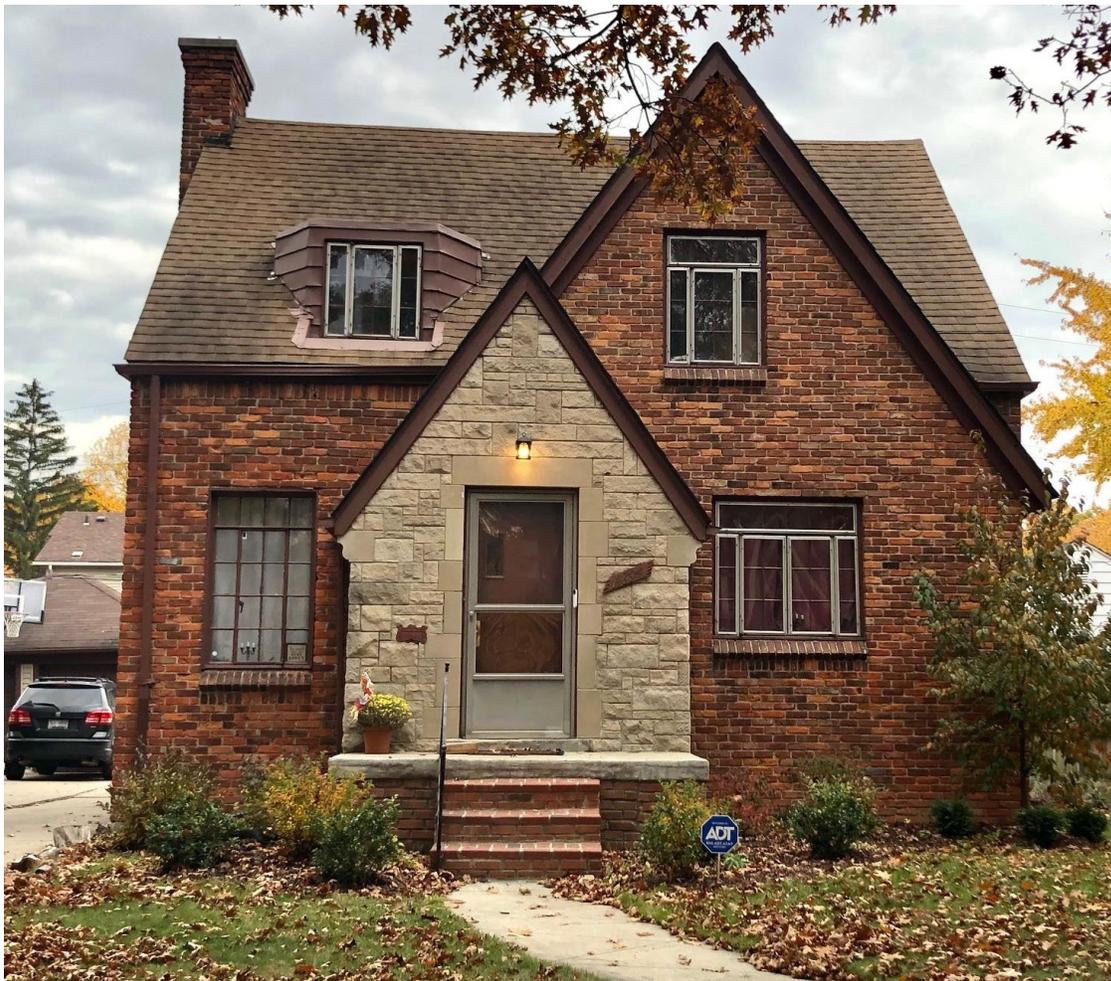
HDC staff photo, October 25, 2022

Erected in 1936, this Tudor Revival-style dwelling is clad in a range of red and brown brick and dark brown aluminum siding. The roofing material is dimensional asphalt shingles. The front elevation features double front-facing gables, the smallest of which is clad in beige stone. A curvilinear concrete front walk leads to a raised open landing which is accessed by three narrow brick-faced steps and a single black aluminum handrail. The landing extends the width of the gabled wall and the entry door is framed by a smooth cut stone surround. The intact historic wood door with a small offset window is behind a non-historic storm door. On each elevation are varying sized window openings of steel sash that include casement and fixed units.

- The Rosedale Park Historic District was established in 2007.
- The windows, due to their thin sash dimensions and multiple operations within each opening, are distinctive character-defining features on each elevation of the dwelling.
- The front and side elevations (the applicant didn't submit a photo of the rear elevation) retain almost all of its historic components. Those components that have been altered, specifically the front entry brick steps, aluminum railing, and aluminum siding on the dormers, were in place at time of local historic district designation. It is staff's opinion the stairs and railings are minimally designed contemporary components, and the aluminum siding could be removed as the original wood siding is likely intact underneath.

It is staff's opinion the replacement of the steel windows with vinyl windows will alter the features and spaces that characterize the property. Staff therefore recommends the Commission deny a Certificate of Appropriateness for the work as proposed because it does not meet the Secretary of the Interior Standards for Rehabilitation and the Elements of Design for the district.
