STAFF REPORT: 2/9/2022 MEETING

APPLICATION NUMBER: #22-7664

ADDRESS: 2485 BURNS

SCOPE: ALTER FRONT PORCH; ALTERATIONS AT REAR PORCH AND SECOND FLOOR SLEEPING PORCH COMPLETED WITHOUT APPROVAL

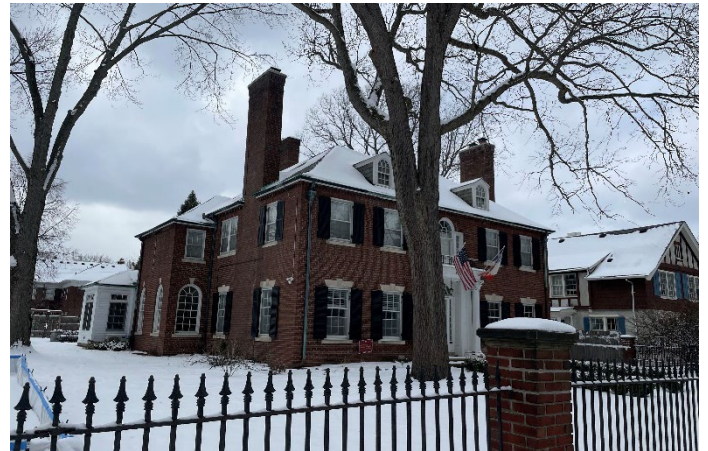
Site Photo 2, by Staff January 25, 2022: (Southeast) front and side elevations showing rear, former screen-in porch.

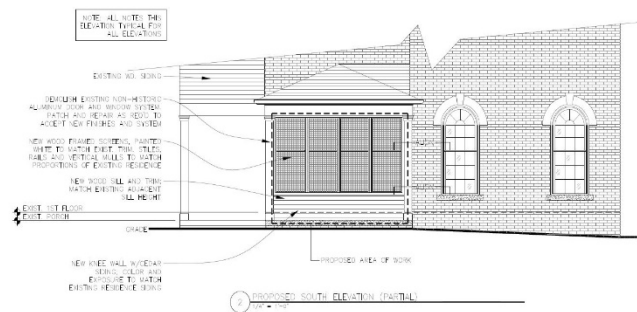
Drawing 1, by Applicant: (Southeast) side elevation excerpt from 2017 COA showing approved new knee wall and original columns.

- Staff has the opinion that the open-air quality of the rear, first story screen-in porch, which was approved to introduce a modest knee wall and approved by the HDC in 2017 is a distinctive, character-defining structure. This porch, publicly viewed from the front, had a quality of light transparency with matching character-defining columns that was destroyed by the construction of the solid block massing. This impervious form hides the rear French doors and arched windows (see photos 2-4 & 7) and reads like an addition rather than a porch. Staff also observed that the corner columns of the screen-in porch have been removed on the southwest wall panel and not retained as described in this application. The addition of vinyl transoms over the 2x3 double hung wood windows introduces a new material and pattern that does not complement the existing 3x3 configuration of existing windows of the house.

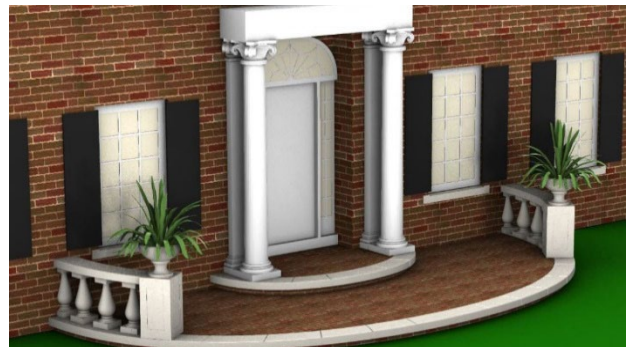
- It is staff's opinion that the introduction of 4x8 cement pavers, replacement of the square form with circular forms, and the introduction of wingwalls destroys the character defining features of the front elevation critical to an understanding of the building's style by obscuring the front elevation windows and introducing a new style and historically anachronistic material, scale and design that is not appropriate.

Conceptual image, by Applicant: (Northeast) front elevation showing proposed new patio and "wingwalls".

- It is staff's opinion that the proposal to change the front porch's material from cast stone and limestone to cement block that does not match the house's material nor scale, changing the shape of the front porch to a circular form and introducing "wing walls" that obscure's the front elevation the house's Georgian Revival architecture would destroy the original *scale, design, and materiality* of this historic property, and therefore does not meet the Secretary of the Interior's Standards for Rehabilitation.

Staff finds that the replacement of wood siding with Hardie board, the replacement of casement windows of the rear sleeping porch with vinyl slider windows, the modification of the rear screen-in porch to an enclosed room, the proposal to replace the front porch cast stone with cement pavers, the redesign of the front porch from rectangular to circular form, and the installation of wingwalls destroys the historic character of this property and removes distinctive, character-defining features.

- The top surface of the front porch floor remain the same in dimension, material and size to support the existing columns.
- The proposed lower step of the front porch consist of the same surface material as the original top step or brick that matches in material and scale of the house with a limestone perimeter step.
- The proposed lower step retain the rectangular form as the original step and reach no wider that the outer limits of the first set of windows on either side of the door.
- The applicant provide HDC staff a revised plan of this front porch for review and approval.
