STAFF REPORT 02-08-2023 REGULAR MEETING

APPLICATION NUMBER: 23-8206

ADDRESS: 415 WEST GRAND BOULEVARD

SCOPE: ALTER FRONT AND REAR PORCH, REPLACE WALKWAYS (WORK COMPLETED WITHOUT APPROVAL), INSTALL FENCE

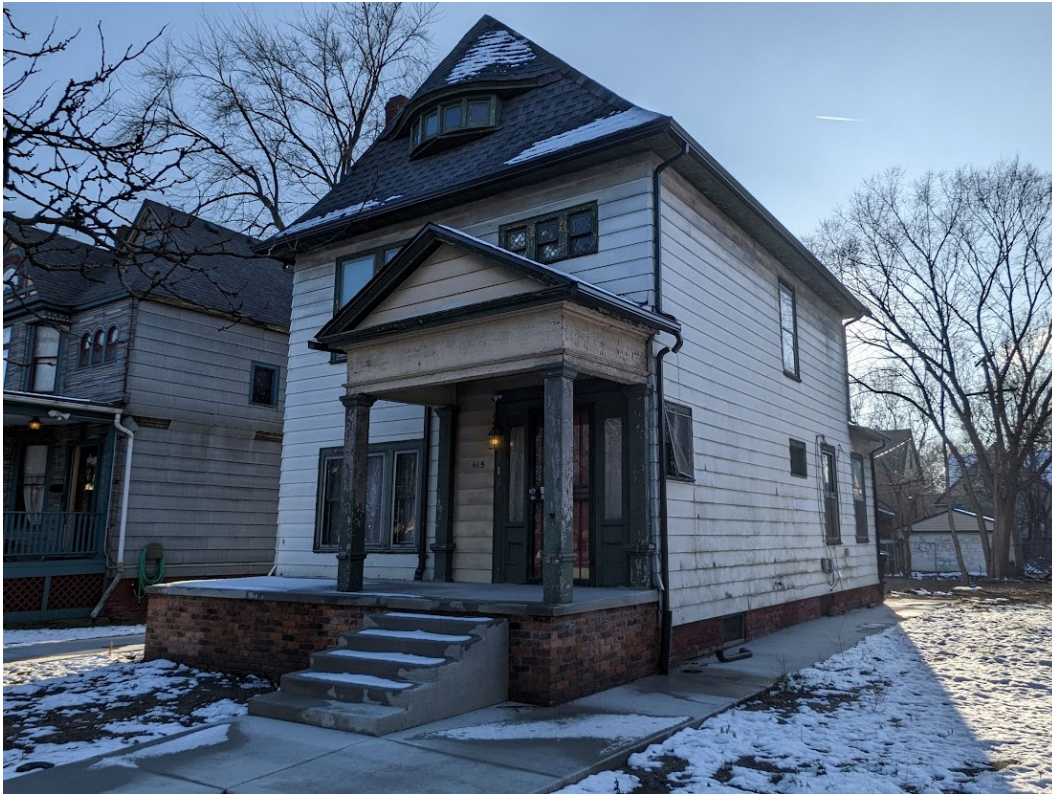
View of 415 West Grand Boulevard, looking southwest. Staff photo, January 24, 2023.

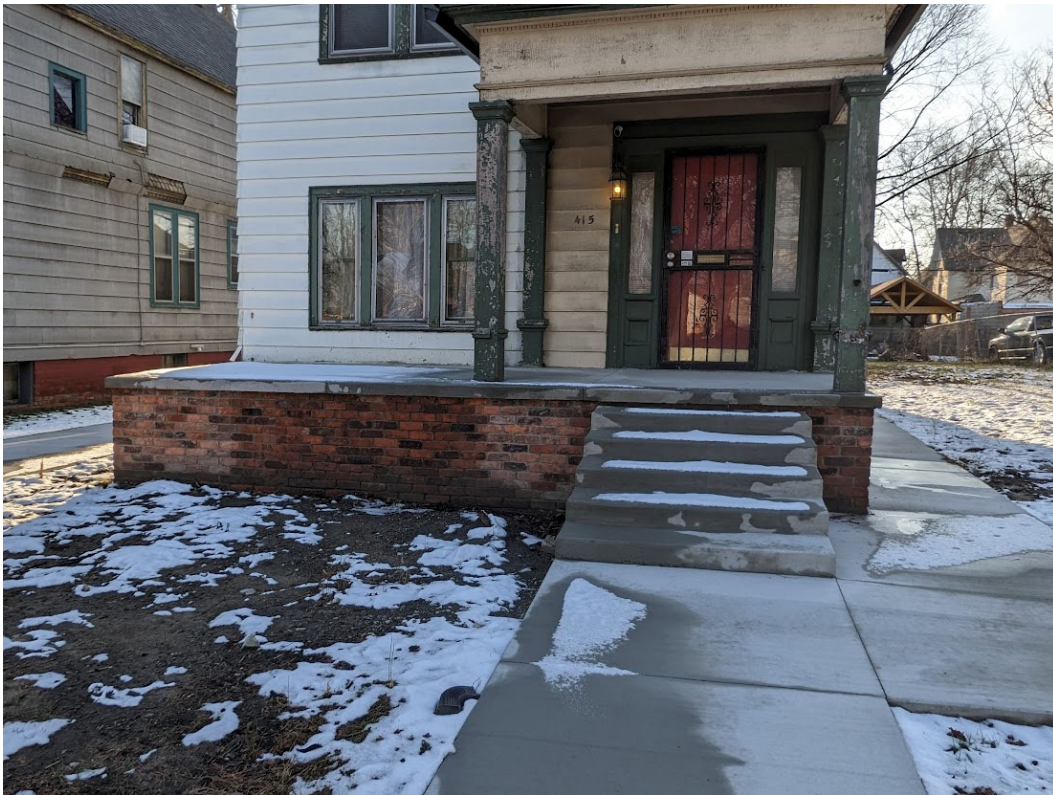
Detail view of porch area. Note the variegated brick pattern and addition of substantial new paving. Staff photo, January 24, 2023

- The as-built design of the new porch detracts greatly from the balance of the historic composition, giving much more visual massing to the new porch than the historic house, which competes with it for attention. A brick porch may perhaps be acceptable in this case given the lack of material integrity present at this property, but only in the historic footprint.

- The brick chosen for the new work, while somewhat similar to the "orange [common] brick" used in the historic foundation and chimney, is a mix of lighter and darker units, which is a modern formulation that unfortunately creates another distracting design element.

- The new front yard paving is more extensive than the previous condition, and offers less room for foundation plantings that were removed without approval.
- In staff's opinion, the combination of the additional paving, the concrete slab porch, and the additional brick massing of the full-width porch adds considerable "hardness" to the front of the property, and detracts from the historic character of the frame house.
- The proposed fence is a high-quality custom architectural product designed and manufactured locally. Though described by the applicant as wrought iron, materials are not specified on the fabricator's drawings (excepting the cast iron spear caps). Staff assumes the fence will actually be steel, executed in a wrought-iron style. In either case, the fence's design and site placement is appropriate.

- The legal status of the recently replaced full-width wood/concrete porch remains unclear, and may predate the district's designation.
- Should the Commission approve all or part of the new brick porch for retention, staff recommends that the modern brick should be painted to mask or de-emphasize the distracting variation in the brick mix, and that this paint should be merged into the painted foundation treatment. Combined with wood steps and other wooden porch elements consistent with the existing wooden porch roof and columns, this may reduce the stark impact of the current design, and integrate it more successfully into the historic massing.

- New foundation plantings at the front should be proposed by the applicant, which would balance the impact of the additional paved areas, or the paving should be reduced to its pre-existing extents.

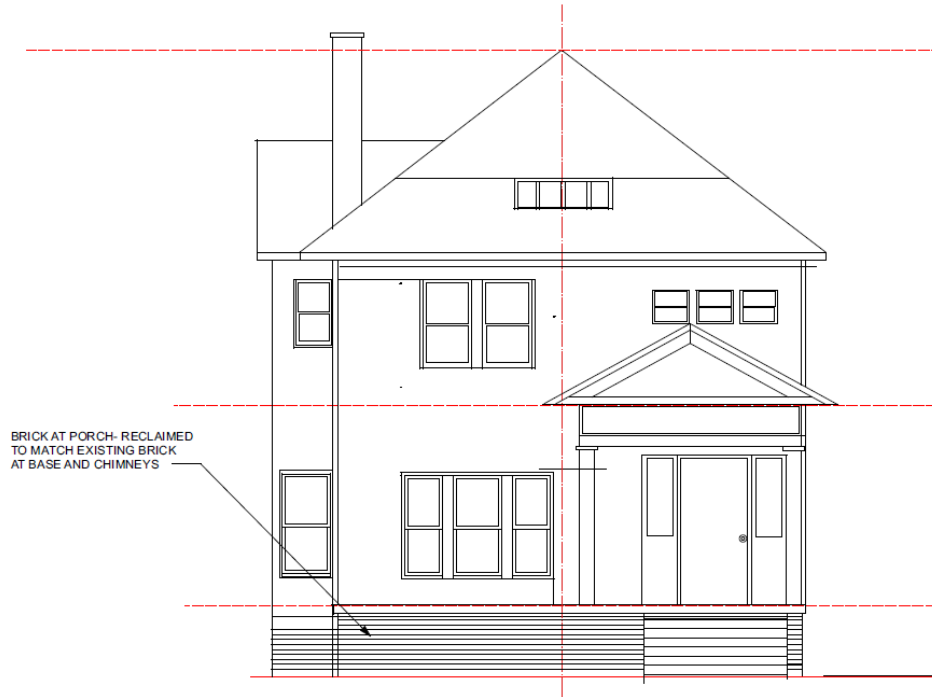
FRONT (GRAND BLVD.) ELEVATION

Front elevation and fence fabrication details from the applicant's submitted materials, above and below.

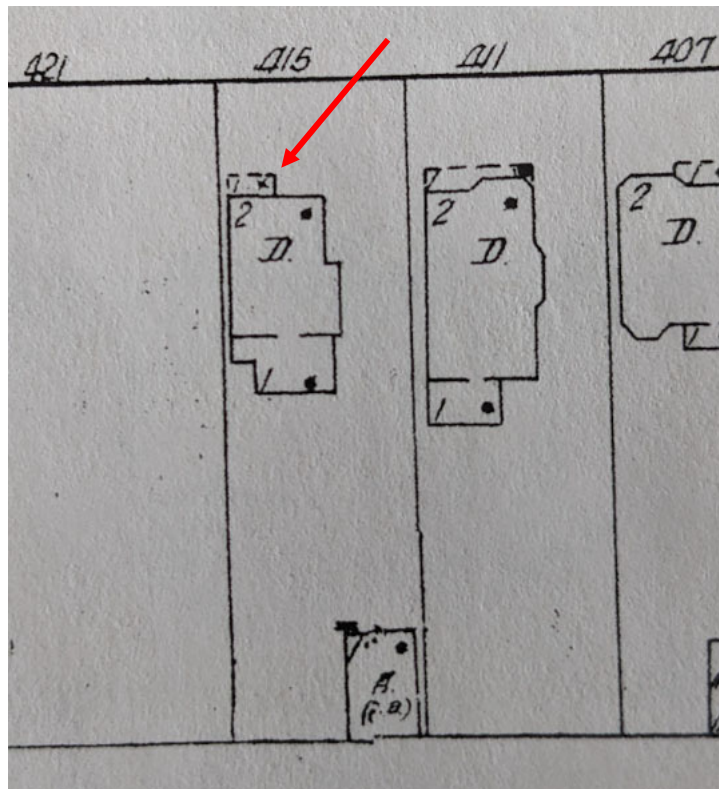
- A review of the historic Sanborn maps for this property show that the original porch, per the extant roof and columns, was situated only at the *right* side of the front elevation, and did not extend the full width of the house. See arrow below.

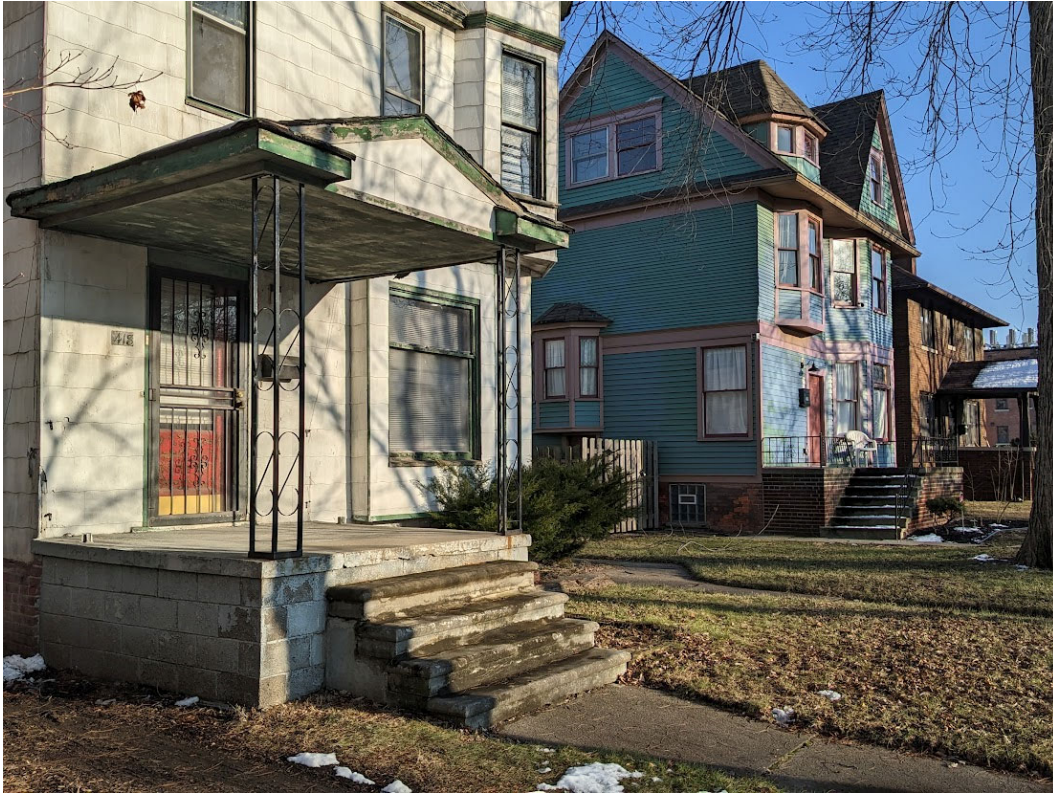
Other incompatibly altered porches exist in the historic district, here directly across from the subject house on West Grand Boulevard. Note that the example in the foreground, at 416 West Grand Boulevard, is limited to the footprint established by the historic roof, despite the incompatible ironwork and concrete block. It is unclear if the alteration at 414 West Grand Boulevard (blue Queen Anne house) was approved. Staff photo, January 24, 2023

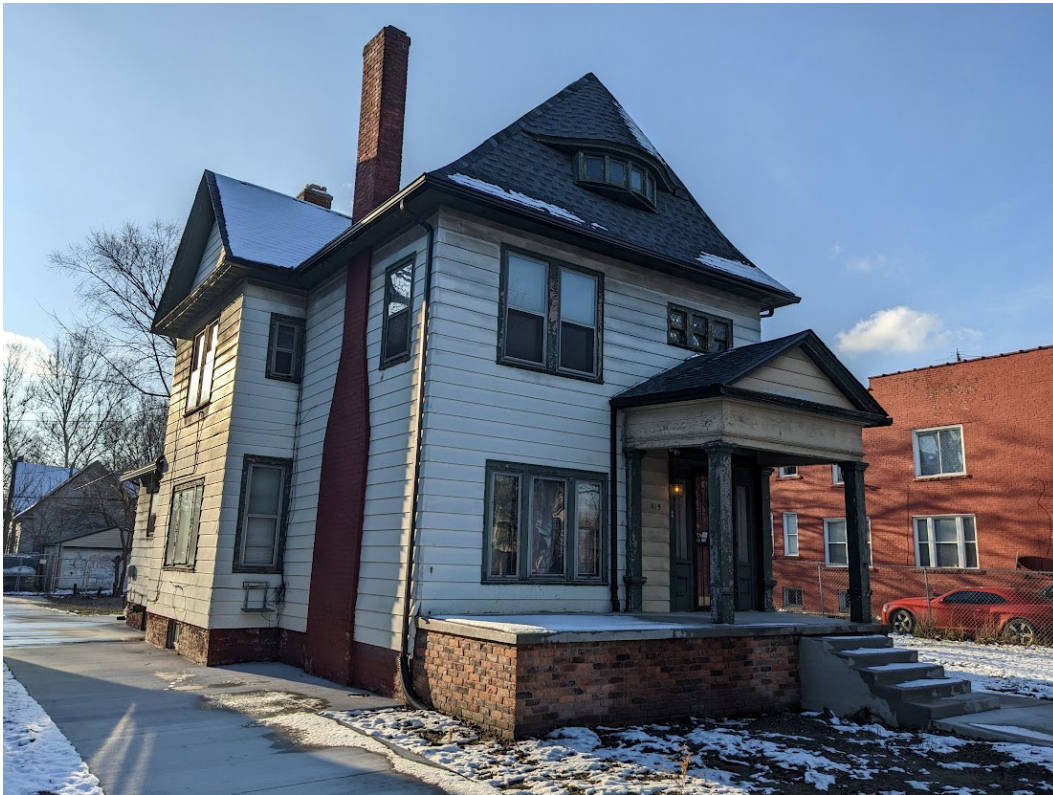
Another view of the subject property. Staff photo, January 24, 2023
