STAFF REPORT: FEBRUARY 8, 2023 MEETING

APPLICATION NUMBER: 23-8197

ADDRESS: 15083 MINOCK

HISTORIC DISTRICT: ROSEDALE PARK

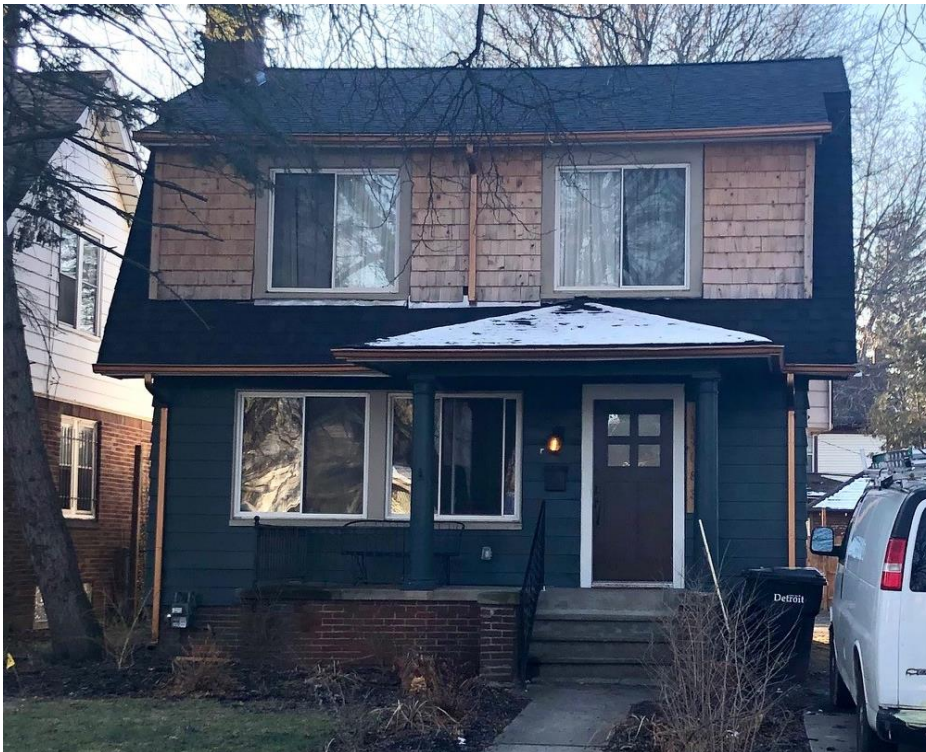
Staff photo, January 24, 2023

The two-story dwelling at 15083 Minock was erected in 1926. Wide shed dormers extend from the gambrel roof on the front and rear elevations; the large front elevation window openings have vinyl sliding units. Black asphalt shingles cover the roof, while the walls are faced with wood, aluminum, vinyl, and asphalt siding.

Most of the front porch is covered by a shallow-pitched hip roof that is supported by round wood columns. The house sits high above grade; the raised porch is accessed by stairs that are enclosed with masonry wing walls. A low iron railing (likely original to the house) runs along the majority of the porch perimeter and a contemporary aluminum railing has been installed on one side of the front steps.

The color palette on the sides and rear of the house are brown (asphalt siding) and white (aluminum/vinyl siding, window sash), while the front elevation is faced with unstained wood shingles and aluminum siding painted a dark blue-green. A new front door (black with square lights in the top half) and copper gutters and downspouts complete the front elevation.

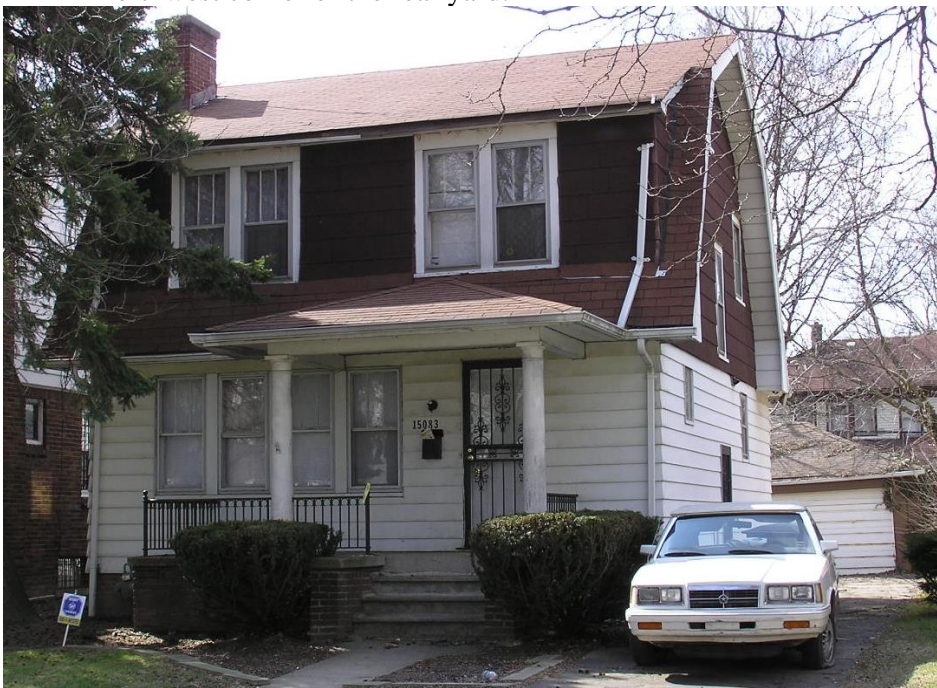
HDAB designation photo, 2006

- The Rosedale Park Historic District was established in 2006.
- Minock Avenue was likely named after Edward J. Minock, who in 1913 recorded a plat of land in Redford Township, which ultimately was developed as part of the Rosedale Park subdivision.
- Below is the district designation photo that shows original/historic wood windows in place on the front elevation, as well as asphalt (second floor) and aluminum siding. The front porch railing extended to the steps (portion between column and steps is now missing), and a two-car garage was present at the northwest corner of the rear yard.

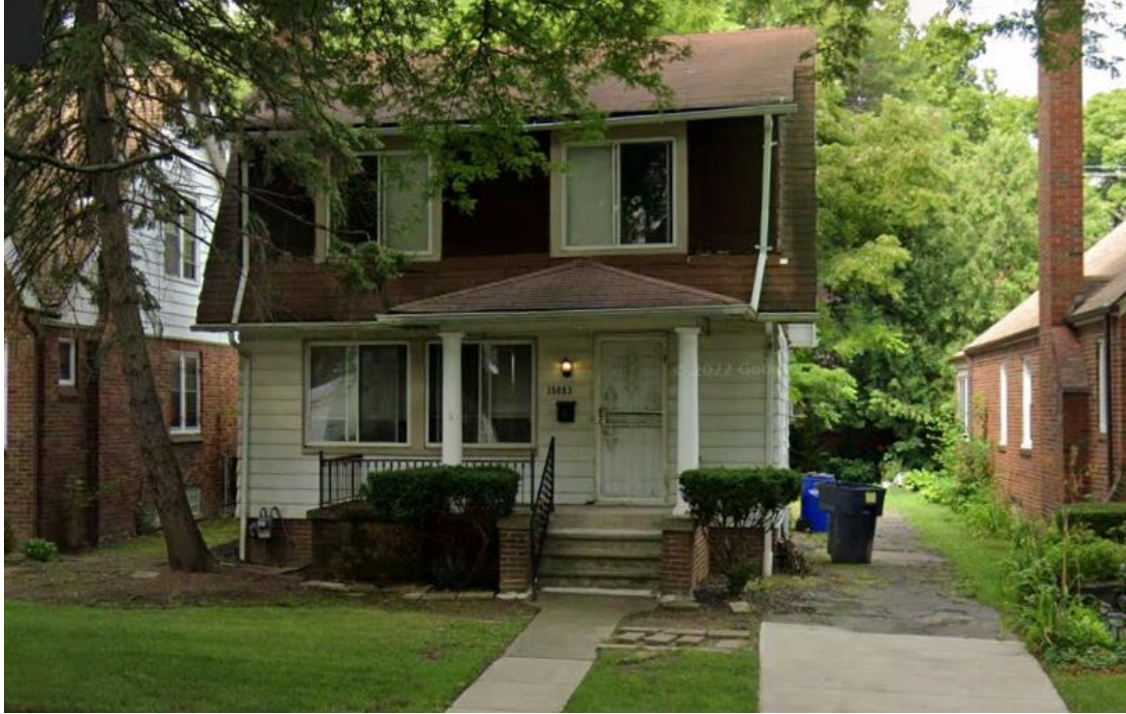
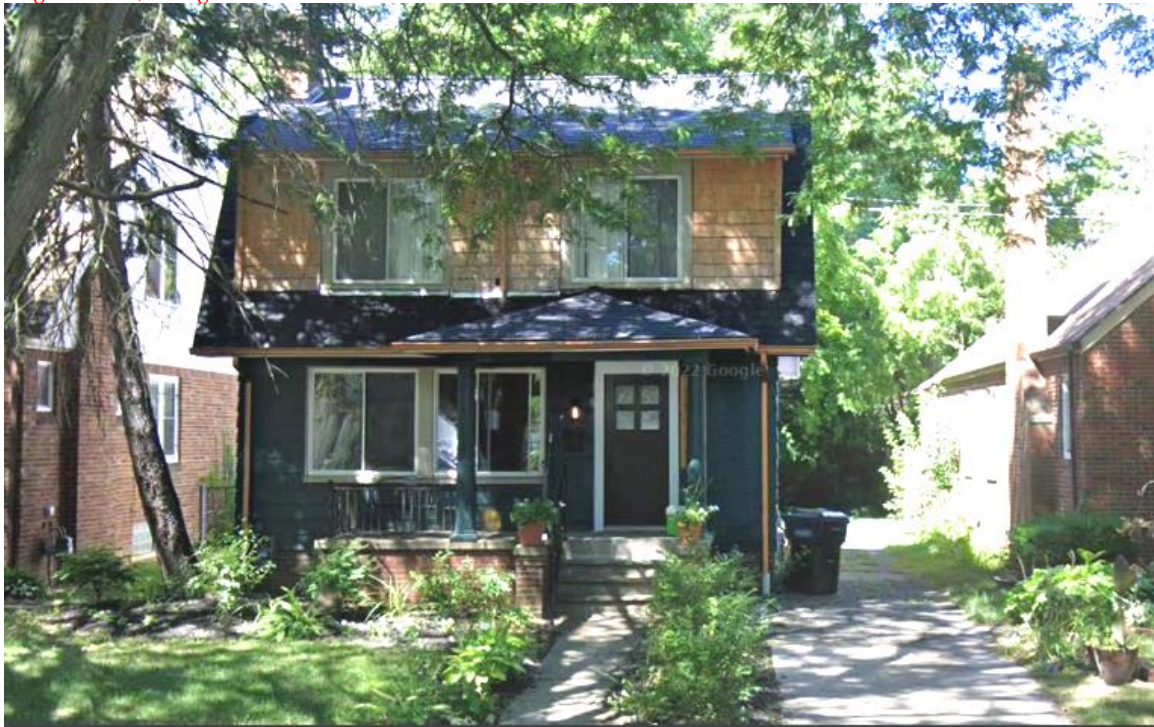
- The following work was completed between August 2018 and July 2021 and shown in the below comparison photographs.
 - A new front door was installed, replacing a non-historic door.
 - Wood shake siding was installed at the front elevation dormer, replacing asphalt siding.
 - Copper gutters and downspouts were installed, replacing white aluminum gutters and downspouts.
 - New front yard landscaping was installed replacing plantings at the base of the front porch.

August 2018, Google street view

July 2022, Google street view

It is staff's opinion the installation of the front door, wood shake siding, gutters/downspouts and front yard landscaping did not replace historic materials. The installed components are appropriate to the house and site and do not detract from the features and spaces that characterize the property and district. Therefore, staff recommends the Commission issue a Certificate of Appropriateness for the work as installed because it meets the Secretary of the Interior Standards for Rehabilitation and the Elements of Design for the district.

- The wood shake siding will be stained a color approved by staff.

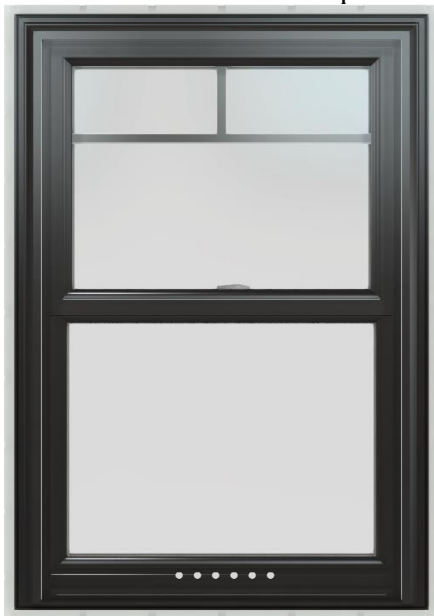
Jeld-Wen V-2500 Vinyl Unit

- Staff isn't sure which Jeld-Wen product is currently proposed. The window order that went with the original design (sliding vinyl windows) specifies the "Builder's Vinyl" product, V-2500. This line only offers between-the-glass grids. However, the catalog cut submitted is for Jeld-Wen's V-4500 unit, which offers simulated divided-light muntins. Both vinyl products offer thick sash with little difference between vertical and horizontal components.

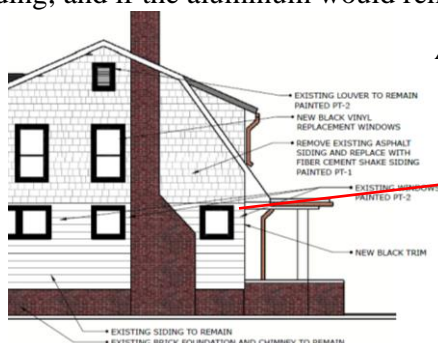
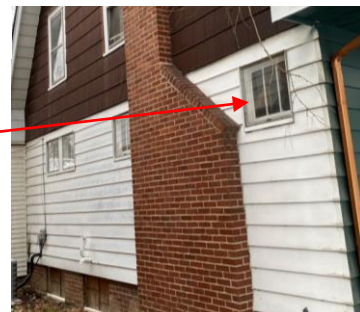
Applicant drawing and photos

- The proposal states the aluminum siding will be cut back for the installation of vinyl trim/window casings for the remaining first floor wood windows. Not only is there inadequate room at the chimney on the south elevation, staff also isn't clear on the long-term viability of vinyl trim being installed within aluminum siding, and if the aluminum would remain rigid if cut back and terminated against vinyl casings.

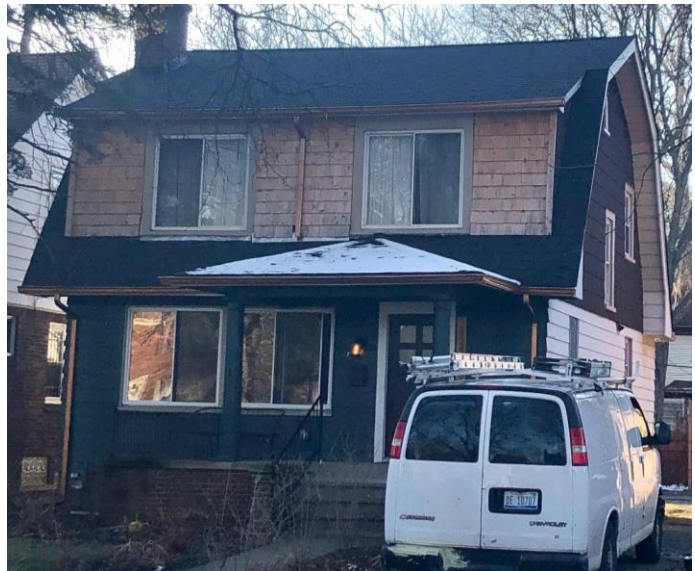
- The proposal states cementitious siding will be installed on the second story side walls where the asphalt siding is to be removed; as well as on the front elevation wall, covering the wood shake siding. Staff disagrees with covering the wood siding; it is a character-defining feature for this style of house and wall location, and it can be painted or stained to match an approved color palette. The applicant told staff that the siding is attached in such a way that when removed, the wood siding will be too damaged to save. If this is true, and subject to additional documentation, this historic feature should only be renewed with like material.

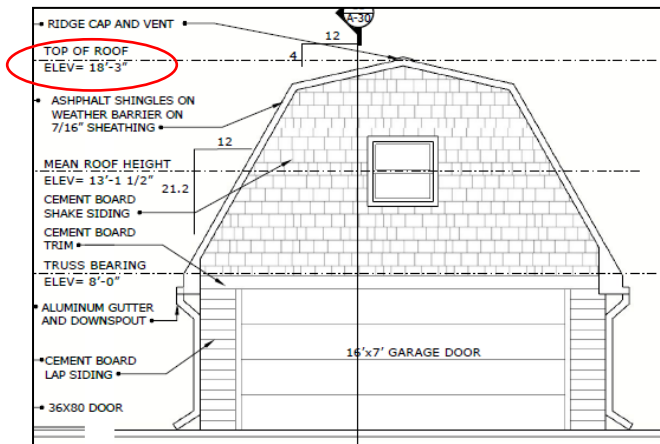
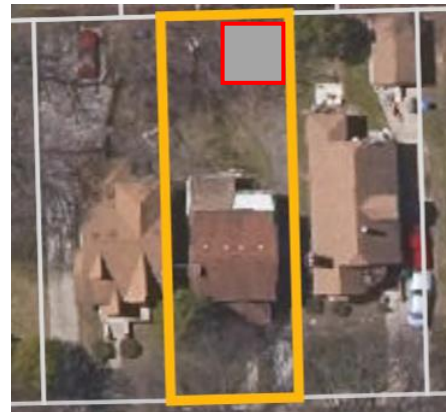
Detroit Parcel Viewer -gray box denotes location of proposed garage.

- The garage has a standard footprint of 20' wide x 20' deep, however the steep pitch of the gambrel roof creates a ridge height of 18'-3". The garage's design is in context with the house's gambrel roof; however, the exceptionally tall height of this garage will be out of proportion for the neighborhood. Additionally, the standard six-foot privacy fence, only five feet way (on 40' wide lots) would only conceal the bottom third of the structure from the neighboring property.

- Staff isn't opposed to the erection of an addition or a 20' x 20' garage, rather the main opposition is over the scale of each structure. Additions extending from the rear elevation are very common, however they often have flat or low slope shed roofs starting at/near the house's eave. ~~An addition should also not have a larger footprint than the house (whether in direct length or overall square footage).~~ Just as the width of the proposed addition is about half the width of the house, the addition's length should be at most half of the existing house's length. Therefore, all elevations would be more proportional to the house, lot, and neighboring properties.

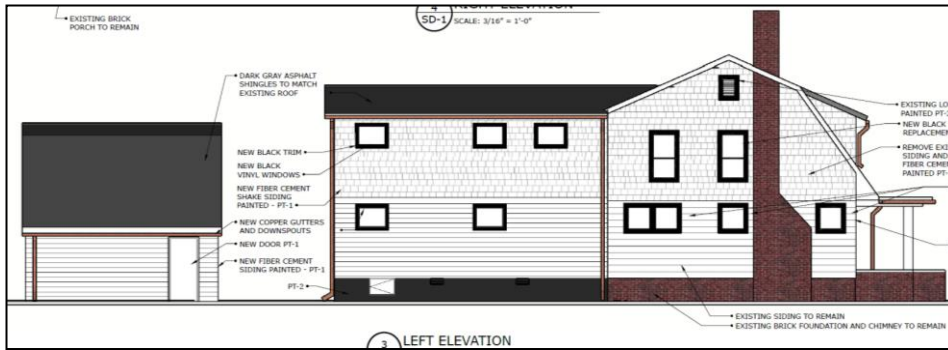
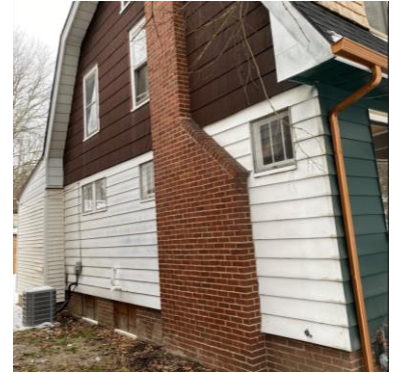
Applicant drawings and photo

- The addition's southern elevation (shown below) has smaller horizontal windows, which are similar to small windows on the house (which the applicant will retain). It is common for side and rear elevation windows to have one-over-one sash (which are shown on the addition's northern and west elevations).

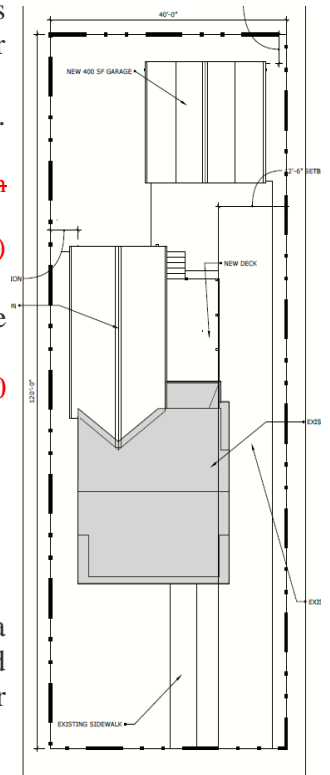
- The term "moderately scaled dwellings" is referenced in multiple elements of design. As staff mentioned with the garage, a two-story addition with a finish

height of ~~over 20'~~ 19'-8" high (~~when the raised foundation is considered~~) and extending 23' ~~almost 29'~~ back from the house, and within five feet of the lot line, will create a large impact on the neighboring house to the south.

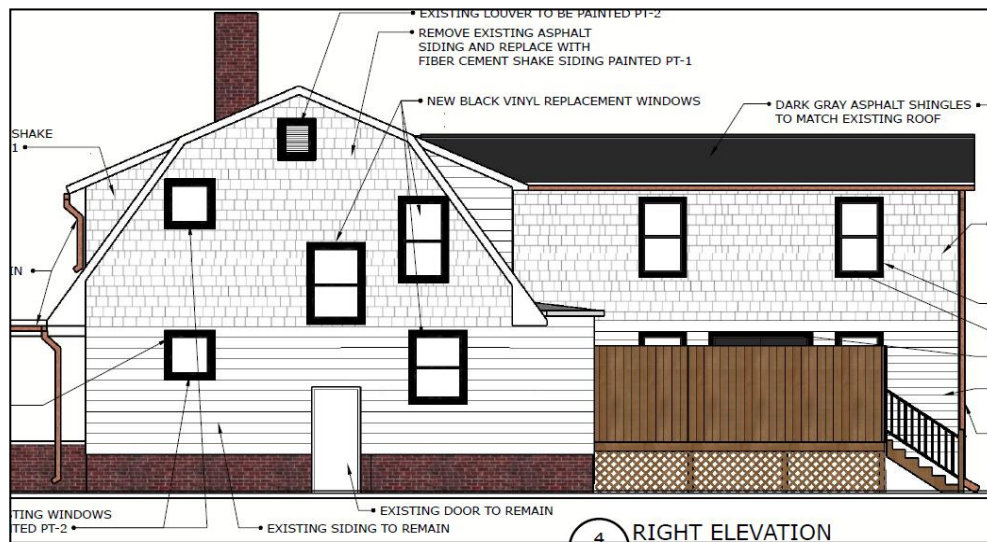
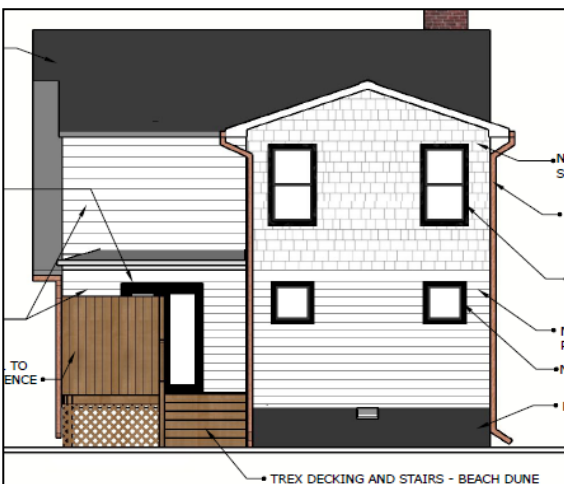
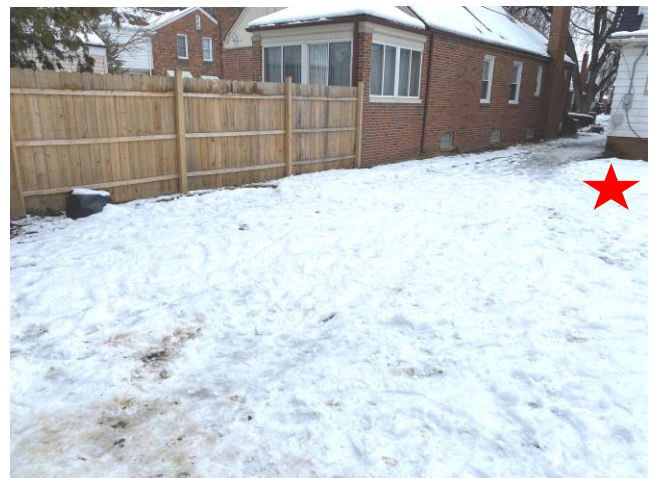
- A raised deck is proposed at the rear elevation and includes a privacy wall that will extend from the corner of the house and return at the west corner to the stairs, enclosing the outdoor space. Decks are contemporary features and are not enclosed spaces/structures. The height of the privacy wall is not noted, but the top of the wood wall is just shy of the sliding door, so it is likely around seven feet tall. Add in the raised distance from grade, the finished height is eight to nine feet. Any vertical element at this location should be lower and transparent in some way. The proposed decking material is Trex, but the privacy wall is to be constructed of wood similar to the lot line fence. It is staff's opinion the material at the north and west deck perimeter should match the selected material for the deck and stairs.

Applicant drawings and photographs. The applicant's photo is taken from the location of the proposed garage. A star denotes the location of the proposed deck.
