STAFF REPORT: FEBRUARY 8, 2023 REGULAR MEETING

APPLICATION NUMBER: 23-8202

ADDRESS: 15015 ASHTON

SCOPE: INSTALL VINYL WINDOWS

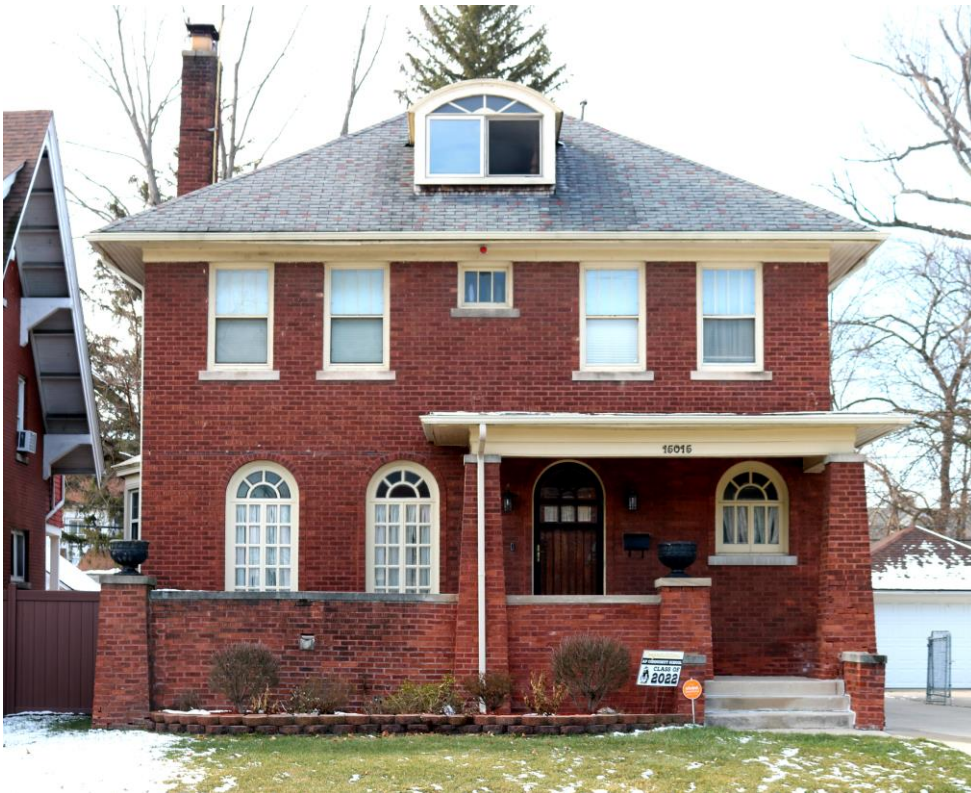
15015 Ashton is a two-story, hip-roof, red-brick building in the Rosedale Park Historic District, built in 1917, and facing east onto the street. It faces east onto the street. Notable details include historic wood windows on the primary (east) façade: multilight casement windows topped by multilight, arched fan windows on the first floor, and four-over-one sash windows on the second floor. Also noteworthy are an arched door opening with wood panel door and prominent, battered, porch columns and piers; these features combine to give the building a subtle Craftsman or Prairie influence. Most of the original windows on the house have been replaced with vinyl windows; the rear porch has also been enclosed with vinyl siding and vinyl windows.

View from east. January 2023 photo by staff.

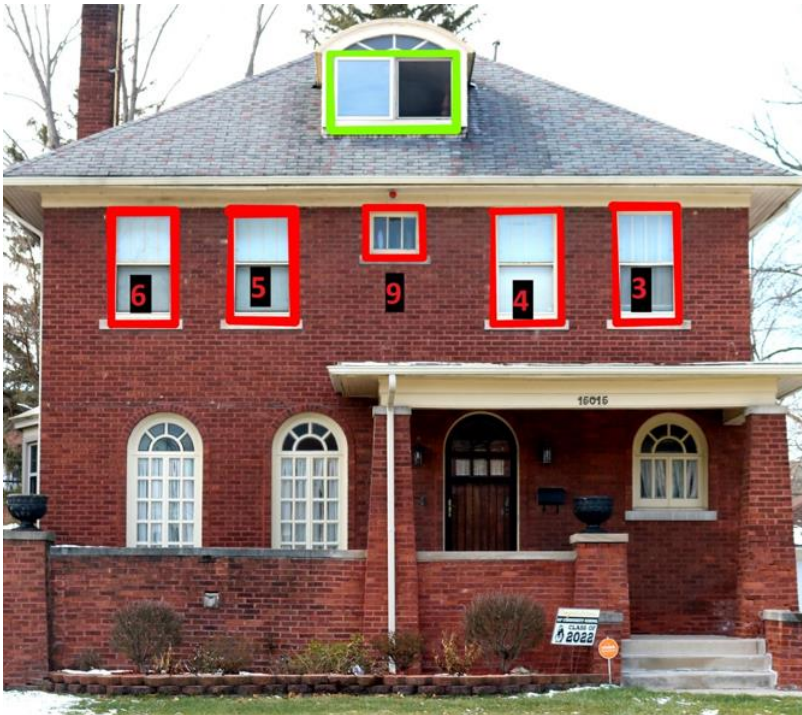
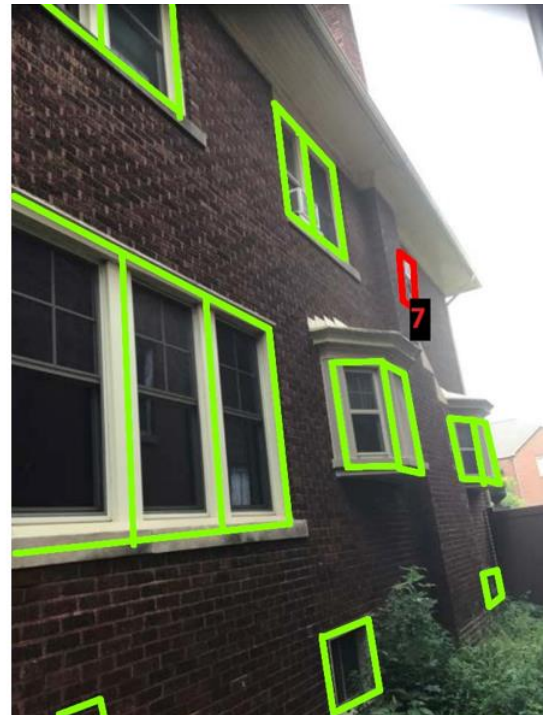
Left: East elevation; 1 vinyl window, 5 wood windows proposed for replacement, 3 wood windows proposed to remain (photo by staff). Right: South elevation; 16 vinyl windows, 1 wood window proposed for replacement (photo from application, note that not all windows are visible.)

- The windows proposed for replacement on the front (east) façade are unambiguously character-defining as they are subdivided, as described in the Elements of Design; further, their vertical muntin pattern imparts a Craftsman style to the house and provides a visual cue to the era of the building’s construction.

- The original windows on the north and south facades, though less clearly distinctive, are important to the character of their house due to their materials and operation.

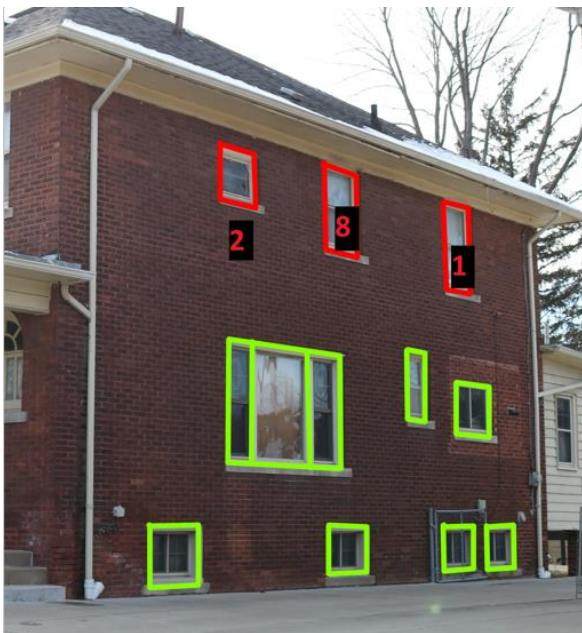
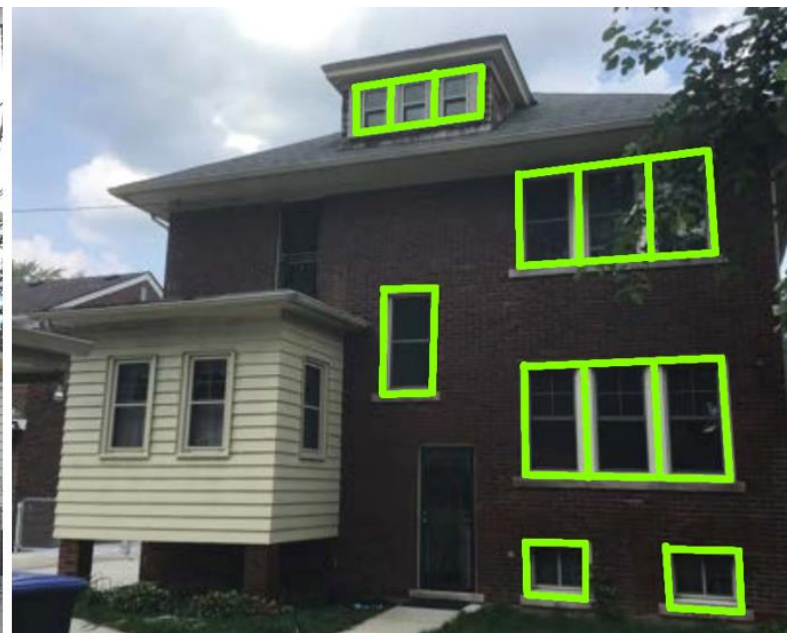
Left: North elevation; 9 vinyl windows, 3 wood windows proposed for replacement. West elevation: 12 vinyl windows. (Note that windows on the enclosed porch are not original or historic; photos from application.)

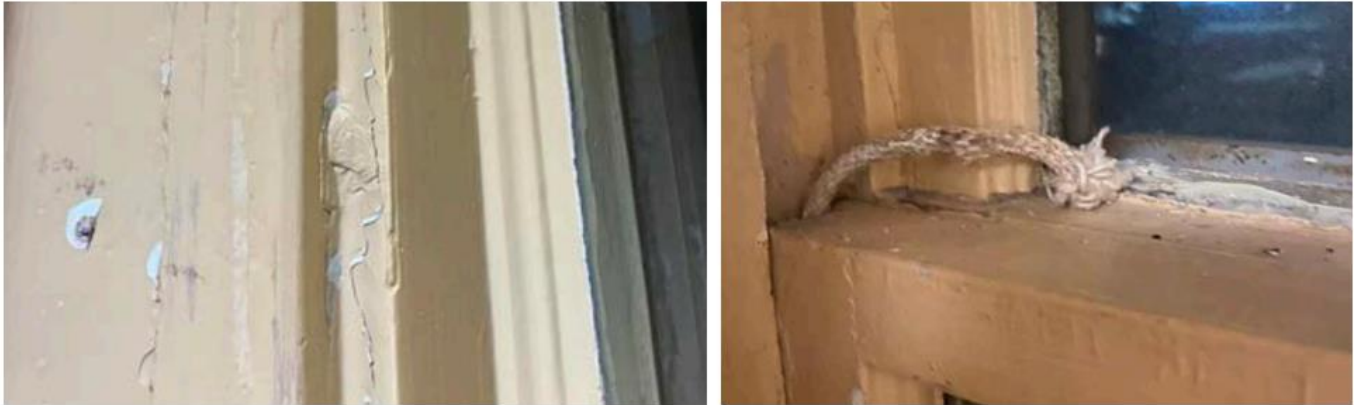
- The application provides clear photos and description of deterioration of the windows proposed for replacement (due to the number and size of the photos, they are not all reproduced in this report; please reference the application). In summary, the applicant describes missing hardware, “soft and rotting” wood, windows unable to open or unable to close fully, broken glass and sash rope: “my repairman was not able to find parts to replace the damaged parts.”

- Staff observes, through application photos, that windows show clear signs of having been painted over numerous times, a condition which will impair their ability to open and close properly; there are also missing and broken sash cords. These conditions are typical maintenance needs of old windows and are repairable (John H. Myers, “The Repair of Historic Wooden Windows,” Preservation Brief 9, (National Park Service Technical Preservation Services), <https://www.nps.gov/tps/how-to-preserve/briefs/9-wooden->

windows.htm). This is also the case with broken glass panes. The areas of damaged wood appear, to staff, to be localized and repairable.

Selected examples of deterioration. Left: damaged parting bead showing overpaint. Right: Sash showing multiple layers of paint and a broken sash cord. Photos from application; cropped by staff. Please see application for additional photos and description.

Staff recommends that the Commission issue a Denial of the proposed window replacement as it would remove historic features of the property and replace them with features of non-historic materials, dimensions, and appearance; consequently, the proposed work does not meet the Secretary of the Interior's Standards for Rehabilitation, in particular:
