STAFF REPORT: 02/08/2023 MEETING
APPLICATION NUMBER: 23-8205
ADDRESS: 100 LONGFELLOW STREET
HISTORIC DISTRICT: BOSTON-EDISON HISTORIC DISTRICT
APPLICANT: RANDY WHITE
PROPERTY OWNER: BRANDI BROWN
DATE OF PROVISIONALLY COMPLETE APPLICATION: 12/20/2022
DATE OF STAFF SITE VISIT: 01/24/2023

SCOPE: RENOVATE FRONT PORCH AND WALKWAY, REPLACE LANDSCAPING, REPAINT EXTERIOR

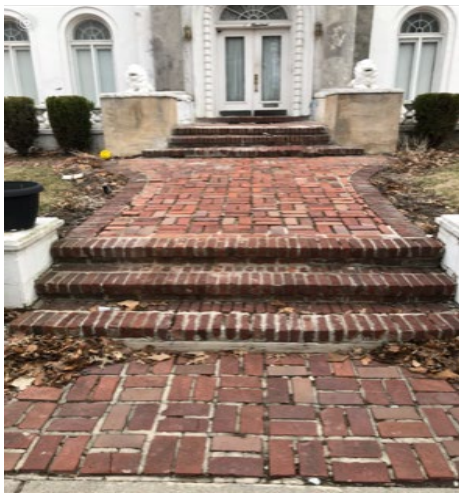
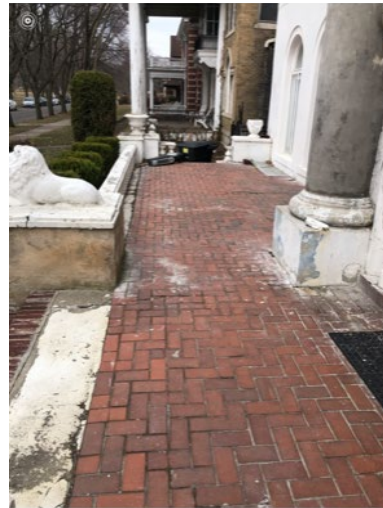
Figures 5,6: Photographs of the brick walkway and porch deck prior to work commencing.

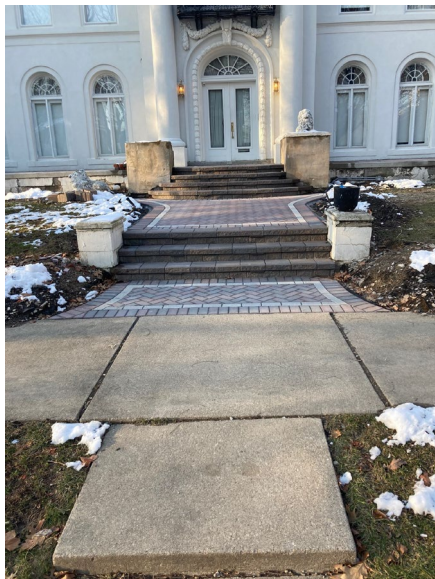
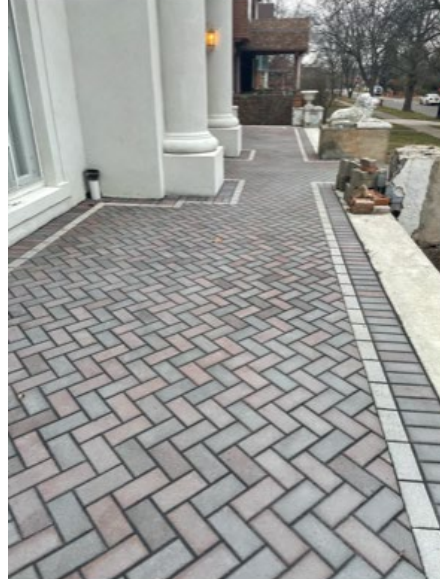
Figures 7,8: Current image of the porch deck and walkway.

- The current paving material is tinted concrete, which differs significantly from the historically appropriate paving materials. The installed concrete pavers are darker in color and of a different texture and finish than the approved vitrified clay brick. A distinct gray accent course runs around the borders of the walkways and porch, while the historic paving schemes were uniform in color. Historic photographs show the original concrete stairs, as well as the 1981 brick stairs, were rectilinear in plan while the installed concrete pavers stairs are curved. Accent lighting on the stairs adds to the historic incompatibility. It is staff’s opinion that the current paving plan presents a decidedly contemporary aesthetic that is not compatible with the historic architecture of the property or the Boston-Edison Historic District.

- It is staff's opinion that replacing the concrete pavers with either a poured concrete (original material), or traditional red-brown common brick (as prescribed in the 1981 COA) paving scheme would meet the Secretary of Interior Standards for Rehabilitation and the Elements of Design for district.

It is staff's opinion the proposed concrete pavers and accent lighting and will significantly alter the features and spaces that characterize the property. Staff therefore recommends the Commission issue a Denial for the work as proposed because it does not meet the Secretary of the Interior Standards for Rehabilitation and the Elements of Design for the district, specifically Standards:

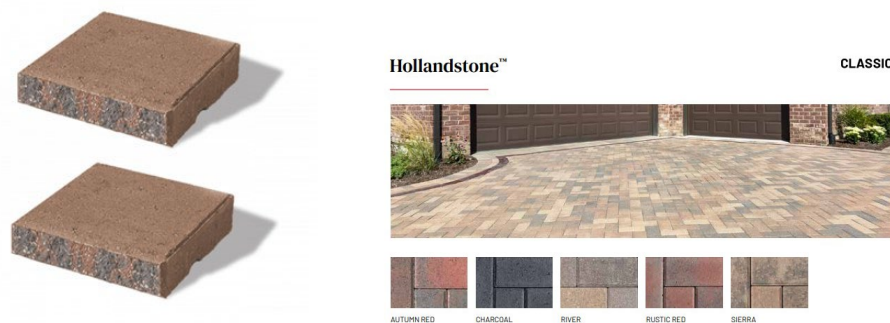
Figures 9,10: Catalog images of the concrete pavers installed at the walkway and porch.
