**STAFF REPORT: 02/08/2023 MEETING**

**APPLICATION NUMBER: 23-8200**

**ADDRESS: 94 EAST BOSTON BOULEVARD**

**SCOPE: REPLACE TERRACOTTA ROOF TILES WITH ASPHALT SHINGLES**

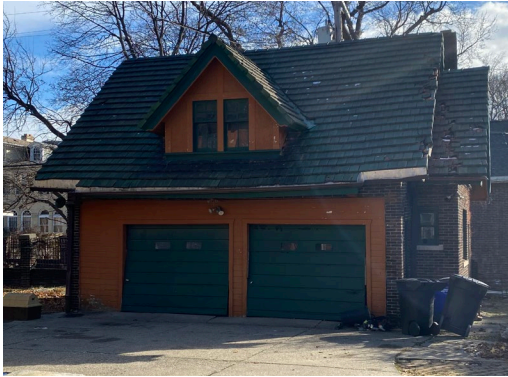
Figure 3: Image of the garage, looking south.

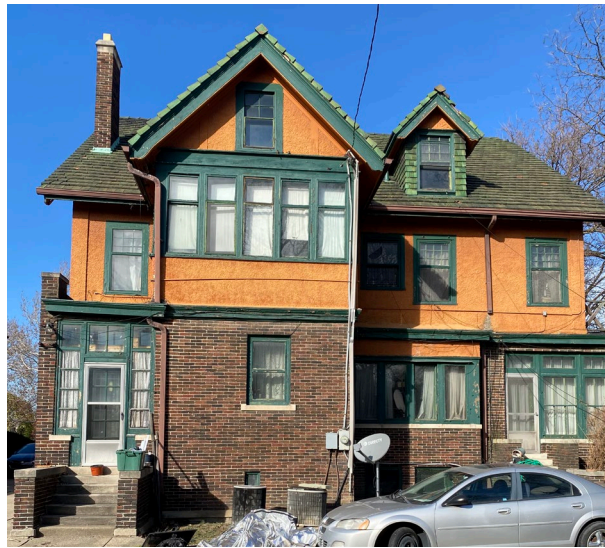
Figure 4: View of rear of dwelling, looking north.

- The Arden Park-East Boston Historic District was established in 1981.
- HDC records indicate the Chicago Roofing and Slate company installed new terracotta roof shingles that matched the existing in 1994.
- Deterioration of portions of the tile, particularly in areas where the roof slope meets the eaves and near overhanging tree branches, is observable from the public right-of-way and in photographs submitted by the client.

- Portions of the tile roof exhibit deterioration, however applicant submitted photographs and observations made during the staff visit do not indicate the roof is deteriorated beyond repair. The deterioration appears to be limited to specific areas of the roof on both buildings.
- The applicant has indicated they are pursuing quotes to repair or replace the tiles at the deteriorated areas of the roof. No quotes for this work were submitted by the applicant to date.

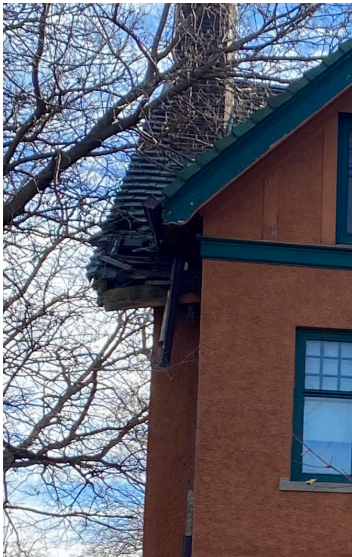
Figure 5: Detail of northeast corner of roof.
