**STAFF REPORT: FEBRUARY 8, 2023 MEETING**

**APPLICATION NUMBER: 23-8204**

**ADDRESS: 7908 – 7912 ST. PAUL**

**SCOPE: REMOVE WOOD SIDING\*, INSTALL SYNTHETIC SIDING, REPLACE WINDOWS AND DOORS, REBUILD PORCH**

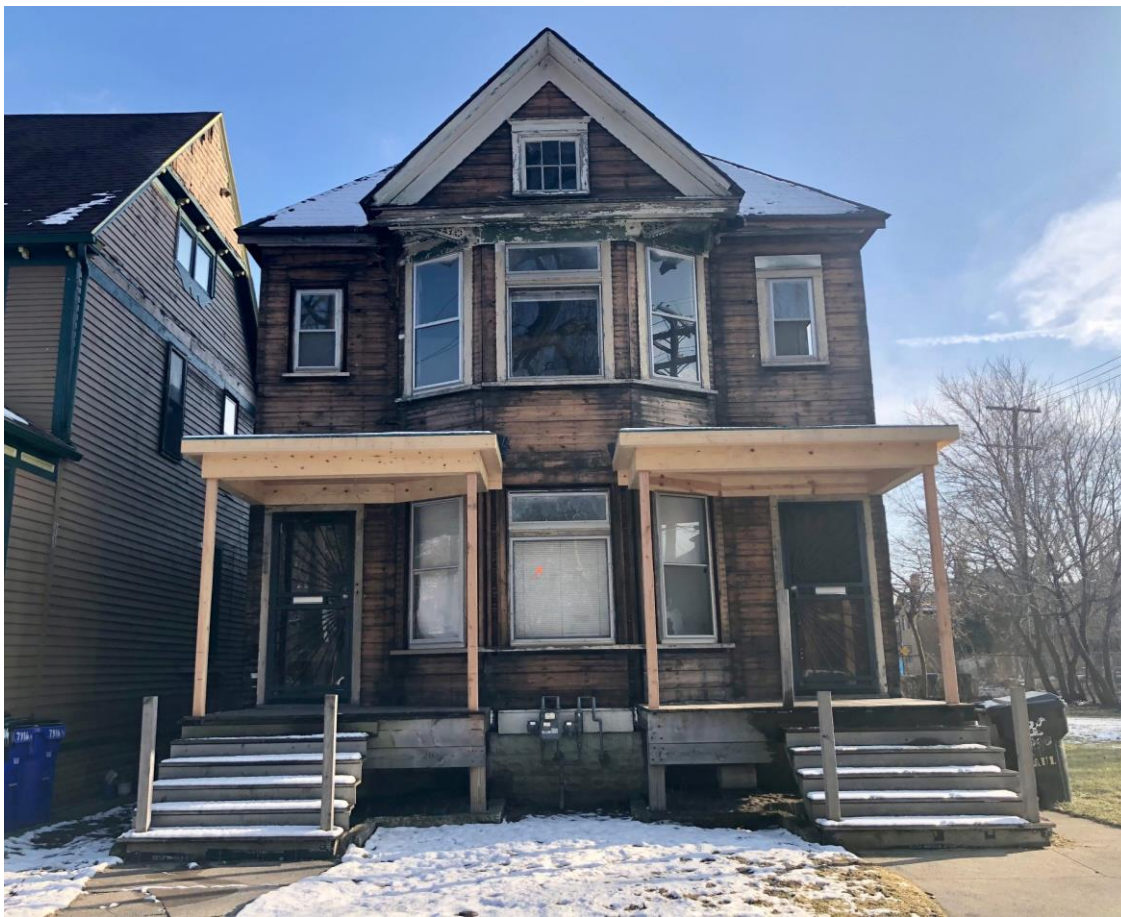
*Staff photo, January 24, 2023*

The two-family dwelling at 7908 – 7912 St. Paul was erected after 1897 and before 1910. It is a 2 ½ story structure on a raised foundation. The symmetrical façade is centered with a two-story bay that displays a typical window pattern for this era: central fixed windows with leaded glass transoms above, and double-hung windows, matching the height of the central openings, in place on the angled walls. The bay culminates with a recessed gable within which is a small centrally placed fixed or awning window. Covered entry porches fill the remaining first floor of the front elevation and small double-hung windows are centrally located within the remaining wall surface at the second level. The historic wood siding was recently removed without HDC approval, so the underlying wood sheathing is the current exterior wall surface. Historic wood windows (some with leaded glass, some with wood muntins) are still in place in most openings, and the majority of visible window sash appear to be wood framed one-over-one double-hung units. Metal storm windows are in place on all non-boarded openings. Wood scrollwork applied trim remains at the underside corners of the front gable.

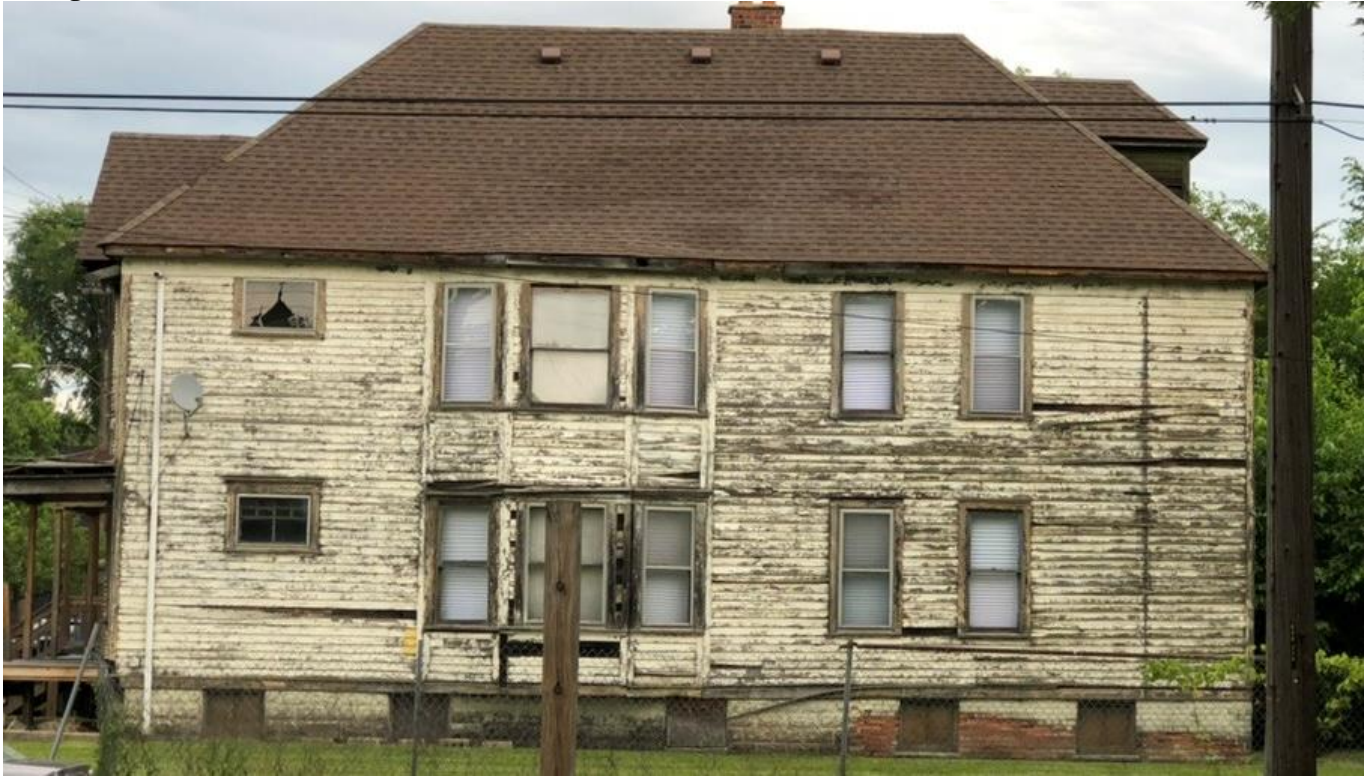
*West side elevation - Applicant photo*

- The applicant's photos give evidence of occasional missing boards and flaking paint; however, the majority of the siding was intact and very likely repairable. This house was constructed in the early 20<sup>th</sup> century of old growth lumber which was exceptionally dense and highly durable.

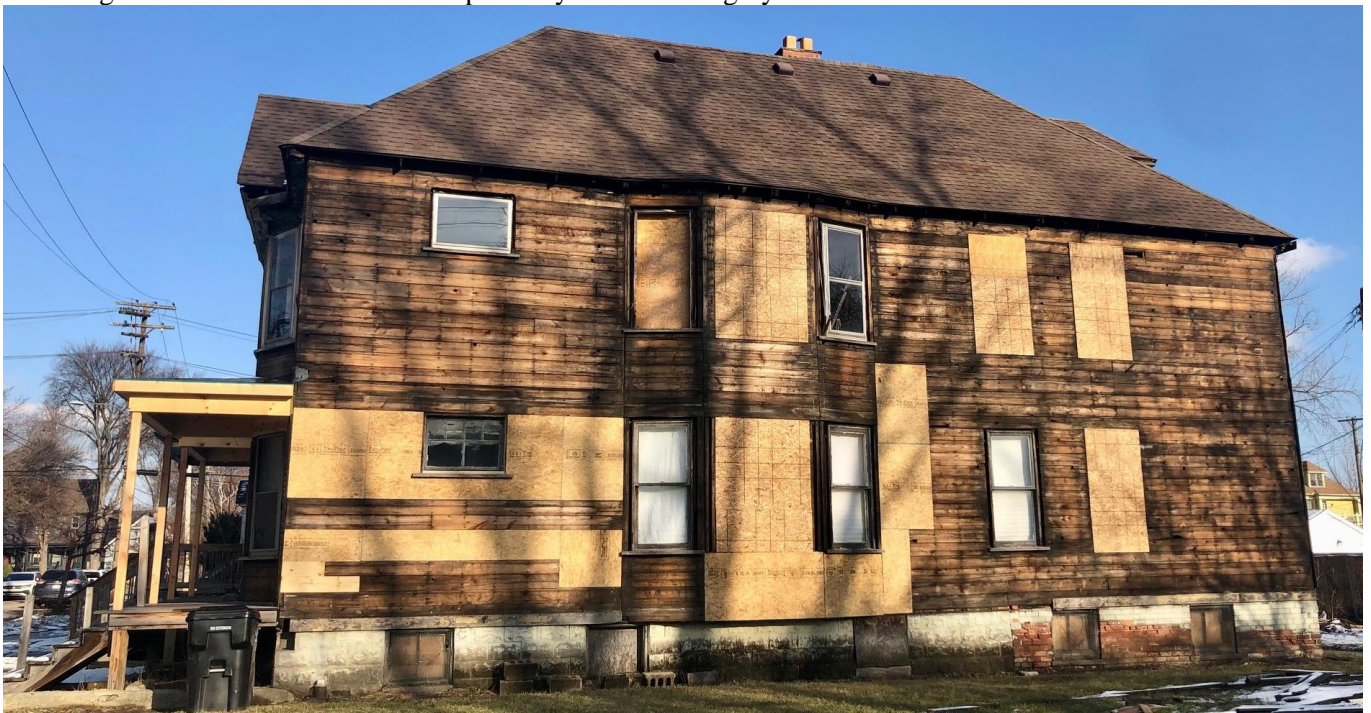
*Staff photo, January 2023*

- As discussed under staff observations, the dimensional difference of the front and side elevation siding is a distinctive character-defining feature of this house and immediately identifies its era of construction. The applicant confirmed the siding on the sides and rear of the house had a 5" reveal; the siding on the front elevation had a 3" reveal.

- The applicant stated the proposed Hardie lap siding can offer a 4" reveal for the front elevation and a 5" reveal for the side and rear elevations. While this offers some dimensional change, the 2" difference in dimensions for the historic siding is distinctly noticeable; a detail that would be lost (or significantly minimized) with the Hardie siding.

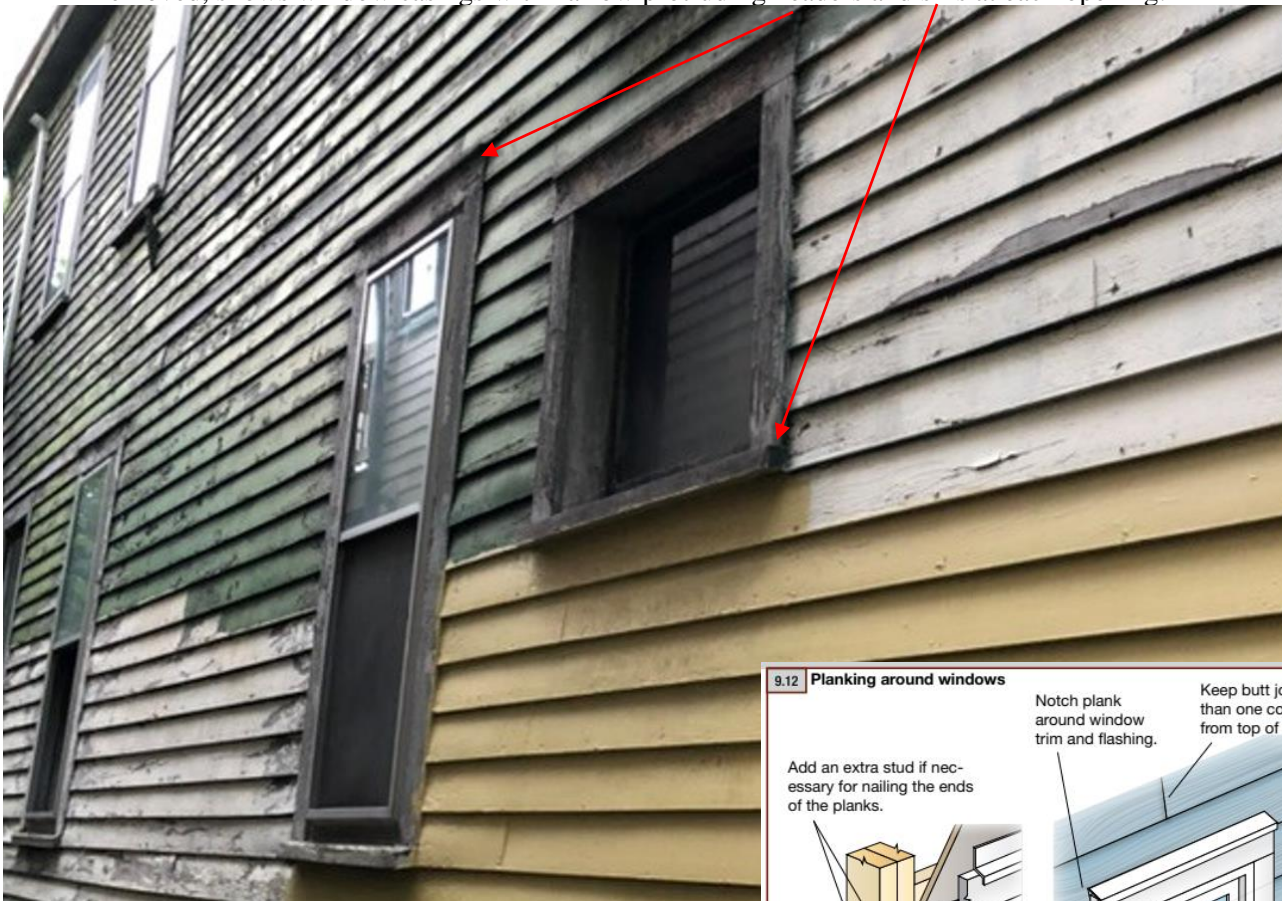
*Applicant photo, west-side elevation*

- Staff is also concerned about the possible loss of detail at each window opening with the installation of the Hardie Product. The below photo, which is of a portion of the west elevation before the historic siding was removed, shows window casings with narrow protruding headers and sills at each opening.

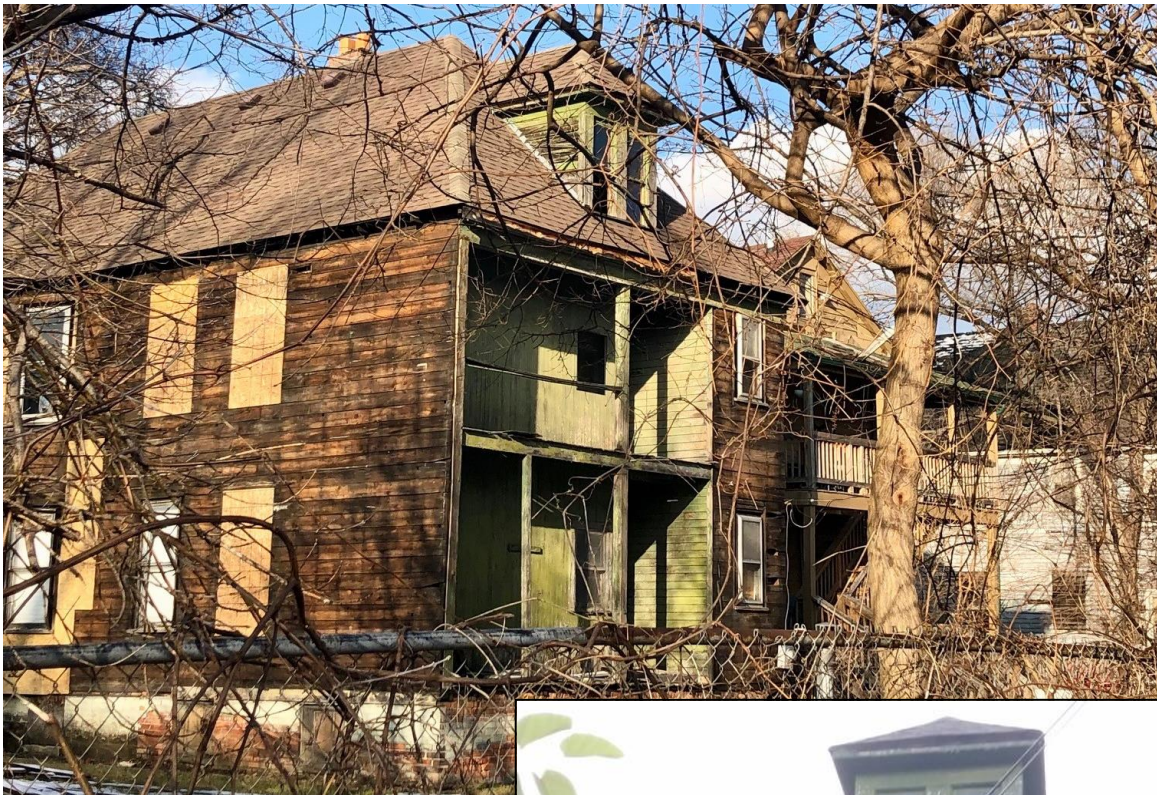
*Rear elevation - Staff photo above, applicant photo at right*

- The applicant noted in the reply to staff that the rear porches will be replaced. However, this scope of work is not included with this application.

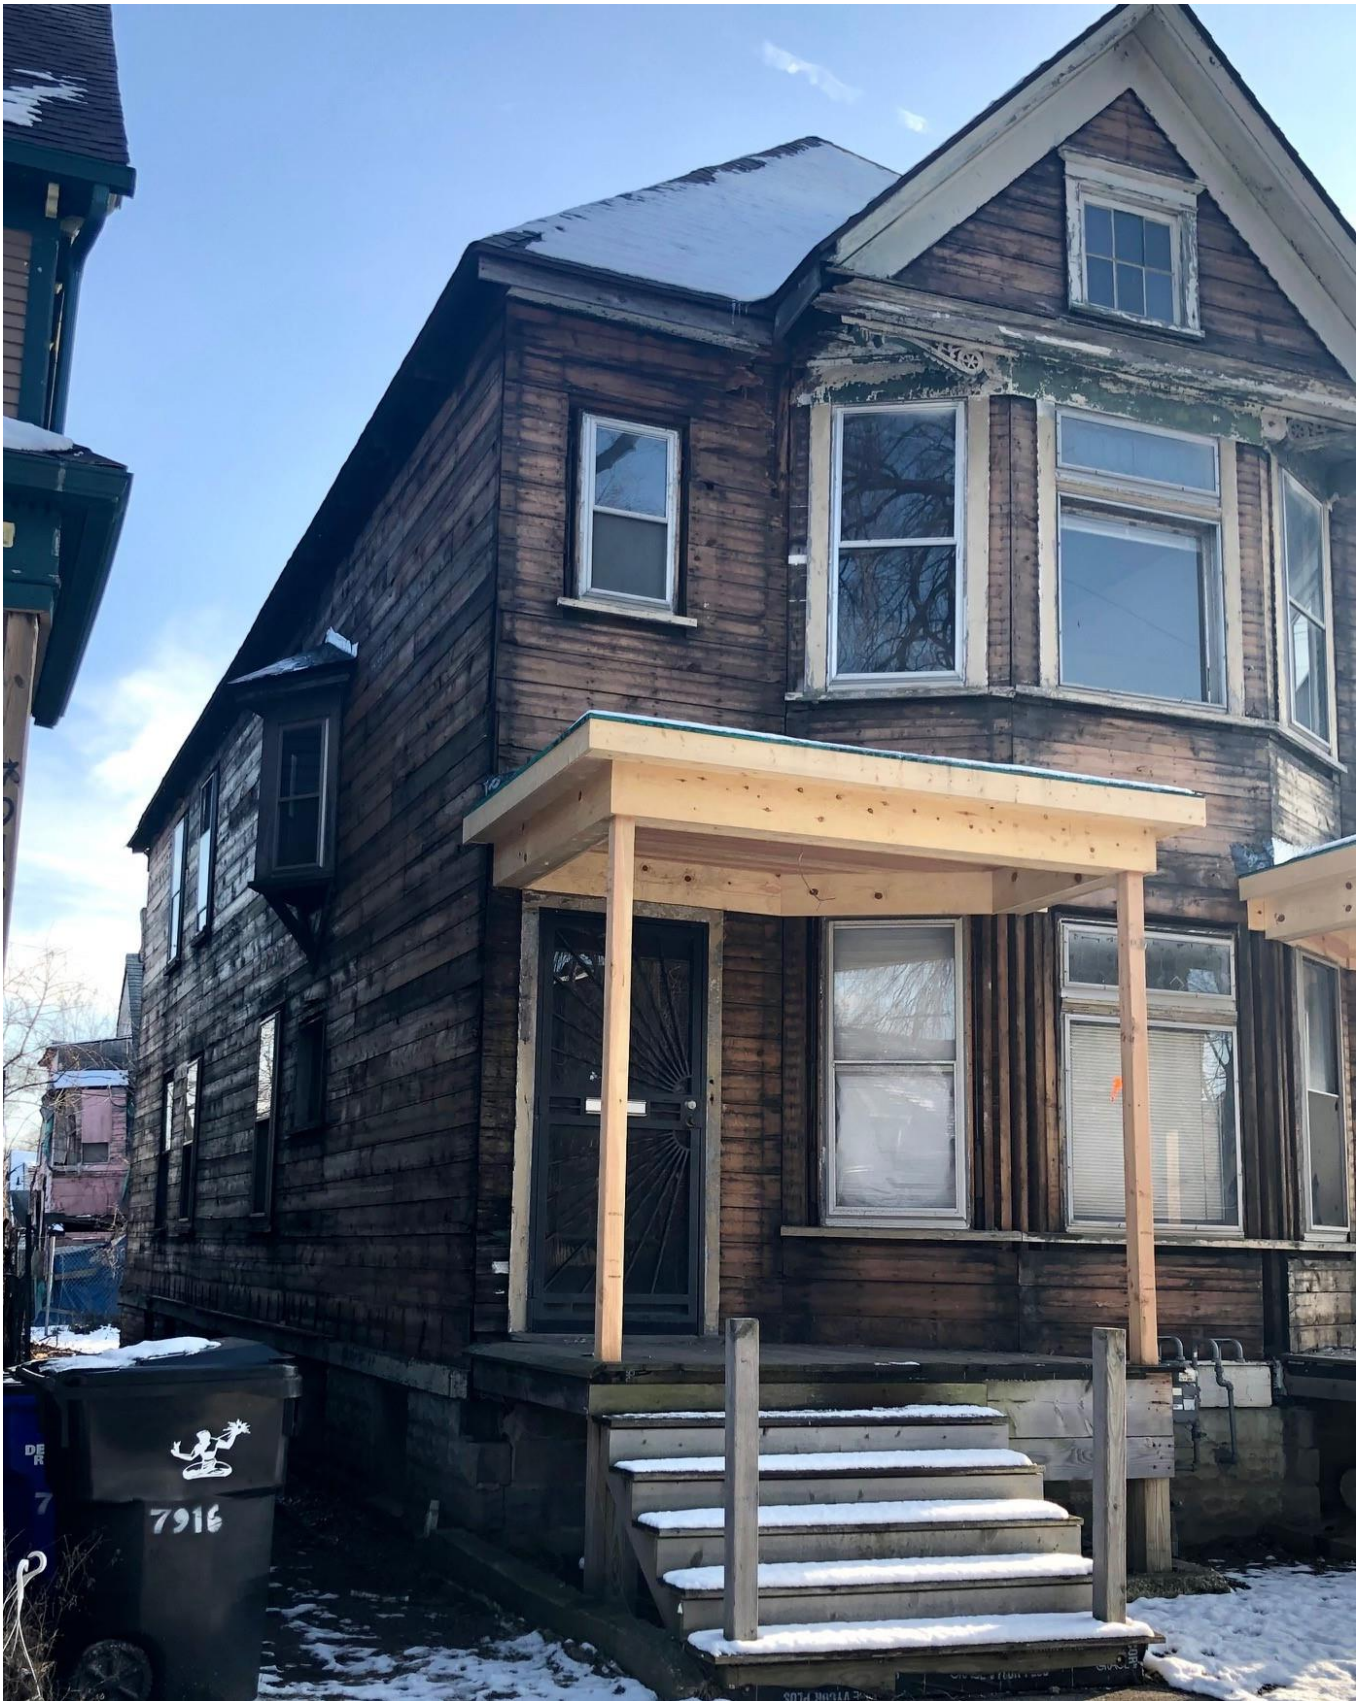
*Staff photo, January 2023*

- The existing loss of detail and character is substantial, and the likely removal of additional detail (window casings, thin windowsills, recessed window openings, reveal and profile of the two differently dimensioned historic wood siding) that would occur with the installation of cementitious siding will further destroy the historic and architectural appearance of this house, its identifiable time of construction, and its historic relationship to the other buildings in the district.

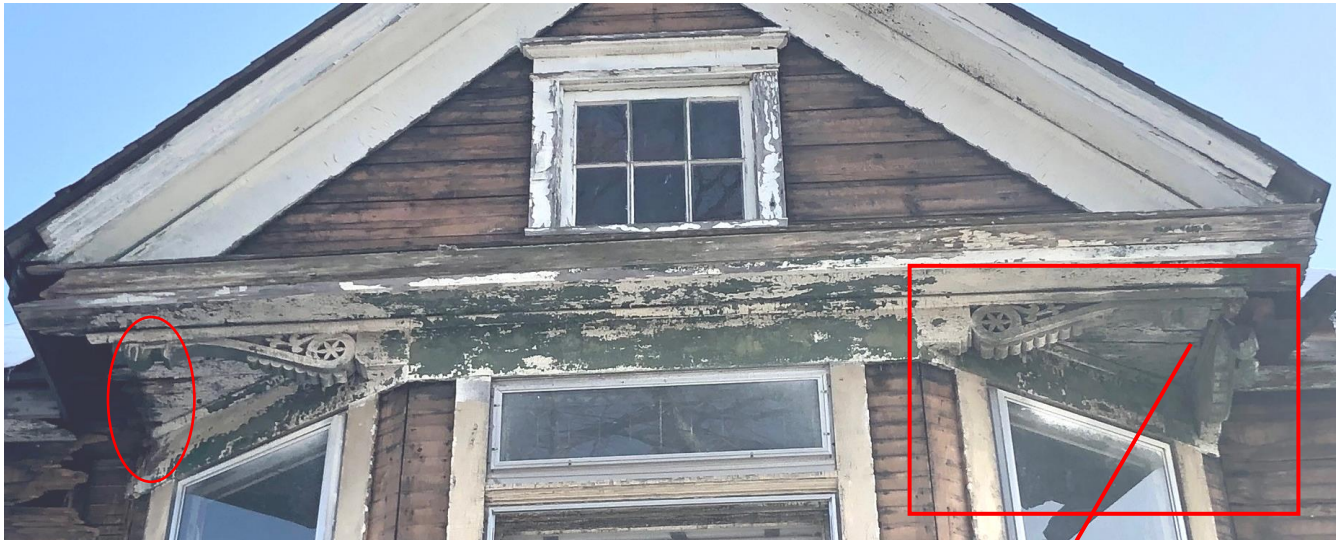
*Staff photos, January 2023*

- These pictures show ornament that remains in place and is unique to 7908-7912 St. Paul. These are distinctive character-defining features. One bracket is missing from the left side, but three remain intact and can be used to fabricate the missing bracket.

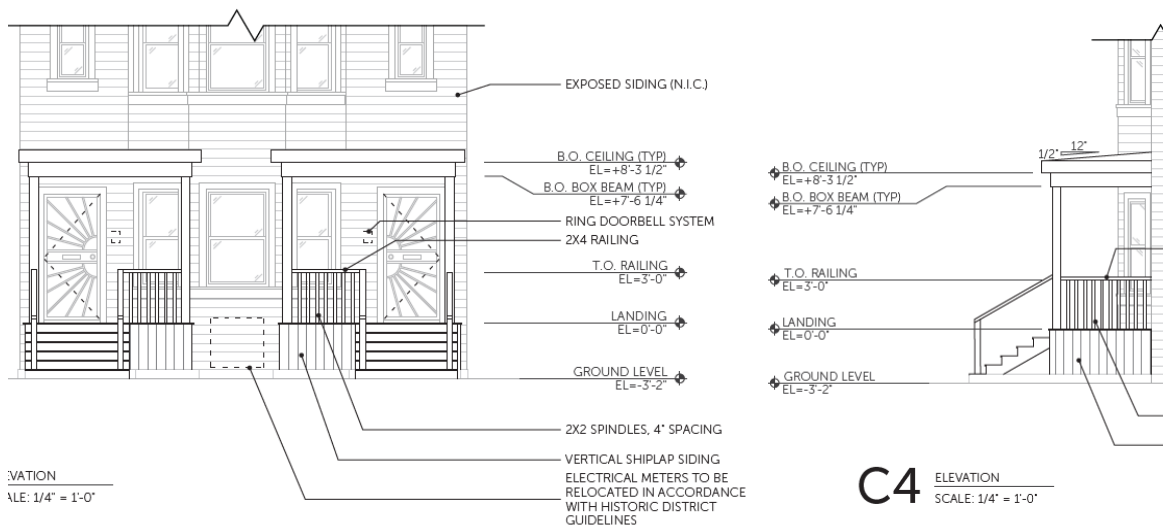
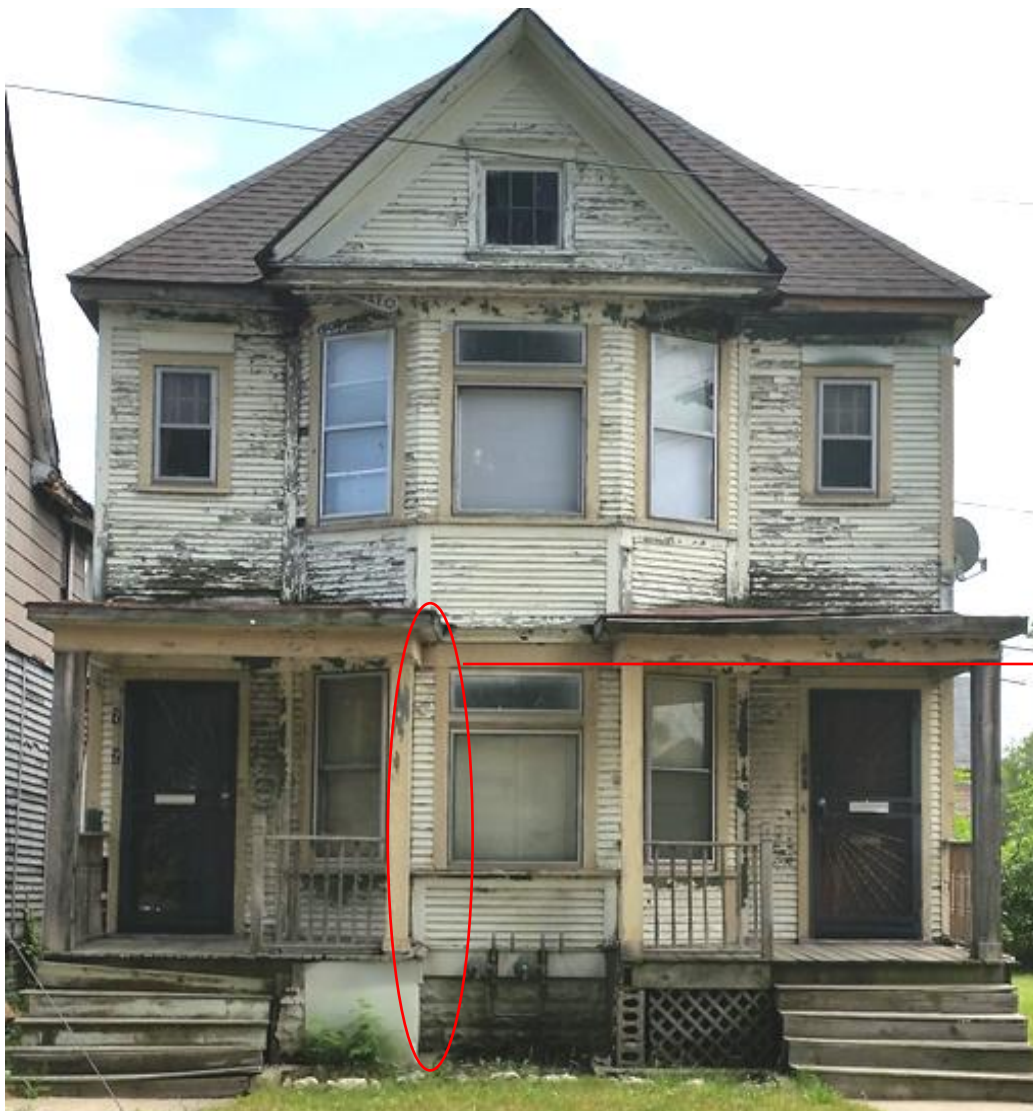
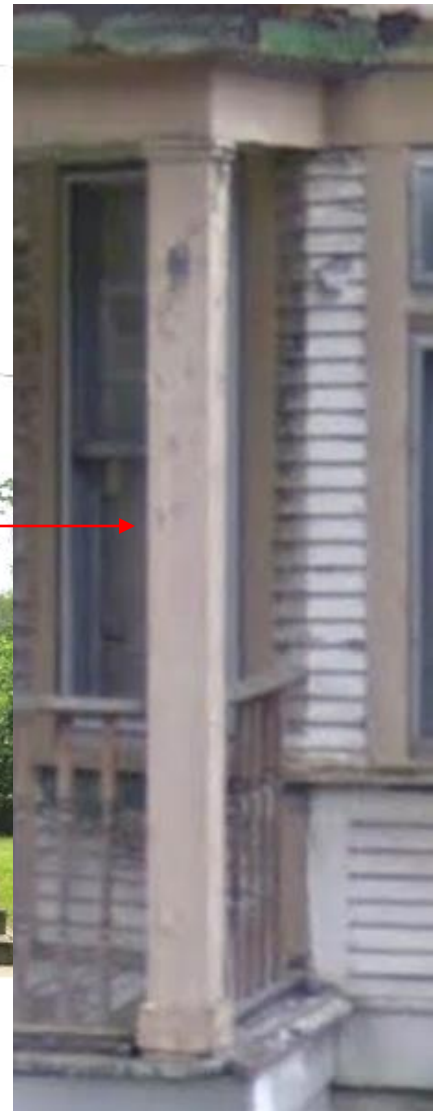
Applicant photo and drawings; photo at right is an enlarged Google street view from 2013.

- The issued Certificate of Appropriateness for the two front porches required the outer posts be constructed to match the existing interior corner posts. Currently all posts have been removed from the porch. The drawing on the following page shows unadorned (and not dimensioned) posts.
- The 2018 approved porch railing was to be similar to a historic design with square spindles affixed within a top and bottom rail that terminates at square corner posts. The railing shown on the drawing is a contemporary deck railing and not appropriate for a front elevation porch of an early 20<sup>th</sup> century house.
- Staff inquired with the applicant if the drawings were a change to the design or a drafting error. The applicant confirmed the drawings don’t reflect what will be constructed.

- The porch corner columns will match the previous interior corner columns in dimension and design,
- The porch and stair railings will have straight spindles, top and bottom rails, and square corner posts.
- The porch components will be left to dry for one to three months before painting; and will be painted C4 Yellowish White.
- Revised plans noting all of the above conditions will be submitted for staff review prior to pulling a permit.
