STAFF REPORT 05-10-2023 MEETING

APPLICATION NUMBER: 23-8337

ADDRESS: 1346 BROADWAY

SCOPE: REHABILITATE BUILDING

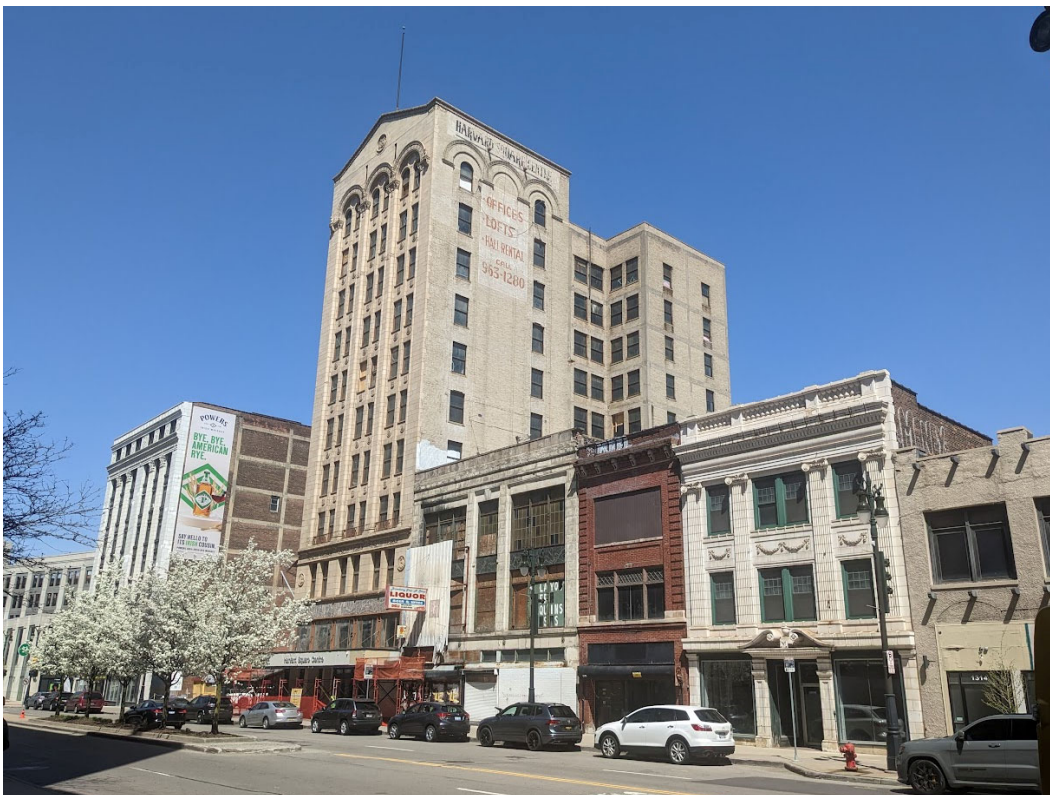
View of 1346 Broadway, looking north. Staff photo, April 19, 2023.

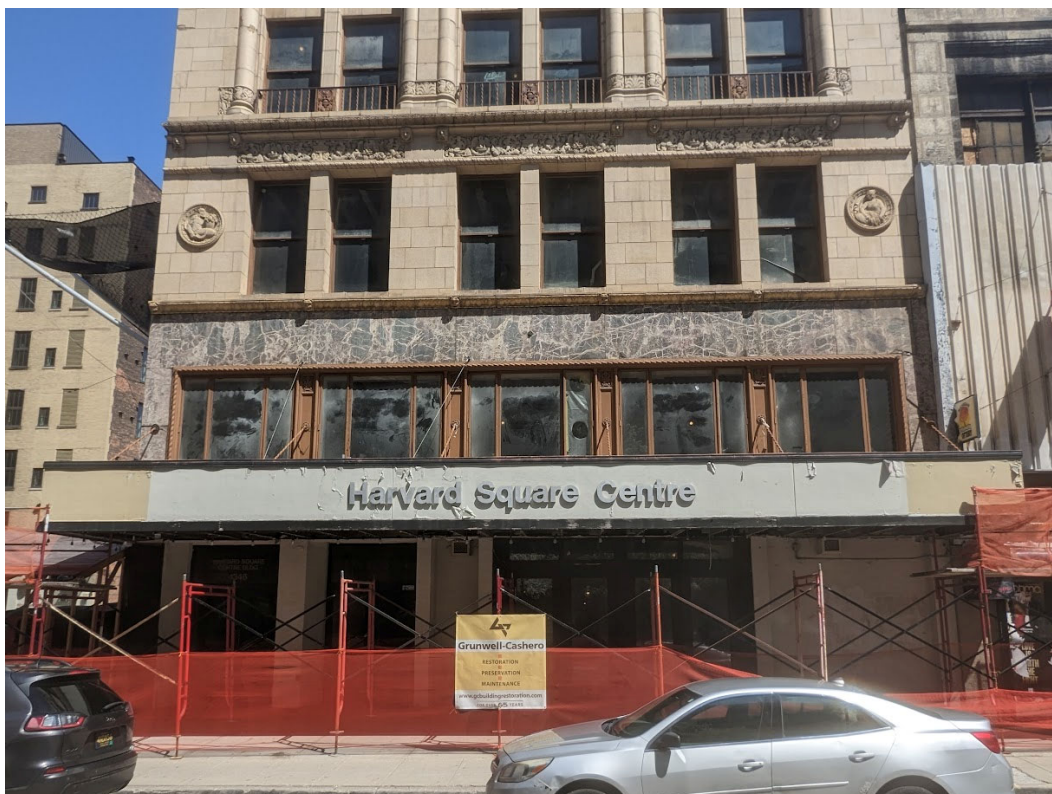
Detail view of the building's base. The ground level storefronts retain no original historic fabric of significance. Staff photo, April 19, 2023.

- Staff notes the appropriate treatments proposed by the applicant for many other distinctive historic features, including the mezzanine casement windows, cast iron elements, and the terra cotta ornament, which prioritize repair and spot replacement (with respect to the masonry) as necessary. The proposed contemporary storefront design is appropriate, in staff’s opinion.

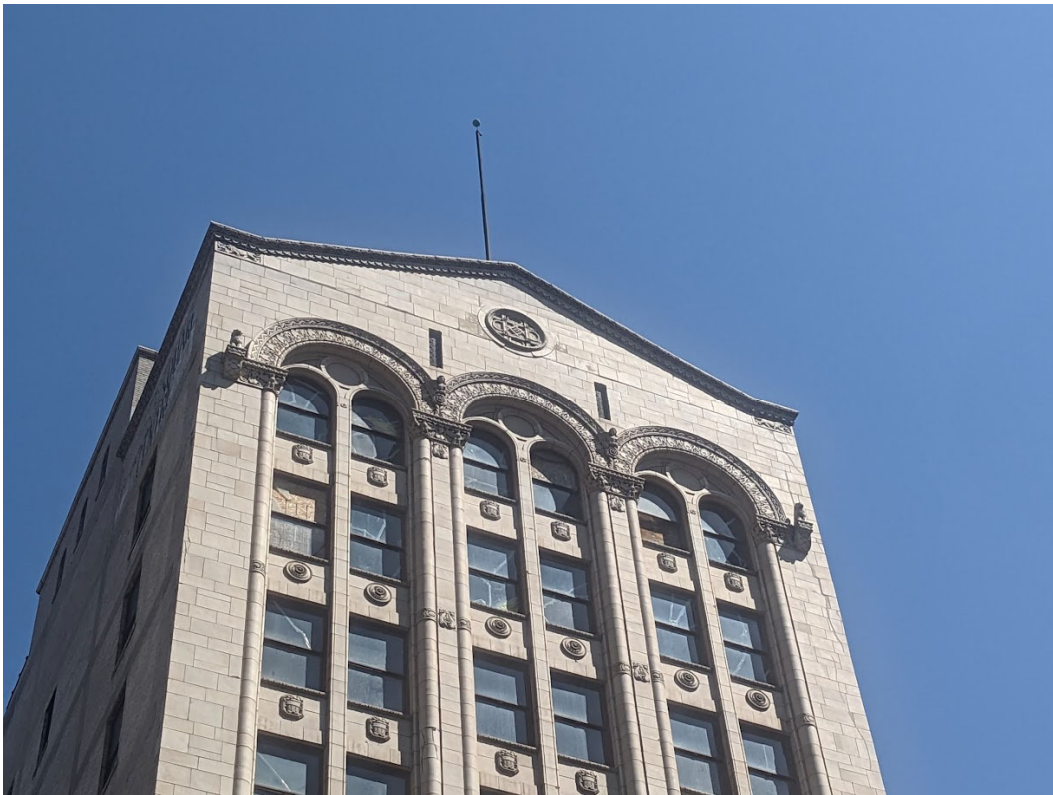
Detail view of the building's crown. Note extant flagpole. Staff photo, April 19, 2023.

- Like many of Detroit’s high-rise 1920s commercial buildings, this resource features a roof-mounted flagpole. Staff assesses that the flagpole is a design element that plays an important role in the architectural design of the building, and is therefore a historically significant and distinctive character-defining feature. Many other recent renovations of similar 1920s buildings in downtown’s historic districts have featured restoration of the roof flagpoles, or renewal with modern reproductions in the same locations. Preservation of these flagpoles, across many blocks, contribute markedly to the retention of early 20th century historic character across downtown.

- The original flagpole at the building's roof be retained, or if beyond repair, replaced with a reproduction subject to staff review and approval.

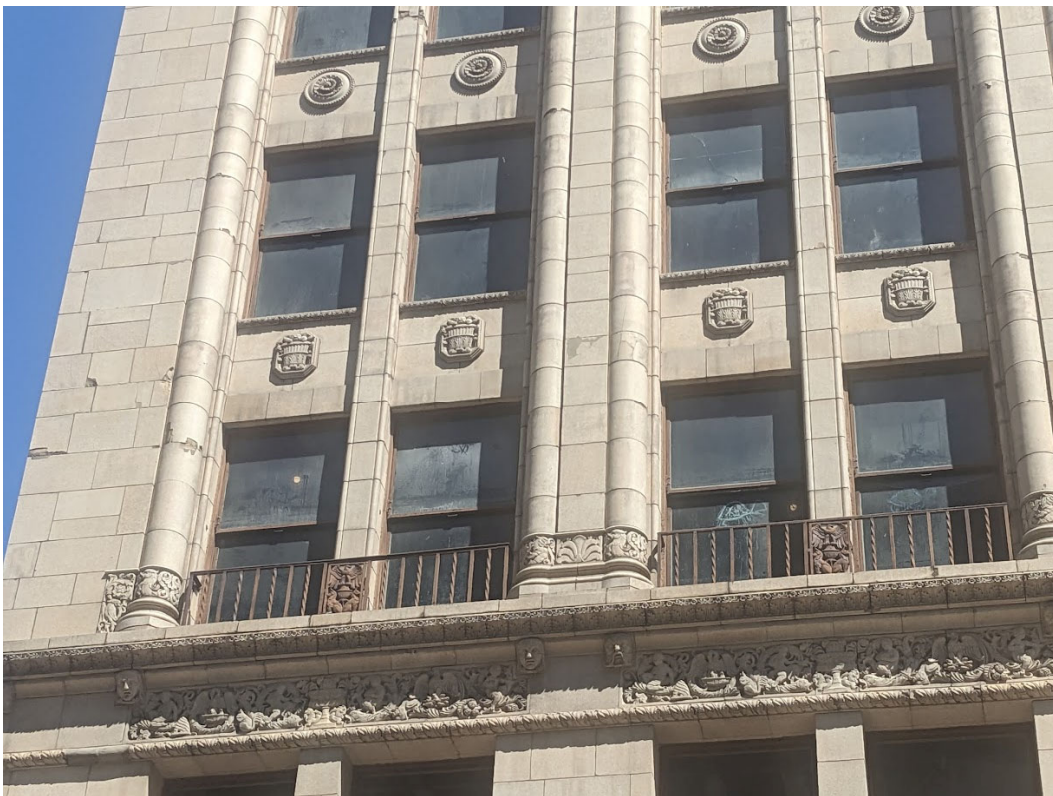
Detail view of the window and façade conditions. Staff photo, April 19, 2023.

- The applicant states that the existing windows above the mezzanine level are steel and have rusted into a ruined condition that precludes effective and feasible restoration. A selection of photographs, and a report provided by Blackberry Windows, supports this contention. Staff agrees with this professional assessment.

- For the proposed replacement windows, reviewed with respect to the NPS guidance given above, staff finds that the proposed replacement windows effectively reproduce the design and visual qualities of the original windows. New windows of the same historic material (steel) are neither feasible nor commonly available. The proposed windows, from Quaker’s commercial product line, reproduce the design, operation, and visual qualities of the historic prototypes, and are recessed properly into the façade, preserving historic shadow lines. Staff assesses that the proposed aluminum windows therefore satisfy Standard 6.

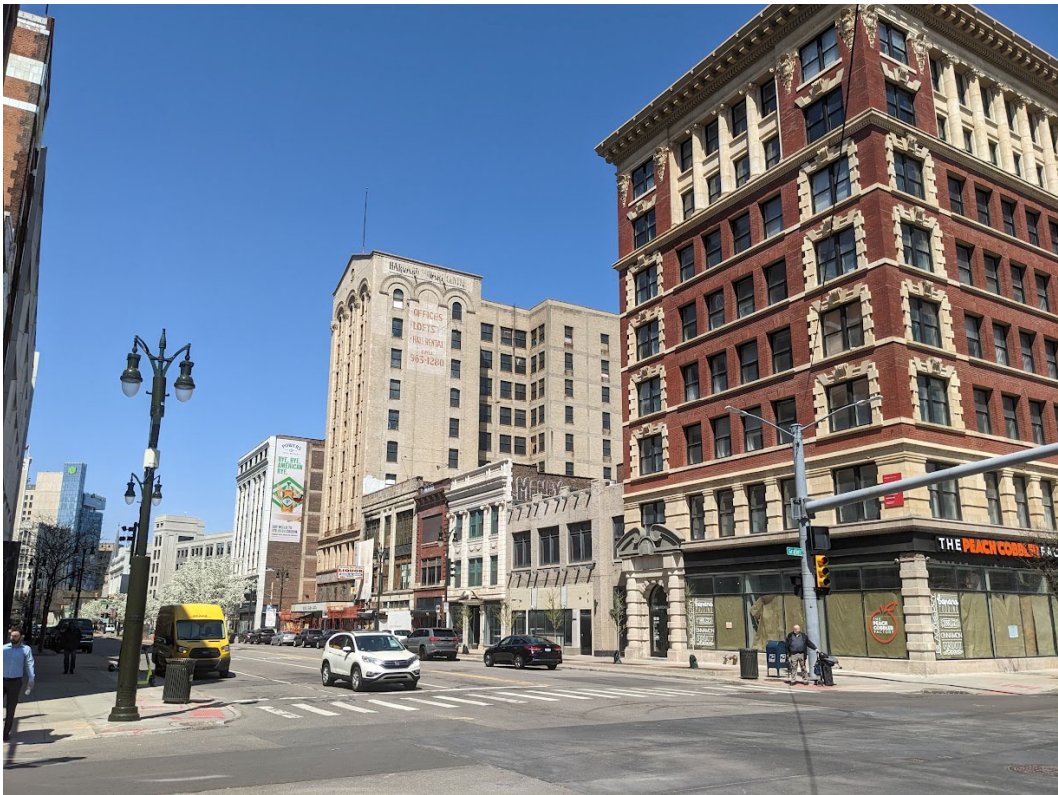
Distant view with additional historic context, view from Gratiot. Staff photo, April 19, 2023.

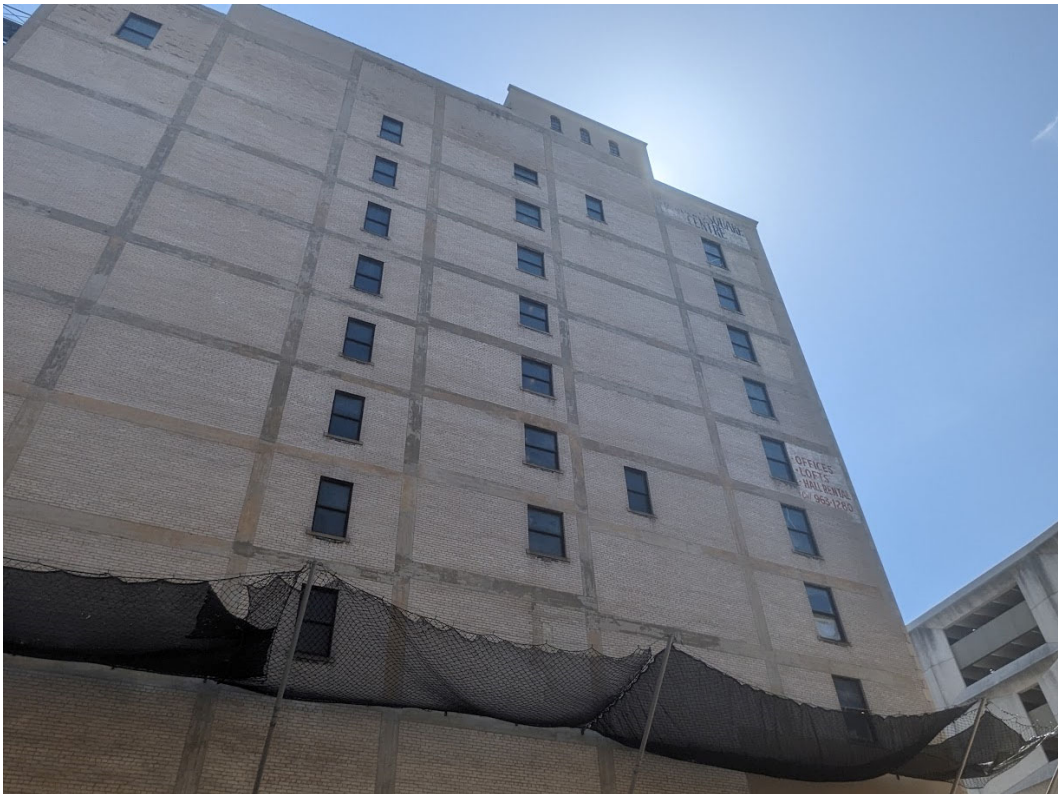
View of the west facing elevation from adjacent parking lot. Staff photo, April 19, 2023.

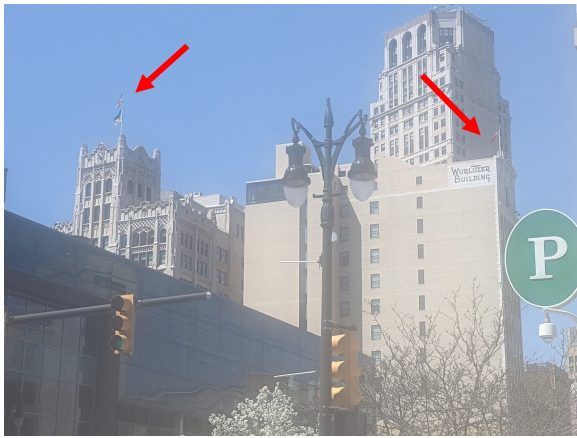
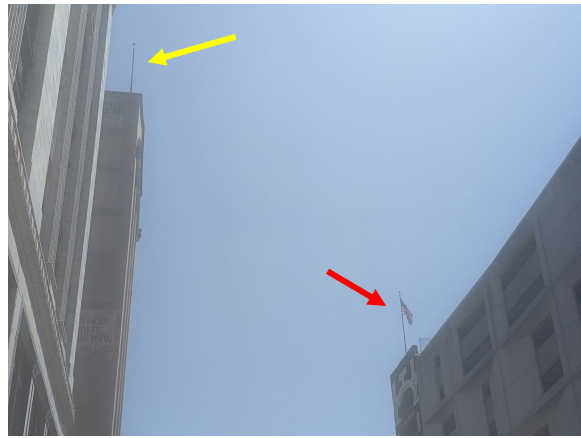
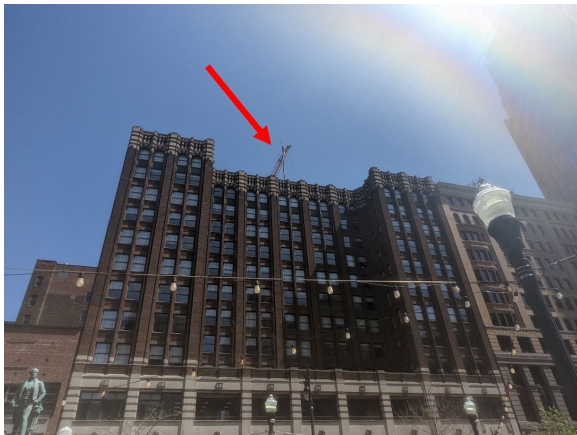
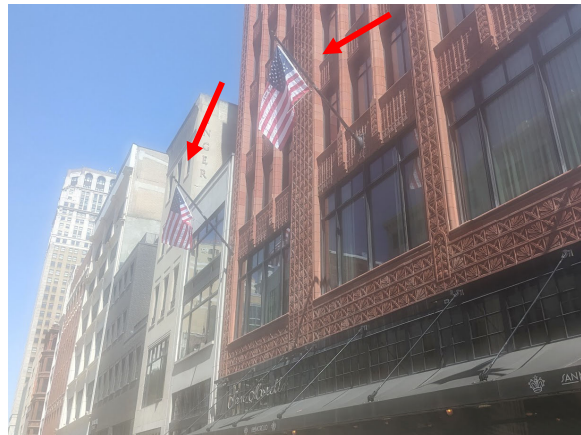
Examples of flagpoles as architectural elements in the Broadway Avenue Local Historic District (top row) and other historic districts. The flagpole at the crown of the subject building is arrowed in yellow, upper right. Staff photos, April 19, 2023.
